**Sir Audley Arms, Audley Rd, Chippenham**

**Further Bat Survey**

**10<sup>th</sup> May 2024**

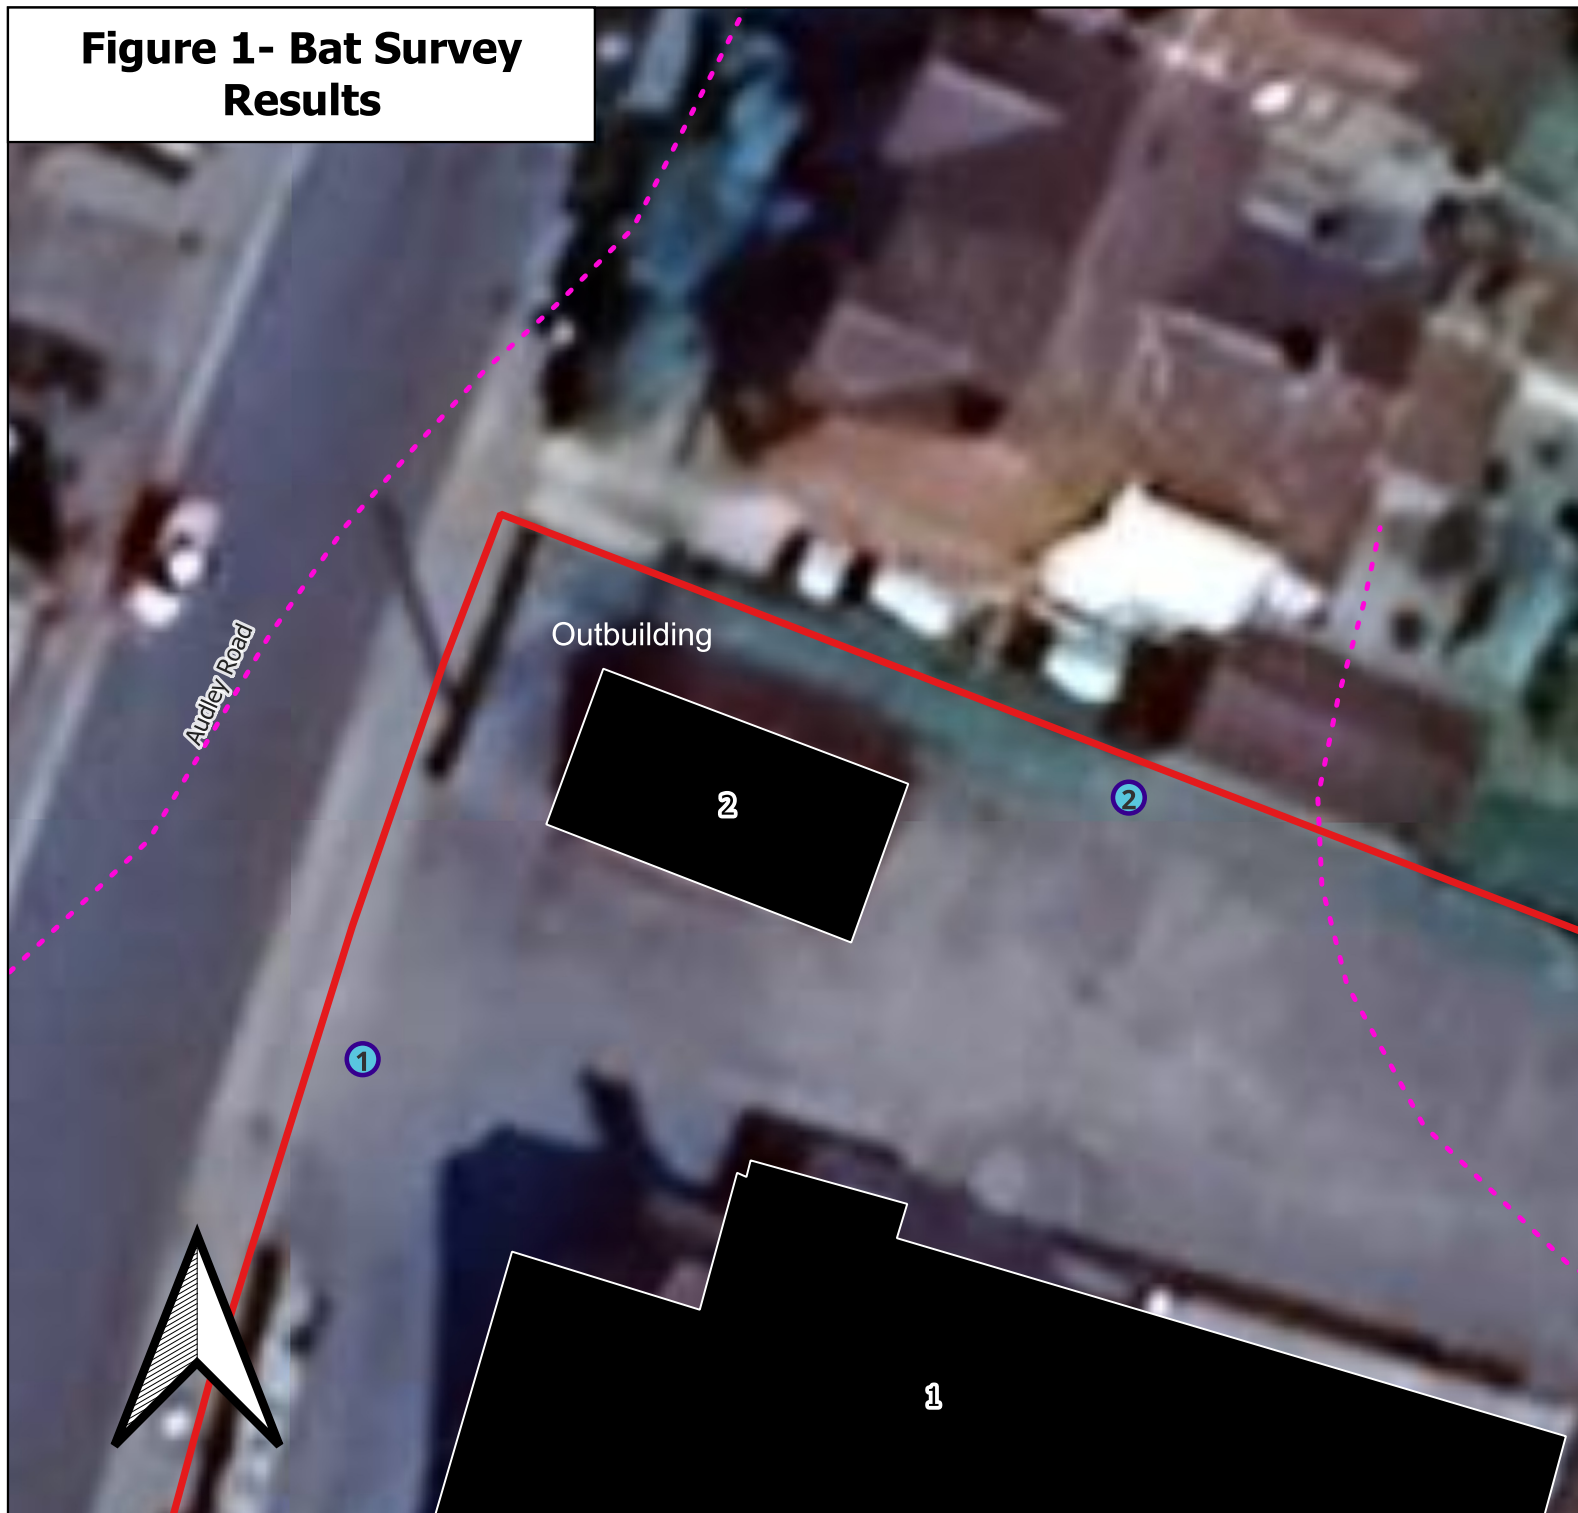
**Figure 1- Bat Survey Results**

In summary, no bats were recorded roosting at the site. Very low levels of bat activity were recorded during survey comprising of a single common pipistrelle passing to the west of the site at 21.10 plus a passing soprano pipistrelle recorded at 21.25 and a further passing common pipistrelle at 21.53. Noctule were recorded passing over the site at 21.03, 21.14 and 21.19. No other bat species or other bat activity was recorded.

The site was observed to be brightly lit by street lighting during survey, with street lighting illuminating the north facing roof pitch and west facing gable of the outbuilding. The street lights switched on at 21.00.

Surveyor locations and bat flight lines are shown on Figure 1 in the Appendix.
