**Potterne****PHASE II INTERPRETATIVE REPORT****Report Number:** R-G0807-01-P01**Date:** December 2025**Client:**

Wessex and West Ground Investigation Limited (WWGI) were instructed by Attwell Projects Ltd (the Client) to carry out a Phase II Geotechnical Assessment for the site known as 'Potterne'. The instruction to proceed is contained in email correspondence dated 5<sup>th</sup> November 2025.

At the time of writing, the future site use is a proposed new build residential dwelling.

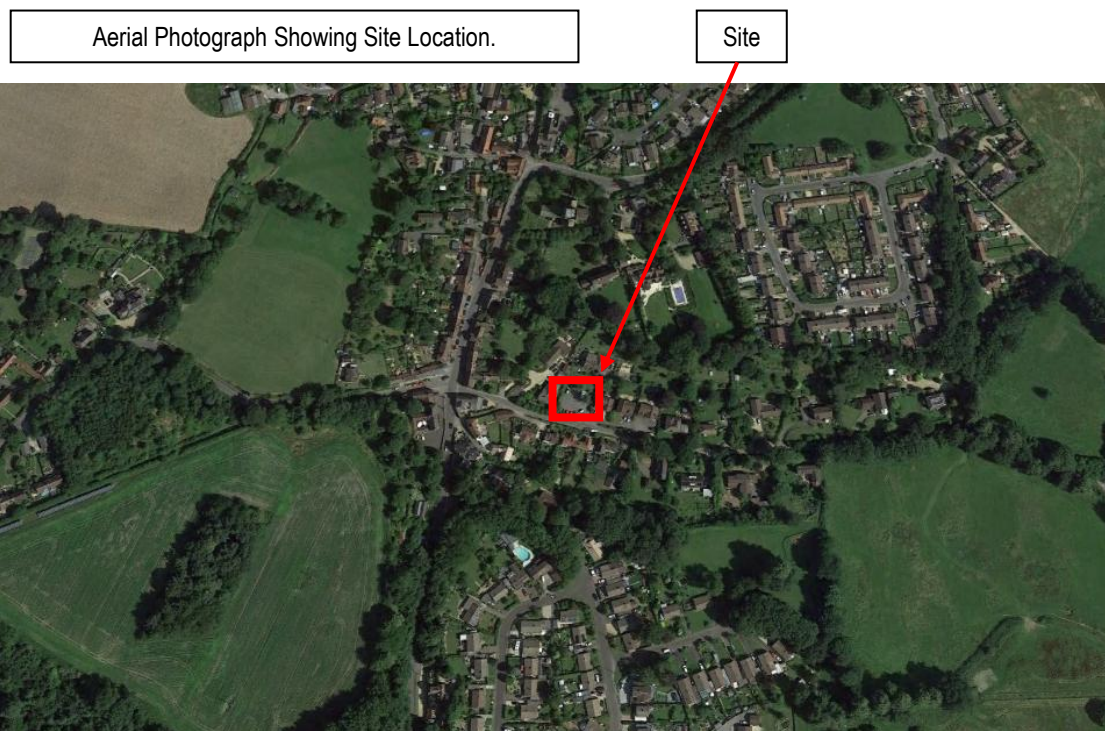
The site is located approximately 7 km to the east of Trowbridge within the village of Potterne, Wiltshire. The National Grid Reference of the site is ST 99549 58404. A Site Location Plan is presented in the Appendix A and an aerial photograph of the site is below.

At the time of the investigation the site consisted of a car park. The site is bound to the north by a garden and residential property, to the east and west by residential property and a road to the south. The site sloped gently from north to south with an existing soakaway present at the southern boundary. It is understood that the site was previously used as a fuel filling station for an adjacent business.
