**PRELIMINARY ROOST ASSESSMENT**  
**OF**  
**22 WOODS HILL, LIMPLEY STOKE, BA2 7GA**

| <b>Site Address</b> | 22 Woods Hill, Limpley Stoke, BA2 7GA |
| <b>Report type</b> | Preliminary Bat Roost Assessment |

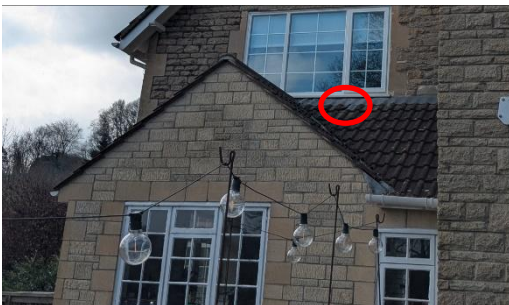
Photograph 5: The northeast extension of B1 with broken tile circled.

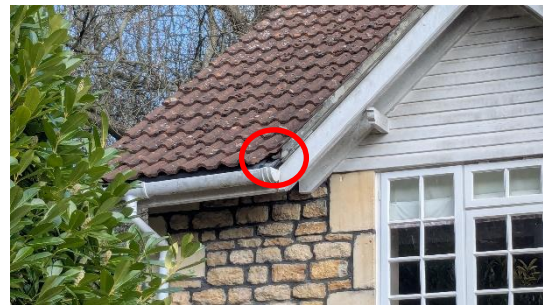
some areas of the roof could not be viewed during the survey. Where visible, the ridgelines across all roofs appeared in good condition with no gaps or cracks noted. The tiles generally appeared to be tightly fitted together (where visible) due to their design, with only occasional gaps noted, including cracked tiles at the base of the dormer on the southwest elevation of the building and on the northeast extension. No gaps or cracks were noted under the end tiles on all the gable ends and dormers across the building.

Photograph 6: Broken tile at the base of the dormer, southwest roof pitch of B1.

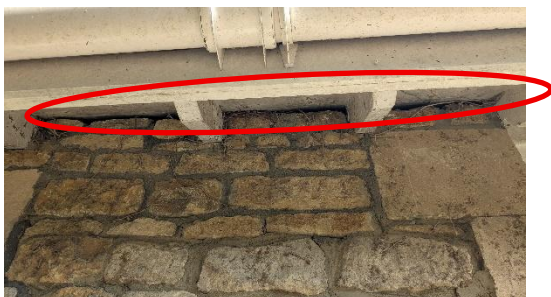
- 3.3.2 Gaps were noted under all the soffits, along the eaves of the building. Areas of wooden boarding were present on the dormers of the southeast and southwest elevations. Gaps were noted around these areas and the internal inspection showed these led directly into the interior of the loft space, as did the stone ventilation feature on the southeast gable.

Photograph 7: An example of the gaps along the eaves of B1.

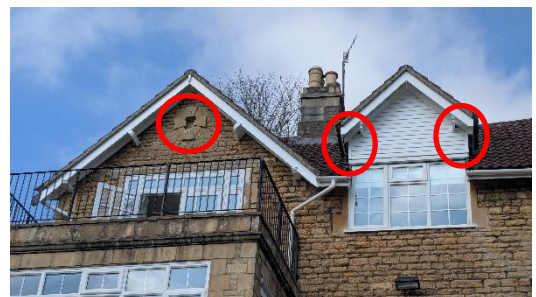
Photograph 8: Gaps around the dormer and ventilation feature noted on the southeast elevations of B1.

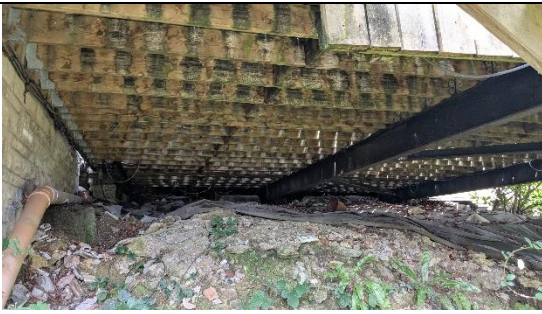
- 3.3.3 The stonework across the building did not have any gaps or cracks and the windows and doors were well fitted within their frames, with no holes leading into the building. A wooden deck was present along the northeast elevation of the building, the space beneath was light and open and the majority was ~1m from ground level.

**Photograph 9: The space under the northwest decking off B1.**

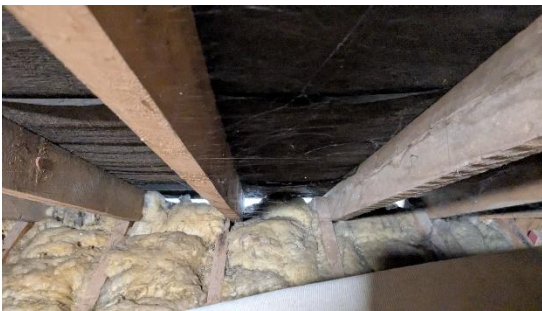
- 3.3.4 Internally a loft space was present above the main dwelling. This was ~210cm tall, was lined by bitumen felt and supported by wooden beams. Daylight was noted around the southeast and southwest dormers and along the eaves of the roof. No gaps or cracks were noted in the internal stone or blockwork of the gable ends. The loft space above the northeast extension was not accessible at the time of the survey due to it lacking a loft hatch.

**Photograph 11: An example of daylight noted along the eaves of the roof space of B1.**

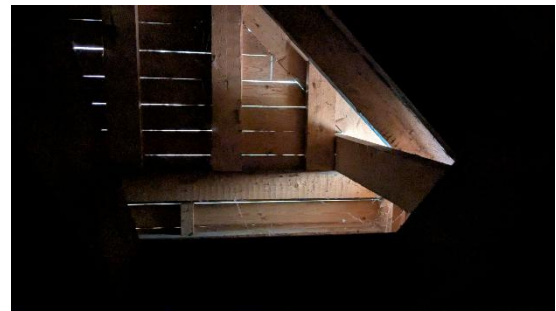
**Photograph 12: Daylight noted from within the loft space, around the southeast dormer of B1.**

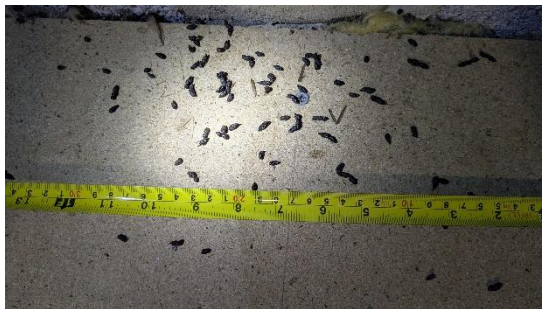
- 3.3.5 Details:
- Evidence of bats was found within the main loft space. This included ~60 bat droppings located in a pile at the northeast gable end of the loft. These appeared fairly fresh at the time of the survey.
  - No individual bats were observed internally or externally during the building inspection.
  - A potential loft space above the northeast extension could not be accessed at the time of the survey.
- 3.3.6 A moderate number of potential roosting features were identified during the inspection of the building. These included:
- A small number of lifted and broken tiles across the roof pitches of the building;
  - Limited views of sections of the roof;
  - Gaps along the eaves of the building and around dormers that led into the loft space;
  - The main loft space above the dwelling;
  - A potential loft void above the northeast extension.

**Photograph 13: Bat droppings noted at the northwest gable within the loft of B1.**

- 5.2.1 Further bat survey work is recommended for the building B1 to confirm how bats are utilising the building and whether bat roosts are present/likely absent within the northeast extension. These should be undertaken during the active bat season of May to September inclusive with at least one undertaken in the optimal survey season, May to August inclusive. Minimum of two bat emergence surveys are recommended to assess the areas to be impacted by the proposed development. However, if a bat roost is identified, further surveys may be required to characterise the roost and inform a bat licence.

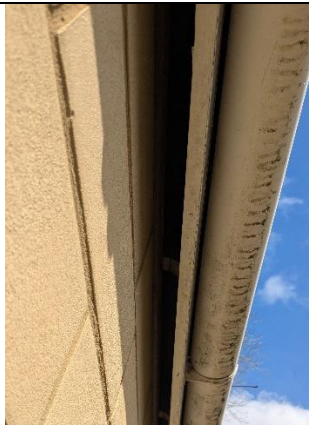
- 3.3.7 Building B2 was a block-built, detached office and garage space with a conventionally pitched roof of interlocking tiles. The ridgeline of the building appeared in good condition with no gaps or cracks, the tiles were well fitted together with no lifted or slipped tiles. Due to the slope of the land, the northwest roof pitch was only ~30cm from ground level. No gaps were noted under the end tiles of the gable ends. The fascia board along the southeast elevation sat far from the external wall without creating a crevice. No gaps were noted in the blockwork across the building, which was believed to not have a cavity wall. The windows along the southeast elevation were well fitted within their frames with no gaps leading into the interior of the building. The garage door on the southwest gable had a thin gap along the top leading inside the building.

**Photograph 17: The gutterboard of B2 sitting far from the external wall.**

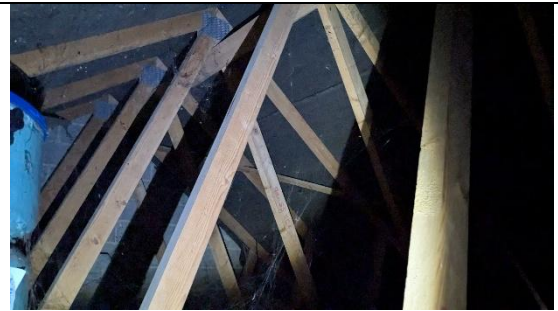
- 3.3.8 Internally, the southern end of the building had a vaulted roof, with a small, enclosed loft space above the northern portion of the building. Both sections were lined by bitumen felt and supported by wooden beams. Daylight was noted along the northwest and southeast eaves. The loft space was full of thick cobwebs during the survey. No gaps or cracks were noted in the internal blockwork and the southern space was very light due to the windows.

**Photograph 18: Small loft space at the northern end of B2.**

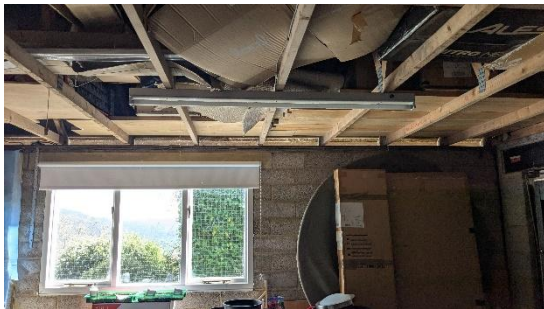
**Photograph 19: Internal environment within the southern section of B2.**
