# 7 STOKE MEAD LIMPLEY STOKE BATH BA2 7GX

## Preliminary Bat Roost Assessment Report

*March 2026*

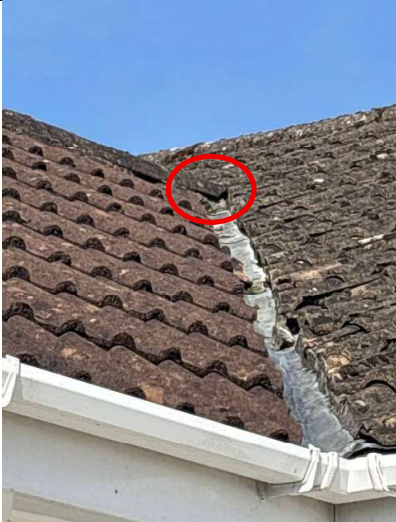
| Feature | Photograph |
|---|---|
| PRF 1 | |

- A localised section of missing mortar was identified beneath the ridge line on the western side of the south-facing roof slope of the extension, creating small crevice features beneath the ridge tiles (PRF 1).

- 3.6.2. In accordance with current Best Practice Guidance (Collins, 2023), a minimum of one bat emergence and re-entry survey (BERS) will therefore be required to determine the presence or absence of roosting bats prior to works commencing. These surveys should be undertaken during the optimal survey season, between May and September 2026, and under suitable weather conditions.

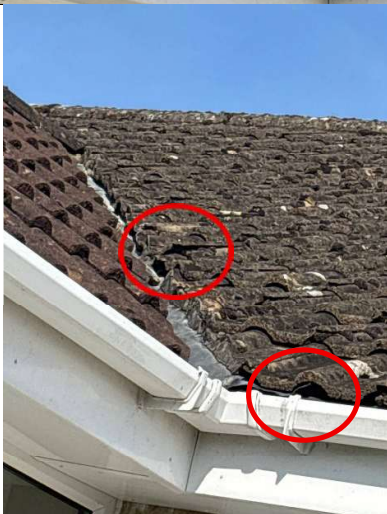
| Feature | Photograph |
|---|---|
| PRF 2 | |

- Several tiles on the western side of the south-facing slope of the main roof were observed to be slightly lifted or displaced, resulting in narrow gaps beneath the tiles (PRF 2).
- Additional lifted tiles were recorded on the extension roof below a rooflight on the western aspect, forming a small void beneath the tile (PRF 3).
- Mortar degradation was noted along the western eaves, creating small gaps beneath the roof edge tiles (PRF 4).
- A single lifted tile adjacent to the ridge on the western side of the south-facing roof slope was also identified, resulting in a narrow gap beneath the tile (PRF 5).

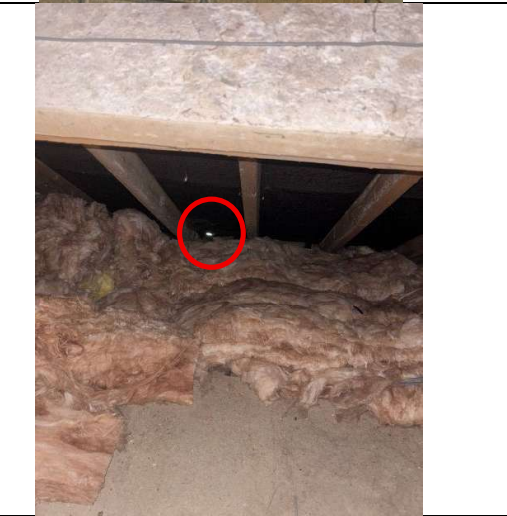
| Access point 1 | | | |

- 3.2.7. During an inspection of the internal rood void, the humidity reached approximately 77% and the internal temperature 9 degrees.
- 3.2.8. A tear in the roofing felt was identified approximately centrally within the loft void, close to the roof edge (Access Point 1). Daylight was observed penetrating through this feature, confirming that it is open to the external environment and therefore has the potential to function as an access point for bats. This feature was not identified during the external inspection, likely due to its position and limited visibility from ground level. The suitability for use by bats is considered limited due to the presence of dense fibreglass insulation directly beneath and surrounding the opening, which is likely to impede access and reduce its functionality as an ingress/egress point.

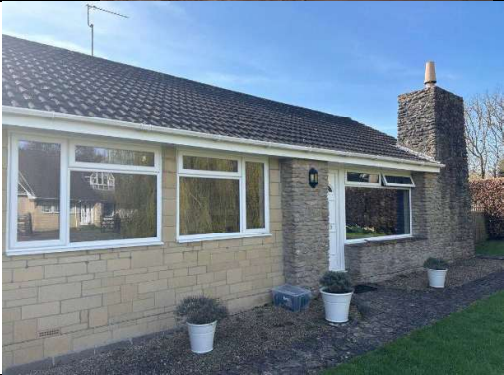
| Northern elevation of the building | | |

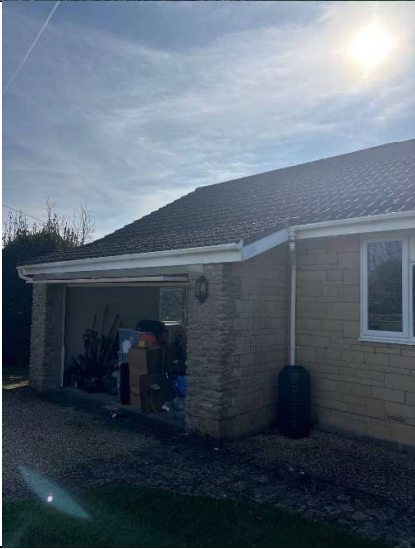
| Northern elevation of the building | | |

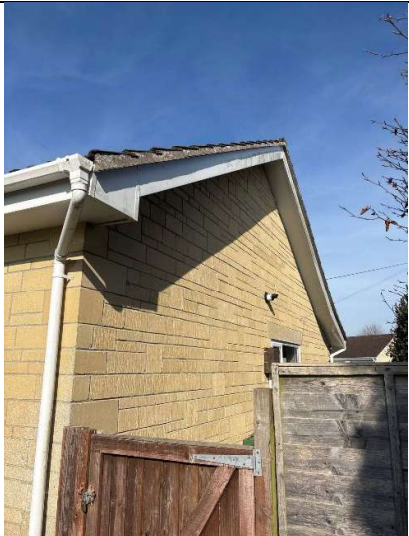
| <i>Eastern<br/>elevation of the<br/>building</i> | A photograph showing the eastern elevation of a building. The wall is covered in light-colored, textured tiles. A white gutter runs along the roofline. A wooden fence is visible in the foreground. |

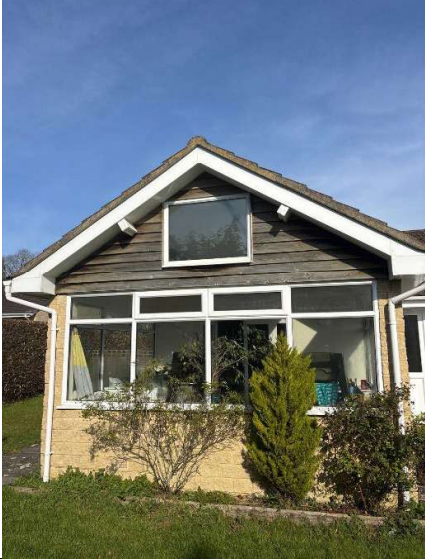
| <i>Southern<br/>elevation of the<br/>building</i> | A photograph showing the southern elevation of a building. The building features a gabled roof with dark tiles and a large, multi-paned glass extension on the ground floor. The lower part of the wall is made of light-colored tiles. There are some bushes and a small tree in front. |

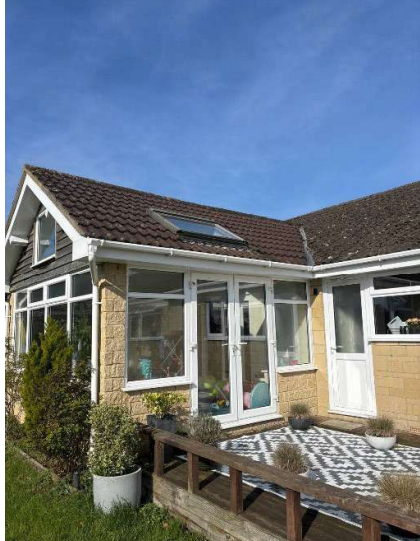
| <i>Southern<br/>elevation of the<br/>building</i> | A photograph showing another view of the southern elevation of the building. This view shows a corner of the building with a glass extension and a tiled roof. A wooden deck with a patterned rug is in the foreground. |

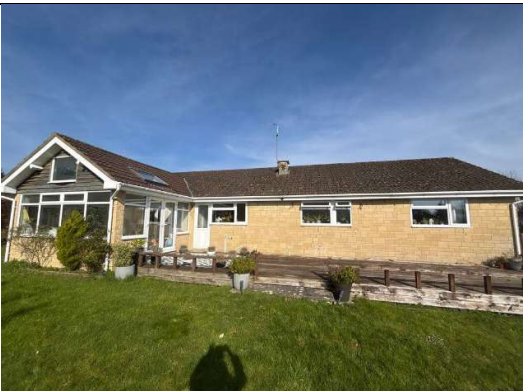
| <i>Southern elevation of the building</i> | A photograph showing the southern elevation of a single-story house. The house has a gabled roof with a dormer window on the left. The exterior walls are made of light-colored stone or brick. There are several windows, including a large bay window on the left. The house is set on a green lawn with some small shrubs and a wooden fence in the background. |

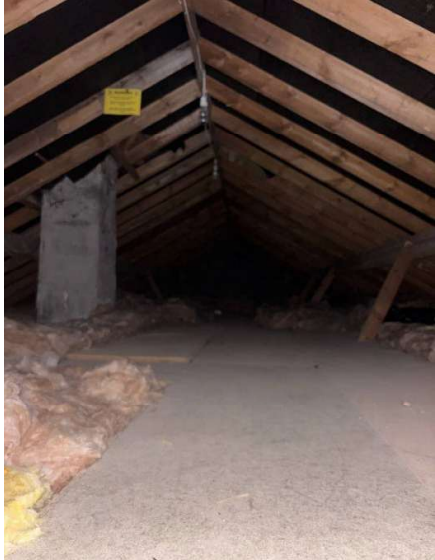
| <i>Roof void</i> | A photograph showing the interior of the roof void. The structure consists of wooden rafters and a concrete support pillar. There is some insulation material visible on the left side, and the floor appears to be a concrete slab. |

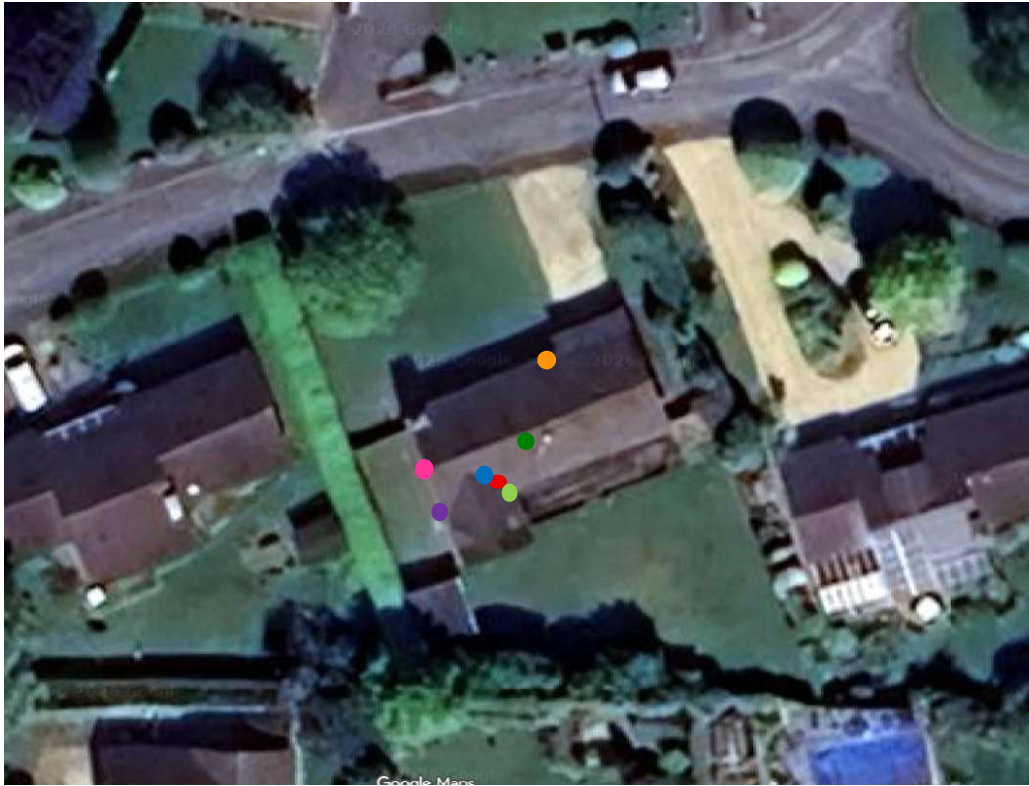
Figure 3.3. Proposed roosting features in relation to proposed plans.

- Blue dot relates to PRF 1.
- Red dot relates to PRF 2.
- Light green dot relates to PRF 3.
- Purple dot relates to PRF 4.
- Pink dot relates to PRF5.
- Orange dot relates to access point one.
- Dark green dot relates to access point two.
