# **The Glen, Chippenham**

Preliminary Roost Assessment

| Project: | The Glen, Ashes Lane, Kington Langley, Chippenham, SN15 5NP |
| Document reference: | 5665.2 |

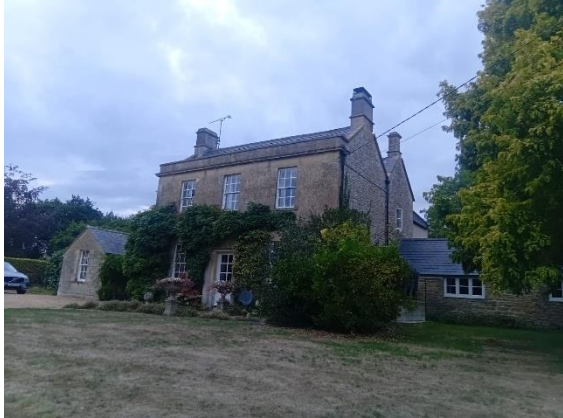
Photo 1 – external view of building 1 front.

Building 1 - there was no evidence of bats recorded externally or internally. The fabric of the building was in very good repair with the structure being largely free of PRFs.

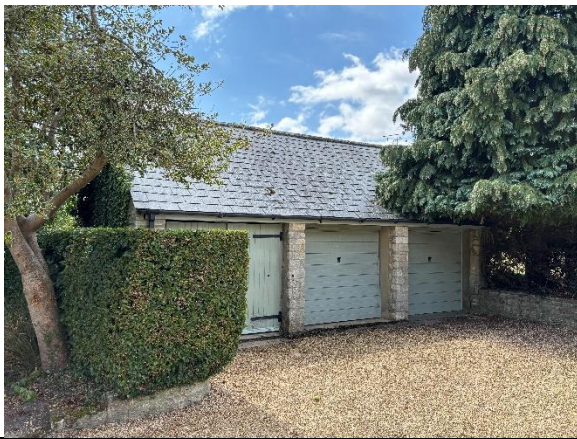
Photo 5 – external view of building 2 front.

Building 2 - the detached garage on Site was CONFIRMED to house a maternity roost for 7 lesser horseshoe bats.

Any works which are proposed to building 2 should only be undertaken when an EPSL has been granted by Natural England. No disturbance to the building or its surrounding should take place between 1<sup>st</sup> may and 30<sup>th</sup> September, whilst pregnant lesser horseshoe and their dependant young are present.

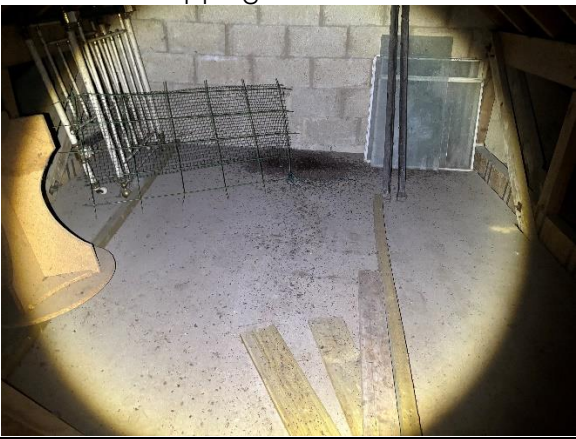
Photo 6 –building 2 internal view, lesser horseshoe droppings on the floor

| Building | Bat Roost Potential | Reason | Requirements |
|---|---|---|---|
| Building 2<br>– the<br>garage | <b>CONFIRMED</b> | <ul style="list-style-type: none"> <li>• Good material condition</li> <li>• C5000 bat droppings recorded on the floor of the mezzanine</li> <li>• 7 lesser horseshoe bats recorded roosting.</li> <li>• No evidence of birds was recorded externally or internally.</li> </ul> | Three surveys required between 1 <sup>st</sup> May and 30 <sup>th</sup> August. |
