## Design & Access Statement

29 Langley Road

This document has been produced in support of a Non-material amendment of an existing planning permission and Listed Building Consent in relation to works pertaining to 29 Langley Road.

This application relates to proposed changes on the rear-most extension of the property only, which was added recently relative to the age of the main property.

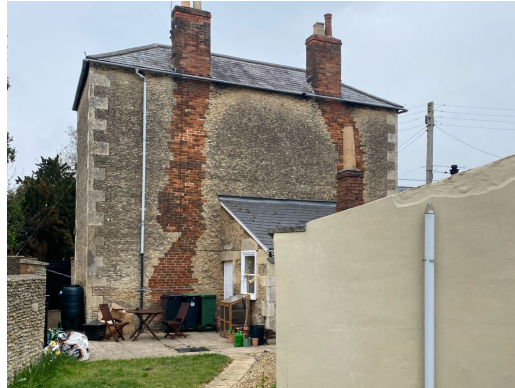
5. Rear blank elevation, with rear-most extension seen to right

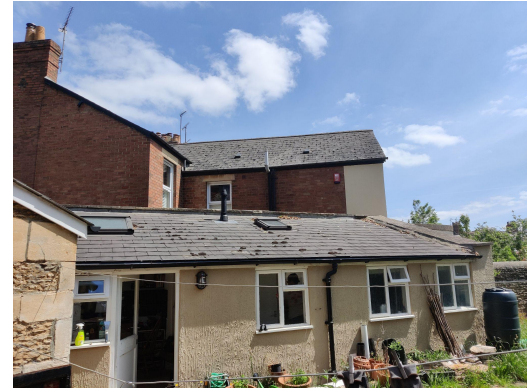
5. Side view of rear-most extension

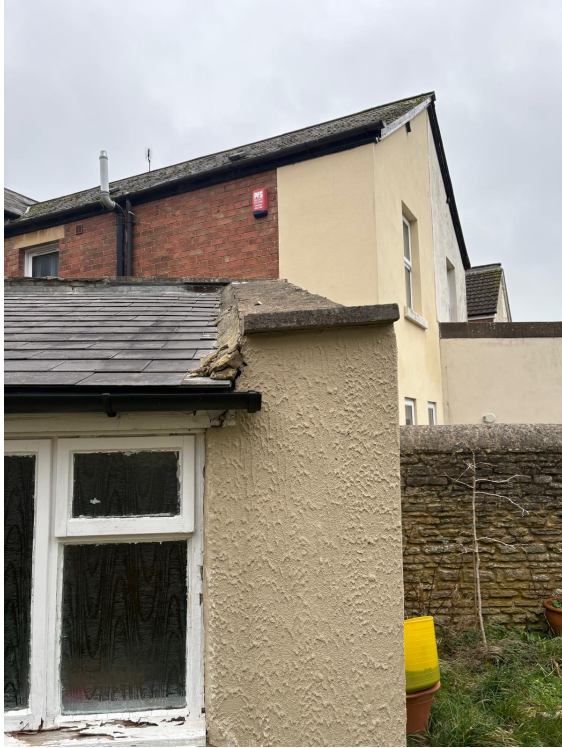
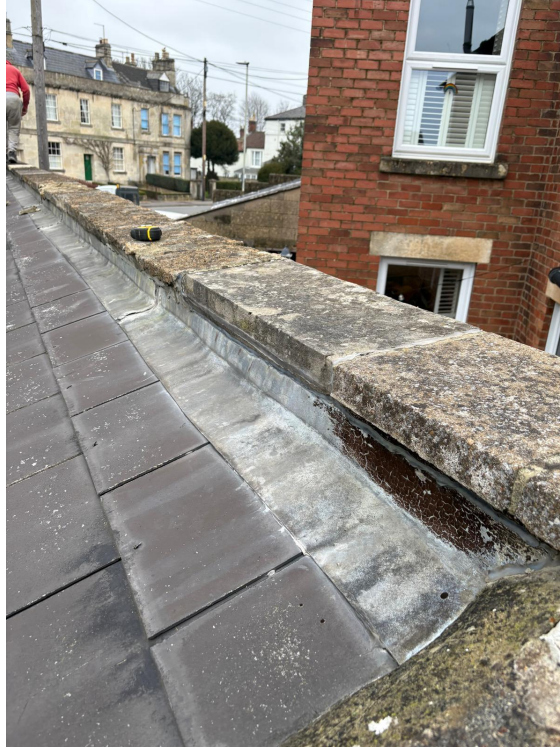
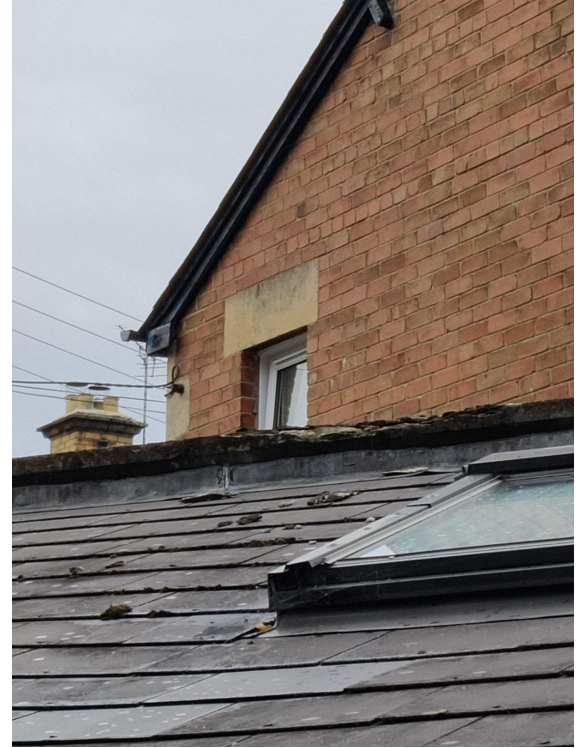
*Existing coping stones; Failure of the coping stones to the boundary wall, with open joints and displaced units resulting in water penetration to the wall head and progressive saturation of the masonry and supporting timber beams in the roof fabric below.*

| Item | Proposed Material/s |
|---|---|
| Coping Stones | <p>Cast Bath Stone, Once Weathered<br/><a href="https://www.thorvertonstone.co.uk/coping-stones">https://www.thorvertonstone.co.uk/coping-stones</a></p> <p>This material replaces plain concrete stones which are badly deteriorating. The cast bath stone proposed is sympathetic to the historic fabric of the property, whilst matching the style and colour of the stone quoins on the main portion of the property.</p> |

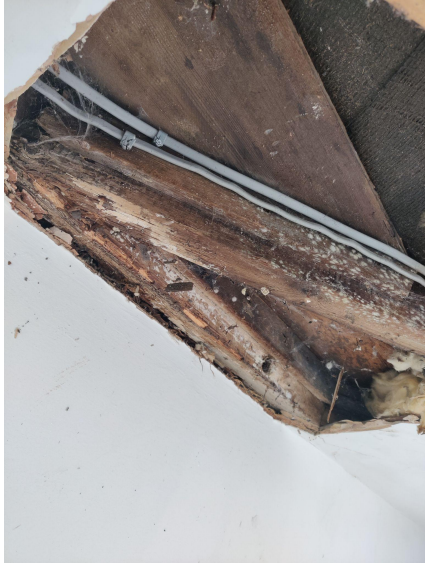
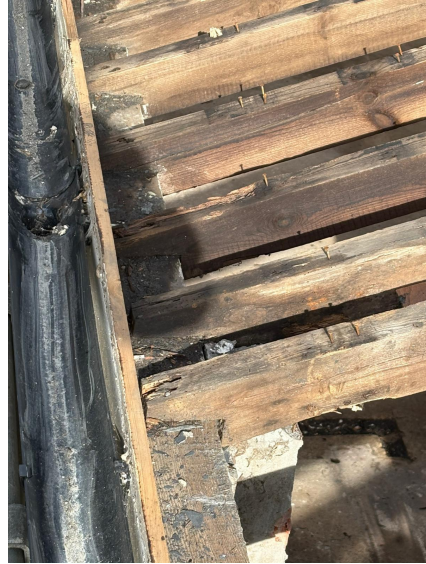
*The roof timbers exhibit evidence of prolonged water ingress, consistent with the failure of the coping stones to the adjacent wall head. Separately, a number of structural members display evidence of mechanical degradation and section loss. This represents a structural risk to the roof assembly.*

A significant portion of the roof timbers in this rear extension were due to be replaced already as part of the work to install new rooflights, as approved in the previous Planning Permission and Listed Building Consent. However, inspection of the material once work commenced highlighted the issues shown here, resulting in this proposal to replace all of the roof timber in the extension.
