**Land North of Swindon Road, Royal  
Wootton Bassett**  
Archaeological Management Plan  
(including Scheduled Monument)

Gleeson Land  
April 2026

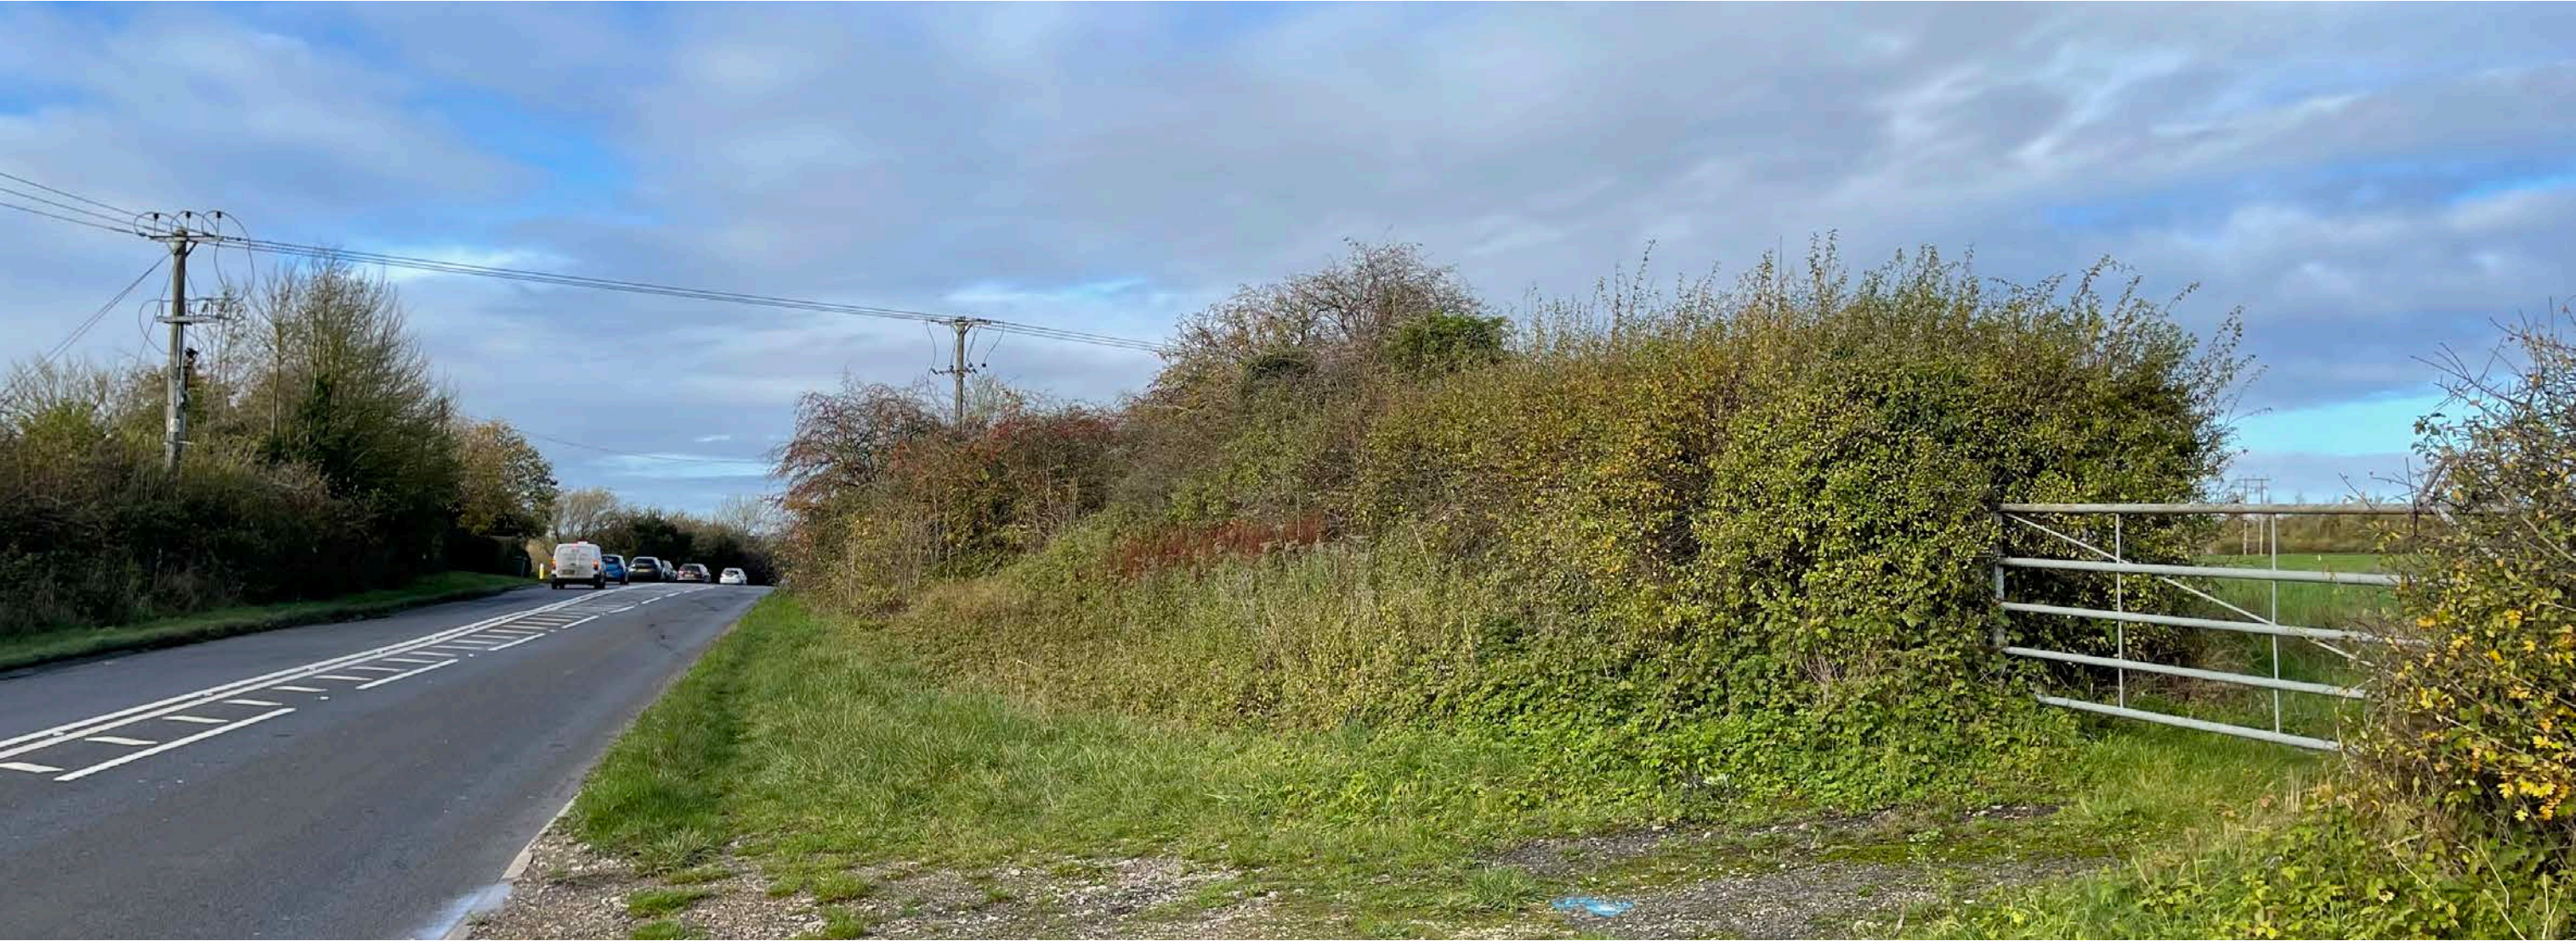
Figure 6a. Primary access to the application site and the Monument along Swindon Road. Facing east

4.9 The monument is accessed through the gated entryway of the application site along Swindon Road to the south (Figure 6a). Although not an official entryway to the monument this allows access to the Monument through the field that comprises the site. At present however, there is no public access to the site and Monument.

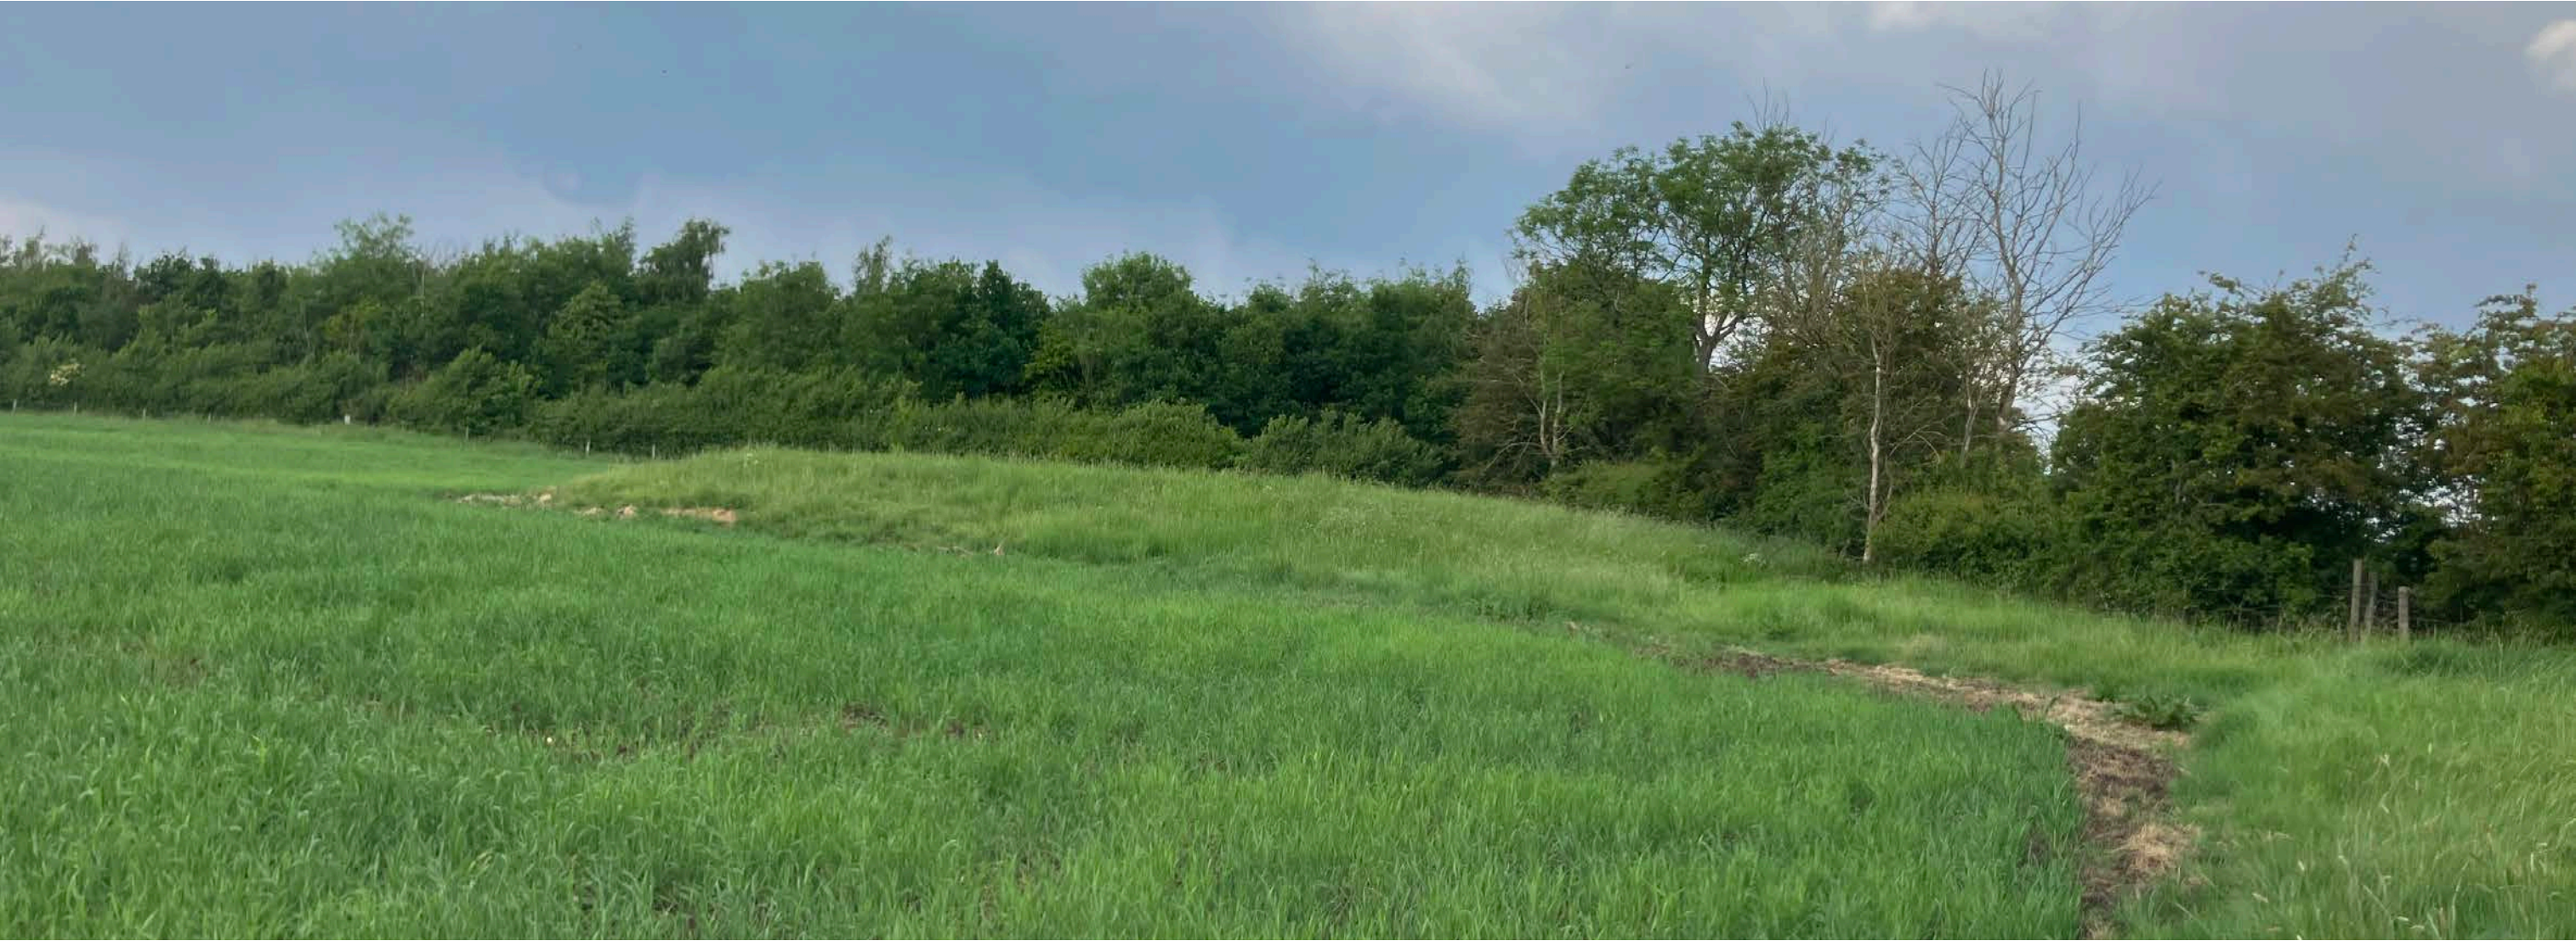
Figure 6b. Eastern approach to monument, facing northwest. Overground mound is visible.

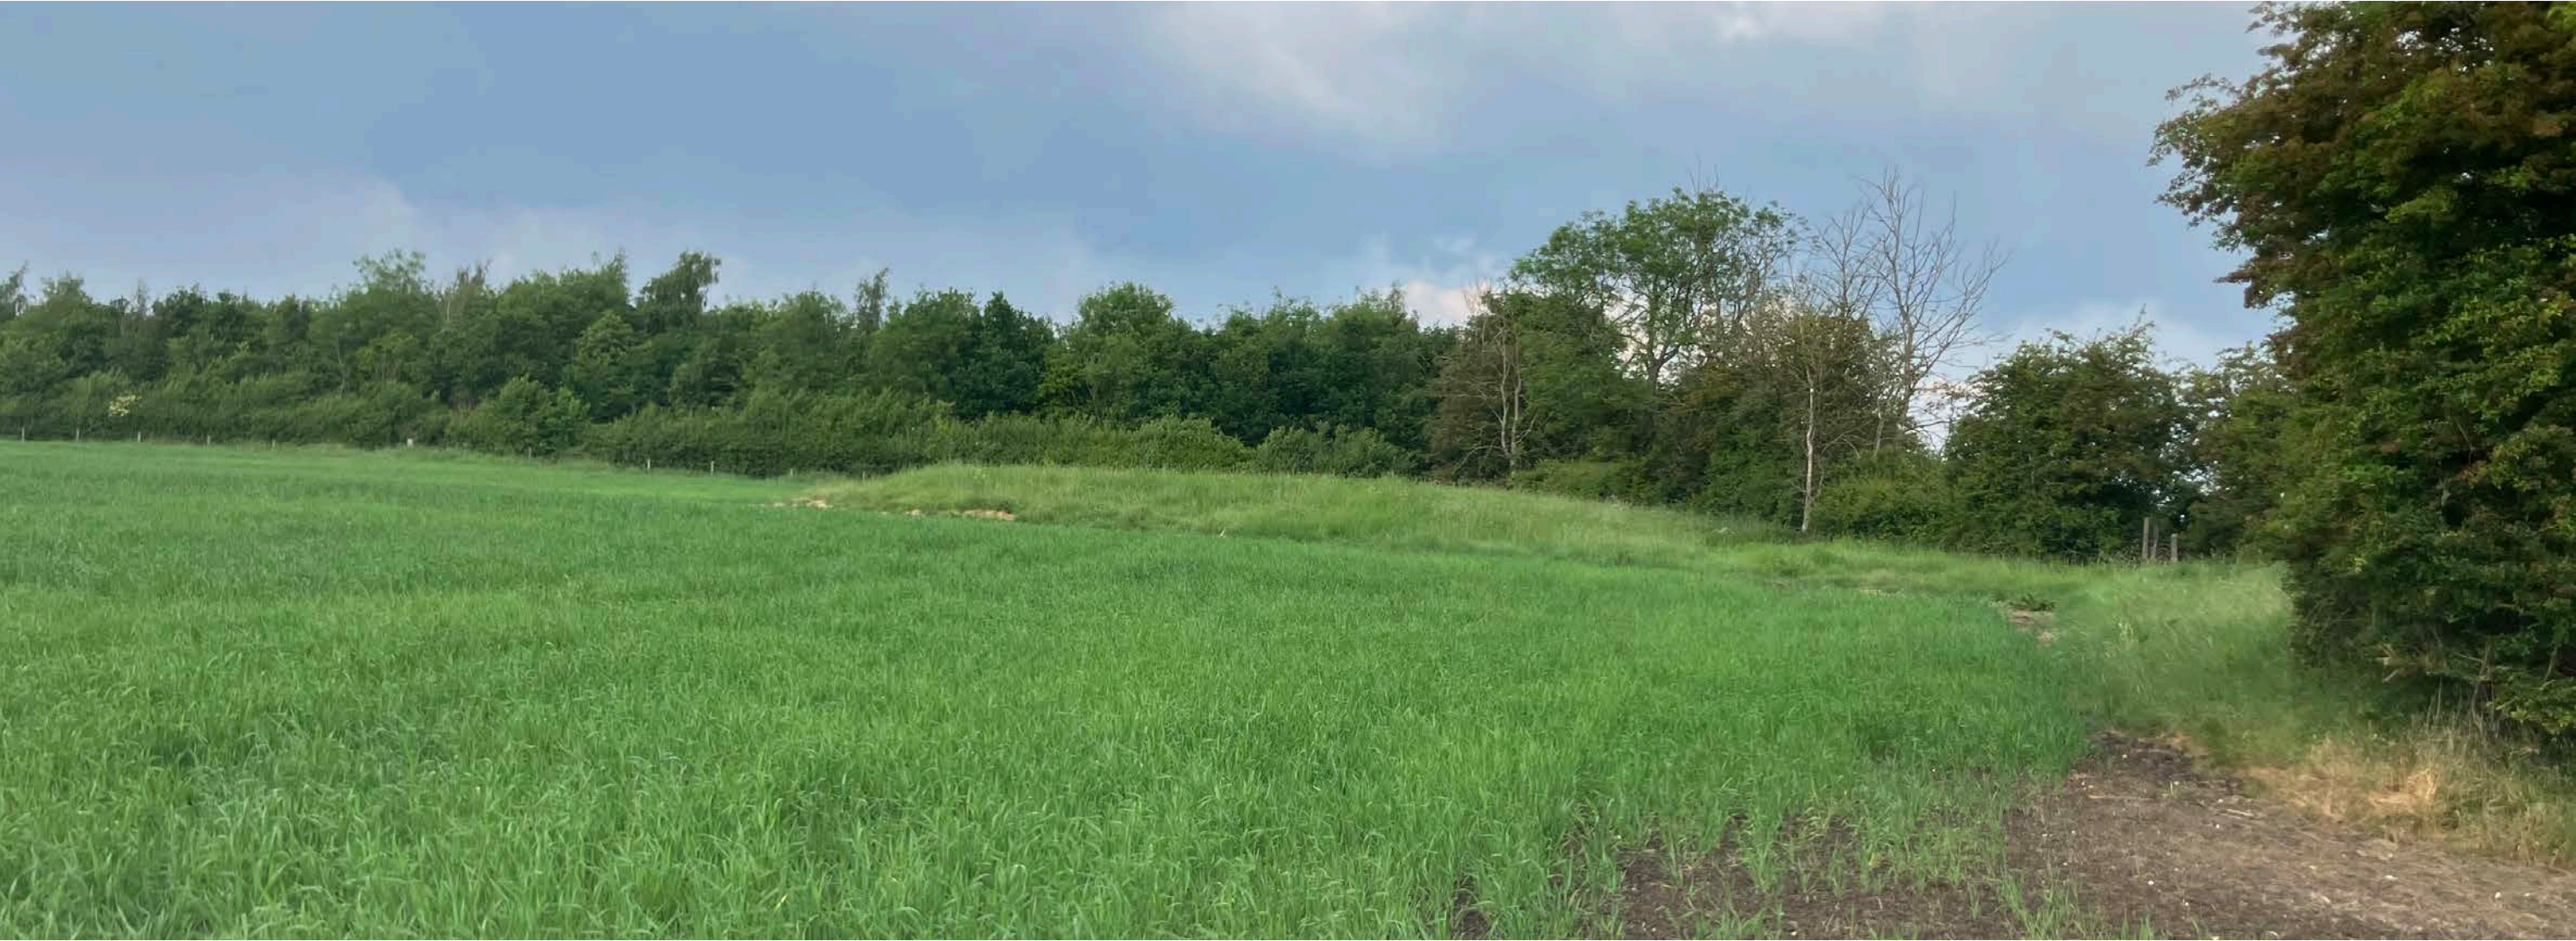
Figure 6c. Closer view of the Monument, overground vegetation and mature hedgerow boundaries visible.

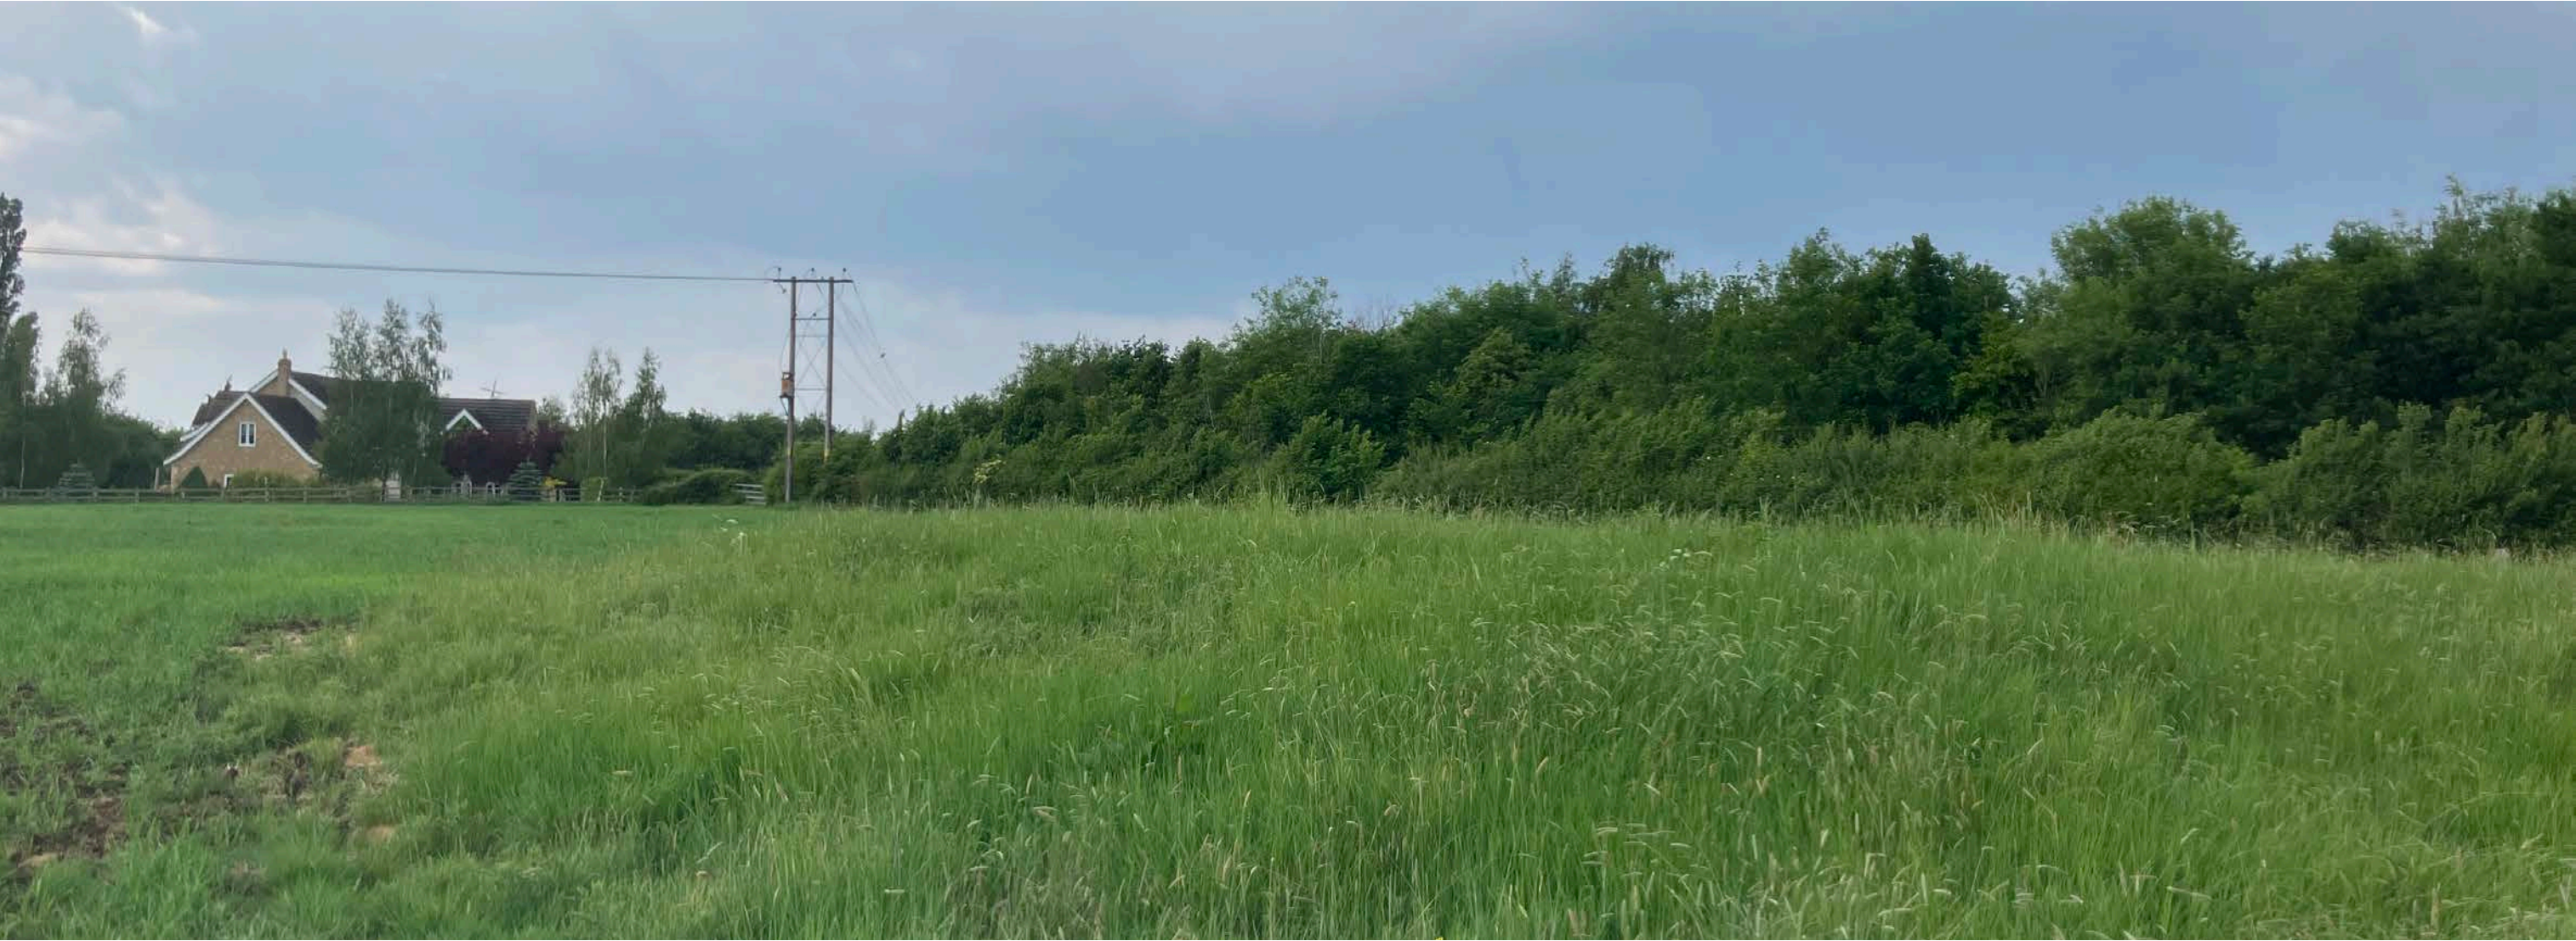
- 4.19 The threat levels to the significance of the Monument from the existing tree lines around the monument is considered as low as despite their somewhat limited management, they remain a relative distance to asset. There is a low level considered to the damage from the shrubbery and weeds across the monument as again, rooting can cause some harm and these are located over the monument itself, albeit their rooting remains very shallow (Figures 6d).

Figure 6d. The overgrown vegetation on the Monument, facing southwest.

- 4.20 Appropriate felling of diseased or unstable trees will reduce the potential for damage to underlying remains through windthrow. In this regard, it is expected that such trees within the site will be prioritised for felling or pruning, proposed for those at the eastern boundary of the monument.

- 4.21 No stump grinding or burning will be permitted and it is expected that trees will be cut to ground level and the stumps/roots left to rot. For their ecological value, small piles of wood arisings may be left on-site but located away from archaeological earthworks.

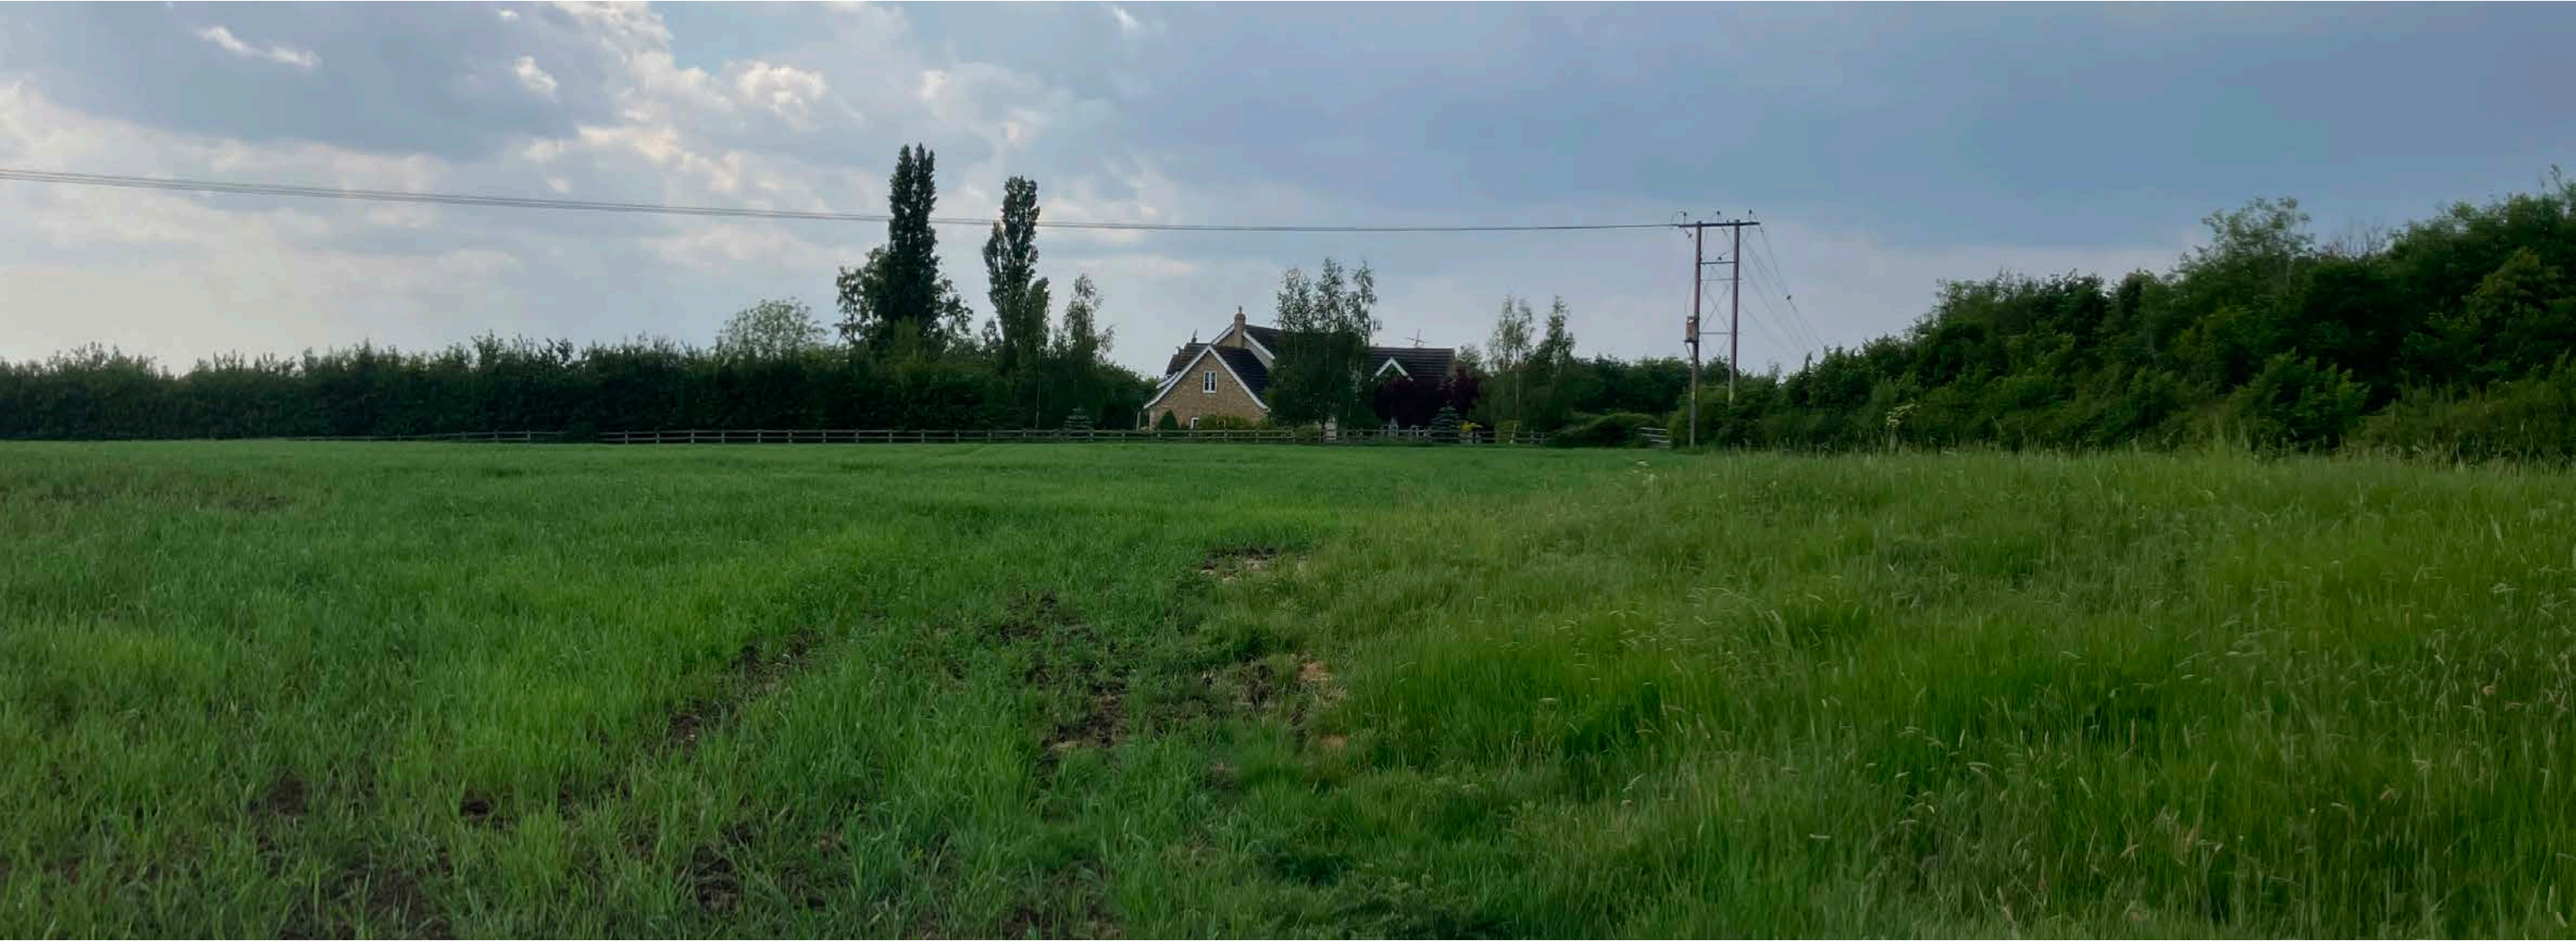
- 4.18 Forestry or the existing tree stock comprises a threat to the monument (Figures 6e-d) as overgrown and unmanaged trees or scrub can negatively impact the archaeological resource via root damage or collapse/uprooting and by providing

Figure 6e. – Eastern boundary of the monument. Overgrown vegetation of the Monument (right), in comparison to the crop overlying the remainder of the site (left). Facing south.
