# **New Farm, Alderton**

## **Remediation Strategy**

P1156/CS-2583

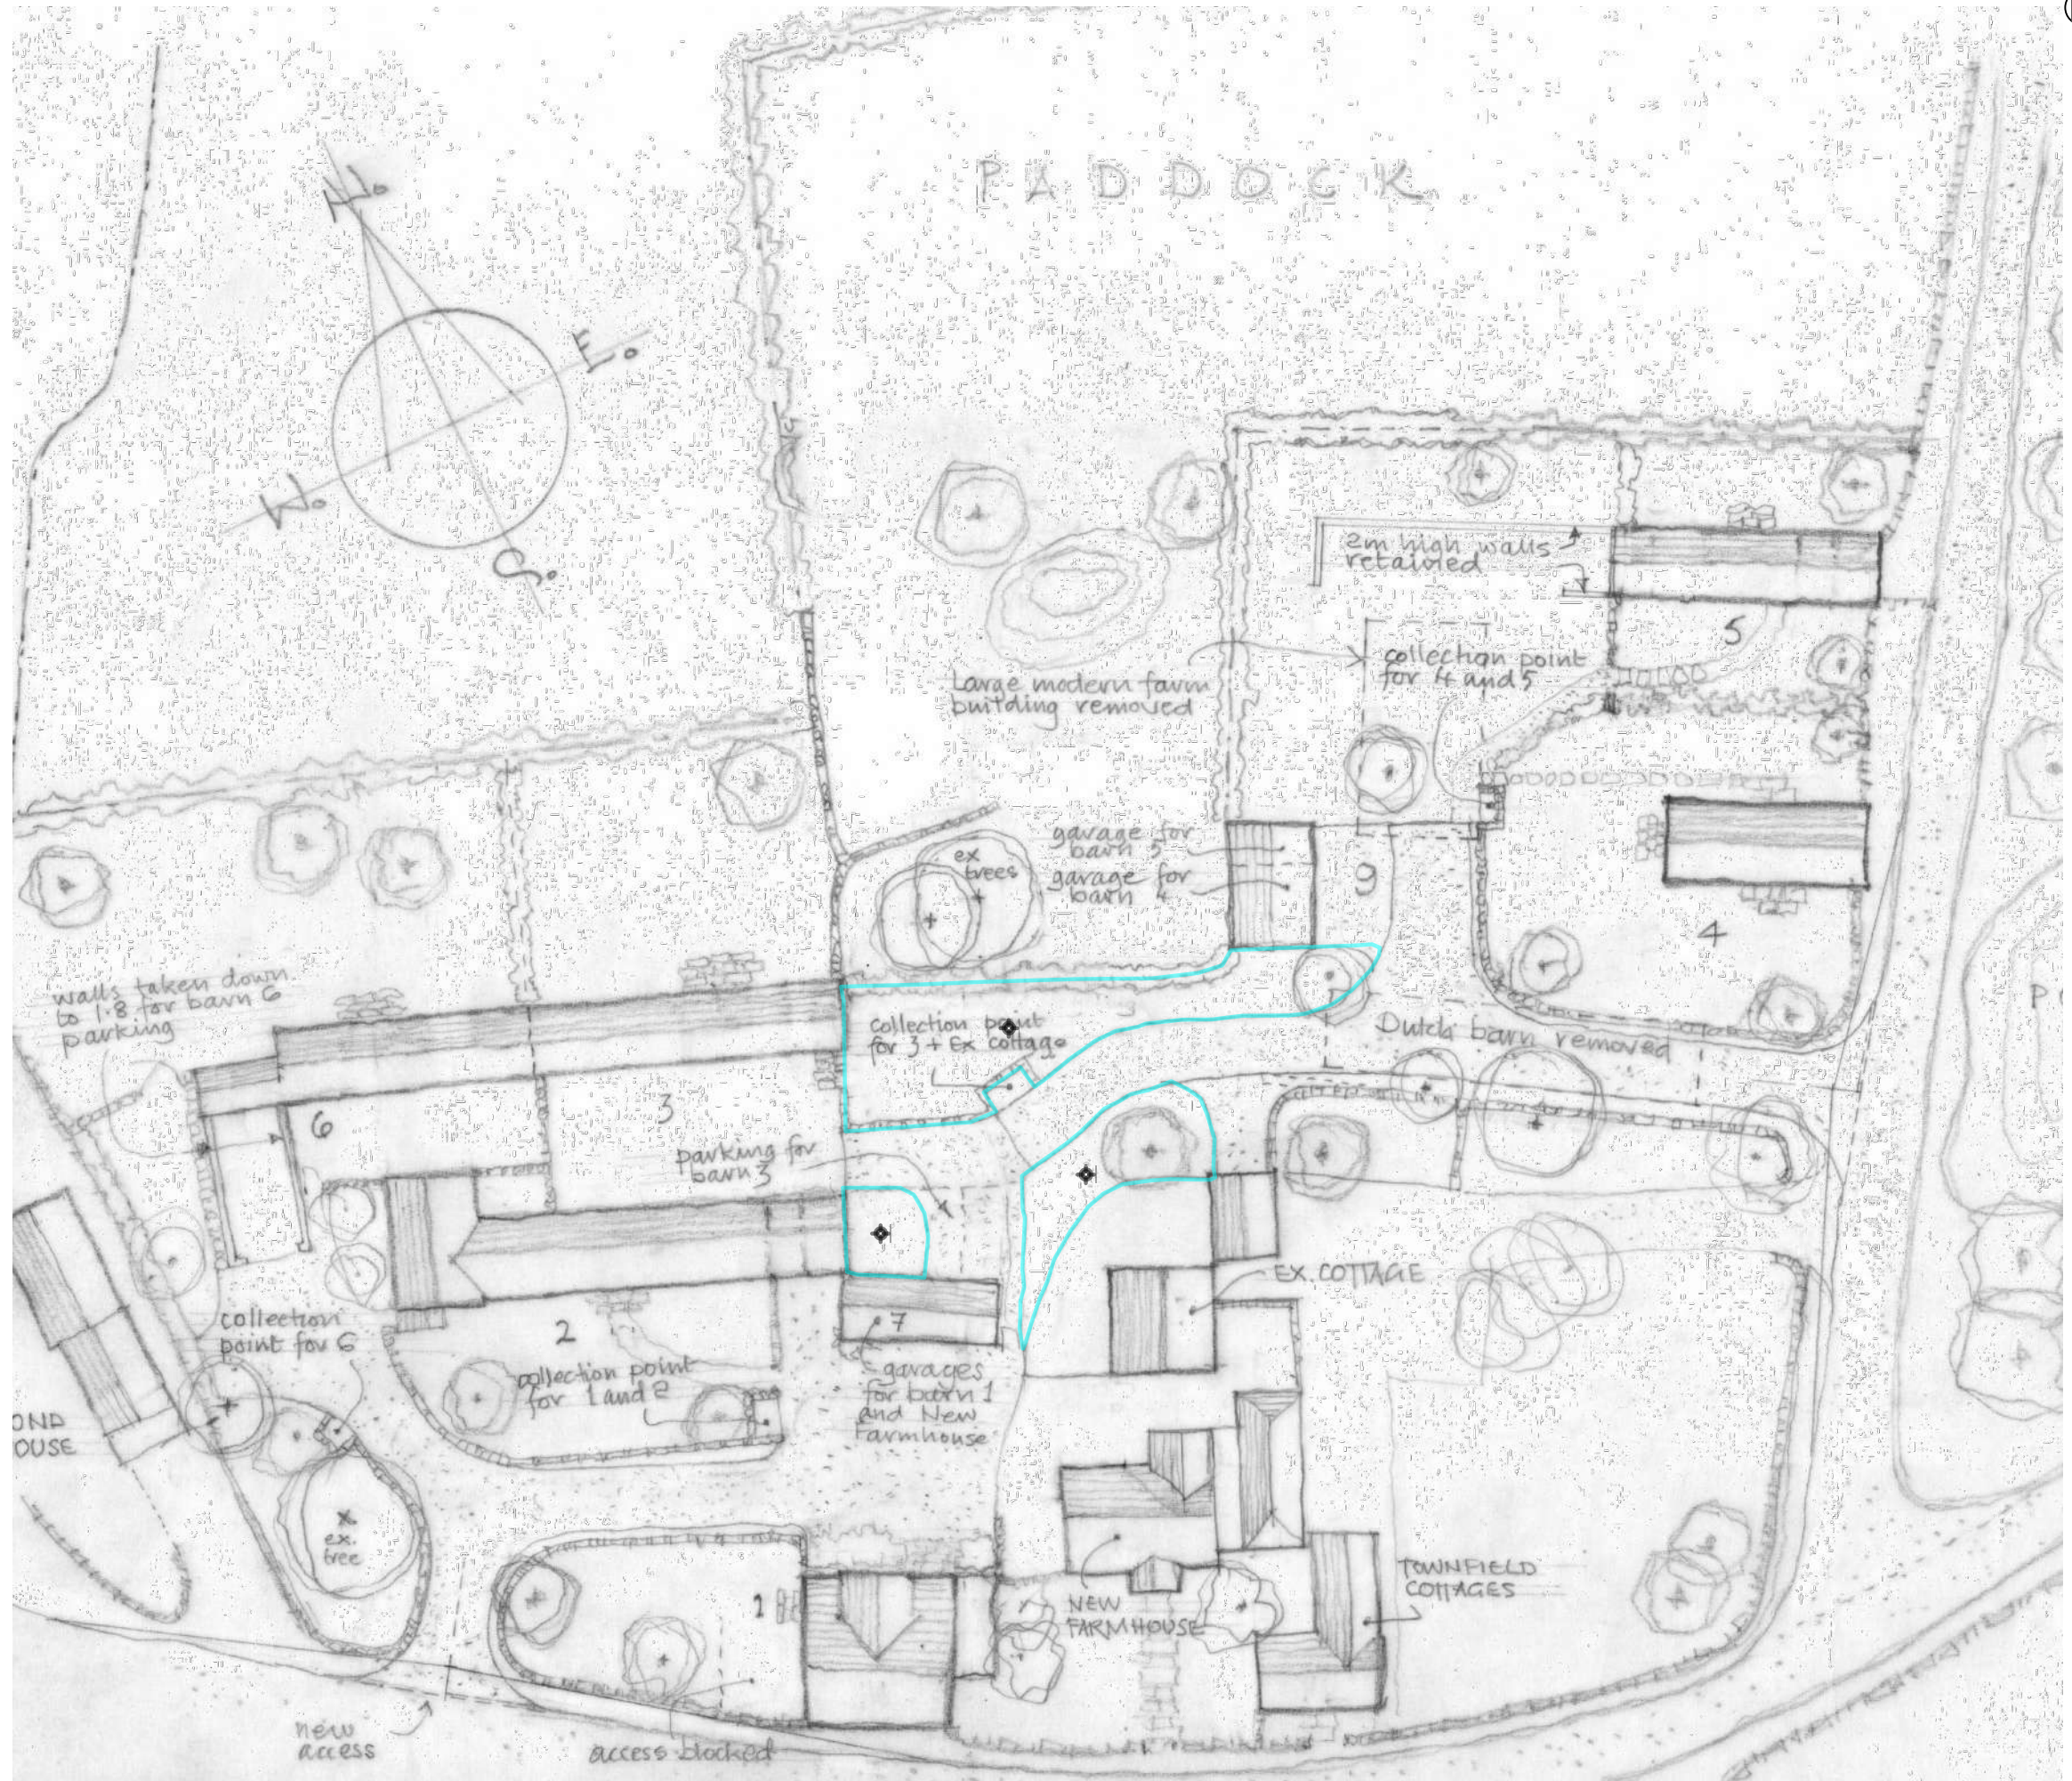
| 1:400@A3 | 09/12/24 | DA | MC | - | P1156-01-008 |

Made ground shall be excavated to a minimum depth of 600mm beneath finished level or the top of the natural soils, whichever is least. Levels shall be reinstated utilising chemically and physically suitable imported or site-won soils. A high visibility geotextile marker should be provided at the base and sides of excavations as a marker layer where existing made ground soils are to remain in situ at the base of the capping excavations.

- In the defined areas of proposed private soft landscaping as shown on the plan within Appendix A, made ground shall be removed down to 600mm below finished level or the top of the natural soils, whichever is least. Levels shall be reinstated to reflect engineering requirements utilising chemically and physically suitable topsoil/sub-soil. A high visibility geotextile shall be provided at the base and sides of excavations as a marker layer where existing made ground is to remain *in situ* at the base of the capping excavations.
