## **Oxleaze Business Park, Greenhill, Royal Wootton Bassett, SN4 8EH**

### **Ground Investigation**

**Skyline Aero Ltd**

**P25-399gi**

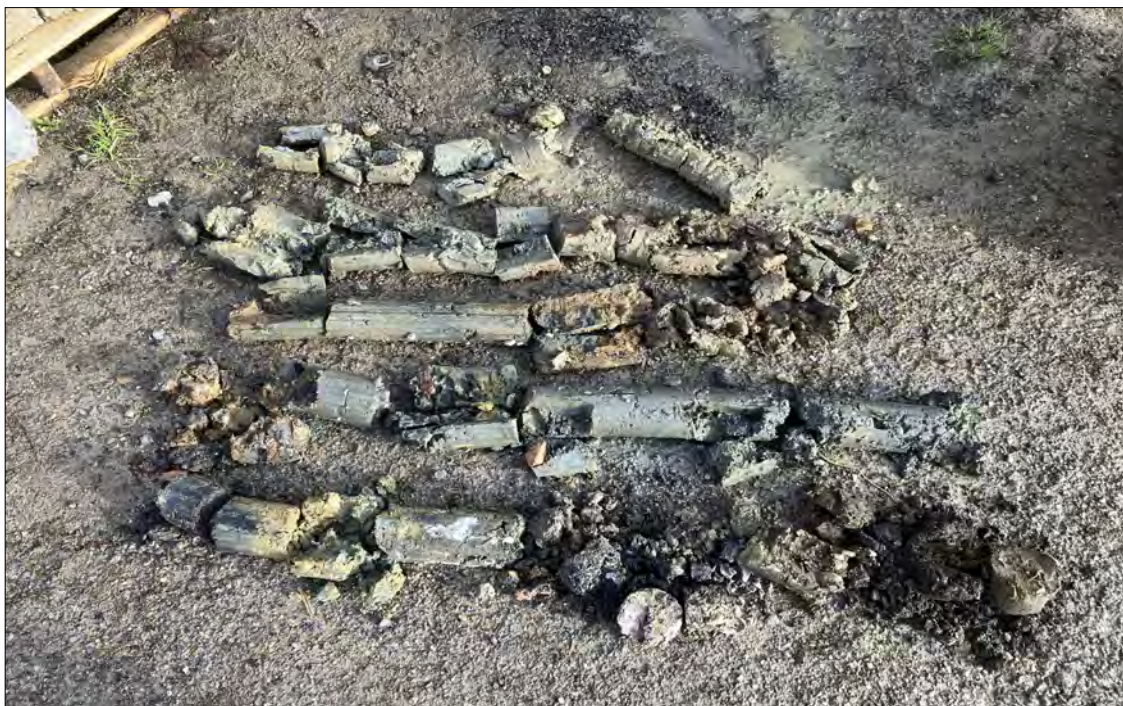
**WS01 Soil Arisings**

Made Ground was encountered from ground surface in all exploratory locations. The encountered Made Ground within WS01 to WS02B (western portion of the site) extended to between 4.50m and >4.80m bgl and was noted to represent the thickest extent of the encountered Made Ground. The encountered Made Ground within these boreholes was variable and included gravelly Clay within gravel of brick and concrete, rubber thought to be old car tyres and clinker.

The softest material was encountered within WS01 to WS02B in the area of the proposed Shed 3. At these locations Made Ground was encountered to 4.50m bgl (WS01) and >4.80m bgl (WS02B). Recorded SPT-N values obtained from natural soils in this area, which was limited to testing in WS01 at 5.0 and 6.0m bgl, indicate very soft to soft conditions. Testing within the overlying Made Ground at

The investigation identified significant Made Ground (c. 4.5-5.0m thickness) within the locations of WS01 to WS02B, across the western portion of the site. In-situ SPT testing identified soft Made Ground conditions from 2.0 to 4.0m bgl in this area.

Based on the foregoing, given the thickness of Made Ground encountered (>4.80m bgl) within WS01 to WS02B conventional spread and isolated pad foundations are not considered suitable for the proposed development in the area of the proposed **Shed 3** and a piled foundation solution in this area should be considered.

***For the Shed 3 area it is recommended that a deeper foundation solution such as piles are employed.***

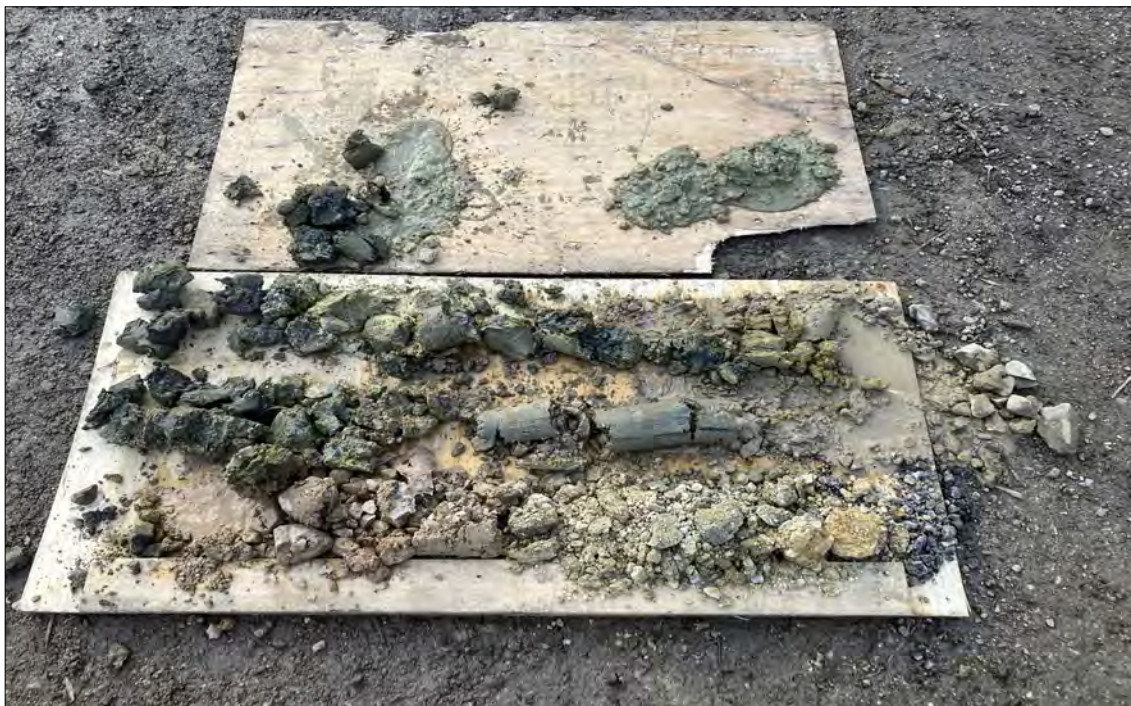
**WS03 Soil Arisings**

Testing results within both WS03 (proposed Shed 1) and WS05 (proposed Shed 2) indicate variable strengths with depth, where SPT-N values ranged from 10 to 34 between 1.0 and 5.0m bgl. In both locations, peak soil strengths were encountered within the upper 2.0m bgl (SPT-N 18 to 34) with a decline in strength generally noted between 3.0 and 4.0m bgl (SPT-N 11 at 4.0m bgl). All testing at these locations was undertaken in natural strata.

Therefore, shallow pad and/or strip foundations constructed at a minimum depth of 1.50m bgl or 0.30m into natural Clay soils of at least firm consistency are considered potentially feasible for the proposed development of **Shed 1 and Shed 2**, when outside the zone of influence of any trees given the worst case High volume change potential. Foundation depths should be increased to below any Made Ground or ground disturbed by removal of buried structures where present.

***Given the variability in soil strength with depth and depth of Made Ground across the proposed Shed 1 and Shed 2 development area, it is recommended that inspection of the soil at the base of the foundation excavations be undertaken by suitably qualified Engineer to confirm that the conditions correspond to those identified by this investigation.***
