## PRELIMINARY ECOLOGICAL APPRAISAL

### LAND & BUILDINGS AT DOG TRAP BARNS, BRAYDON HALL FARM, MINETY, WILTSHIRE

**File:** Preliminary Ecological Appraisal, Land & Buildings Dog Trap Barns, Braydon Hall Farm Minety  
Wiltshire

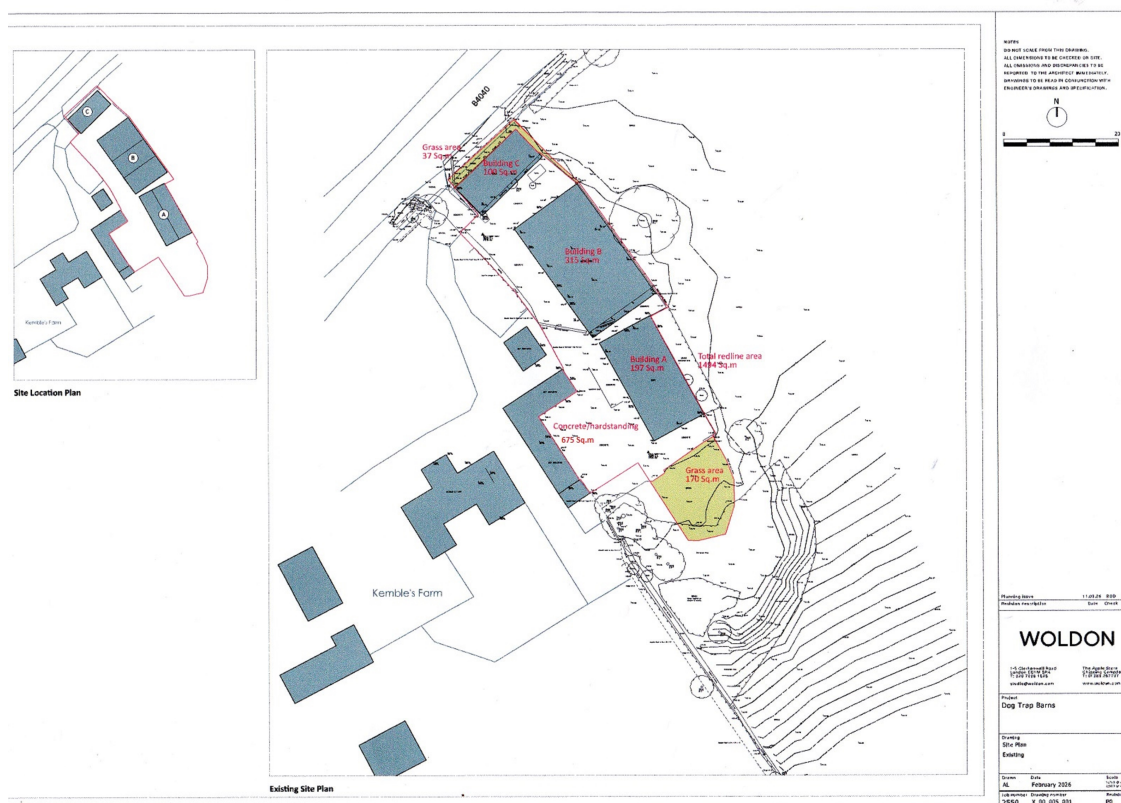
**Figure 2.** Baseline Plan of site showing existing buildings, hard standing & habitats

The site, which was approximately 0.1494 hectares in area, consisted of a concrete hard standing yard along with three agricultural buildings (please see section 5.32 Bats below for details of the buildings) along with an area of rough grass at the southeast end of the site and a very small area of short grass at the northern boundary. There was a row of semi-mature ash trees at/close to the site's south-west corner boundary. There were no ponds or water courses on the site. There was house and garden to the south-west of the site with pasture /grassland on all sides. Please see Figure 2. & photos 1-4 below:

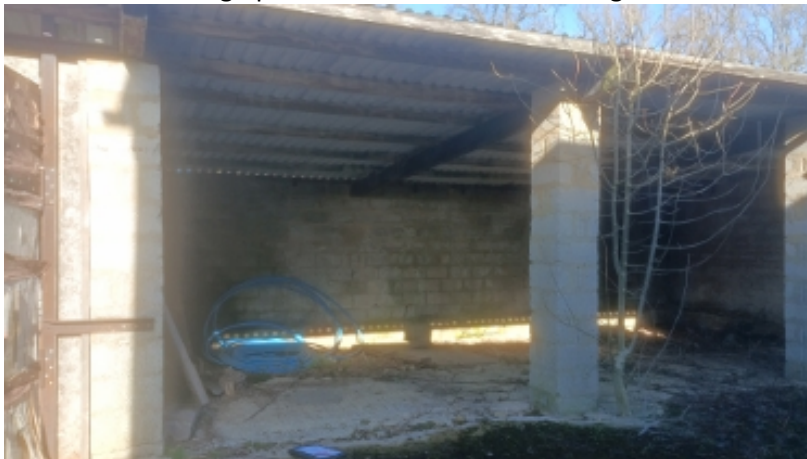
**Photos 5.** Showing open fronted section of building C

This single story, mainly open fronted shed, was constructed of concrete block walls with a gently sloping single pitch roof clad with corrugated steel sheets. There was no roof space or underlay. There was a closed section (with a closed door) on the western end of the building (please see Photo 5. below). There was a gap at roof level between the closed section and open fronted section of the building. The shed was searched and no bat droppings were identified. Mouse droppings and some bird droppings (swallow) were found in the closed section of the shed. No bat signs were identified. This shed was assessed as having a low potential as a bat roost.

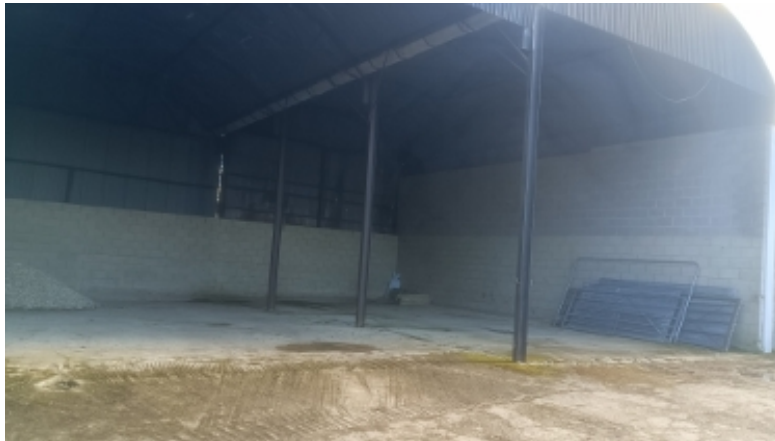
**Photo 7.** Interior of steel framed barn B

This was a large steel framed barn constructed of a mixture of concrete block walls and corrugated steel sheets with a double round roof clad with corrugated steel sheets. There was no roof void or underlay. The building was open fronted and so had a lot of natural light within. There was a lean-to shed on the southern side of this building, which was constructed of concrete blocks and had a locked door. This building was dark inside with very little natural light entering via a small gap around the door and a small hole in the roof. No signs of bats were found in the main part of the building. The main barn was assessed as having a negligible potential as a bat

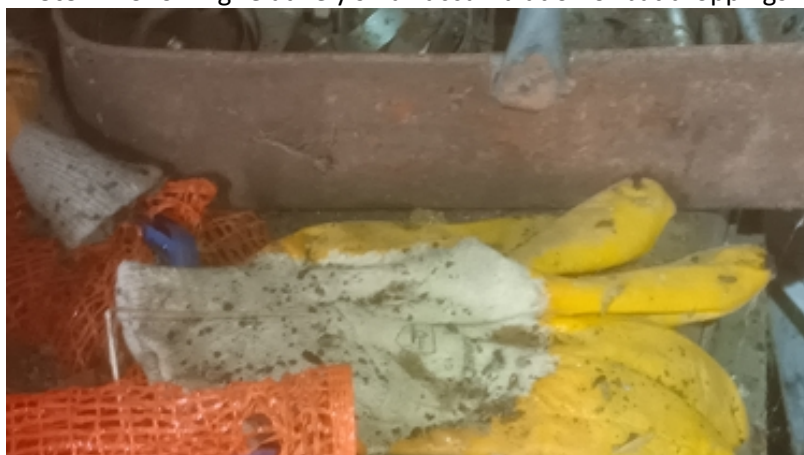
**Photo 11.** Showing relatively small accumulation of bat droppings in shed

roost location. However, some bat droppings were found within the lean-to shed: There was a small number/accumulation of old droppings on a surface in the left-hand corner of the shed (looking from the front. Please see Photo 11 below). There was a small hole in the roof directly above the location of the droppings that was the likely access point. The small number of droppings suggested that a single bat (or possibly bats) had roosted at this location on an occasional basis outside of the hibernation period. The droppings were very dry meaning that the bat activity was from the previous summer at the most recent, probably longer ago than that. Please see section 6.1 Bats of section 6. Conclusions and Recommendations below.

Evidence of a bat (or bats) was identified in a locked shed attached to building B. This was a small accumulation of droppings which were not fresh. There was access into the building through a gap in the roof above the area of droppings. This indicated that the building had been used by a bat or bats on a few occasions as a roost outside of the hibernation period. The main part of building B and the other two buildings were assessed as having low/negligible bat roost suitability. A recommendation is given below for further survey of the shed. Electric lighting associated with any new development could potentially have a negative impact on bats so a recommendation to produce a ‘bat friendly’ lighting plan is given below along with enhancement measures to give net gain for bats:

- **An ecologist licensed by Natural England to survey for bats should carry out more detailed survey work of the shed attached to building B involving a possible roost characterization survey/roost and/or presence/absence survey. If it is determined that a bat roost will be affected by the development proposals, i.e. by demolition, modification or disturbance, it is possible that a European Protected Species (bat) licence would be required prior to works commencing, issued by Natural England and subject to a suitable mitigation/compensation strategy.**

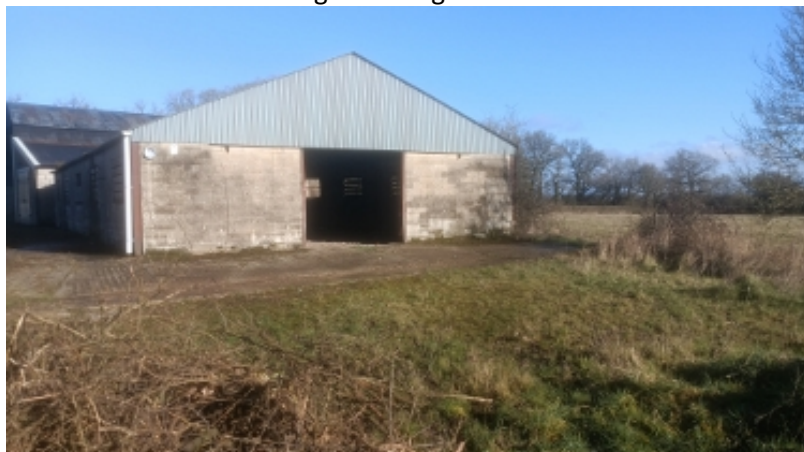
**Photo 12.** Front of building A looking north from southeastern end of site

This building was constructed of concrete block walls with a steel framed apex roof clad with corrugated steel roof sheets with no roof space or underlay. The building was well lit with natural light from the permanently open doorway and large open section at the rear of the building along with a number of clear roof sheets. No signs of bats were identified within this structure and it was assessed as having a negligible bat roost suitability.

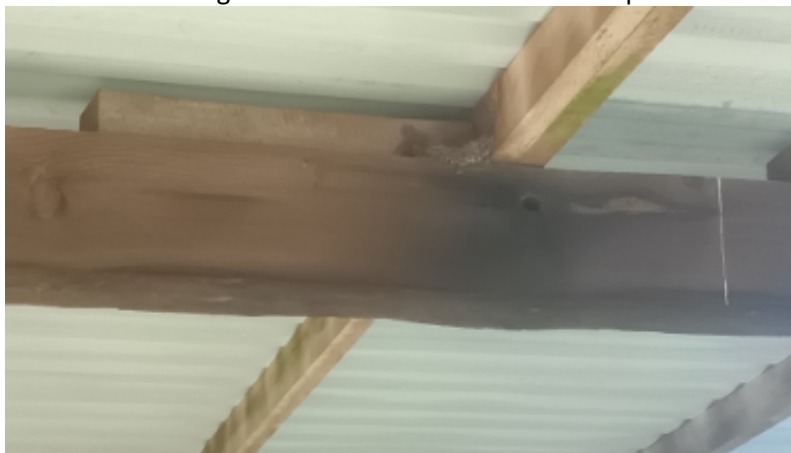
**Photo 14.** Showing swallow nest on roof timber of open fronted section of shed C

A swallow nests were identified on a roof beam in open section of shed C (please see photos 14 below). All three buildings offered some potential as bird-nesting habitat although no other nests were identified.

One swallows nest were identified on a beam in the small open fronted shed (shed C) and the other two buildings had some nesting potential although no nests were identified. No other nesting habitat was identified within the red line other than some semi mature ash trees close to or just on the red line at the south-west corner, these trees should not be affected by the proposal. The following precautionary recommendations are given to protect nesting birds from disturbance. Enhancement measures are also recommended to both replace lost nesting locations and give net gain for birds:

- **Ideally, any building work affecting building A, and/or demolition work on building B & C or any work that might disturb trees on the site boundaries should be undertaken outside of the bird-nesting season (which is March-August inclusive *although birds can sometimes nest outside of this period*). It is important to remember that nesting birds can become trapped within a building or exclude from a nest site if existing gaps in walls, roofs and doors are blocked during the nesting season. However, if it is deemed essential to carry out works during the nesting season then the area of works should be checked by the ecologist prior to the work. If it is deemed likely that a nesting birds will be disturbed then the works will be delayed until the fledglings have left the building/nest.**

- **Mitigation & enhancement measures to replace the loss of the swallows nest and give a net gain for birds should be included as part of the development, should it be given consent. We would recommend the installation of a number of swallow nest boxes under the eaves of both the retained and new buildings. This would replace the existing nest with more nesting locations than would be lost. These boxes should be included on the design drawings with input from the ecologist in terms of type and siting.**
