**Preliminary Bat  
Roost Assessment  
& Nesting Bird  
Survey**

78 High Street, Dilton  
Marsh

February 2026

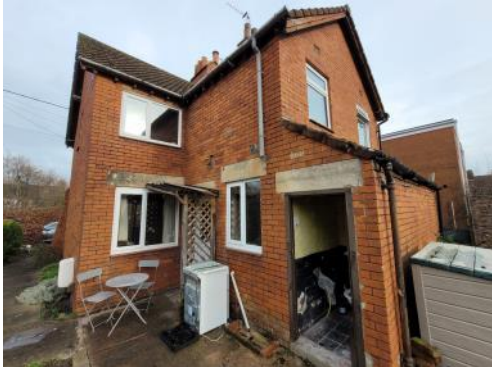
**Photo 1: View of the building from the south-west.**

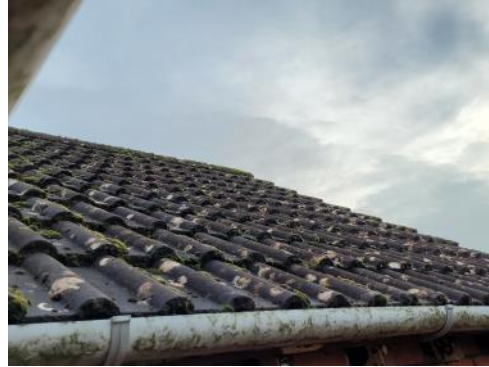
- 3.11 Externally, the brickwork of the dwelling was largely well pointed, with little evidence of cracking, mortar loss, or deterioration. The ridge tiles displayed intact bedding mortar with no gaps or crevices, and the concrete interlocking roof tiles lay flat, showing no evidence of slipping, lifting, or damage. Window and door frames were well fitted, with no visible gaps.
- 3.12 Within the proposed area of works, several small features were identified at the eaves that could provide potential roosting opportunities. These included gaps around the exposed rafter tails where some localised loose brickwork was present, and narrow gaps at the wall top between the masonry and the underside of the roof covering. Similar gaps were also noted at the eaves of the mono-

**Photo 2: Well fitted concrete interlocking tiles.**

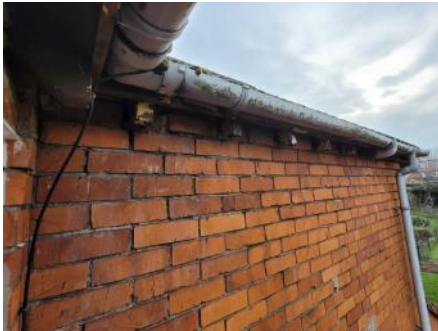
pitched WC extension, between the wall top and the roof tiles. Collectively, these represent external Potential Roosting Features (PRFs) suitable for crevice-dwelling bat species such as pipistrelles *Pipistrellus* spp., while the gaps at the eaves of the main roof could also provide potential entry points for void-dwelling species such as brown long-eared bats. No direct evidence of bat activity, such as droppings or staining, was recorded around the building exterior.

**Photo 3: View of the eaves along the southern elevations.**

- 4.13 The building has been identified as holding moderate potential to support roosting bats, therefore, before works can proceed it is recommended that two dusk emergence surveys be undertaken on the building to confirm the presence or absence of bats. These surveys should be completed during the optimal survey period between May and August. One surveyor will be required to provide adequate visual coverage of the rear elevations during each survey (see Figure 3 for the proposed surveyor position). Should bats be recorded, further survey effort may be necessary, and it is likely that a European Protected Species Licence (EPSL) from Natural England will be required before works can lawfully proceed.

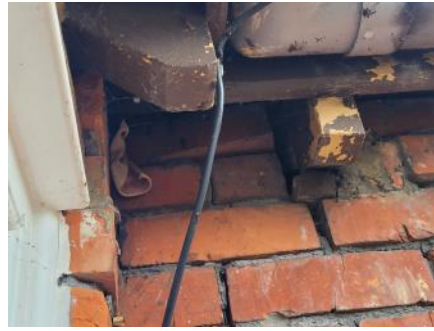
- 4.9 However, several small external Potential Roosting Features (PRFs) were identified at the eaves within the area likely to be affected by the proposed works. These comprised narrow gaps between the wall top and roof covering and gaps around exposed rafter tails, along the south facing elevation of the building and similar features at the eaves of the mono-pitched WC extension. Such features offer limited opportunities for crevice-dwelling species, such as pipistrelles, and may also provide potential entry points for void-dwelling species, such as brown long-eared bats. In addition, the client reported a historical observation of bats accessing the WC roof, although this was not supported by any physical evidence during the survey.

**Photo 4: Loose brickwork around exposed rafter tail.**

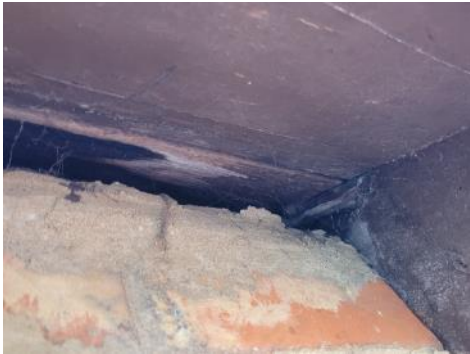
**Photo 5: Gap between the wall top and roof.**

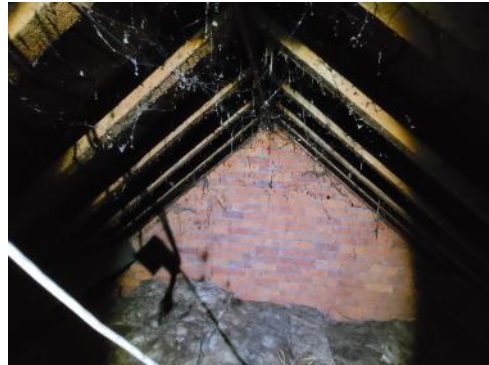
- 3.13 Internally, the main loft void was inspected. The space measured approximately 6 metres by 4 metres and comprised exposed timber rafters and purlins with wooden boarding beneath the tiles, and insulation present at floor level. The roof structure appeared to be in good condition, with no areas of daylight ingress observed, and the loft appeared generally well sealed. No evidence of bats, such as droppings or feeding remains, was recorded. The WC extension was also inspected internally. The door is typically kept closed, and the roof space has been fully boarded, forming a sealed internal compartment with no accessible voids.

**Photo 6: An internal view of the loft void.**

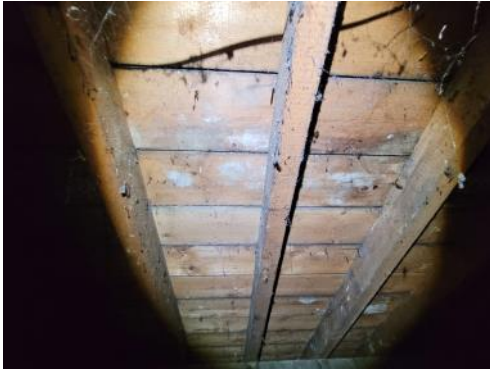
**Photo 7: Wooden boarding beneath tiles.**

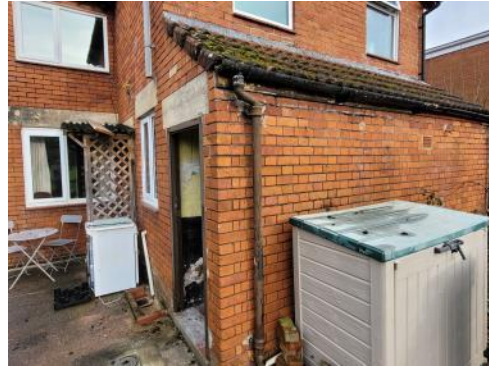
- 3.14 During the survey, the client reported that roosting bats had historically been observed accessing the roof of the WC extension (B. Miller, 2026, pers. comm.). This information is based on anecdotal observation and was not corroborated by physical evidence during the survey.

**Photo 8: View of the WC building which adjoins southern elevation.**

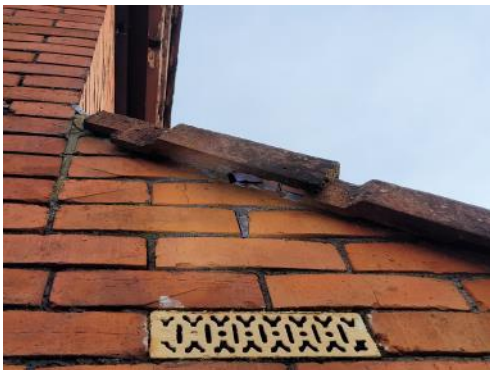
**Photo 9: Gap between roof tile and wall of WC building.**

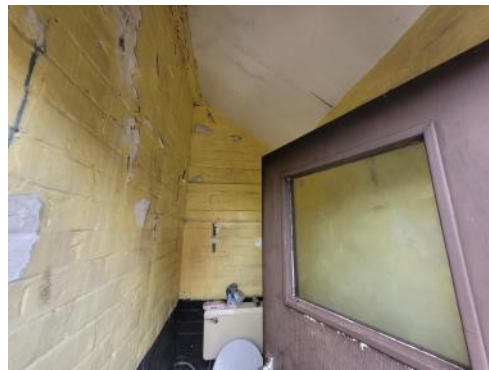
**Photo 10: An internal view of the WC building showing boarded ceiling.**
