# PRELIMINARY ECOLOGICAL ASSESSMENT

Oysters Farm, Gutch Common, Wiltshire SP7 9BE

Prepared for: S. Priest, Oysters Farm, Semley, Wiltshire SP7 9BE

Prepared on: 31st March 2026

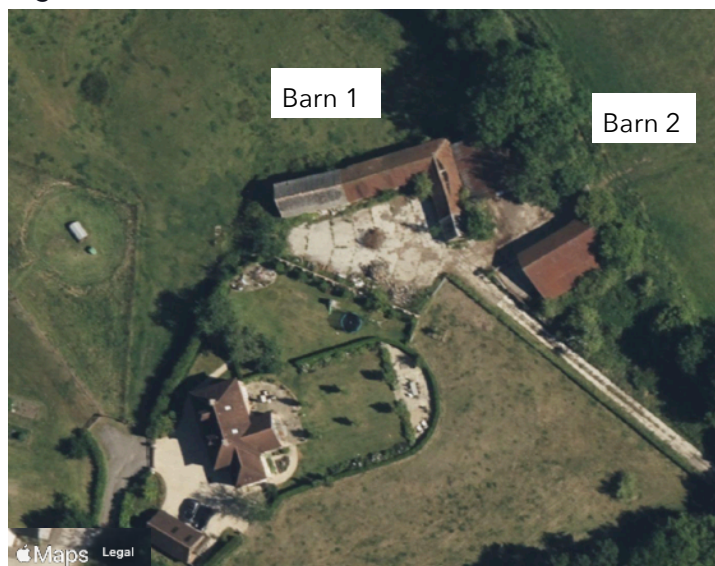
Figure 2. Aerial View of Site

1.4. Description of Site – The site includes two barns, both in bad states of repair, on the edge of a hardstanding farmyard, to the NE of Oysters Farmhouse. The farm building range at Oysters Farm is not listed but, as a traditional range of agricultural buildings, may be regarded as a non-designated heritage asset (NDHA). The owners of the property are seeking planning permission to restore and convert the range and immediate setting to residential use.

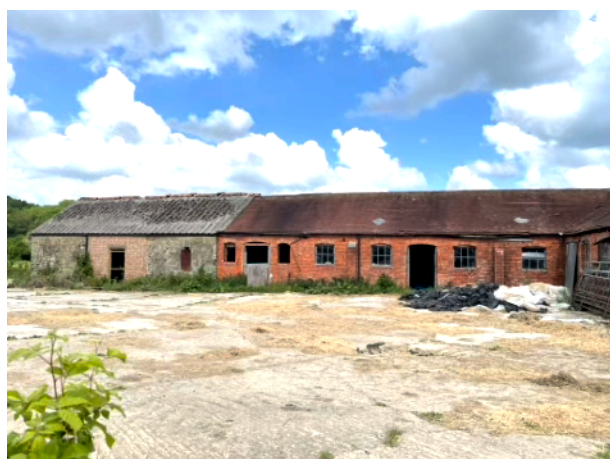
Figure 4. South-east elevation of Barn 1

- Barn 1 – A single-storey, L-shaped brick and stone building situated within the hardstanding farmyard. There are three open doorways and numerous open windows along the south-east elevation, and two closed doorways and a window on the south-west elevation (Figs. 4 - 5).

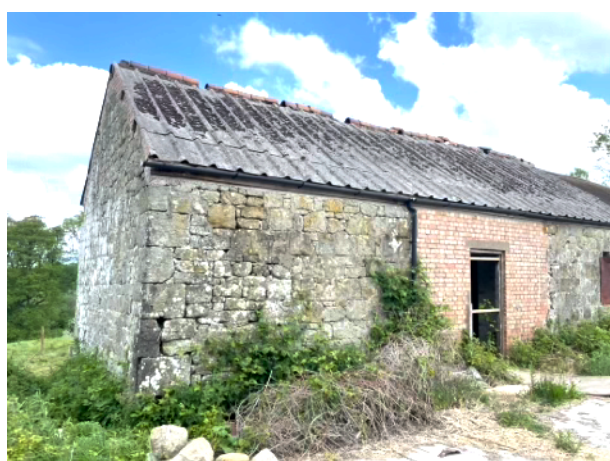
Figure 6. Close-up of SE & SW end elevations

The south-western end of Barn 1 is built from both stone and brick, with a noticeable crack in the stone on the north-western elevation. On the south-west and north-west elevations, which also feature doors and windows, the barn faces onto improved grassland. This land will form part of the garden for Barn 1 and was previously used for grazing (Figs. 6 & 7).

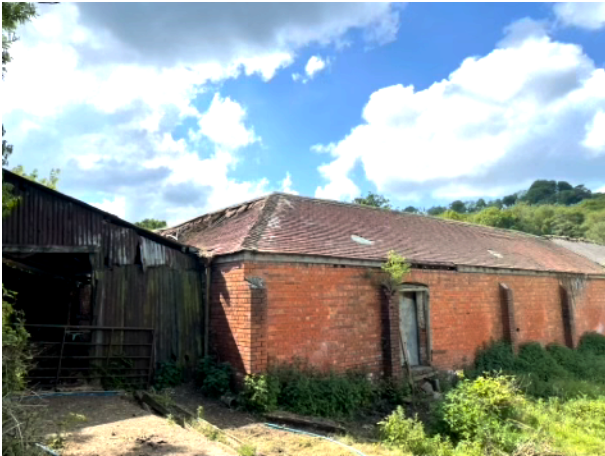
Figure 8. NW & NE elevations of Barn 1 & Lean-to

At the NE end of Barn 1 is an open steel-framed structure, which runs along most of its length. There are also two ash *Fraxinus excelsior* trees immediately adjacent to the NE end of Barn 1, again with open windows and a wooden doorway (Figs. 8 & 9).

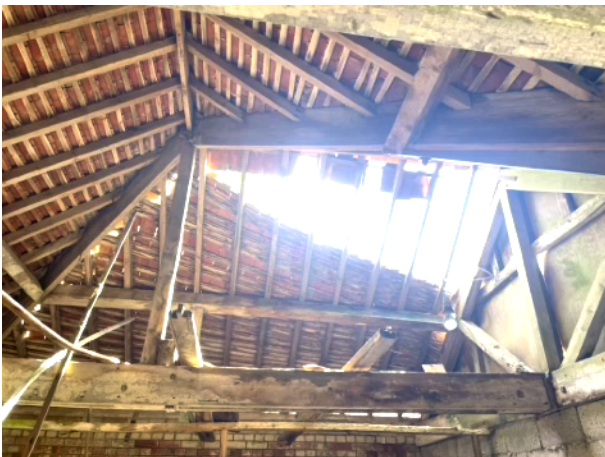
Figure 10. Hole in roof of Barn 1

- Roof – The roof of Barn 1 is mainly covered with clay tiles, with a few roof lights on the NW and NE elevations. Additionally, there are two sections of corrugated asbestos sheeting over part of the stone section of the building at the SW end and on the SE gable end (Figs. 4 - 9). There are some large holes in Barn 1's roof, allowing significant water ingress. The tiles are not lined (Figs. 10 - 15).
- Interior – The inside of Barn 1 is damp due to water ingress, with rotting timbers and water on the floor. The barn is now used for only a small amount of storage due to water ingress (Fig. 15). It is light inside through windows, doors, and holes in the roof, and is very draughty (Figs. 10 - 15).

No bats, or evidence of bats, e.g. bat droppings, urine stains, or feeding remains (butterfly/moth wings/beetle elytra) were observed in the barn. It is not being used by bats to roost.

There were also no signs that the barn had been used by barn owls or other nesting birds, such as old nests, owl pellets, or white staining.

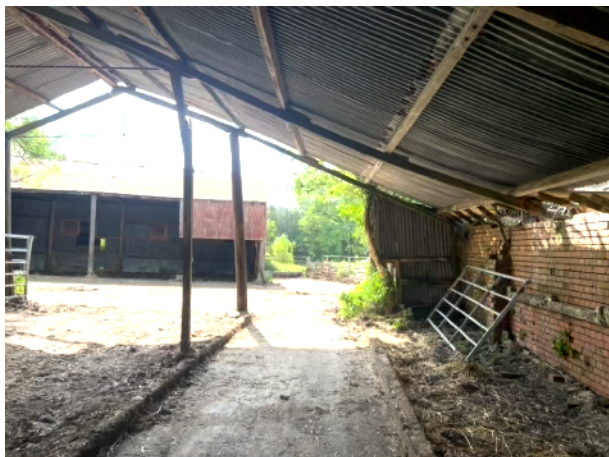
Figure 16. View through Lean-to, to Barn 2

- Lean-to at NE end of Barn 1 – This timber-framed building is open on three sides, with a corrugated metal roof. It has been used for livestock in the past (Figs. 16 -17).
- Barn 2 – A timber-framed barn, open on one side, located to the SE of Barn 1. It is roofed and clad (on two sides) with corrugated metal sheets. It is draughty and light (Figs. 18 - 20).

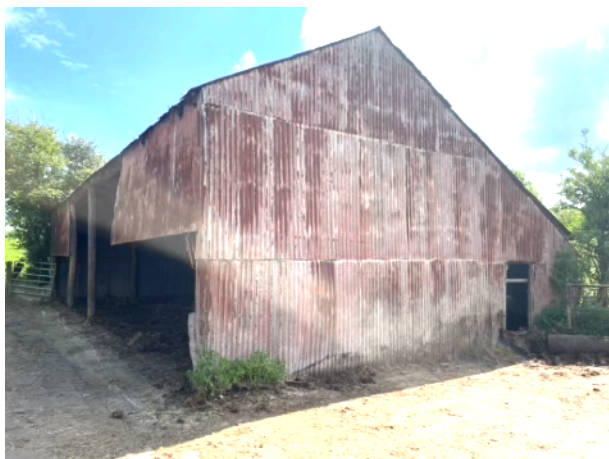
Figure 18. SW and NW elevations of Barn 2

No bats, or evidence of bats, e.g. bat droppings, urine stains, or feeding remains (butterfly/moth wings/beetle elytra) were observed in the barn. It is not being used by bats to roost.

There were also no signs that the barn had been used by barn owls or other nesting birds, such as old nests, owl pellets, or white staining.

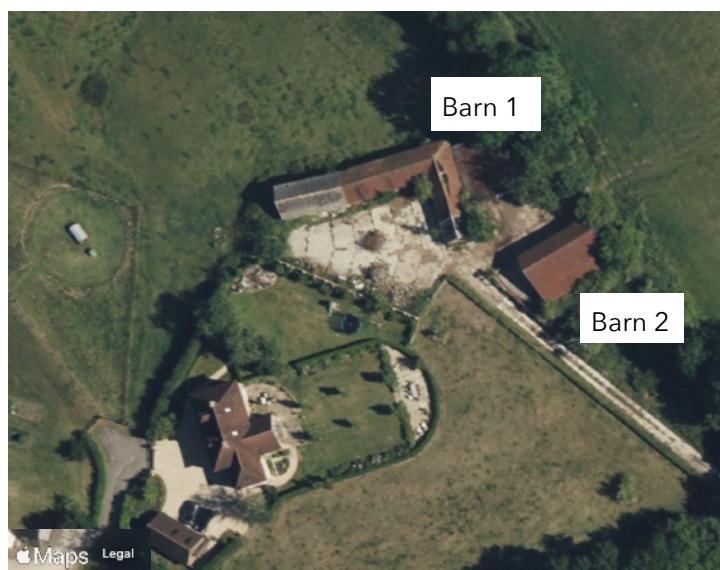
Figure 21. Aerial View of Site

There are boundary trees along the NE of the site, but these are outside the development boundary (Fig. 21).
