**Thatch Cottage, Lower Road, Britford,  
Salisbury, SP5 4DU.**

**Discharge of Pre-Commencement Planning Conditions Number 3 and 4.  
Application Reference Number: PL/2026/00870.**

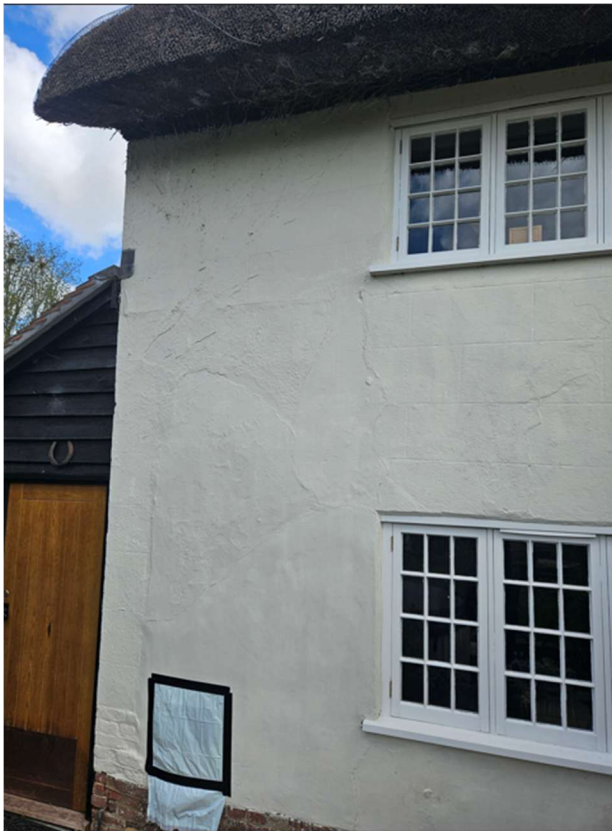
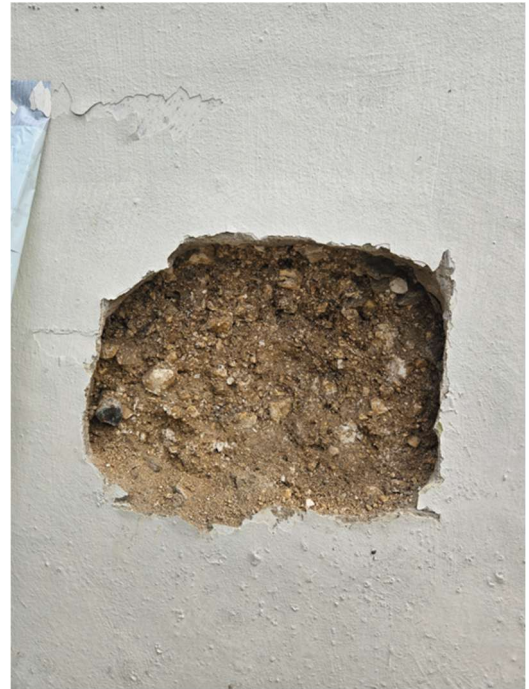
**Condition 3** - on the 14<sup>th</sup> of April 2026, our Specialist Lime Contractor attended site to expose the trial area as requested by the condition. Photographs of the existing render and the cob substrate behind it are provided below.

Our Contractor recommended that area exposed be limited to that illustrated because of his concern on how live the surrounding render was, the issues this could cause and the potential need for emergency repairs not covered or allowed by the Condition.

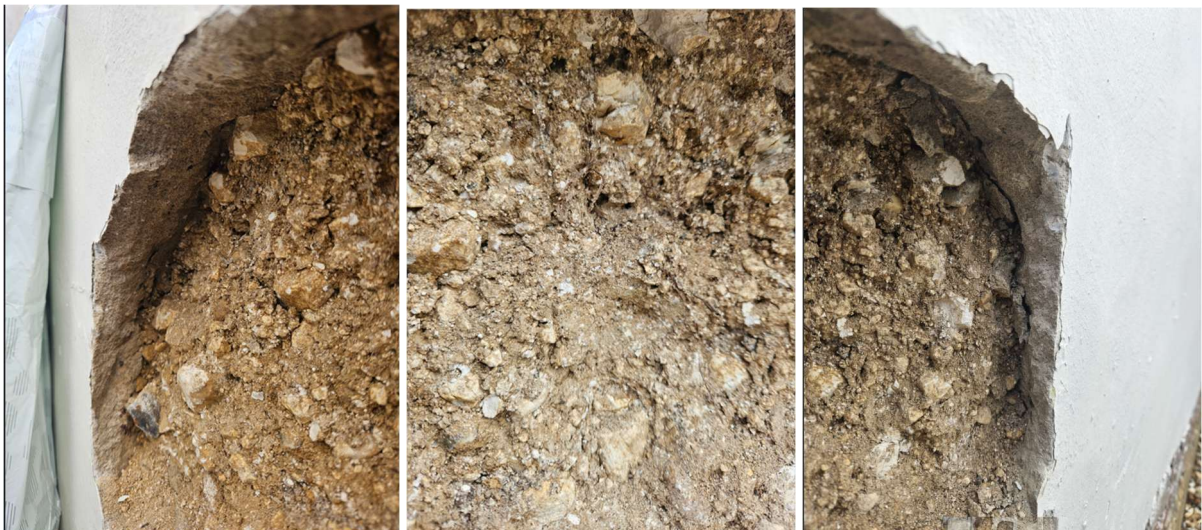
However, the existing render was as expected, a cement and sand coating with chicken wire reinforcing mesh, and in general terms as was the cob.

Inspection of the cobb substrate beneath the cement render has identified a weak friable Chalke / Clay cobb wall that would greatly benefit from a more traditional aggregate / lime mix in order to achieve greater compatibility with the existing cob structure.

Aggregate / lime offers improved compressive strength, reduced moisture retention, and greater material compatibility with traditional earthen buildings.

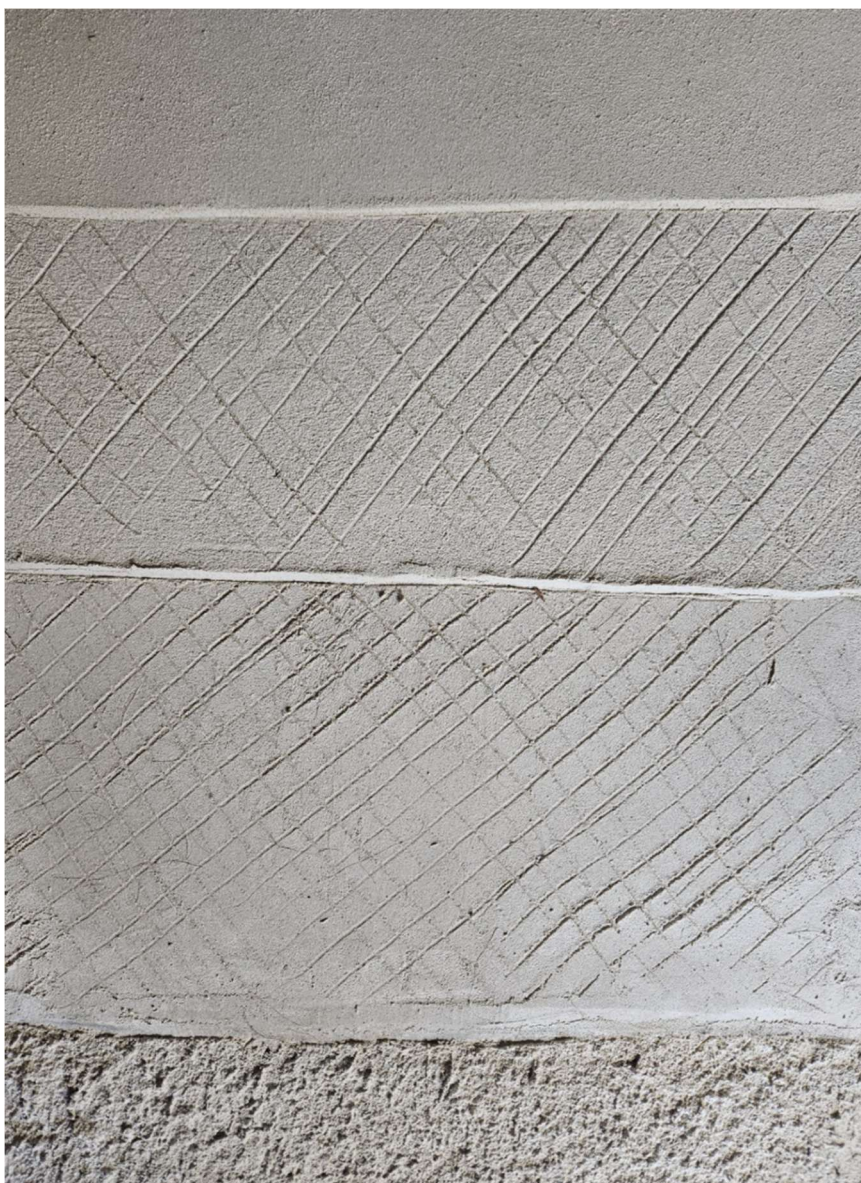
**Condition 4** - due to the condition of the existing render our Contractor produced a sample board. This will be stored in the dry area on site and will be the control sample for each application / layer.

As the photograph below, this is now available for inspection and sign off.

Having reviewed the exposed area our Contractor, by way of the sample board, would like to propose a slightly different four coat system that he genuinely believes the Conservation Officer would have agreed to had they been present yesterday. The detail of this as follows:

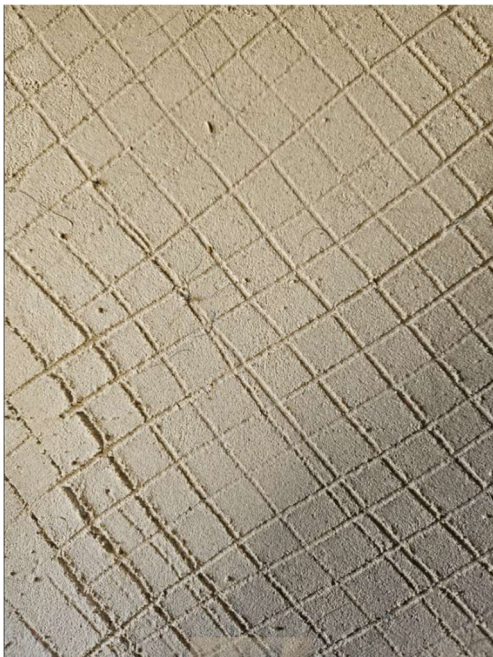
**Scratch coat** - hand applied coating to dampened coating using 1 part quicklime / 1 part grit sand / 2 part washed sand – horsehair added. Left keyed ready for further coats - cured for 3/5 days under hessian coverings - sample panel photo provided below.

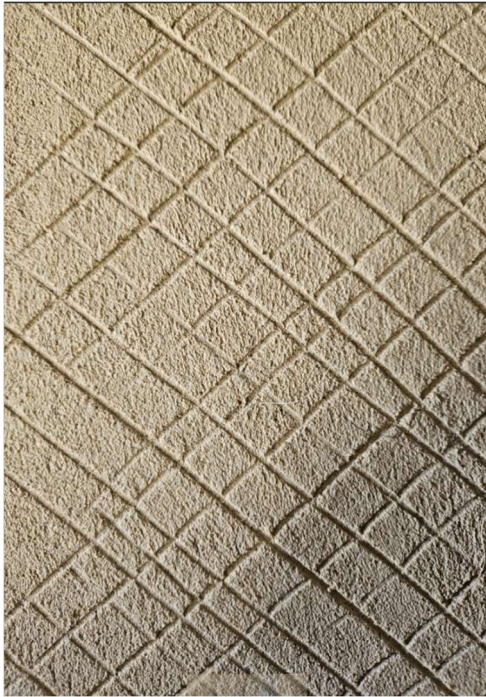
**Float coat** - hand applied coating to dampened background using 1 part quicklime / 0.5 part grit sand / 2 part washed sand - horsehair added. Left keyed ready for final coating - cured for 5/7 days under hessian coverings - sample panel photo provided below.
