## PLANNING STATEMENT

This statement has been prepared by Sarsen Designs on behalf of Gillian Aldridge and Phillip C. Parrott to support the application for retrospective listed building consent for replacement of two windows to the rear of the property .

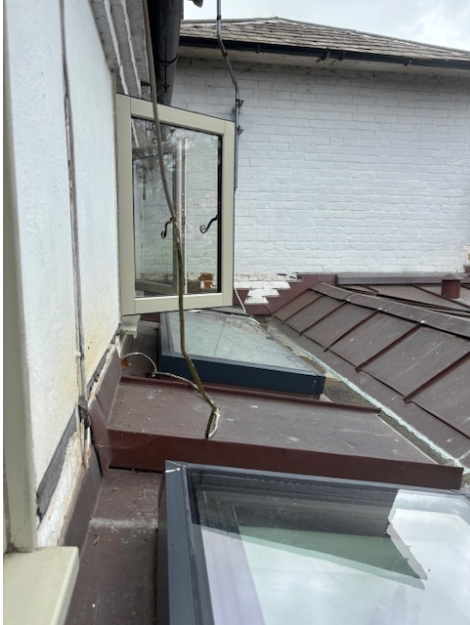
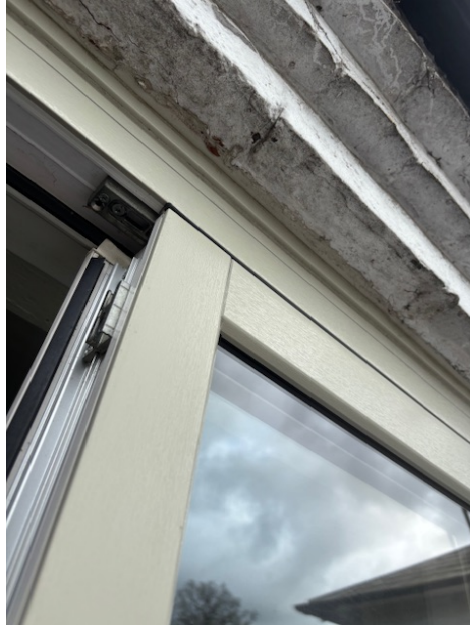
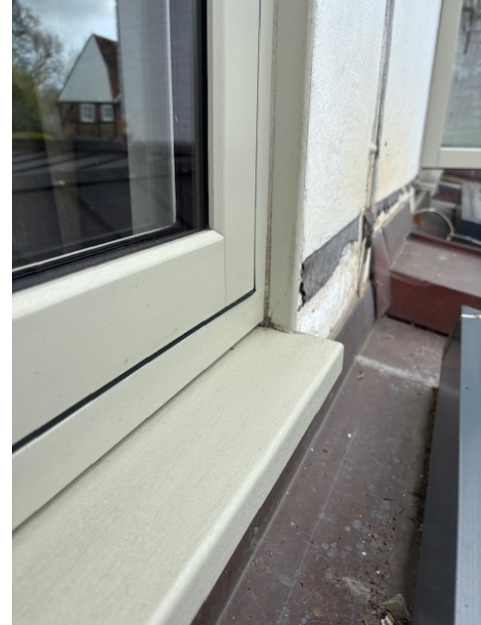
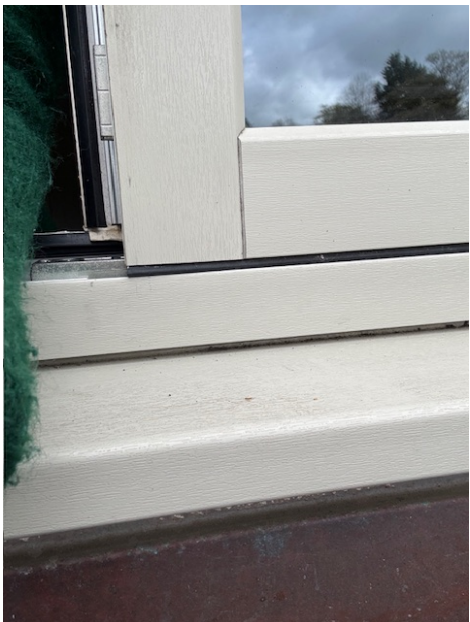
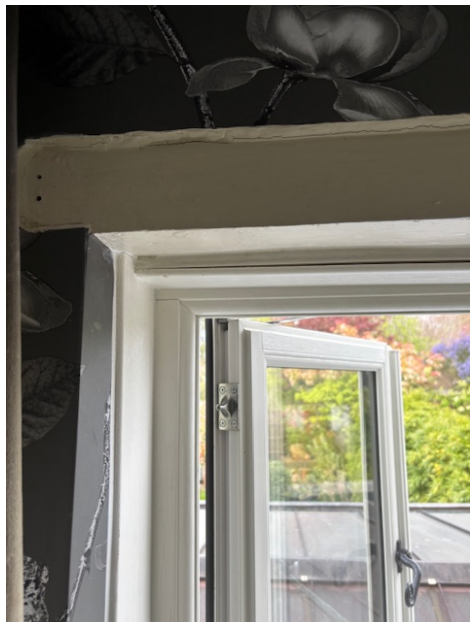
The new windows are double glazed upvc white on the inside and a pale green wood grain effect on the outside; without trickle vents. They are a flush fit casement to mimic the original windows with rats black metal 'rats tail' Ironmongery. The reveals inside and out are clad with 8mm upvc board however the original wooden windows sills have been retained. To meet current building regulations for fire safety means of escape the windows had to be constructed with two opening casements and flying mullion to provide sufficient space to exit the building in case of a fire.

No alteration has been made to the fabric of the building the windows have been made to fit the existing openings. The existing timber lintels and cills are still in place. Whilst the use of UPVC is not ideal these are flush casement windows in a rear location. They can be seen by the rear windows of 28 and 28a South street however this is over two gardens with hedges and trees and the angle is oblique. They are not visible to the public and as a result of the rear extension it is even hard to see the frames in any detail from the garden.
