# Coles Farm, Alcombe

## Preliminary Bat Roost Assessment

August 2025/April 2026

Client: WebsterHart  
Report Ref: SEB3147\_01 V4  
Author: Kate Hayward  
MCIEEM  
[www.seasonsecology.co.uk](http://www.seasonsecology.co.uk)

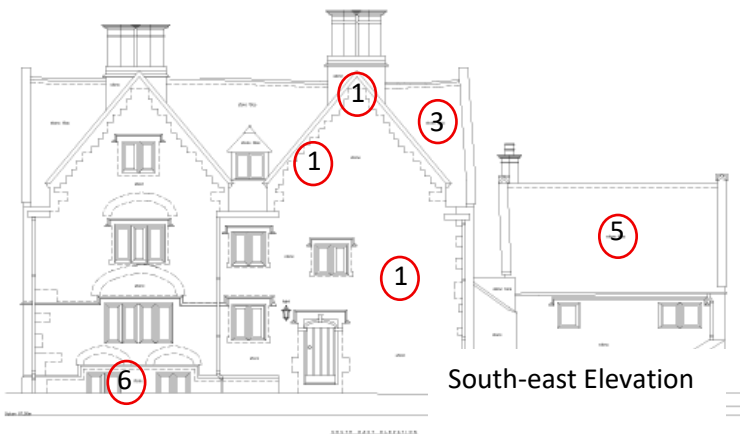
South-east Elevation

- Gaps in stonework on the south-east elevation (Target Note 1, Annex 1).
  - A gap at the apex on the north-west elevation (Target Note 2, Annex 1).
- 4.2.5 Internally, there is one large, L-shaped roof space and a smaller roof space over the kitchen. The L-shaped roof space is approximately 1.5m in height and 3m width. It has a combination of a traditional Bitumen-type liner and lath and plaster, both in poor condition with sections of the roof tiles visible, with gaps, and notably one large gap evident (Target Note 3, Annex 1). The roof space is uncluttered apart from one section containing a water tank.

- 4.2.8 The basement is split into two compartments, one in the south-east corner and one L-shaped compartment extending from the north-east to the south-west of the basement. The north-east and south-east of the basement are well-lit due to two windows on the south-east elevation (Target Note 6, Annex 1). The south-west of the basement appears dimly lit, as the lightwell in this area is covered by a metal vent at ground level (Target Note 7, Annex 1). The metal vent is partially obstructed across the bottom two thirds of the vent, with the top being open and providing a sub-optimal access point into the interior. Internally, the basement provides no perching habitat and presents a very low number of suitable crevices, mainly surrounding the boiler in the north-west of the basement. One potential access point was noted to the rear of the boiler, being a historic coal shoot.

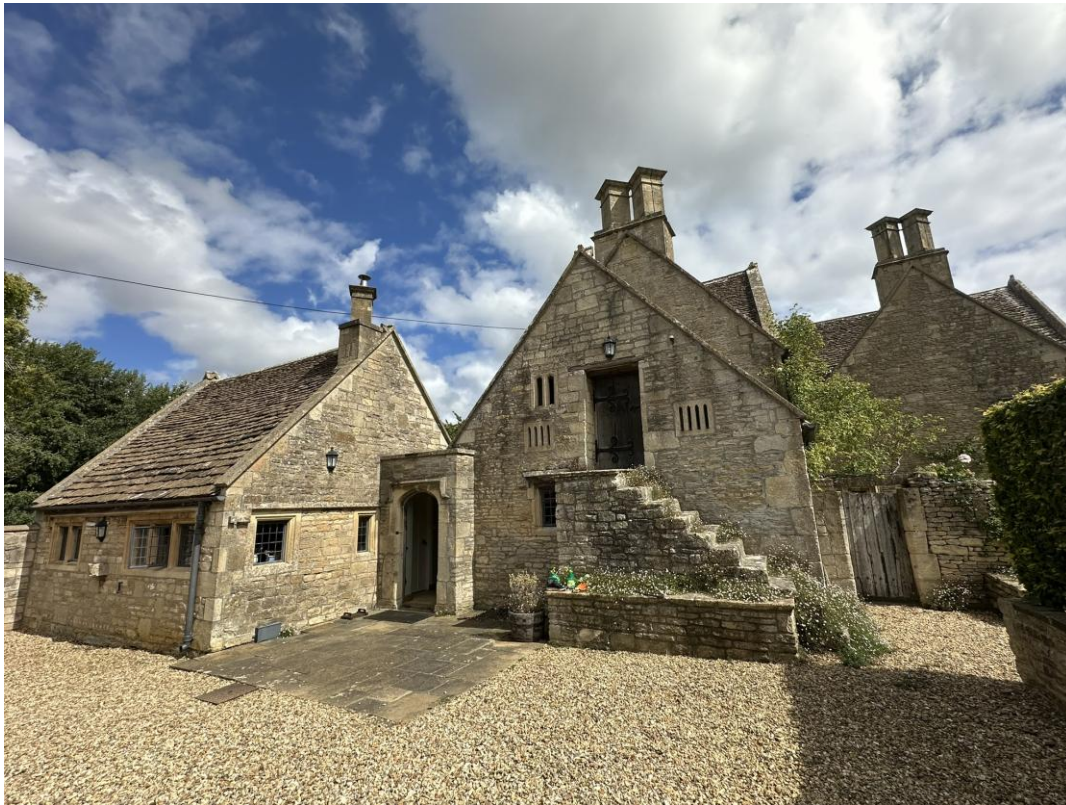
Photograph 1: North-west elevation of the house.

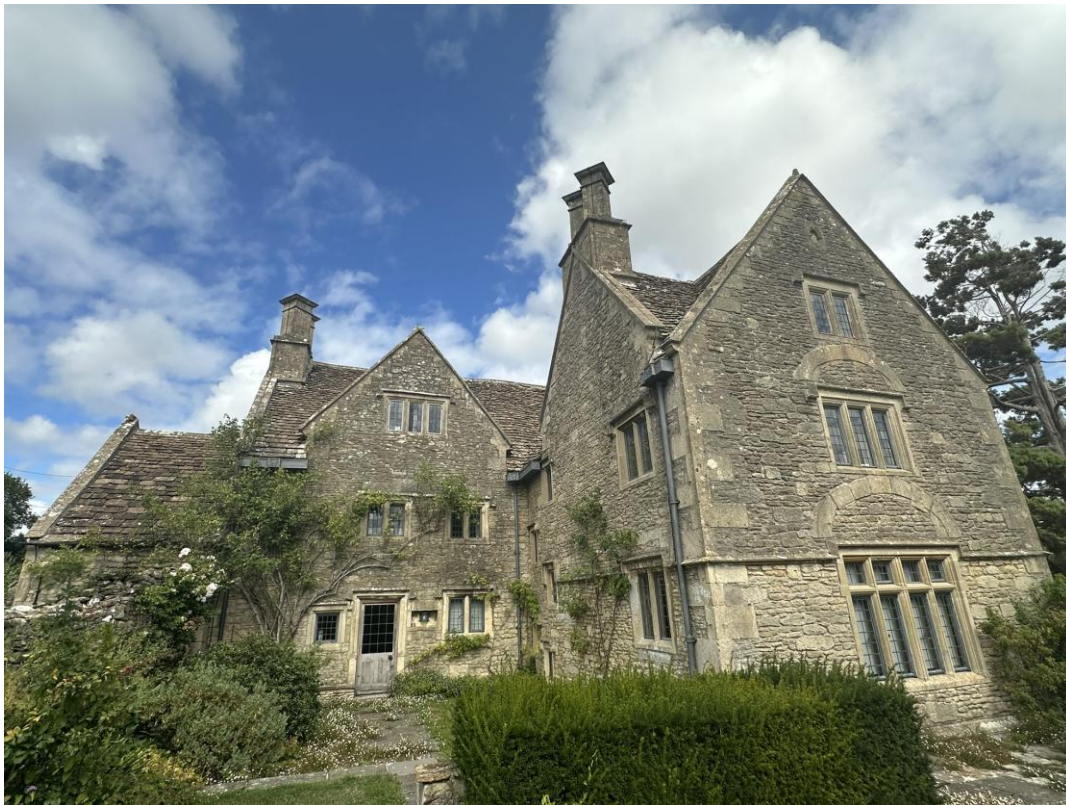
Photograph 2: South-west elevation of the house.

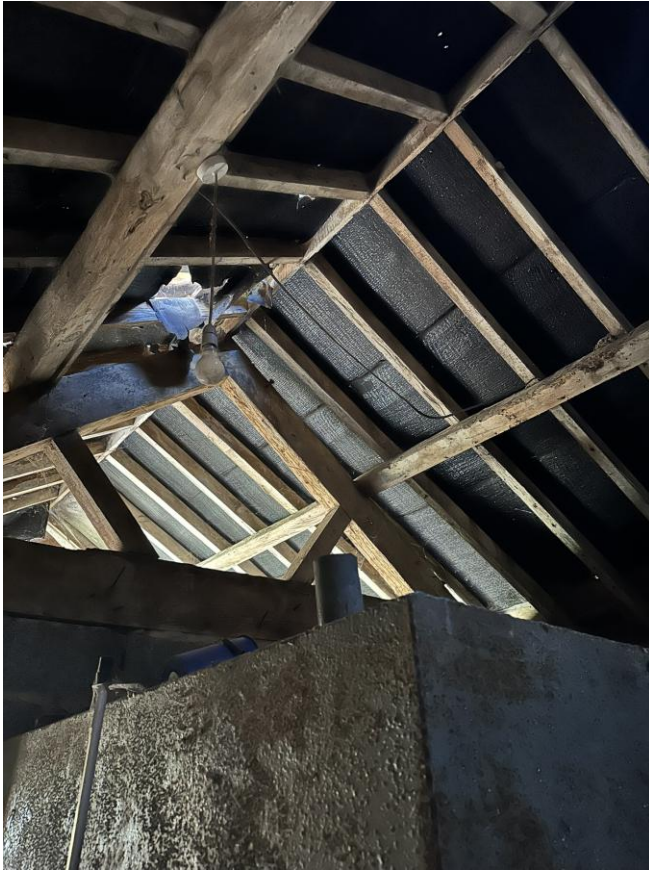
- 4.2.6 A low number of bat droppings were found in the roof space (approximately ten) (Target Note 4, Annex 1). A sample of the bat droppings was collected for DNA analysis to confirm species.
- 4.2.7 The smaller roof space over the kitchen is approximately 2m height and 6m by 4m. There is no liner below the roof tiles and there is daylight entering via gaps between the tiles (Target Note 5, Annex 1).

- 5.1.1 The house at Coles Farm lies in a rural location surrounded by open countryside. It is assessed as *High* suitability to roosting bats owing to its ecological context, age, style and construction. Evidence for the presence of roosting bats was identified within the main roof space of the house. DNA analysis of the bat dropping sample collected confirmed brown long-eared bat, indicating a day roost for low numbers of this species.

Photograph 3: Part of the L-shaped roof space of the house.

- 6.1.1 The Grade 1 Listed property is the subject of a Listed Building application for internal renovation works. There are no works proposed to the roof or roof spaces. Therefore, areas with suitability to roosting bats and the brown long-eared probable day roost in the main roof space of the house, will not be impacted.
- 6.1.2 It is not expected that access to roof spaces will be required. However, should this change at any point during the renovation works, then a Licensed Bat Ecologist should be contacted to carry out a pre-works inspection of the roof spaces and to be present whilst any minor works are carried out.
- 6.1.3 No other precautionary measures are required prior to and during the works.

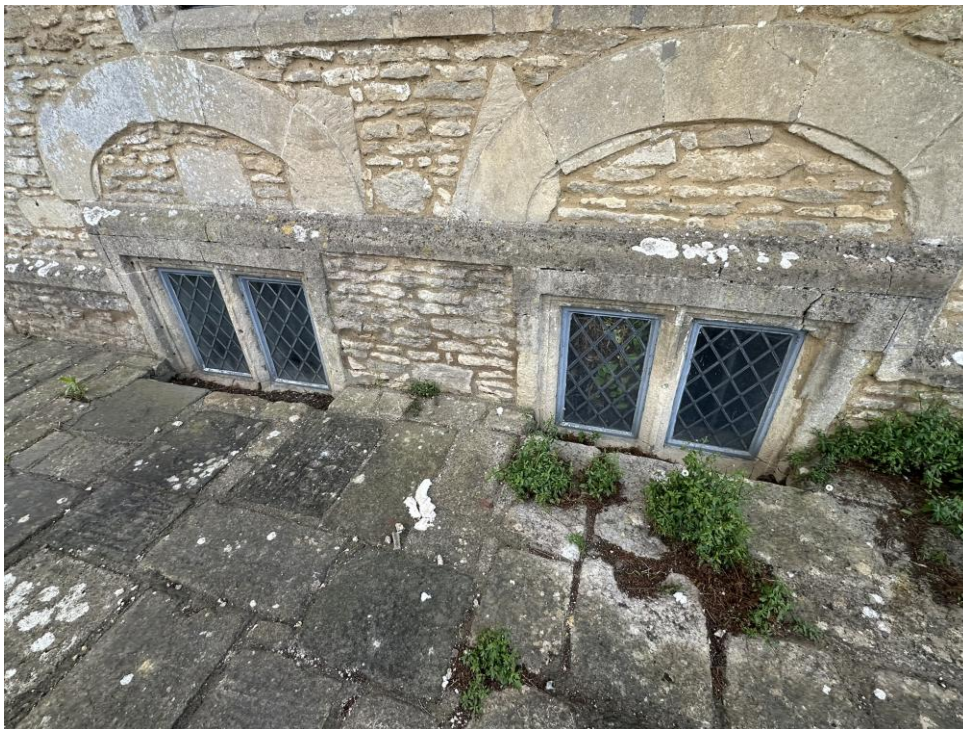
- 4.2.9 Externally, no further access points were identified into the basement, with the two south-east elevation windows appearing in good condition and well-sealed, and the exterior location of the historic coal shoot no longer evident externally, having been previously removed and filled in. The blocked lightwell in the south-west of the basement is partially obscured externally by a number of slate tiles, therefore reducing the suitability of this access point.

Photograph 4: Basement windows.

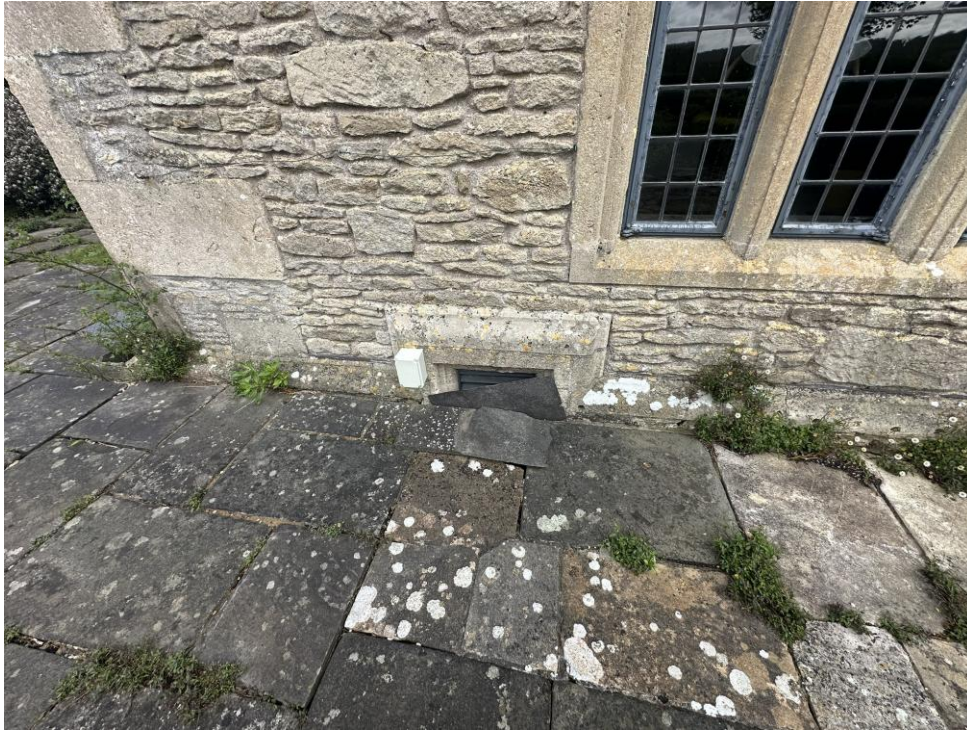
Photograph 5: Partially obscured metal vent to basement.

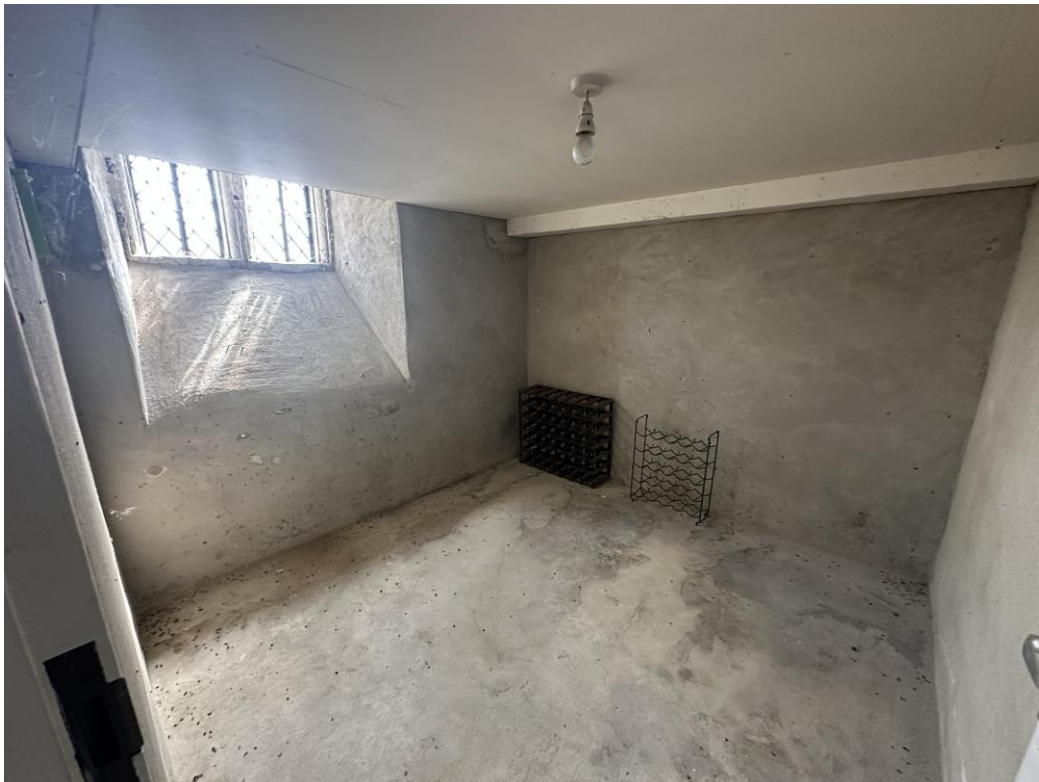
Photograph 6: Well-lit internal area of the basement.

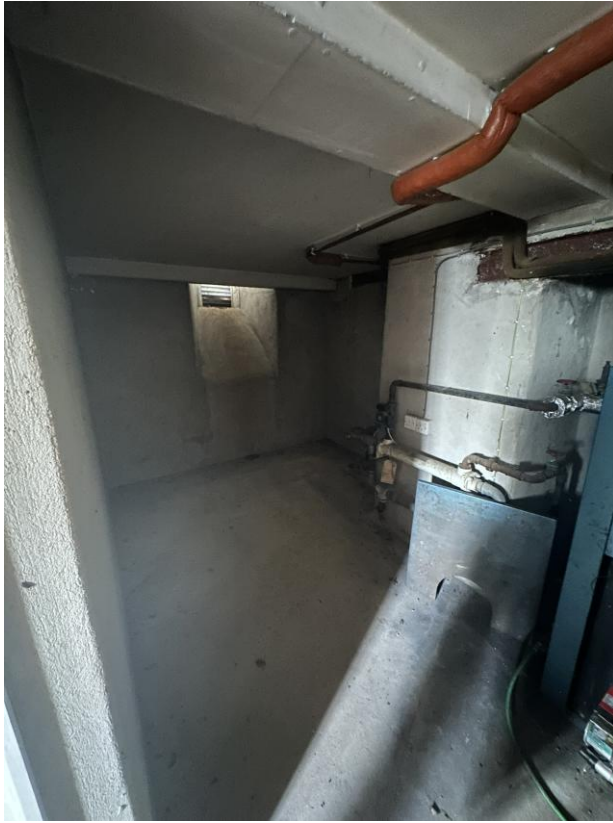
- 5.1.2 The basement has one suboptimal, partially obscured, access point, and only a very low number of suitable crevices within the interior, no suitable perching habitat and no evidence of roosting bats found. Therefore, it is considered that the basement has *Negligible* suitability to roosting bats.

Photograph 7. Internal view of basement showing the metal vent.
