# Land off Trowbridge Road, Bradford on Avon

Waddeton Park Ltd

Active Travel England Route Audit Report

April 2026

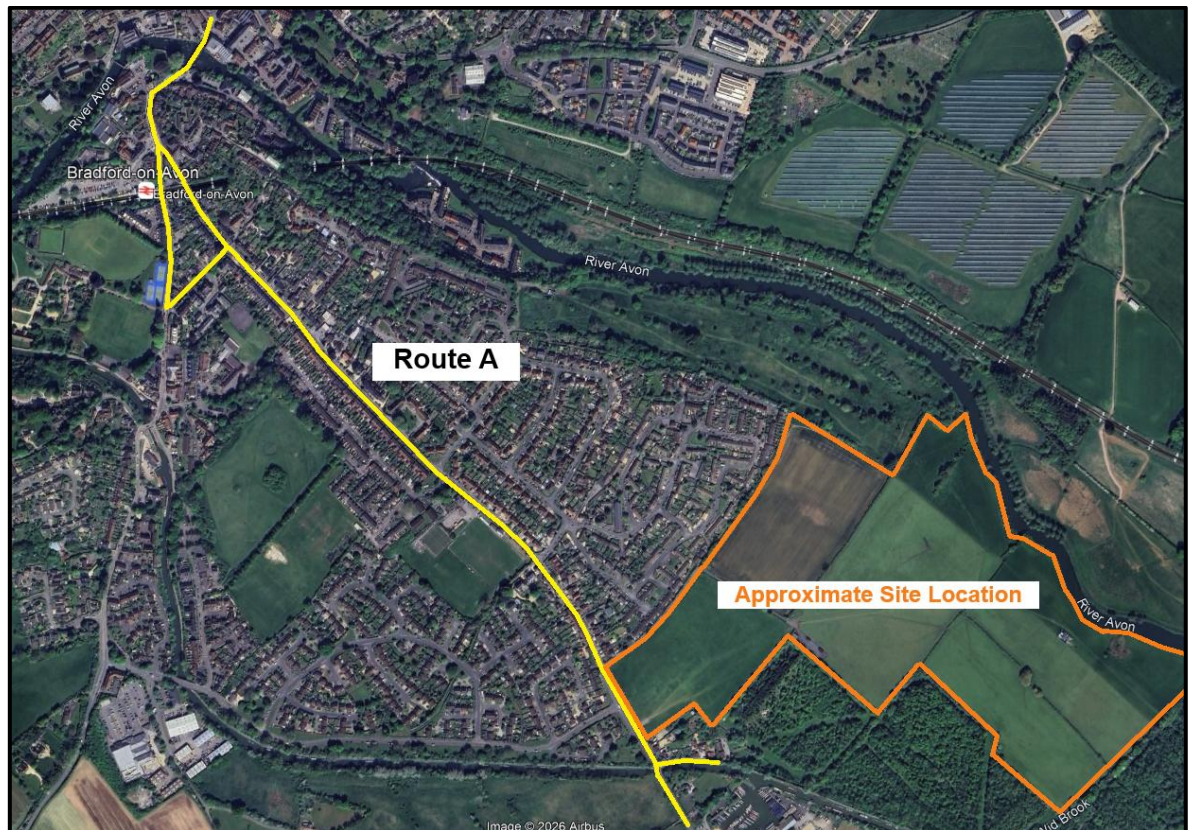
**Figure 2.1** Route A Plan

- 2.1 **Route A** is approximately 1290m in length and runs from Bradford on Avon town centre to just south of the Kennet and Avon Canal. The route also includes the triangular road layout of Junction Road and Frome Road, in addition to the main access route to the Kennet and Avon Canal Path to the east of Trowbridge Road. An overview of the route audit is presented at **Figure 2.1**.

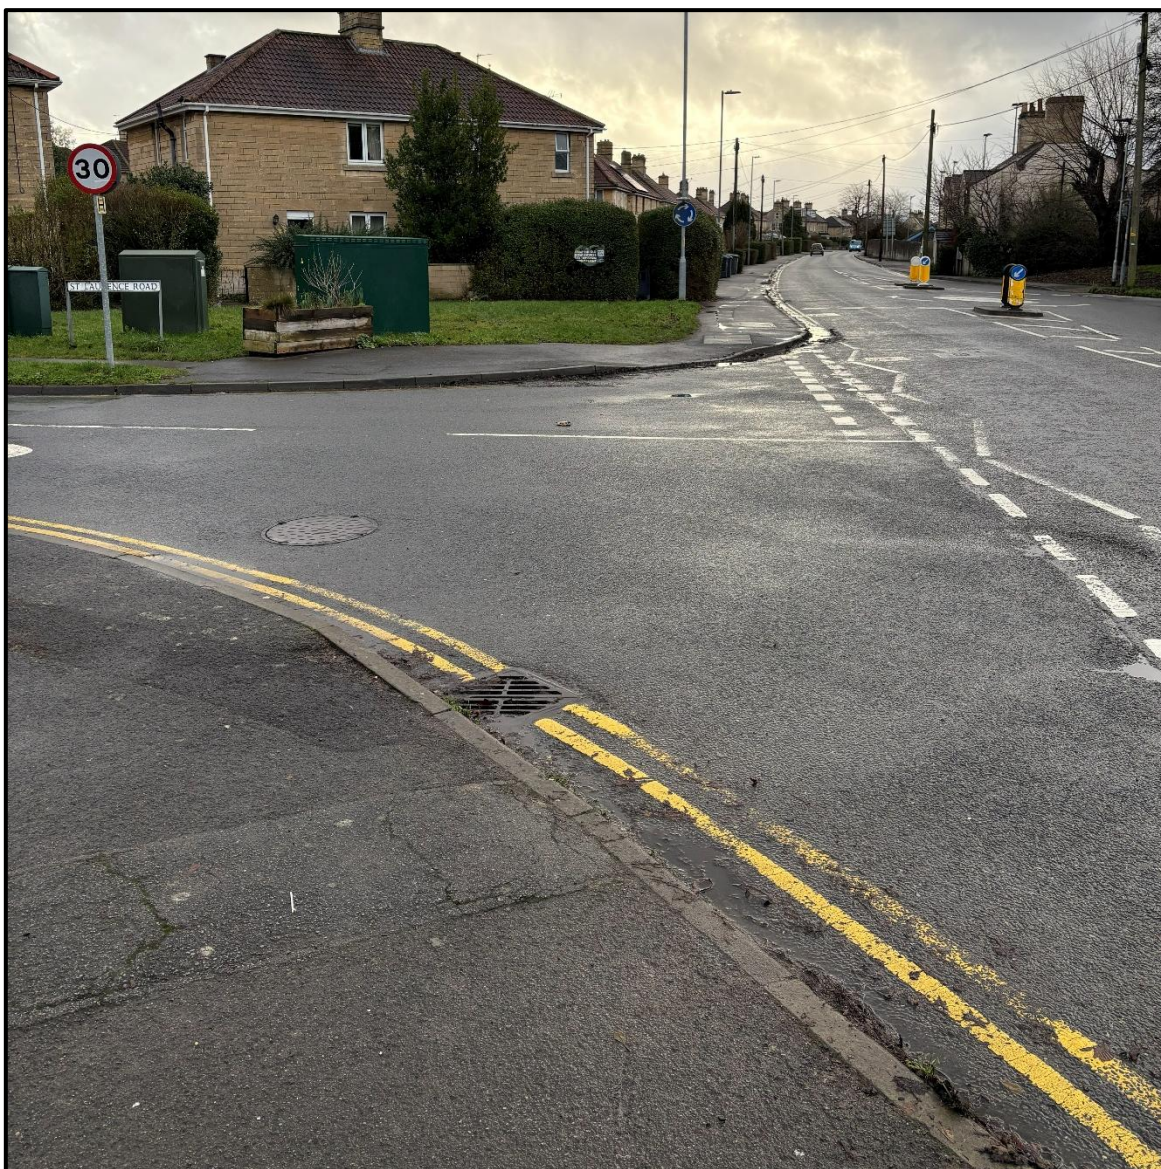
**Photo 2.1** Crossing at St Laurence Road / Trowbridge Road junction

- 2.9 In accordance with ATE guidelines, level differences greater than 13mm without the presence of specific tactile paving information and colour contrast present a critical risk to pedestrians if not remediated. This hazard is pertinent at the crossing of St Laurence Road.
- 2.10 The conditions at the time of a site visit conducted on the 23<sup>rd</sup> of January 2026 are documented within **Photo 2.1** below.

- 2.11 It has been identified within the BOA LCWIP to provide an improved crossing arrangement at the location of the St Laurence Road / Trowbridge Road junction. There are currently no proposals as part of this application to deliver improved crossing facilities at this junction. However, subject to discussions with WC, proportional contributions towards an improvement scheme could be provided.
- 2.12 It should also be noted that there is no tactile paving at the Regent's Place, St Margeret's Hil and St Margeret's Villas minor arm junctions on Trowbridge Road.

| Critical Issue Reference ID | Critical Issue | Stage | Latitude and Longitude | Location Name | Resolved by Design | Commentary & Feedback |
|---|---|---|---|---|---|---|
| 250372_SA04_01P | 4 - Trip Hazards: Level differences more than 13mm with no tactile information and colour contrast | Existing | 51.340717 , -2.2449798 | St Laurence Rd | Yes | Surface Level to be reviewed and tactile paving to be installed at crossing |

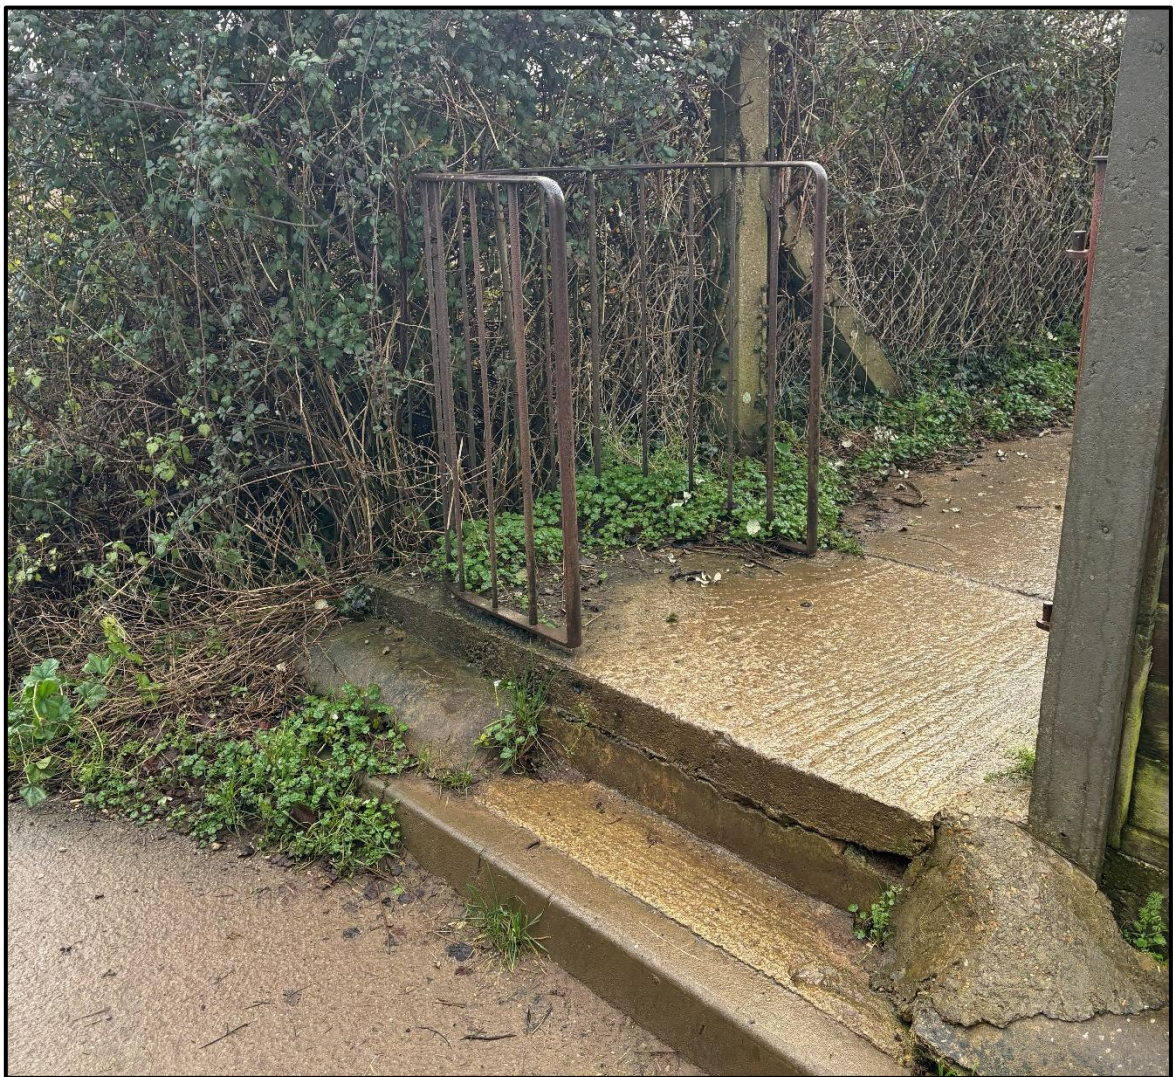
**Photo 3.1** Existing steps at access point to BRAD19 footpath to the south of Mythern Meadow

- 3.16 As discussed previously in **Section 2**, in accordance with ATE guidelines, level differences greater than 13mm without the presence of specific tactile paving information and colour contrast present a critical risk to pedestrians if not remediated.
- 3.17 At present, it is recognised that Route B is not fully accessible, due largely to the steps found to the south of Mythern Meadow on the BRAD19 public right of way footpath. The conditions at the time of the site visit are depicted below within **Photo 3.1**.
- 3.18 As stated previously, it should be appreciated that an alternative route within the site boundary, in the form of a 3.0m wide shared-use path, will be provided, thus alleviating the impact of this non-compliant feature.

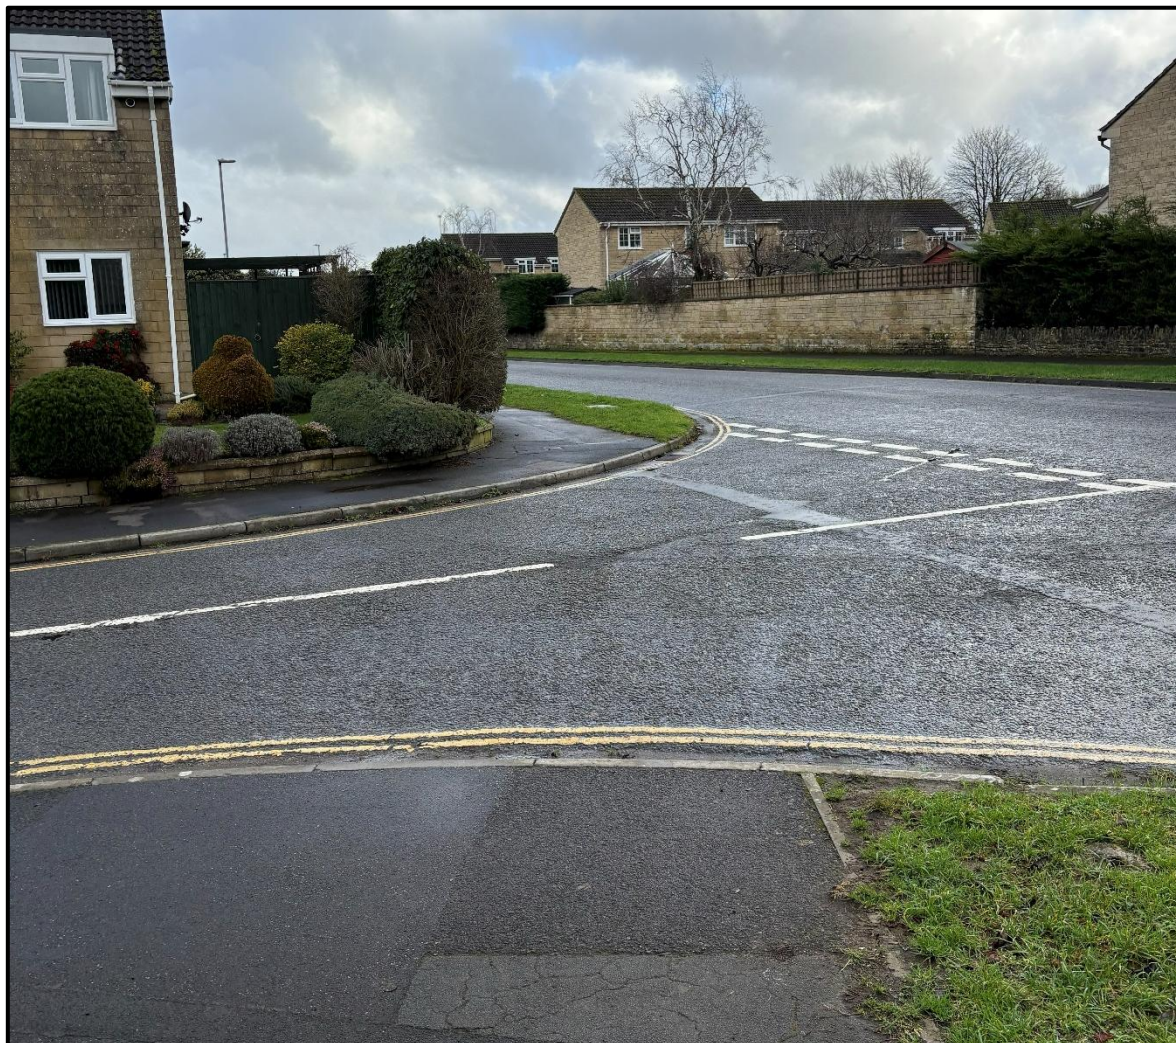
**Photo 3.2** Current condition of proposed crossing location at Fitzmaurice Close, looking east

- 3.19 Further to this, it is noted that at present, Fitzmaurice Close does not have possess any tactile paving or dropped kerbs along the pedestrian desire line. The current conditions of the crossing location are depicted within **Photo 3.2** below.

- 3.20 It is currently not proposed to provide tactile paving at the Fitzmaurice Close junction. However, subject to discussions with the LHA, improvements could be provided.

| Critical Issue Reference ID | Critical Issue | Stage | Latitude and Longitude | Location Name | Resolved by Design | Commentary & Feedback |
|---|---|---|---|---|---|---|
| 250372_SA04_01P | 4 - Trip Hazards: Level differences more than 13mm with no tactile information and colour contrast | Existing | 51.3365692, -2.242190872 | Fitzmaurice Close | Yes | Lack of dropped kerb and tactile paving across Fitzmaurice Close - to be addressed in off-site works |

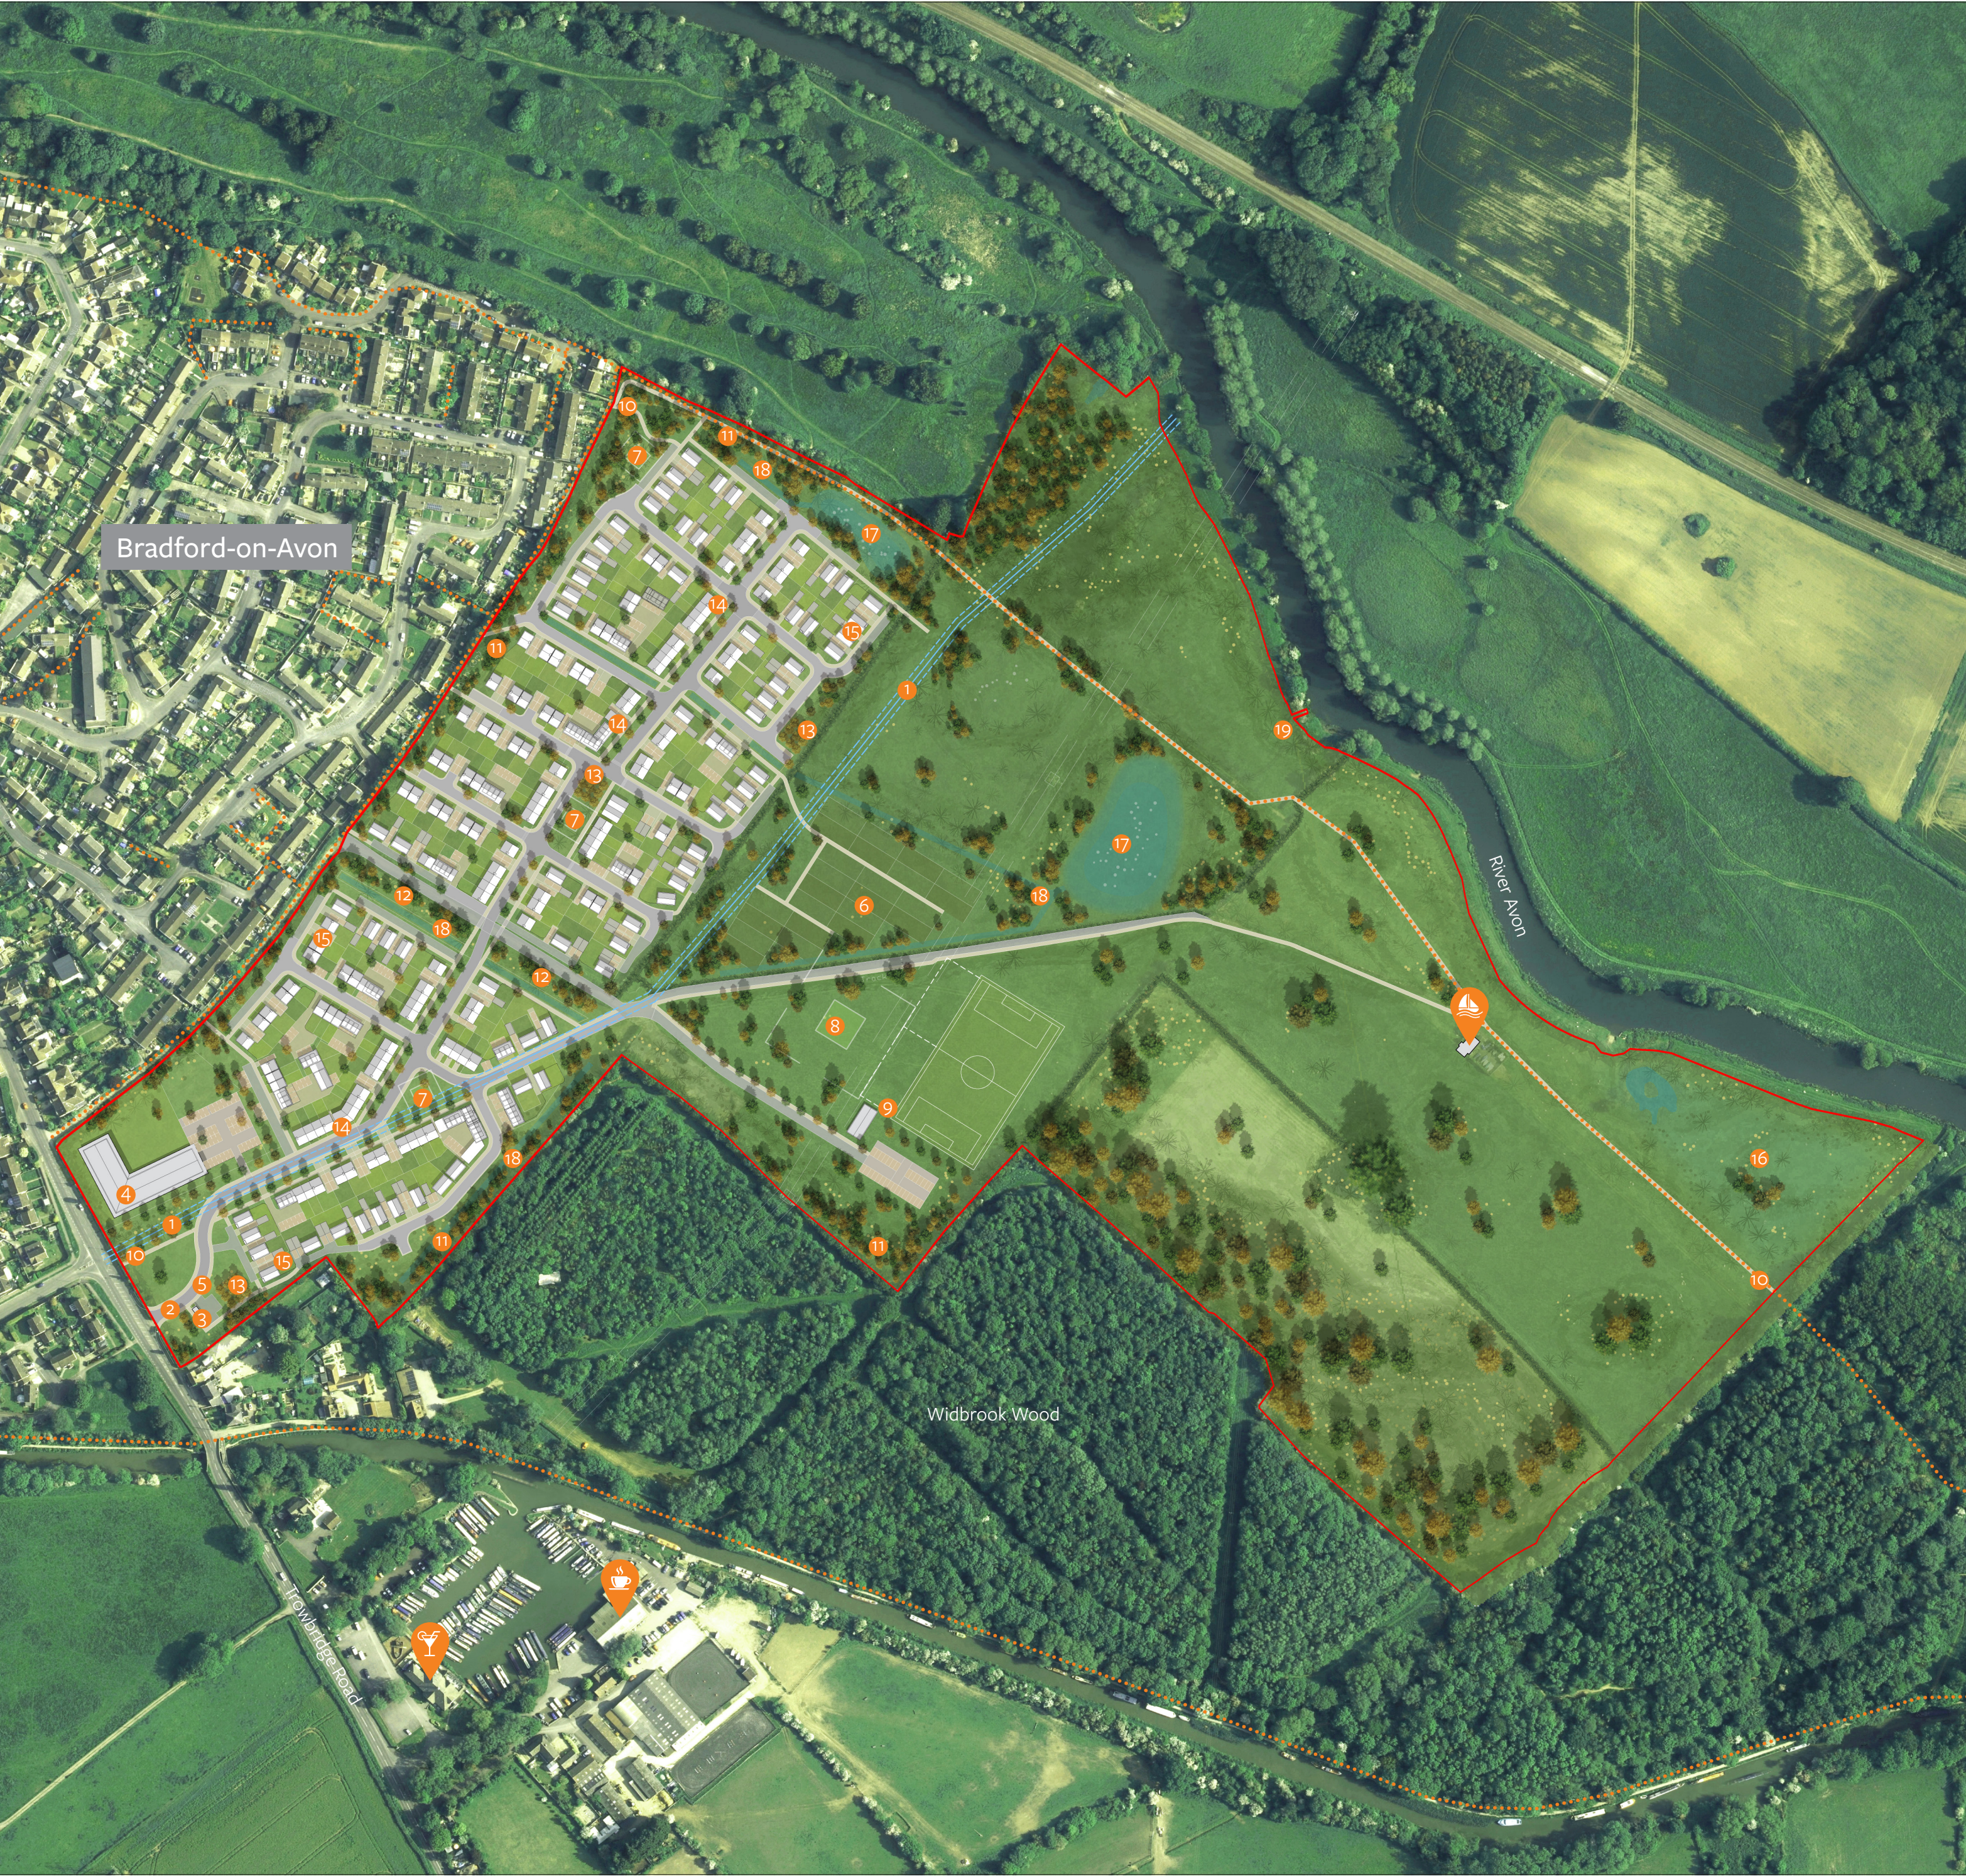
## Appendix A – Illustrative Layout Plans

- Application boundary
- ① Existing pipeline
- ② Access from Trowbridge Road
- ③ Proposed mobility hub
- ④ Residential care facility
- ⑤ Primary access route
- ⑥ Proposed community allotments
- ⑦ Local Area of Play (LAP)
- ⑧ Local Equipped Area of Play (LEAP)
- ⑨ Changing facilities and associated pitches
- ⑩ Pedestrian connection
- ⑪ Proposed woodland buffer
- ⑫ Central green street
- ⑬ Community garden i.e orchard
- ⑭ Higher density core
- ⑮ Lower density periphery
- ⑯ Wetland and marginal planting
- ⑰ Proposed attenuation pond
- ⑱ Proposed swales
- ⑲ Drainage outfall
- ... Public Right of Way
