# 8 Mount Pleasant, Chippenham

## Preliminary Roost Assessment (PRA) Report

1946/Version 1.0

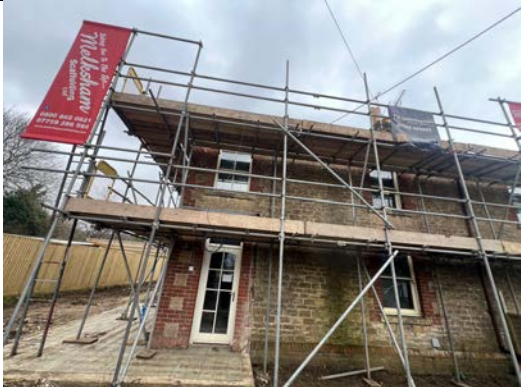
| Building reference | Notes | Photograph of bat feature(s) |
|---|---|---|
| Southwestern elevation | Windows and doors well sealed with no obvious features.<br><br>At the time of the survey, the scaffolding restricted visibility | |

| | <p>of the roof.</p> | |

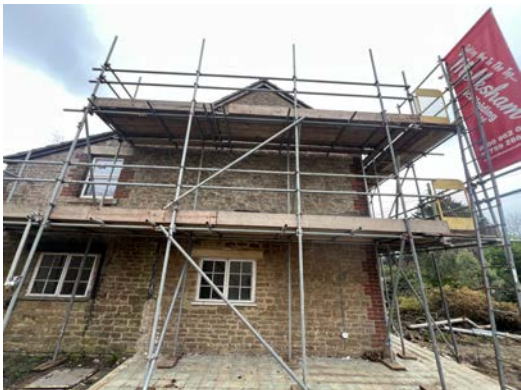
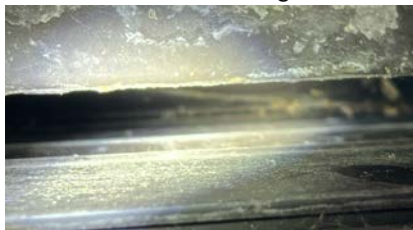
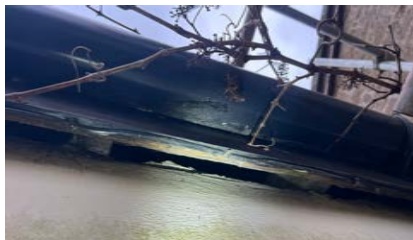
| <p>Western elevation</p> | <p>There was a gap between the window and shutter casing – potential roosting feature (Plate 1)</p> <p>The wooden fascia board had deteriorated, leaving a gap underneath. (Plate 2)</p> <p>Windows well sealed – no obvious gaps.</p> <p>The scaffolding obscured the view of the western roof elevation.</p> | <p>Plate 1: Gap present between window and shutter casing</p> <p>Plate 2: Gap behind wooden fascia board</p> |

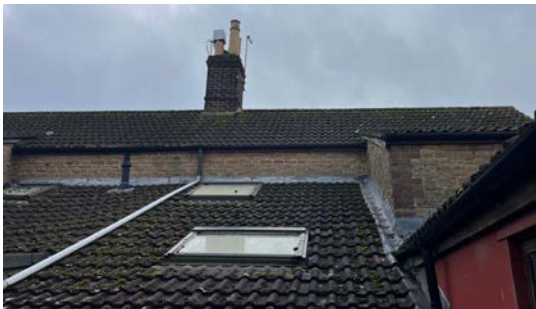
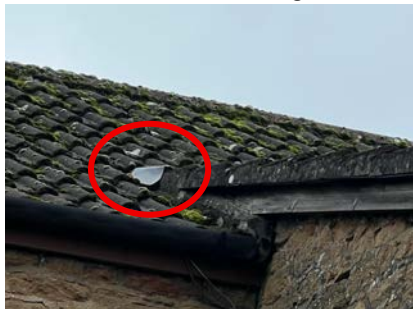
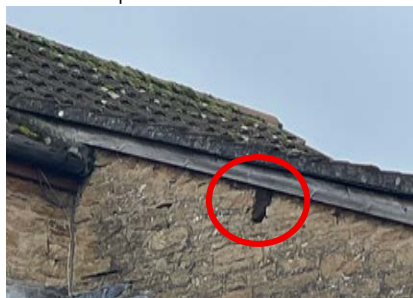
| <p>Northeastern elevation</p> | <p>Raised lead flashing observed at the roof junction to the upstairs bathroom – potential roosting feature (Plate 3)</p> <p>A gap was observed along the wooden beam within the brickwork – potential access/roosting feature (Plate 4).</p> | <p>Plate 3: Raised lead flashing</p> <p>Plate 4: Exposed wooden beam</p> |

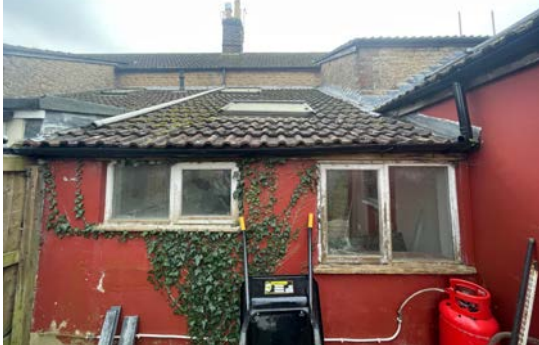
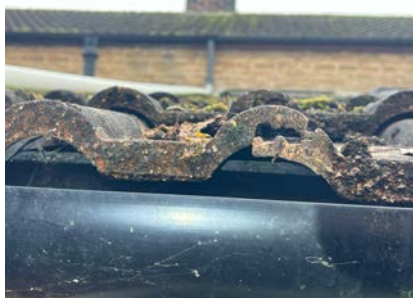
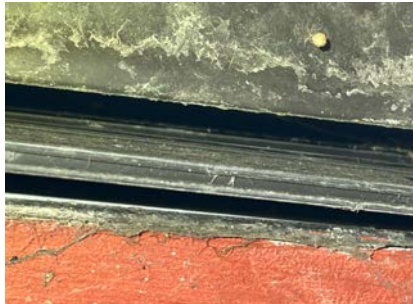
| | underneath (Plate 5).<br>Gaps were present between UPVC door and shutter casing (Plate 6). | <br>Plate 6: Gap between door and shutter casing<br><br>Plate 7: Gap under tile behind the skylight |

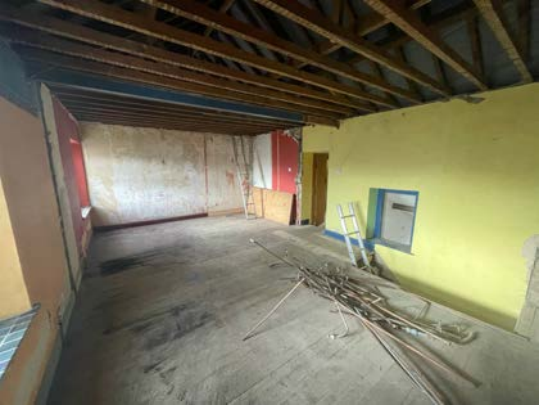
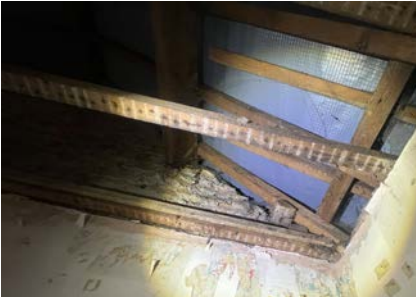
| First floor – Room 1 | There was a ridge beam in the pre-existing loft void – potential roosting feature.<br>The northwestern gable end | |

| | <p>wall was constructed of brick. A large gap was observed above the wall plate, which could provide access or roost space for void-dwelling species (Plate 9).</p> <p>The southeastern gable end was also constructed of brick, with cobwebs present.</p> <p>There was a gap in the wall plate creating fly through access for bats into the adjoining property. Windows well sealed with no obvious gaps.</p> | <p>Plate 9: Gap running along the top of the gable end wall</p> |

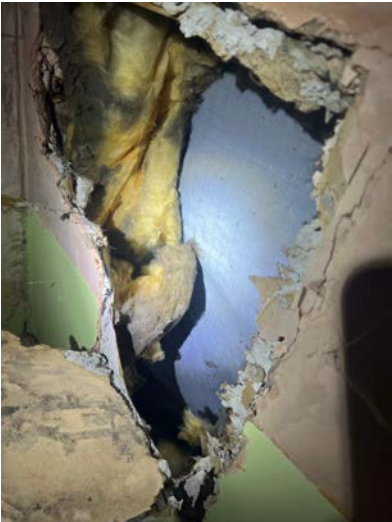
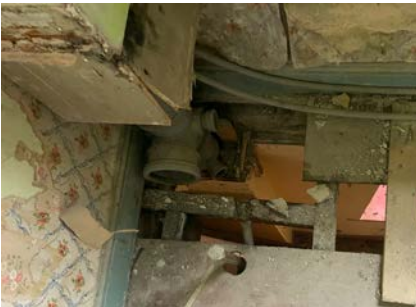
| <p>First floor - Room 2</p> | <p>A section of the ceiling had deteriorated, with a hole present exposing fibre wool insulation (Plate 10).</p> <p>Sections of floorboards were missing, and several areas of lifted floorboards were observed, allowing access to the floor below (Plate 11).</p> | <p>Plate 10: Exposed roof</p> <p>Plate 11: Missing floorboards</p> |

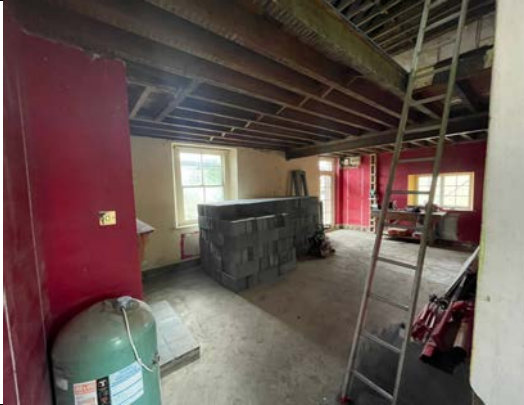
| <p>Ground floor - Room 1</p> | <p>Doors and windows well sealed</p> <p>Room being used for storage of building supplies.</p> <p>No obvious features.</p> | |

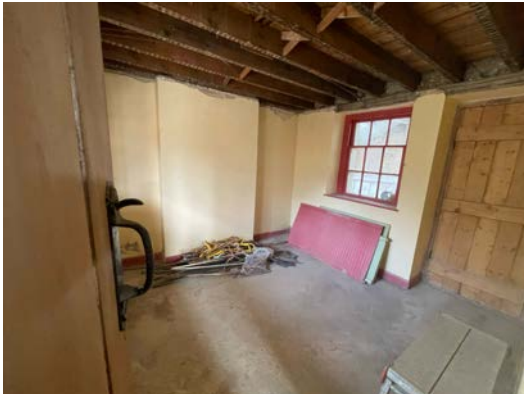
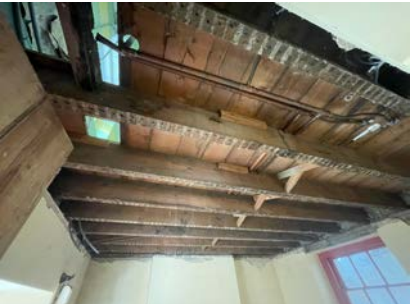
| <p>Ground floor - Room 2</p> | <p>Missing floorboards exposing access to upstairs (Plate 12)</p> <p>Windows and doors well sealed.</p> | <p>Plate 12: Exposed floorboards</p> |

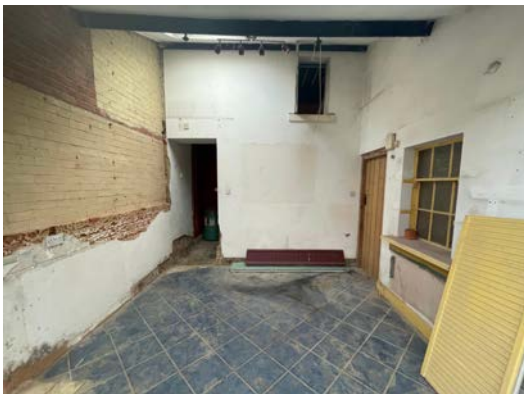
| <p>Room 1</p> | <p>Windows well sealed.</p> <p>Cobwebs present on exposed beams</p> | |
