# Woodlands Road, Mere

## Remediation Strategy

Redcliffe Homes

S1313/4272

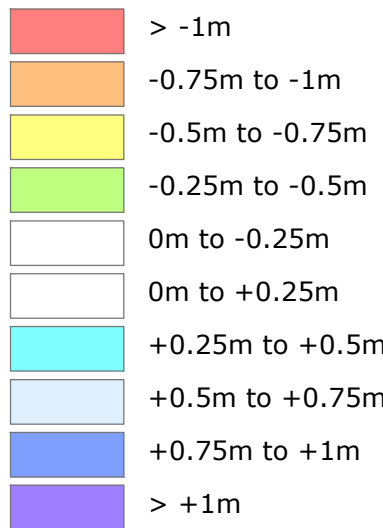
Level against Topsoil Strip:

Cut/Fill Summary

- A Topsoil strip of 150mm has been assumed across the site
- House & Garage foundation construction depth has been assumed at 450mm below FFL.
- Highway construction depth has been set to **640mm** based on Wiltshire CC's Highway Design Guidance. This also assumes CBR of 2-5%
- Footway construction depth set to **240mm** based on Wiltshire CC's Highway Design Guidance.
- Attenuation basin included.

As a result of the development works, site levels are due to be raised by between 0.0 -1.0m with localised deeper fill >1.0m. A plan is provided within Appendix A showing the proposed cut and fill. In consideration of the planned earthworks and significant fill volumes required within the development, opportunities for re-use within the scheme have been identified, and which will be discussed further in Section 4.4.

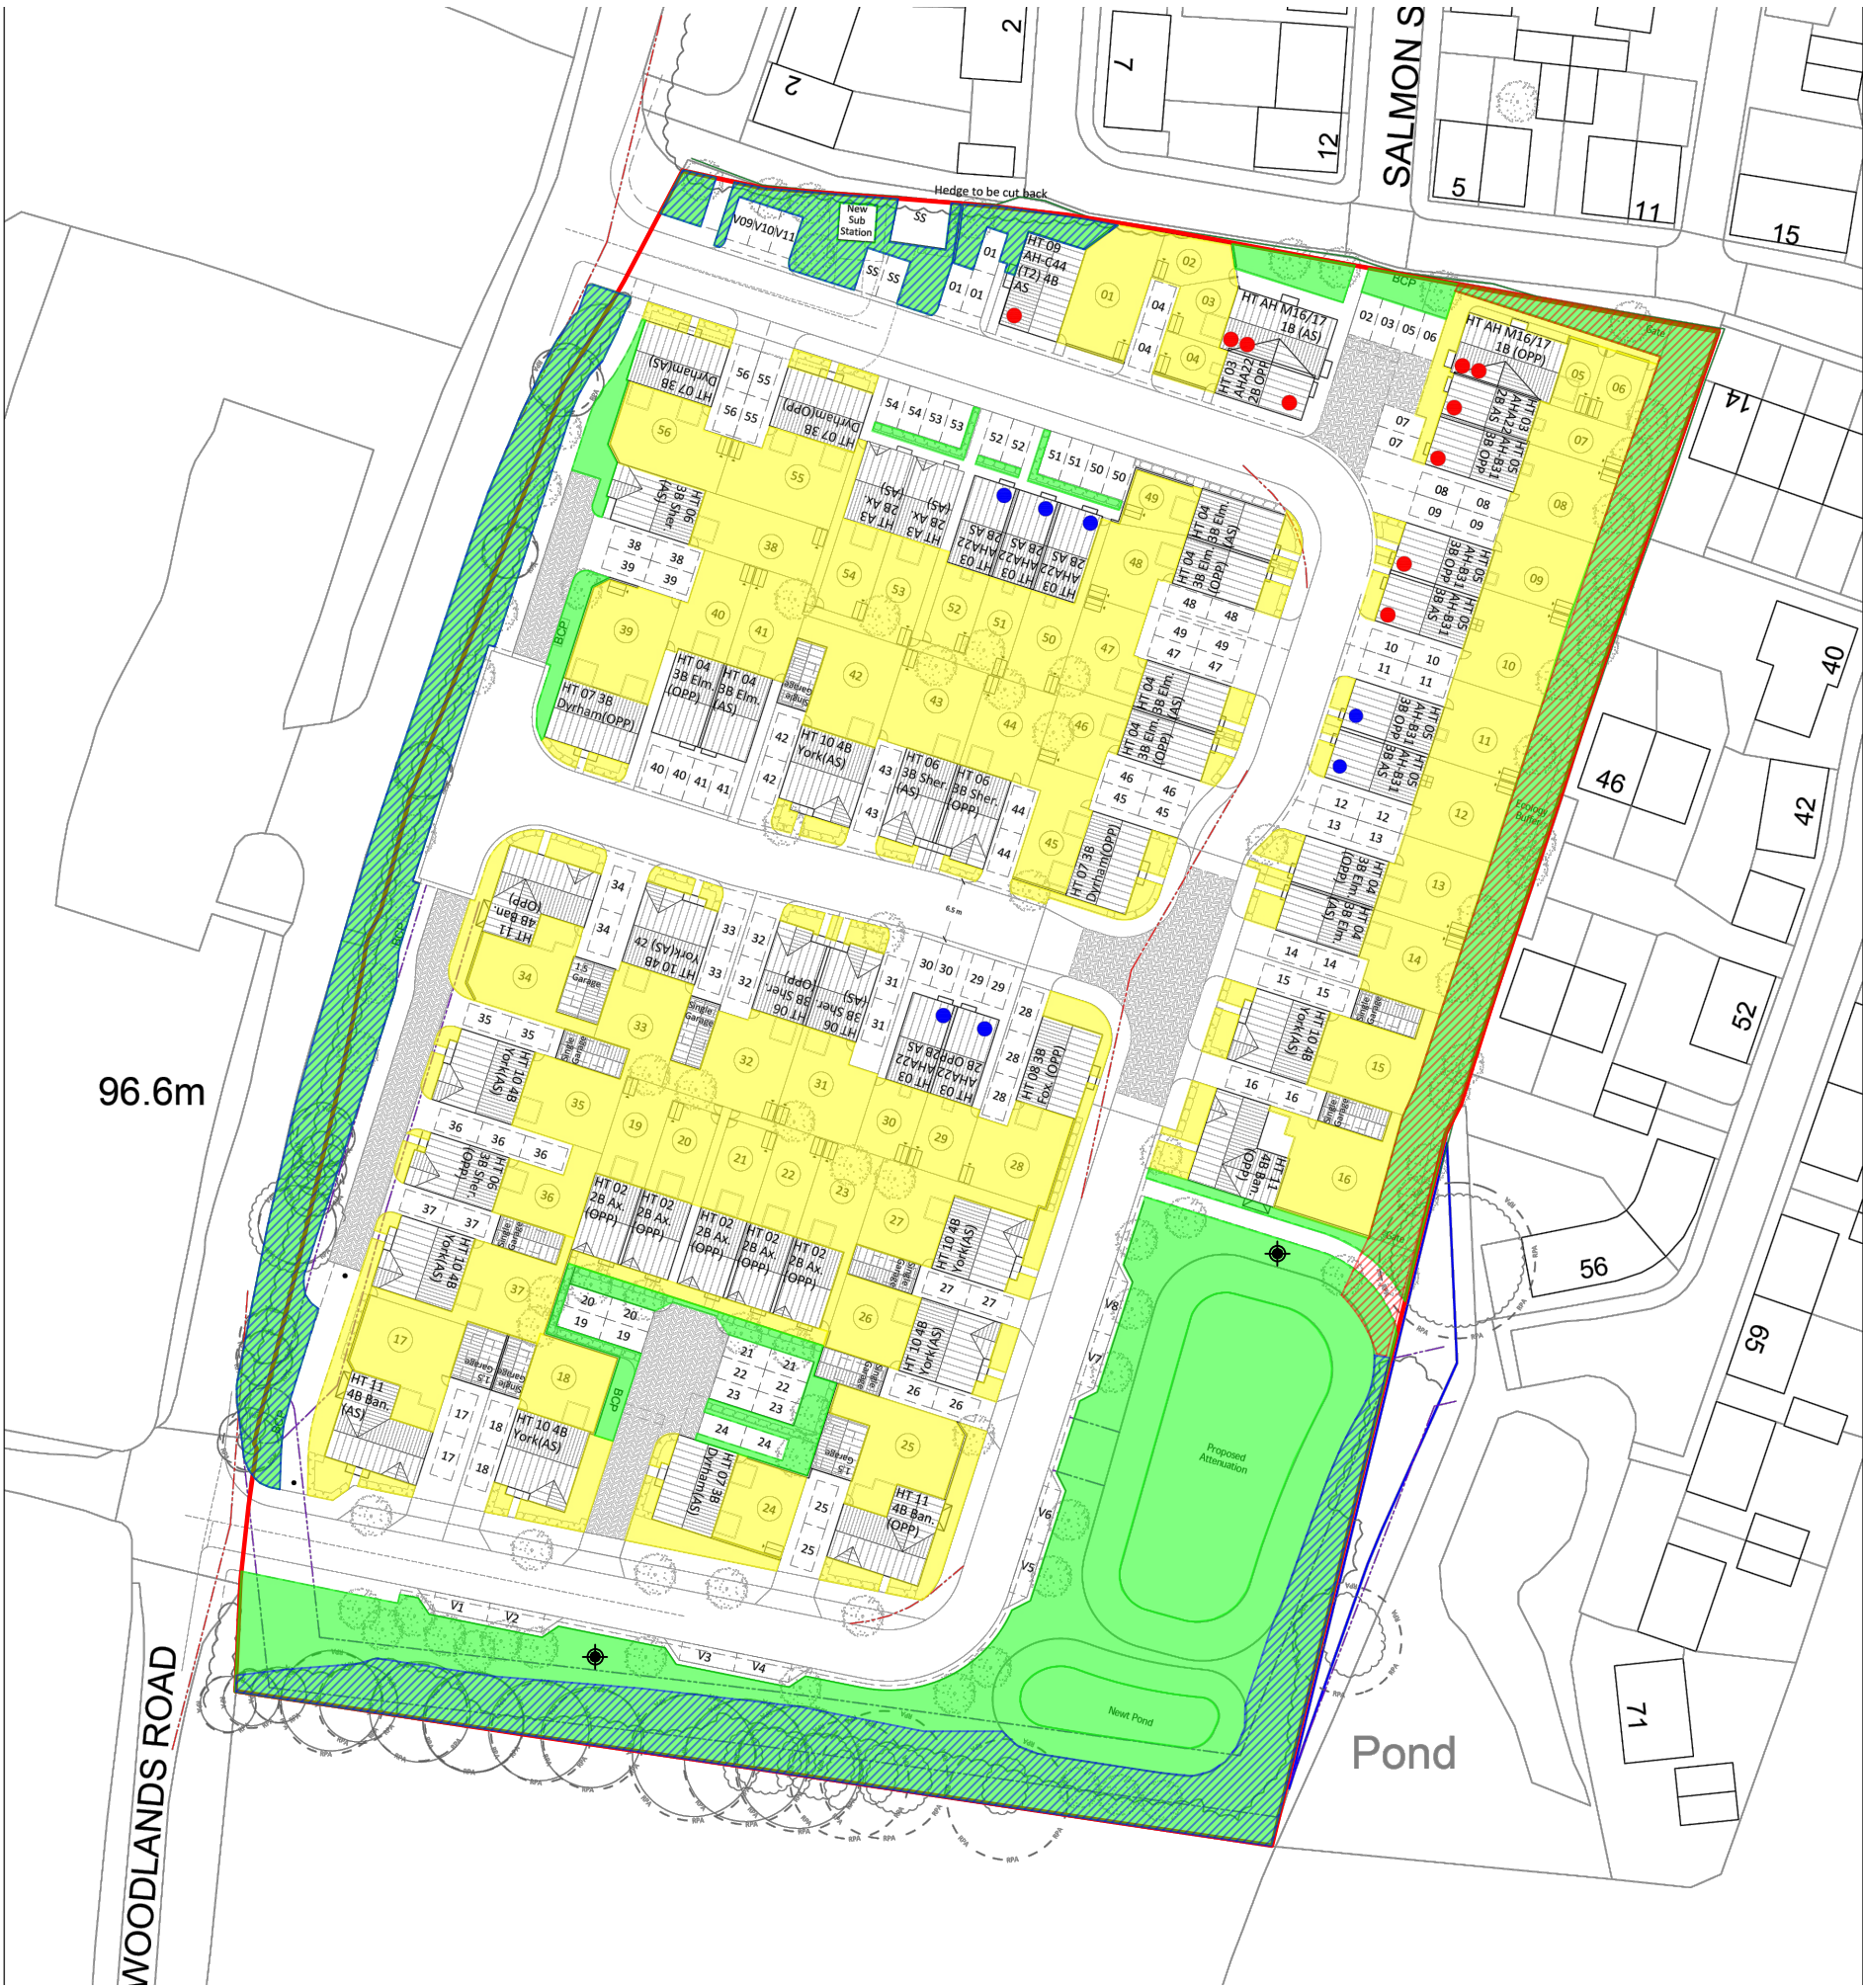
| Drawing No. | S1313-4272-01-001 |

- Upgraded water supply pipework shall be used if installed within site-wide made ground.
- Where specialist planting is dictated by landscaping proposals, a deeper growth medium may be required, including up to 450mm in areas of proposed shrubs and up to 900mm for tree pits (which may also require specialist installation in line with BS 5837). These details should be confirmed with the project landscaping adviser.
- Vigilance should be employed for any unforeseen ground conditions when excavating in previously inaccessible areas and when grubbing out, where specialist advice may be required.
- The required thickness and quality of capping soils to support the necessary plant growth should be discussed and agreed separately with the project landscaping team as necessary.

- In the defined areas of proposed private soft landscaping as shown on the plan within Appendix A, made ground shall be removed down to a minimum 600mm below finished level. It may be possible to terminate the capping depth on natural soils if encountered at shallower depths providing adequate additional testing has been undertaken to demonstrate that natural soils on site do not pose a risk to future site users. Levels shall be reinstated to reflect engineering requirements utilising chemically and physically suitable topsoil/sub-soil, as detailed within Section 6.1. A high visibility geotextile shall be provided at the base and sides of excavations as a marker layer

- In the defined areas of communal soft landscaping as shown on the plan within Appendix A, made ground shall be removed down to a minimum 300mm below finished level or the top of the natural soils, whichever is least. Levels shall be reinstated to reflect engineering requirements utilising chemically and physically suitable topsoil/sub-soil, as detailed within Section 6.1. A high visibility geotextile shall be provided at the base and sides of excavations as a marker layer where existing made ground is to remain *in situ* at the base of the capping excavations. If natural soils are found to be at the base of the excavation then providing it can be shown not to pose a risk to future site users a geotextile membrane will not be required. The geotextile membrane requirement can also be excluded in areas of POS where increases in levels with chemically suitable imported material provides a minimum total capping thickness of 600mm above residual made ground or where an impermeable clay pond liner has been used in the creation of the attenuation basins.
