**TUTTON HILL BARN**

**STRUCTURAL REPORT  
on  
CONCRETE FRAMED BARN**

### **Calculations for Concrete Frame**

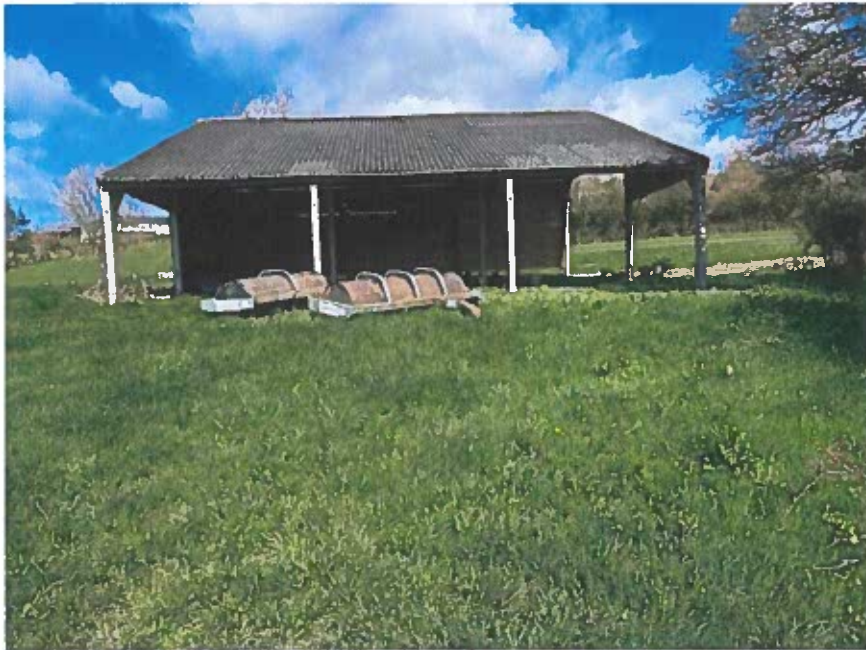
South Elevation

The east and south elevation are open and unclad. The concrete columns stand reasonably plumb. They have been patched in a few places where spalling had occurred, but are generally in good structural condition.

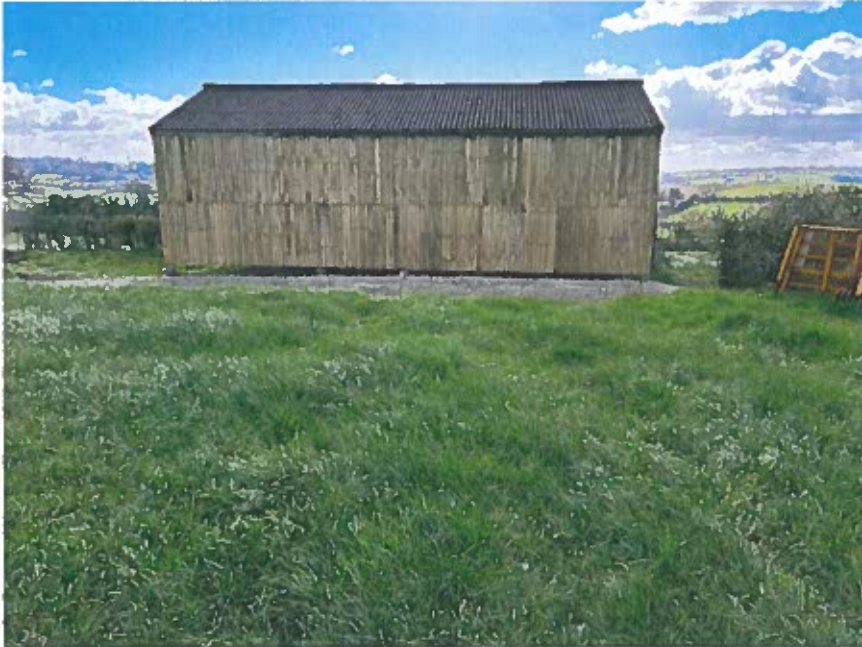
North Elevation

The corrugated cladding to the west elevation is in reasonably good condition, with no evidence of movement. The timber cladding to the north elevation is in good condition.

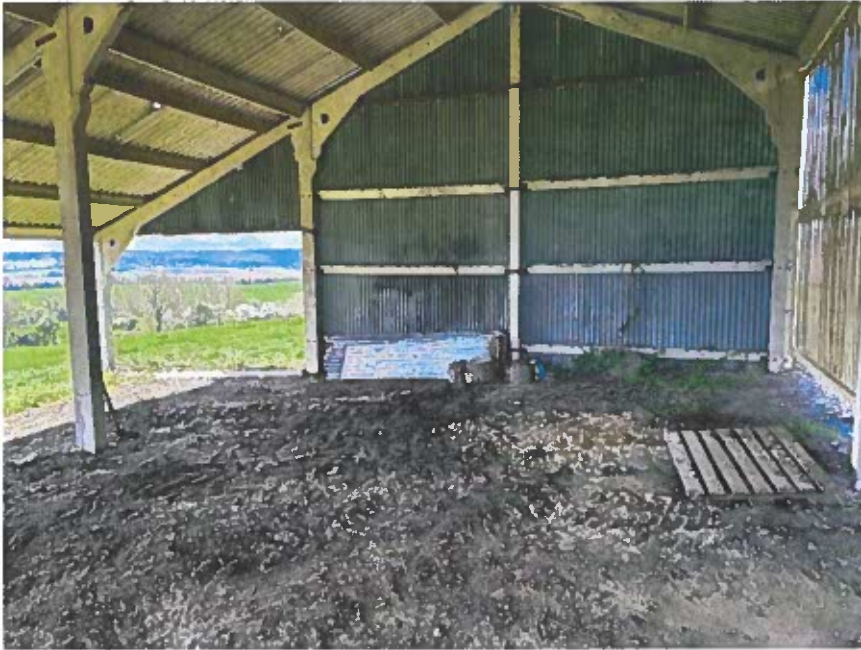
West Gable

The west gable is clad with corrugated steel sheets supported on precast concrete sheeting rails. The north elevation has vertical timber cladding. The other elevations are open apart from corrugated cement sheeting at the top of the east gable and lean-to.

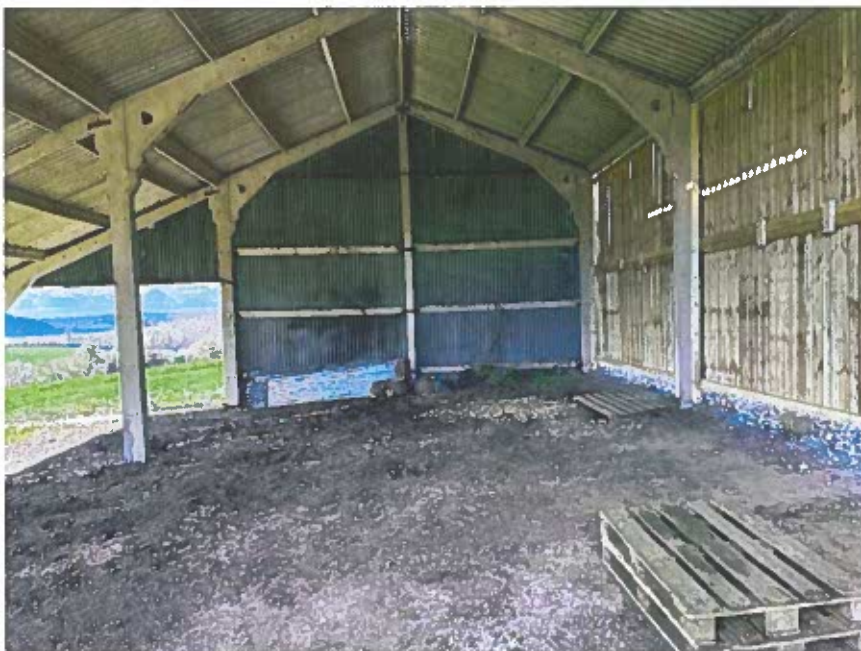
Interior View

The space is divided into three equal bays by four concrete portal frames.

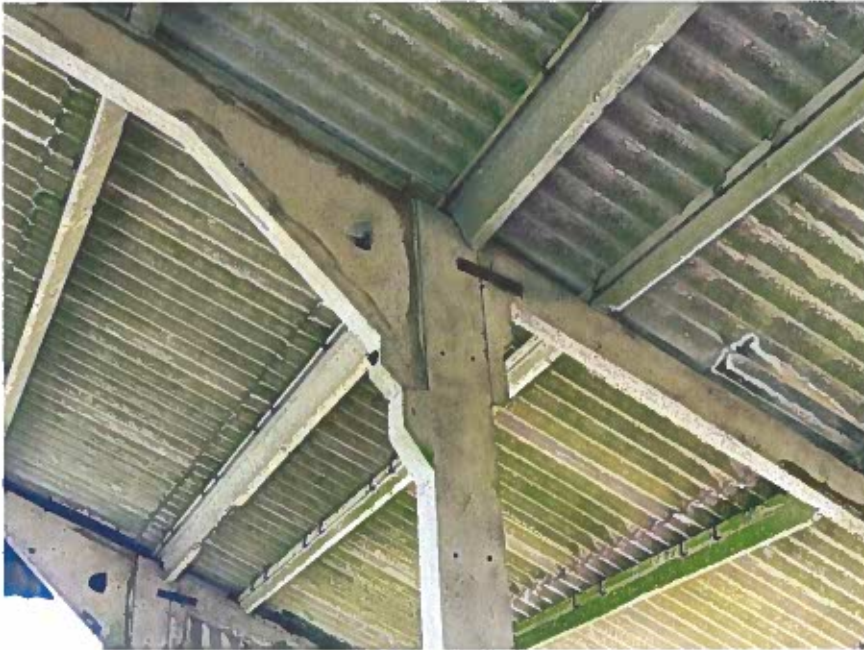
Central Column Head

The portal frames consist of 250x150mm columns. These are bolted to the 150mm wide rafters, which have a haunch depth of about 800mm, tapering down to 300mm, and then continuing to taper down to about 250mm at the apex, where there is a simple pinned connection.

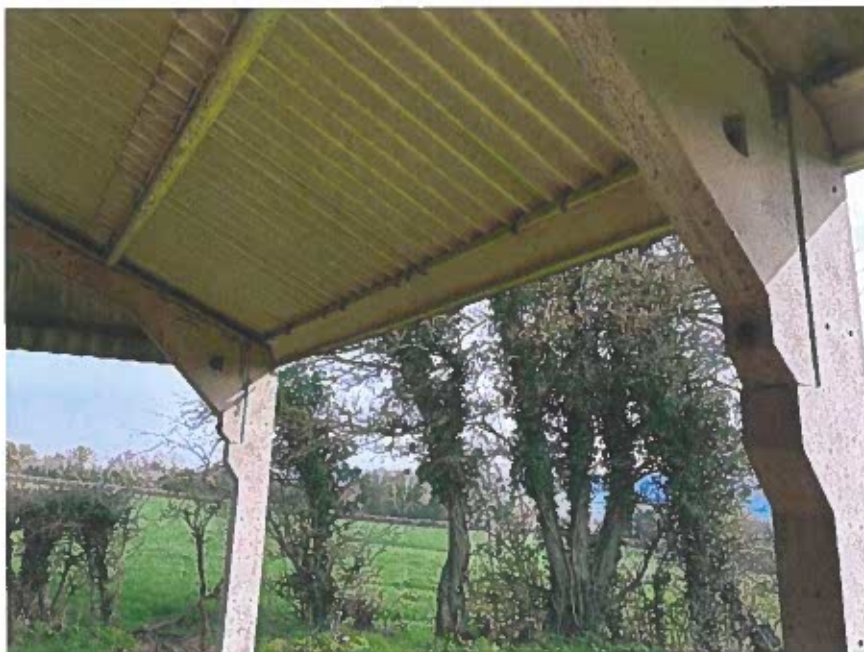
Lean-to Column Head

The lean-to columns and rafters are the same size as the main frames. At the upper end the rafters have a pinned connection to the main frame columns.

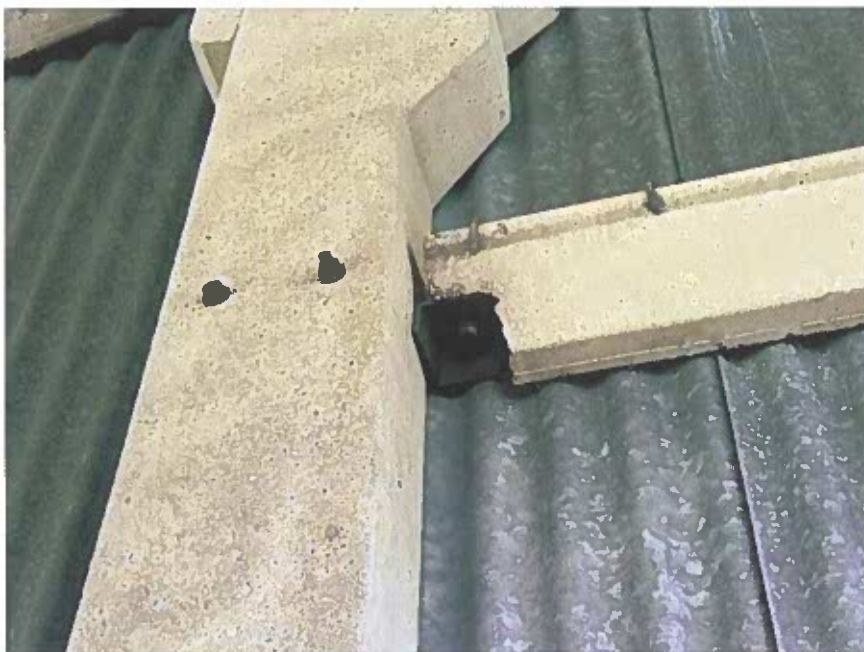
Sheeting Rail Connection

Sheeting rails are about 150mm deep, with width tapering from 120mm to 30mm. These have bolted connections to the sides of the columns.

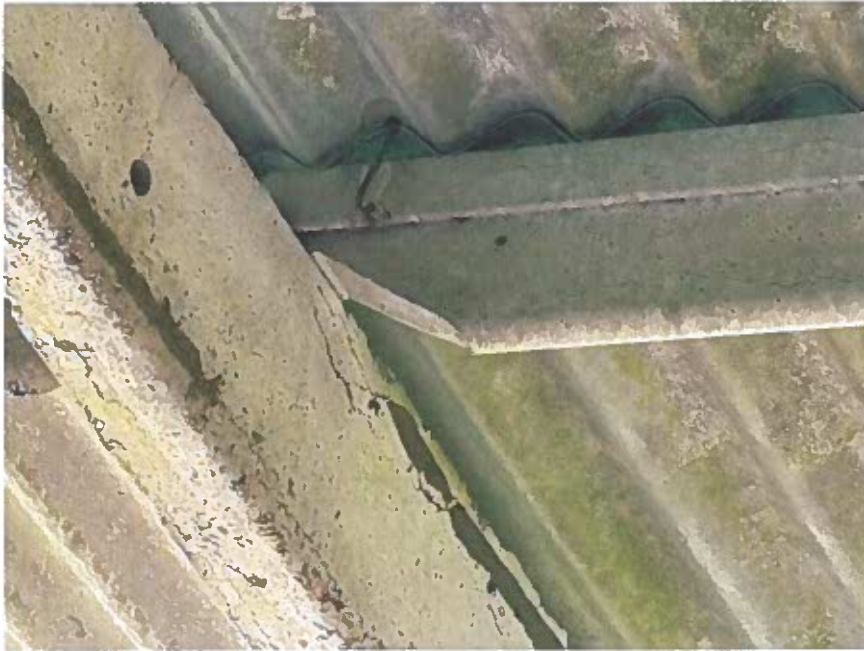
Purlin Support

Between the frames there are precast concrete purlins spanning approximately 4.5m. These are 200mm deep, tapering in width between about 125mm and 50mm with a rebate at the side to take the roof sheet hook bolts. The purlins taper to a smaller depth at the supports.

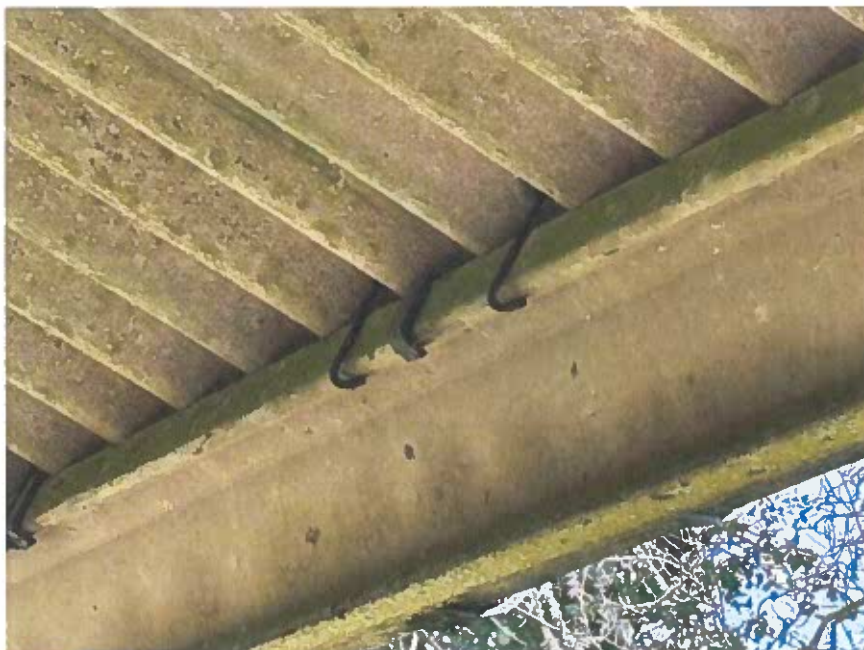
Eaves Beam

At the eaves is a different precast section about 200mm deep x 175mm wide set vertically on the outer face, and with a sloping top surface to suit the roof slope. These have rebates for hook bolt fixing to the roof sheets and to allow for wall sheets also.
