## **TECHNICAL NOTE**

### **Drainage Calculations**

#### **237 London Road, Chippenham**

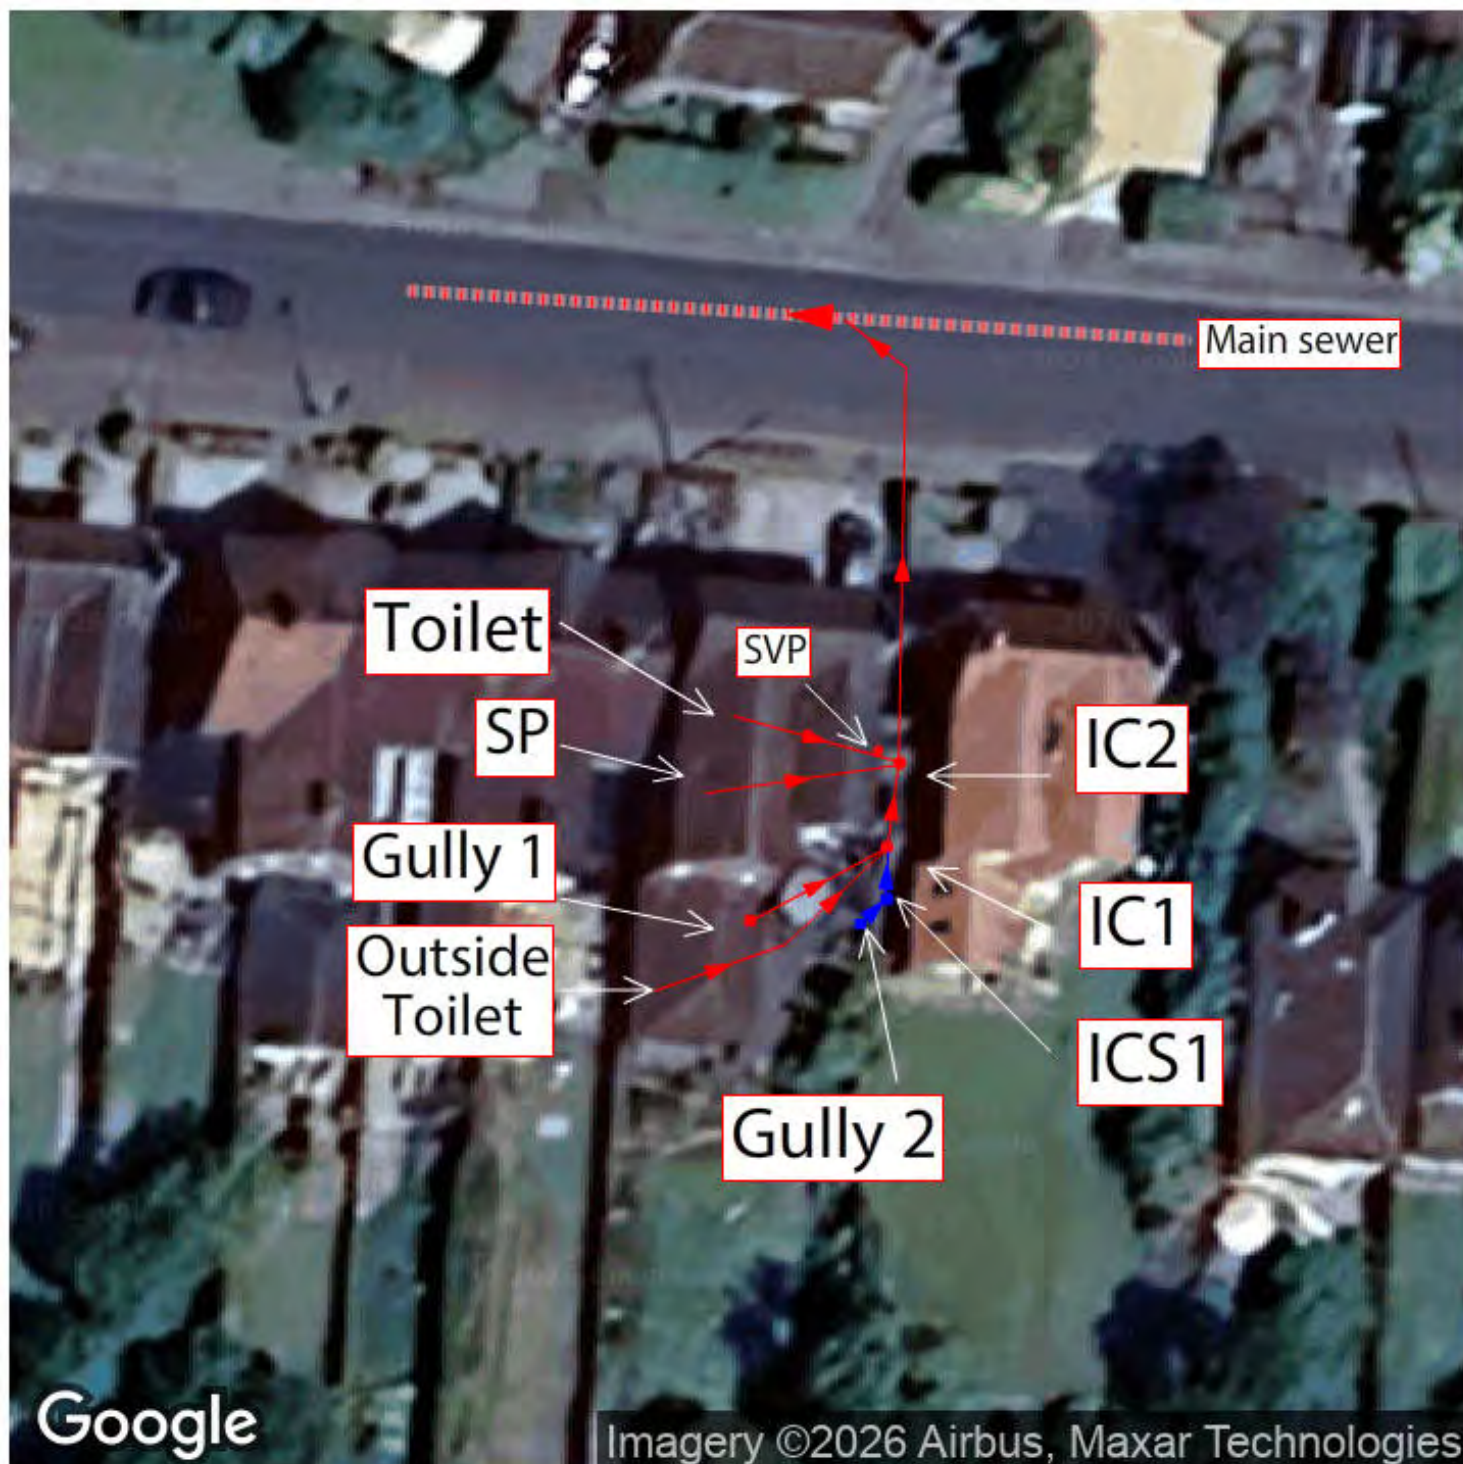
This sketch is not to scale and does not represent the exact routing of the drainage system

A CCTV survey of the drainage serving the existing property has been undertaken. This found that the building is drained via several manholes to the side of the house that connect to the public sewer in the road. The public sewer is identified on the records as a 225mm diameter foul sewer.

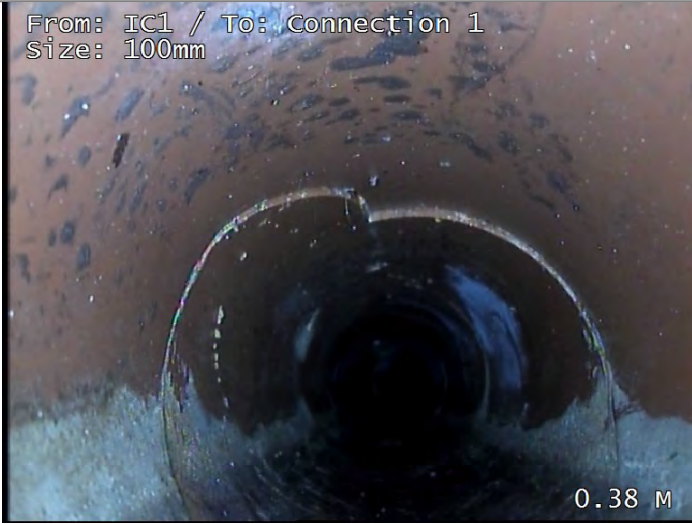
| Job Number<br>1521488 | Surveyed by (Operator)<br>A Anderson | Base Unit<br>HITAR4XYJT | Date<br>15/04/2026 |
|---|---|---|---|
| <p>From: IC1 / To: Connection 1<br/>Size: 100mm</p> <p>0.38 M</p> <p>Fracture circumferential from 12 to 12 o'clock</p> | | <p>From: IC1 / To: Connection 1<br/>Size: 100mm</p> <p>0.62 M</p> <p>Fracture circumferential from 12 to 12 o'clock</p> | |

In this section the survey identified Fractures in the pipe work at 0.38 + 0.62mtrs.

| Position | Code | Description | Photo | Type/Grade |
|---|---|---|---|---|
| 0.38 | FC | Fracture circumferential from 12 to 12 o'clock | 14653322 | Structural / 3 |

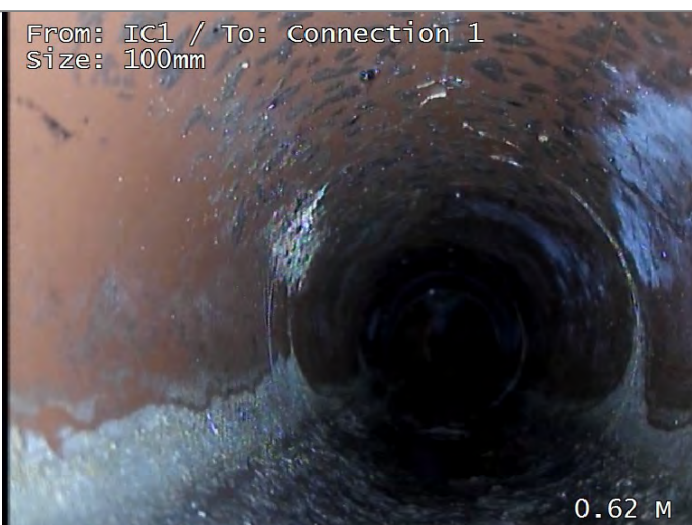
| Job Number<br>1521488 | Surveyed by (Operator)<br>A Anderson | Base Unit<br>HITAR4XYJT | Date<br>15/04/2026 |
|---|---|---|---|
| <p>From: IC1 / To: Connection 1<br/>Size: 100mm</p> <p>0.62 M</p> <p>Crack longitudinal at 12 o'clock</p> | | <p>From: IC1 / To: Connection 1<br/>Size: 100mm</p> <p>1.31 M</p> <p>Line of drain/sewer deviates right</p> | |

| Position | Code | Description | Photo | Type/Grade |
|---|---|---|---|---|
| 0.62 | CL | Crack longitudinal at 12 o'clock | 14653333 | Structural / 2 |

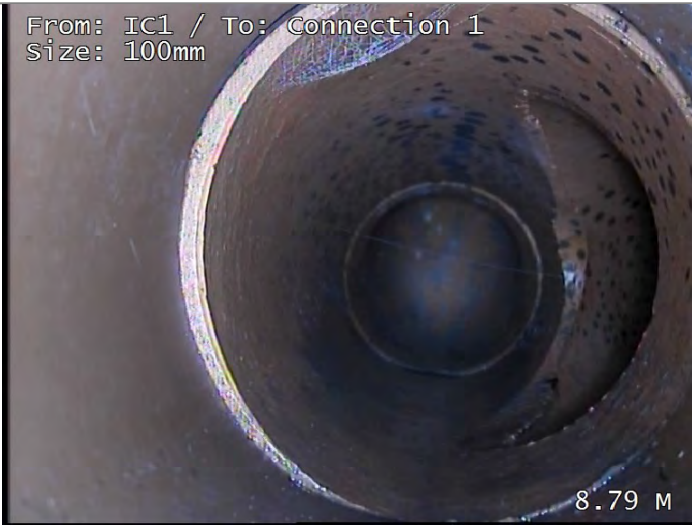
| Job Number<br><b>1521488</b> | Surveyed by (Operator)<br><b>A Anderson</b> | Base Unit<br><b>HITAR4XYJT</b> | Date<br><b>15/04/2026</b> |
|---|---|---|---|
| <div> <div> From: IC1 / To: Connection 1<br/>Size: 100mm </div> <div>8.79 M</div> <div>Connection other than junction at 3 o'clock, diameter 100mm</div> </div> | | | |

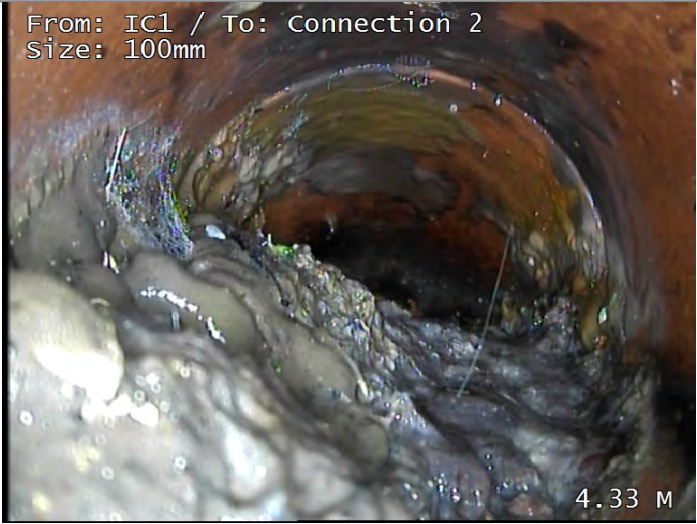
| Job Number<br>1521488 | Surveyed by (Operator)<br>A Anderson | Base Unit<br>HITAR4XYJT | Date<br>15/04/2026 |
|---|---|---|---|
| <p>From: IC1 / To: Connection 2<br/>Size: 100mm</p> <p>1.76 M</p> <p>Line of drain/sewer deviates left</p> | | <p>From: IC1 / To: Connection 2<br/>Size: 100mm</p> <p>4.33 M</p> <p>Attached deposits, grease from 4 to 10 o'clock 50% cross-sectional area loss - Remark: Build up on outlet to Gully 1.</p> | |

In this section the survey identified Grease build-up on the outlet of the Gully.

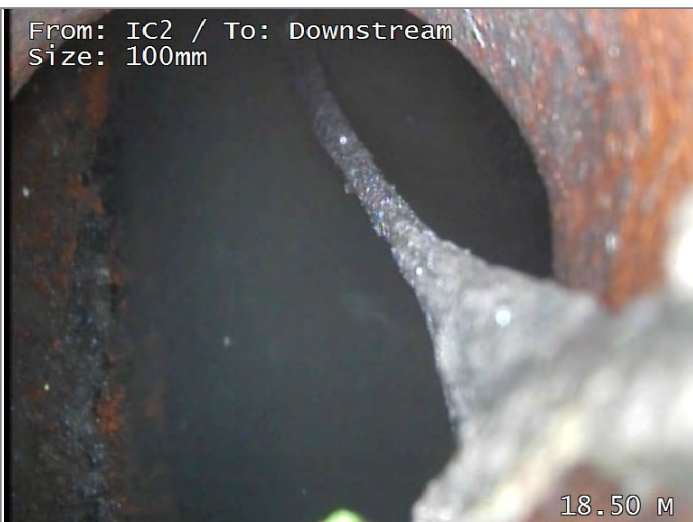
End of survey: Entered the Main sewer.

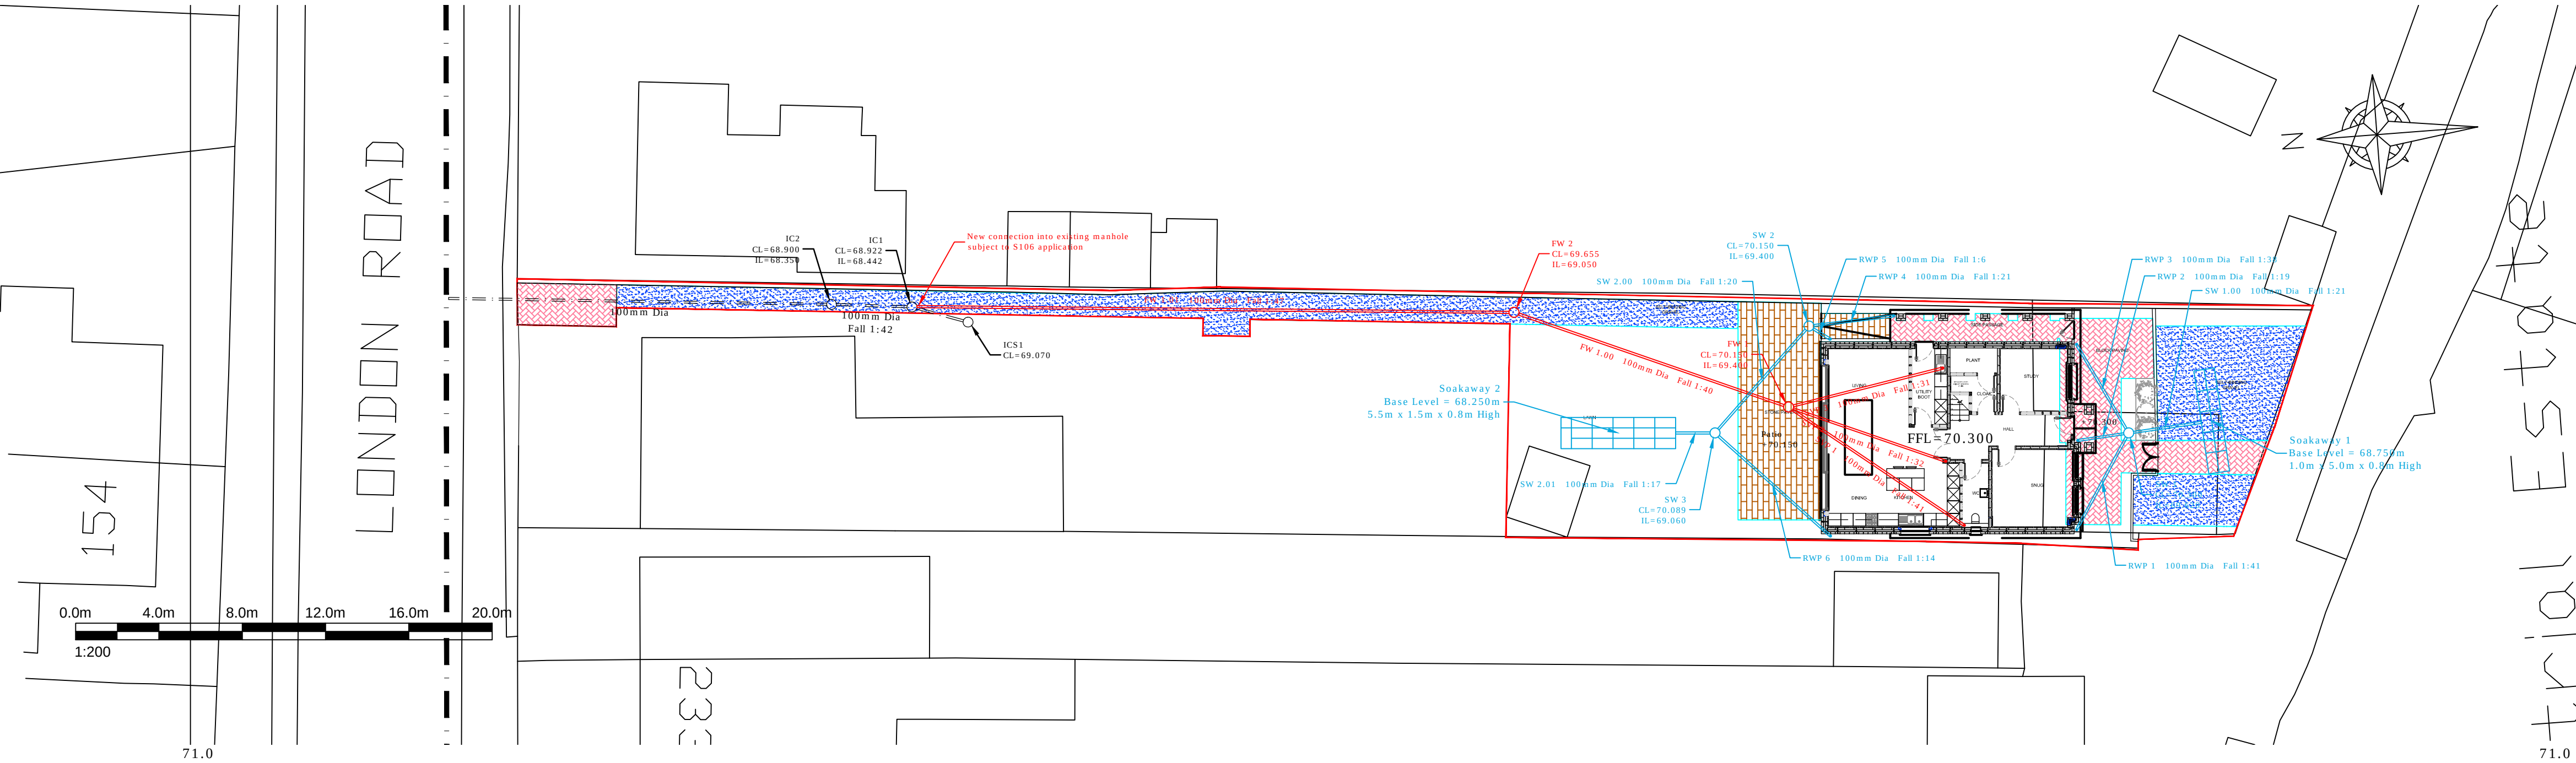
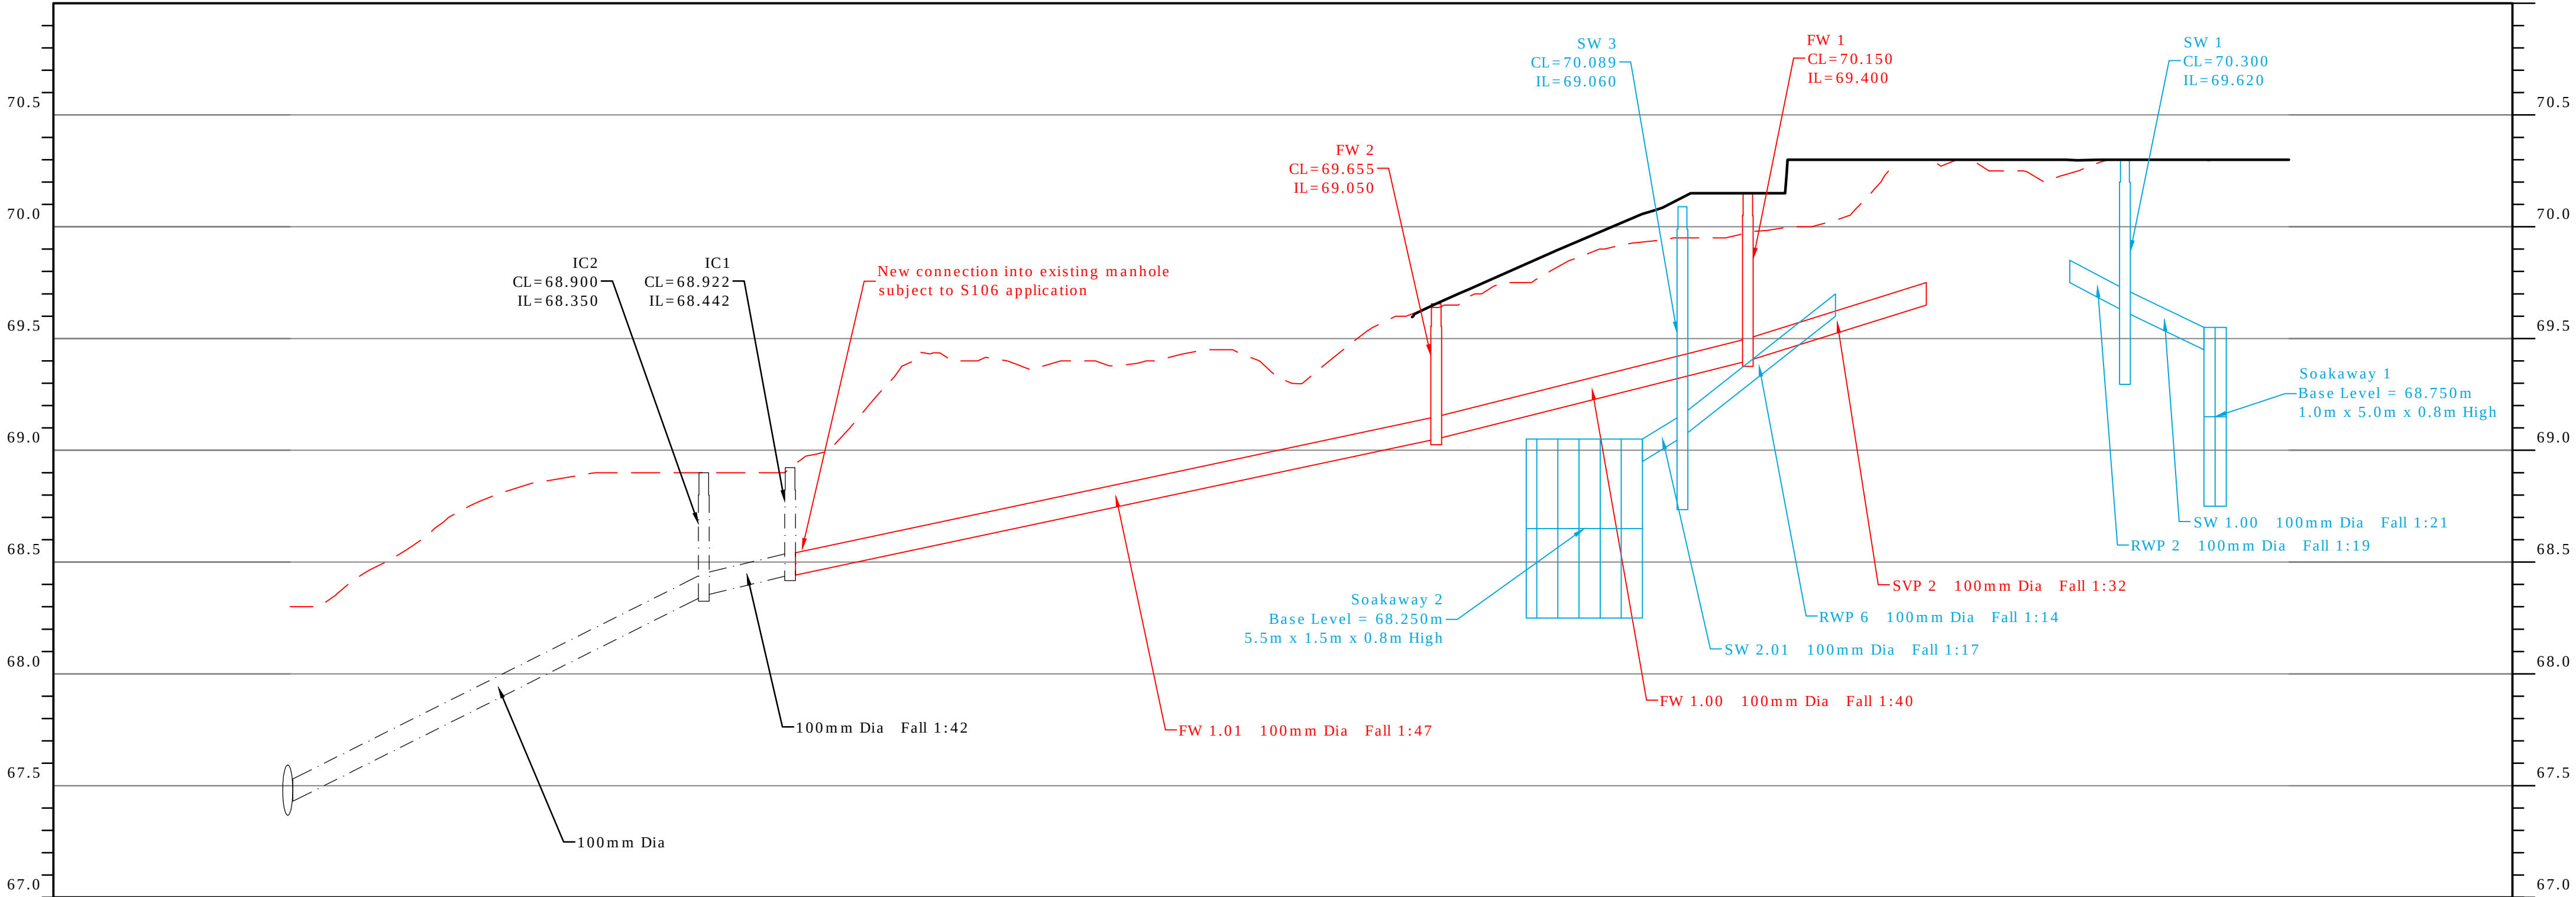
| SURFACE WATER MANHOLE SCHEDULE | | | | | | | | | SURFACE WATER PIPE SCHEDULE | | | | | | | | | |
|---|---|---|---|---|---|---|---|---|---|---|---|---|---|---|---|---|---|---|
| | | | | | | | | | SW 2.00 | 100 mm | 6.831 m | 1:20 | PVC | S or Z | SW 2 | 69.400 m | SW 3 | 69.060 m |
| | | | | | | | | | SW 2.01 | 100 mm | 1.894 m | 1:17 | PVC | S or Z | SW 3 | 69.060 m | | 68.950 m |
