Client  
**Jason & Sarah Clarkin-Yates**

Project  
**St Olaves  
Bradford On Avon  
BA15 1AD**

Drawing Title  
**Proposed  
Basement Tanking  
Details**

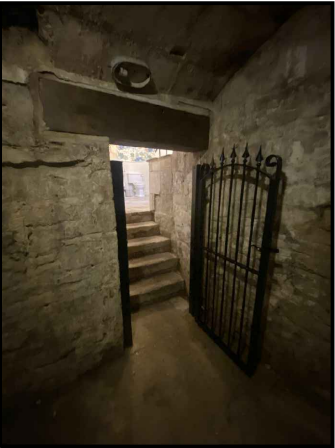
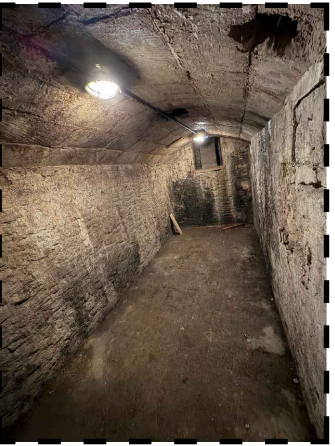
Photo toward WC above. Showing existing gate to be repositioned to clear the raised floor note the bottom step will be the new ffl.

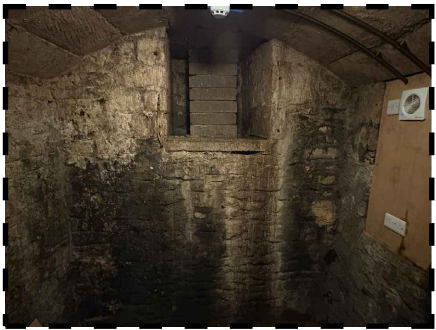
This area seems to have got worse and there is running water into the vault.

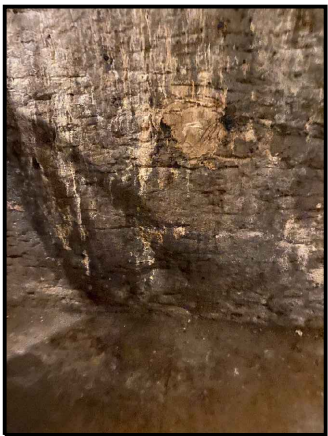
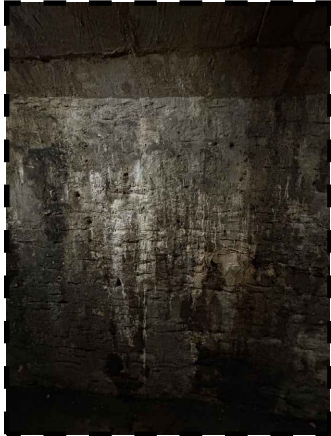
Photo showing water ingress at far end. Video is available showing free flowing water into this area.

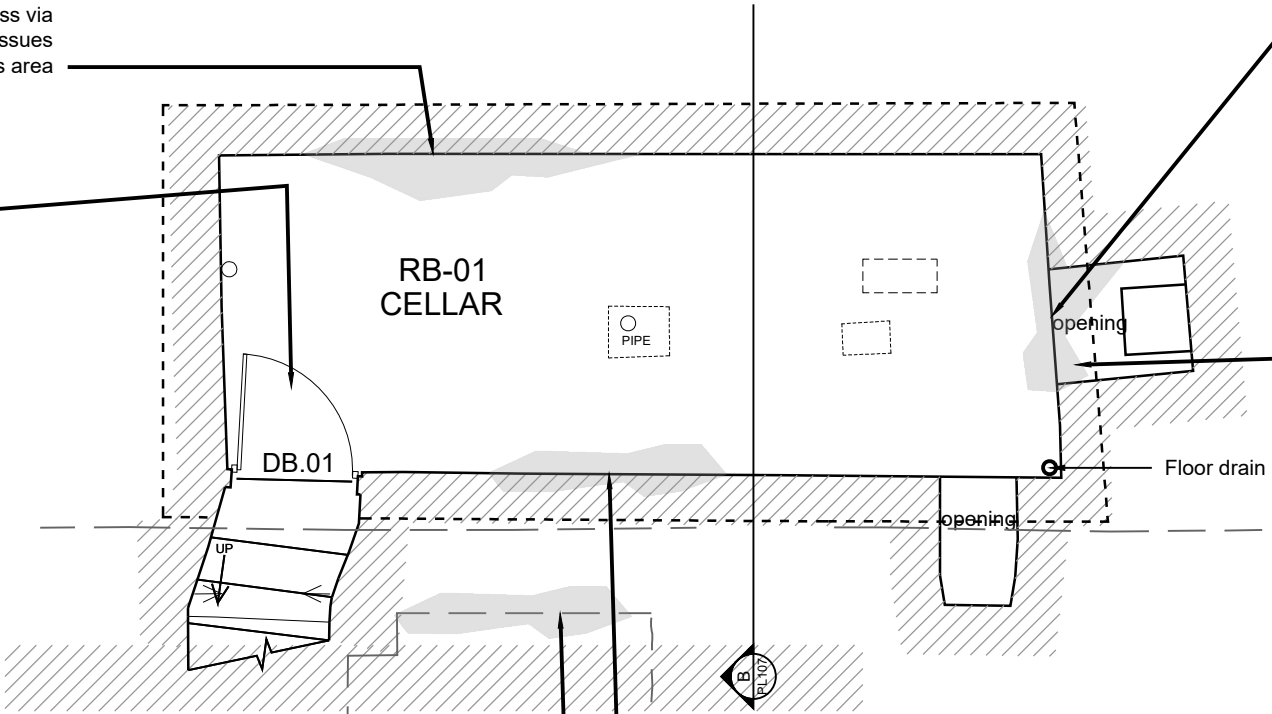
Photos showing water ingress. in this area

Continuing water seepage into here and running on the worst days.

Water seeping into main house beneath stairs.

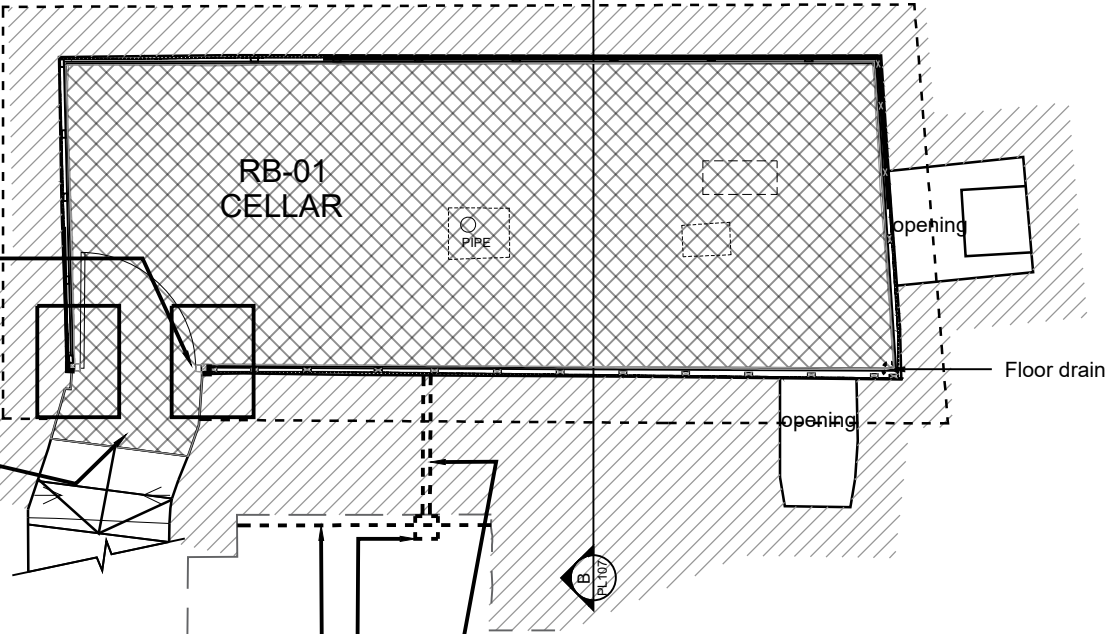
wrought iron gate to be repositioned -due to raised floor level..

Extent of Newton 500 waterproofing and new finished floor level- to be level with top of first riser.

Dash shows drainage channel beneath stair  
Dash shows drain Access point  
Dash shows drain to newton 500 drainage gap

Water Ingress Ongoing- As Existing

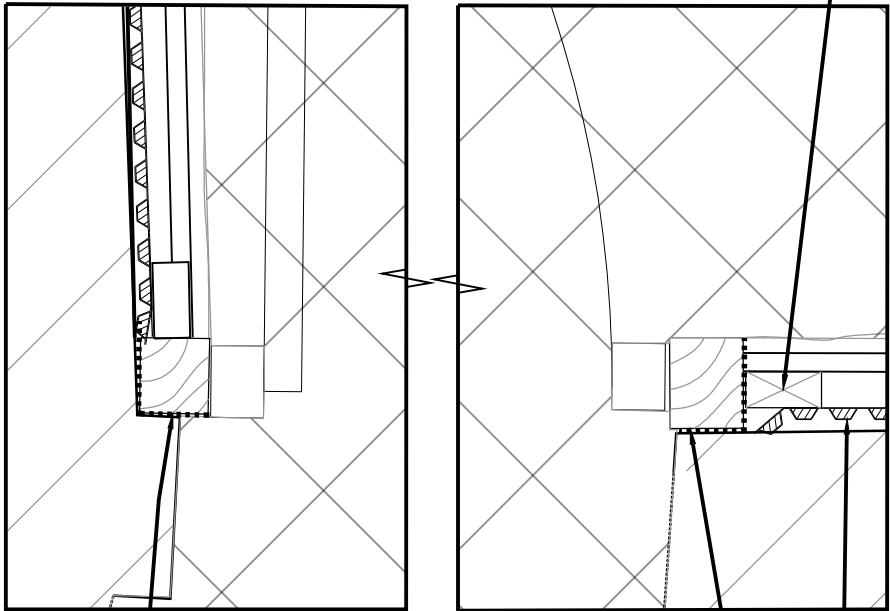
25 x 50mm treated sw battens, plasterboard lining and one coat plaster to resemble lime render.

Newton 500 or Delta membrane
