# **Bluemay Phase 3 at Bidmead Park**

## **Interpretive Report on Ground Investigation**

Report No: 738355-2 (01)

Client: E.W. Beard Limited

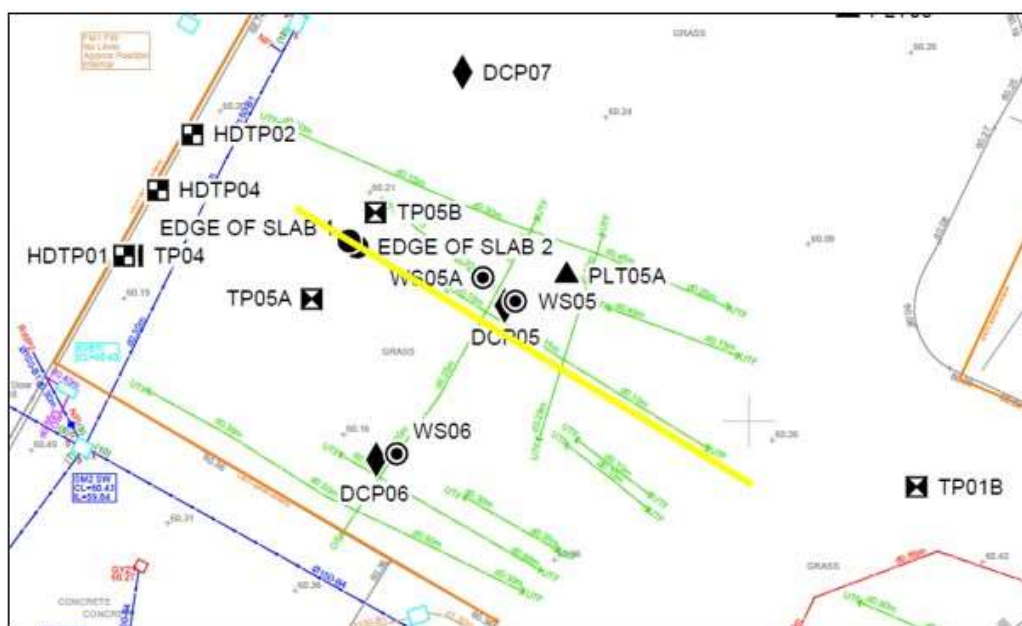
In the image on the following page, the exploratory holes are superimposed upon an extract from the Solum drawing. Two GPS measurements were made of the edge of the slab exposed in TP05A/5B, labelled 'Edge of Slab', below which appears to coincide with one of the mapped linear features (highlighted yellow in the image).

The measured coordinates for the two Edge of Slab locations were (in metres): (1) 395534.443, 162027.021, elevation 59.530, and (2) 395534.754, 162026.79, elevation 59.554. Although reported to the nearest millimetre, an accuracy of +/- 50 mm should be assumed for these measurements.

A concrete slab was also found in TP01B which lies north of the linear feature highlighted above. WS06 and DCP06 plot as being close to other linear features but did not encounter concrete.

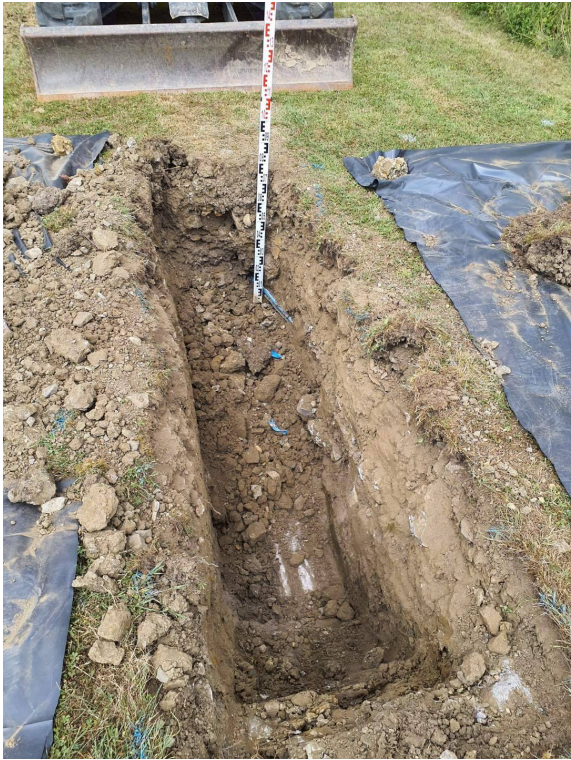
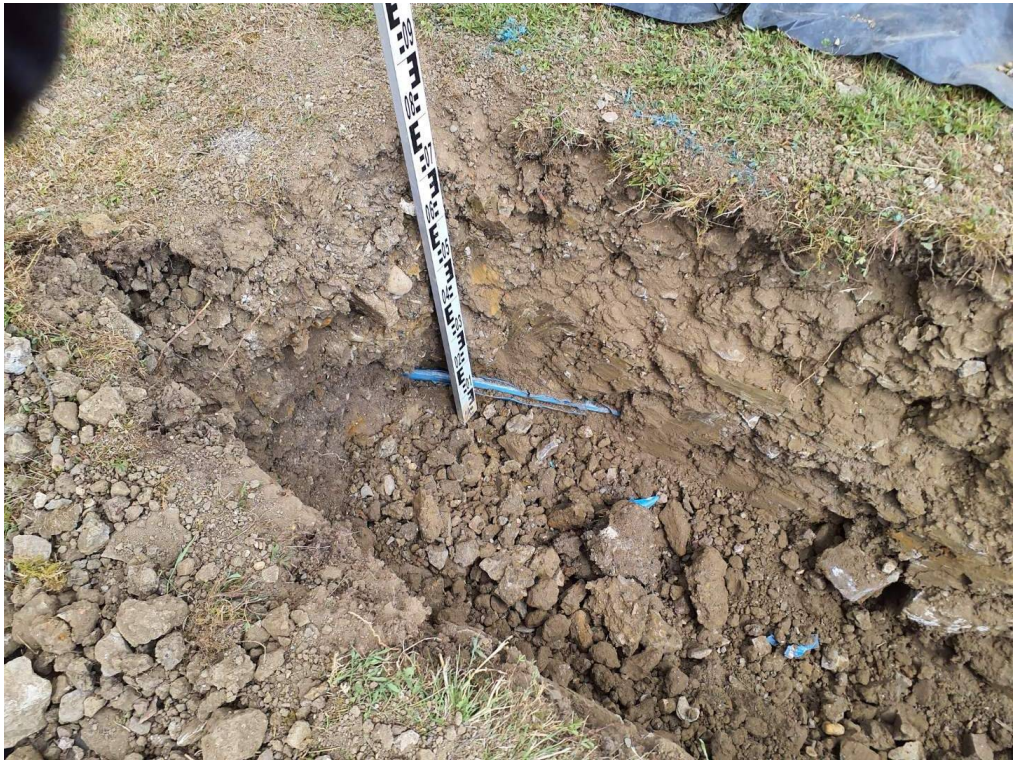
Excavation. Concrete in base, pipe in NW corner.

Pipe within larger duct in NW corner.

Whilst clearing loose material out of the TP01B the mechanical excavator exposed a 50 mm diameter blue plastic duct in the north-western corner of the pit, breaking off a section of the upper surface of the duct, exposing a 25 mm diameter blue plastic water supply pipe inside which was undamaged.

It has been planned to conduct soakaway infiltration tests in TP01B, however due to concrete being found at the base of the pit and a plastic duct being struck in the corner of the pit which would have provided a pathway for water to drain from the pit, the test was not completed as it would have been unrepresentative of the ground.

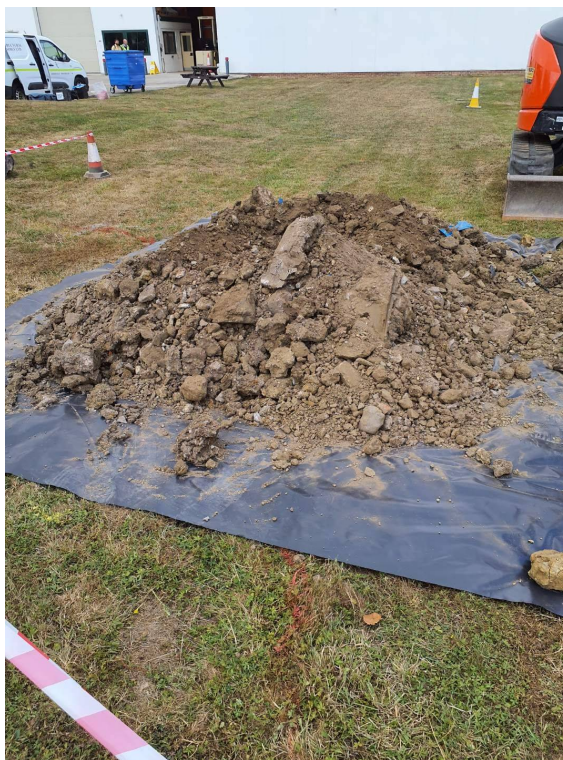
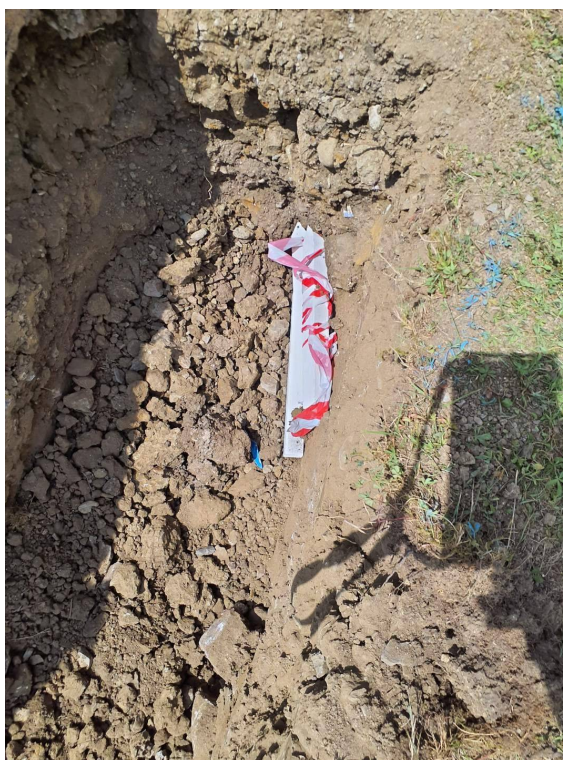
Main spoil heap.

Pipe protected when backfilled using wooden pegs.

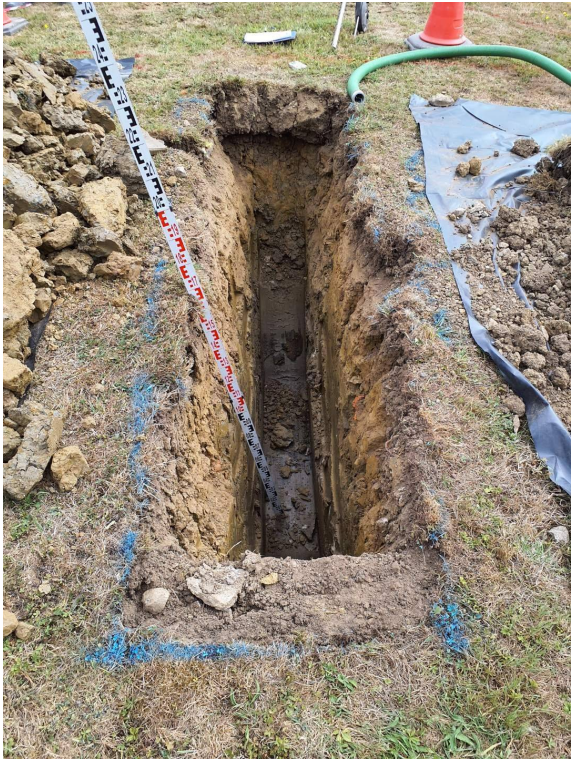
Excavation prior to commencing soakaway test.

The Soakaway test was undertaken in trial pit TP02 in general accordance with recommended practice given in BRE Digest 365. Only a single filling was completed as the soil under test was clay and negligible infiltration occurred. The test result is contained in Appendix C.

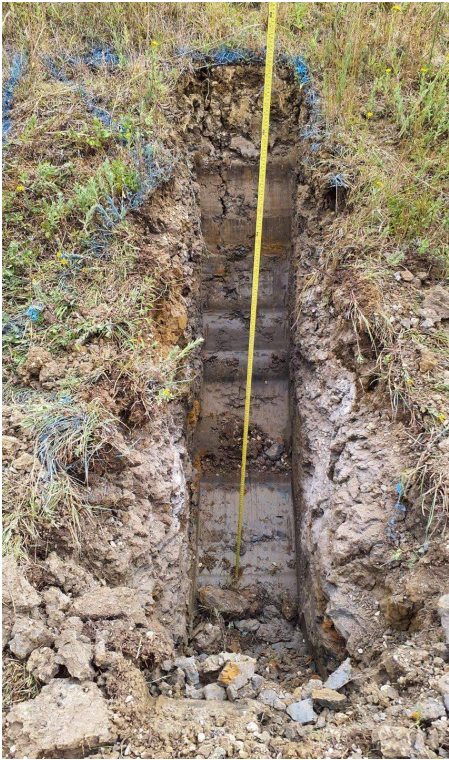
| Contract:<br>Bluemay Park Phase 3, Bidmead Park, Melksham | | Client:<br>E. W. Beard Limited | | Trial Pit:<br>TP03 |

Photographs of the trial pits are presented in Appendix B, alongside the logs. A sketch showing the foundation detail exposed is included with the log for TP03.

- 1.11 The eastern elevation of the newer Bluemay production was found to be supported on a trench fill strip foundation overlain by flat concrete surface that projected by between 0.62 m and 0.93 m from the face of the building at around 0.20 m depth. The foundation tapered back towards the building with depth; the base was not reached by 1.40 m depth at which point the foundation was projecting by 0.50 m from the face and the trial pit appeared to just be reaching the natural clay soils.

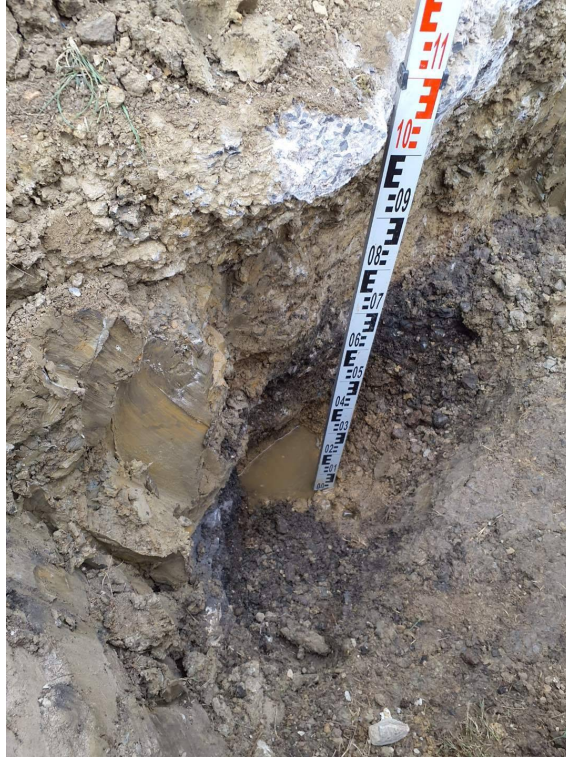
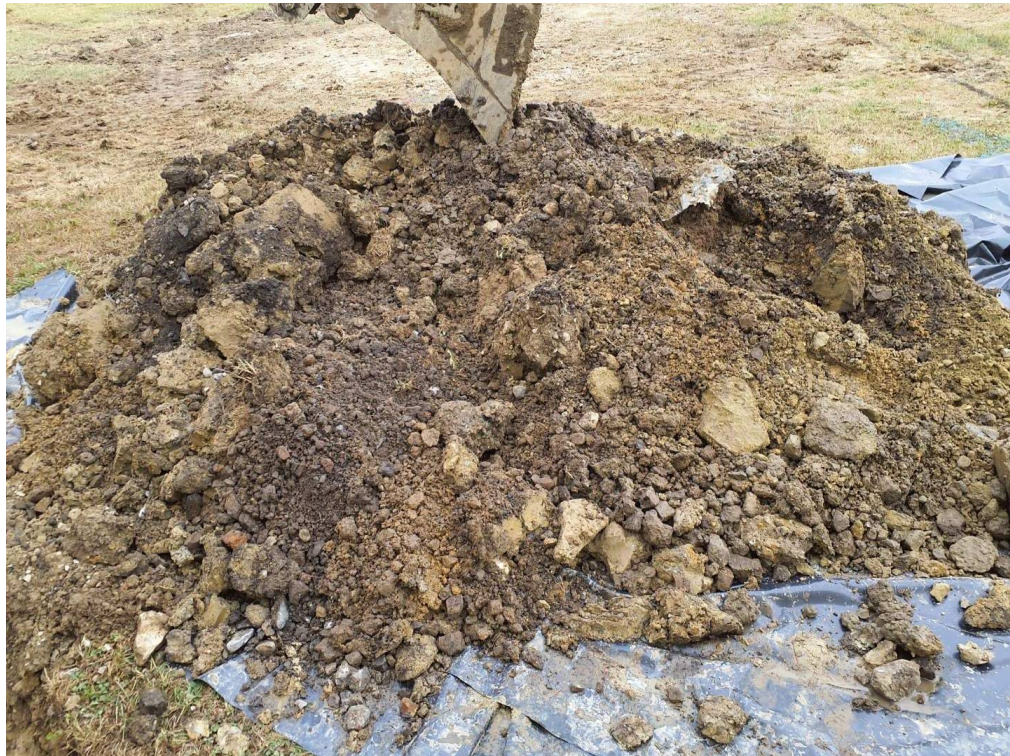
Concrete foundation tapering in towards building.

Excavated material.

TP04 was dug down the side of the concrete 'shelf' seen in HDTP01, alongside the Bluemay storage building to expose the foundation. Here the concrete locally 'overhung' a concrete foundation by around 150 mm, and the foundation gradually curved back in toward the building. The pit was initially extended to 1.55 m depth but it was not possible to 'scrape' the excavator bucket down along the foundation due to an adjacent buried surface water drain preventing the excavator working perpendicular to the foundation. The pit was therefore backfilled to 1.00 m depth to enable safe personnel entry and extended by hand down the face the foundation to 1.40 m depth. The bottom of the foundation was not found; however it was not possible to extend it further due to groundwater inflow (at 1.35 m depth), difficult digging conditions and time constraints.

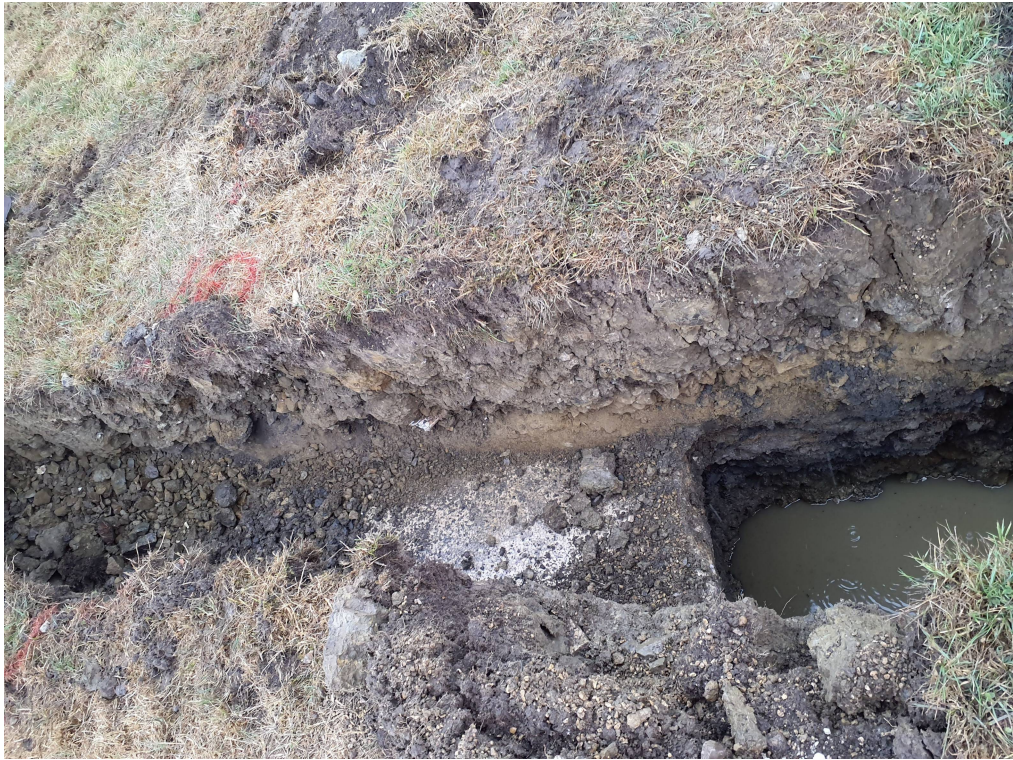
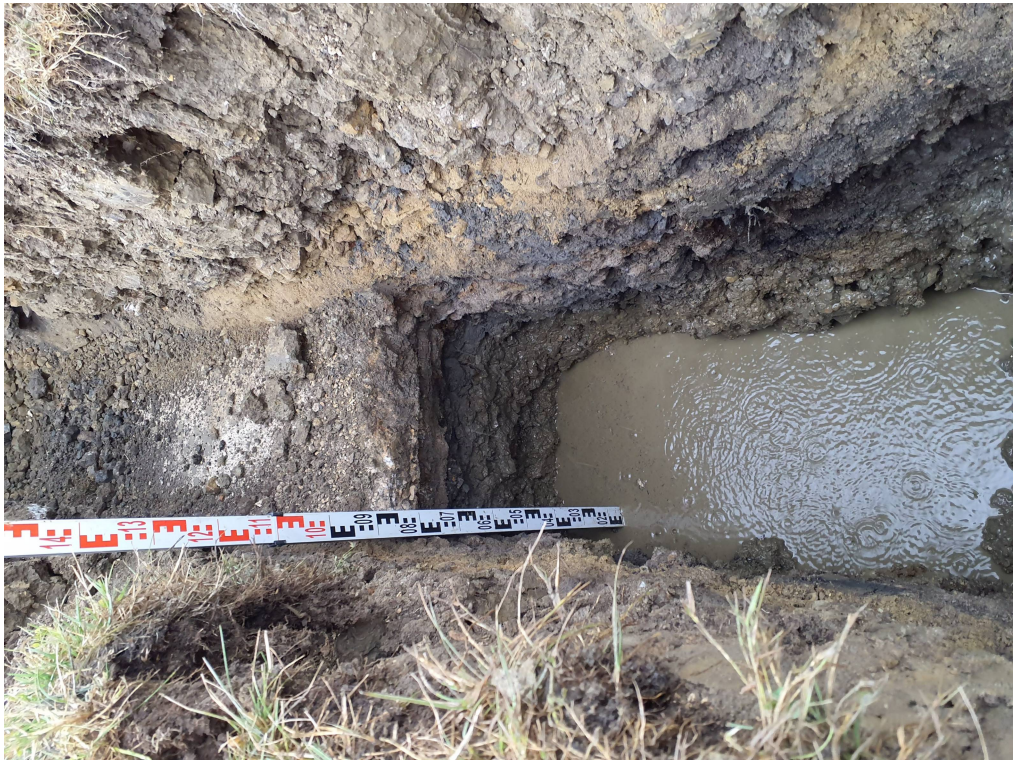
Edge of concrete exposed at northern end of pit (which bounds TP05B).

View south showing edge of concrete slab.

On the visit of 31 July 2025 trial pits TP05A and TP05B were cautiously excavated either side of a linear feature detected by GPR initially thought to be a buried utility. It was subsequently found that the linear feature was the edge of an old concrete slab, and trial pits TP05A and TP05B were eventually extended into a single trench.

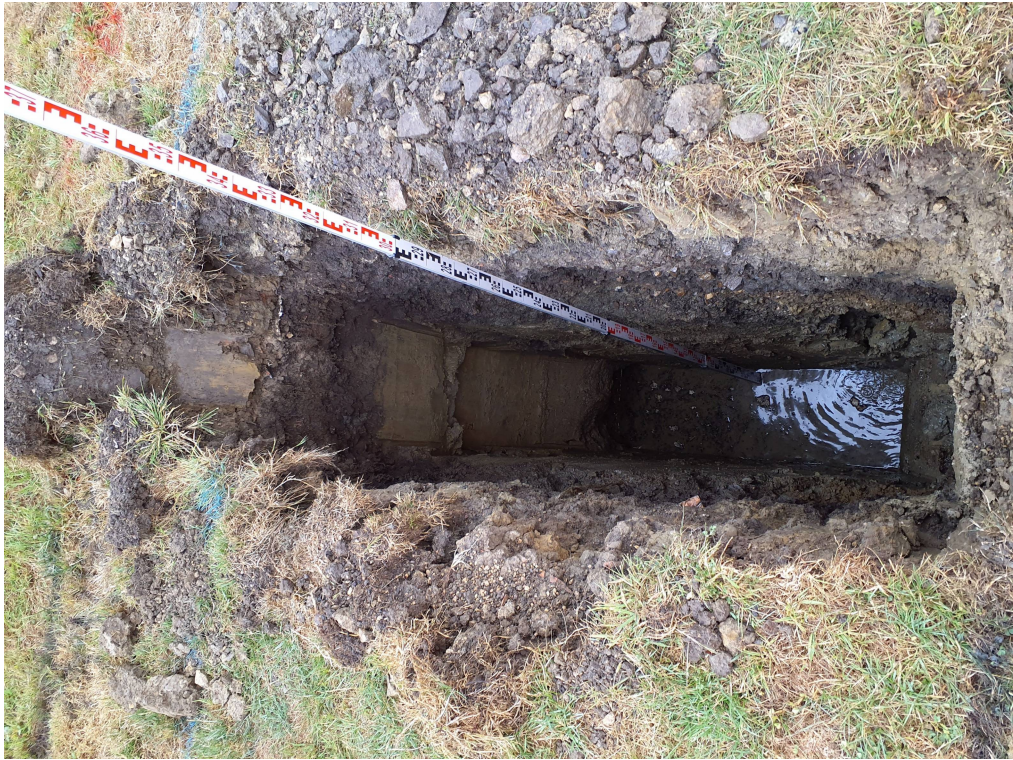
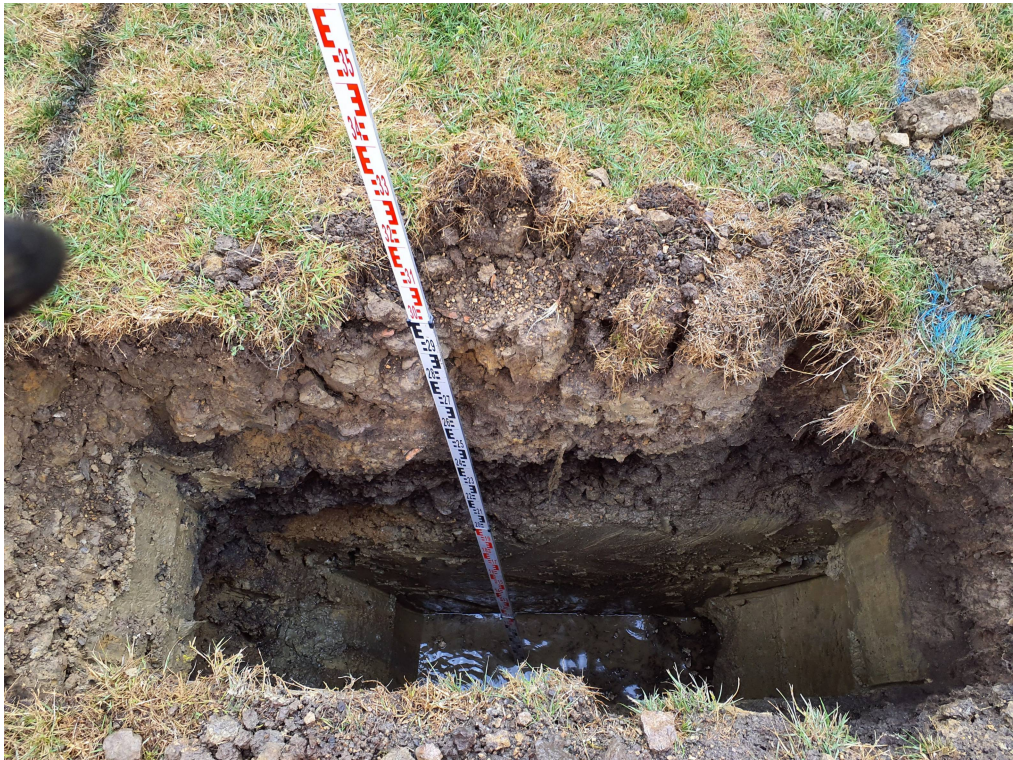
View facing north.

View looking west (before pit extended south to join TP05A).

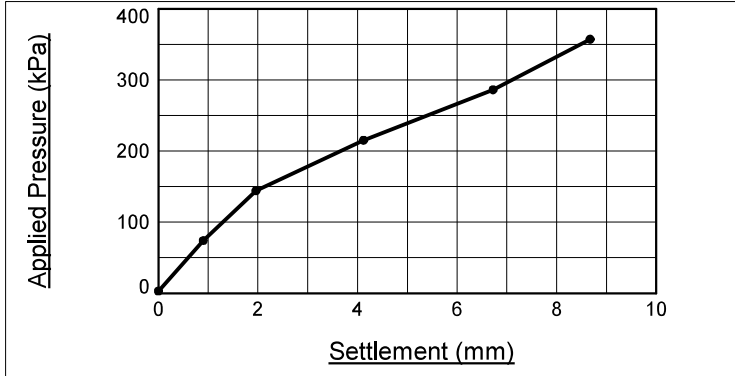
Position ID: **PLT03** Depth (m) : **0.00** Date of Test : **24/07/25**

| Applied Pressure (kPa) | Average Settlement (mm) |
