# **Preliminary Ecological Appraisal**

Report prepared for: Mr R Livock

Kington Langley Stud

| Document Number: | CE001749 |

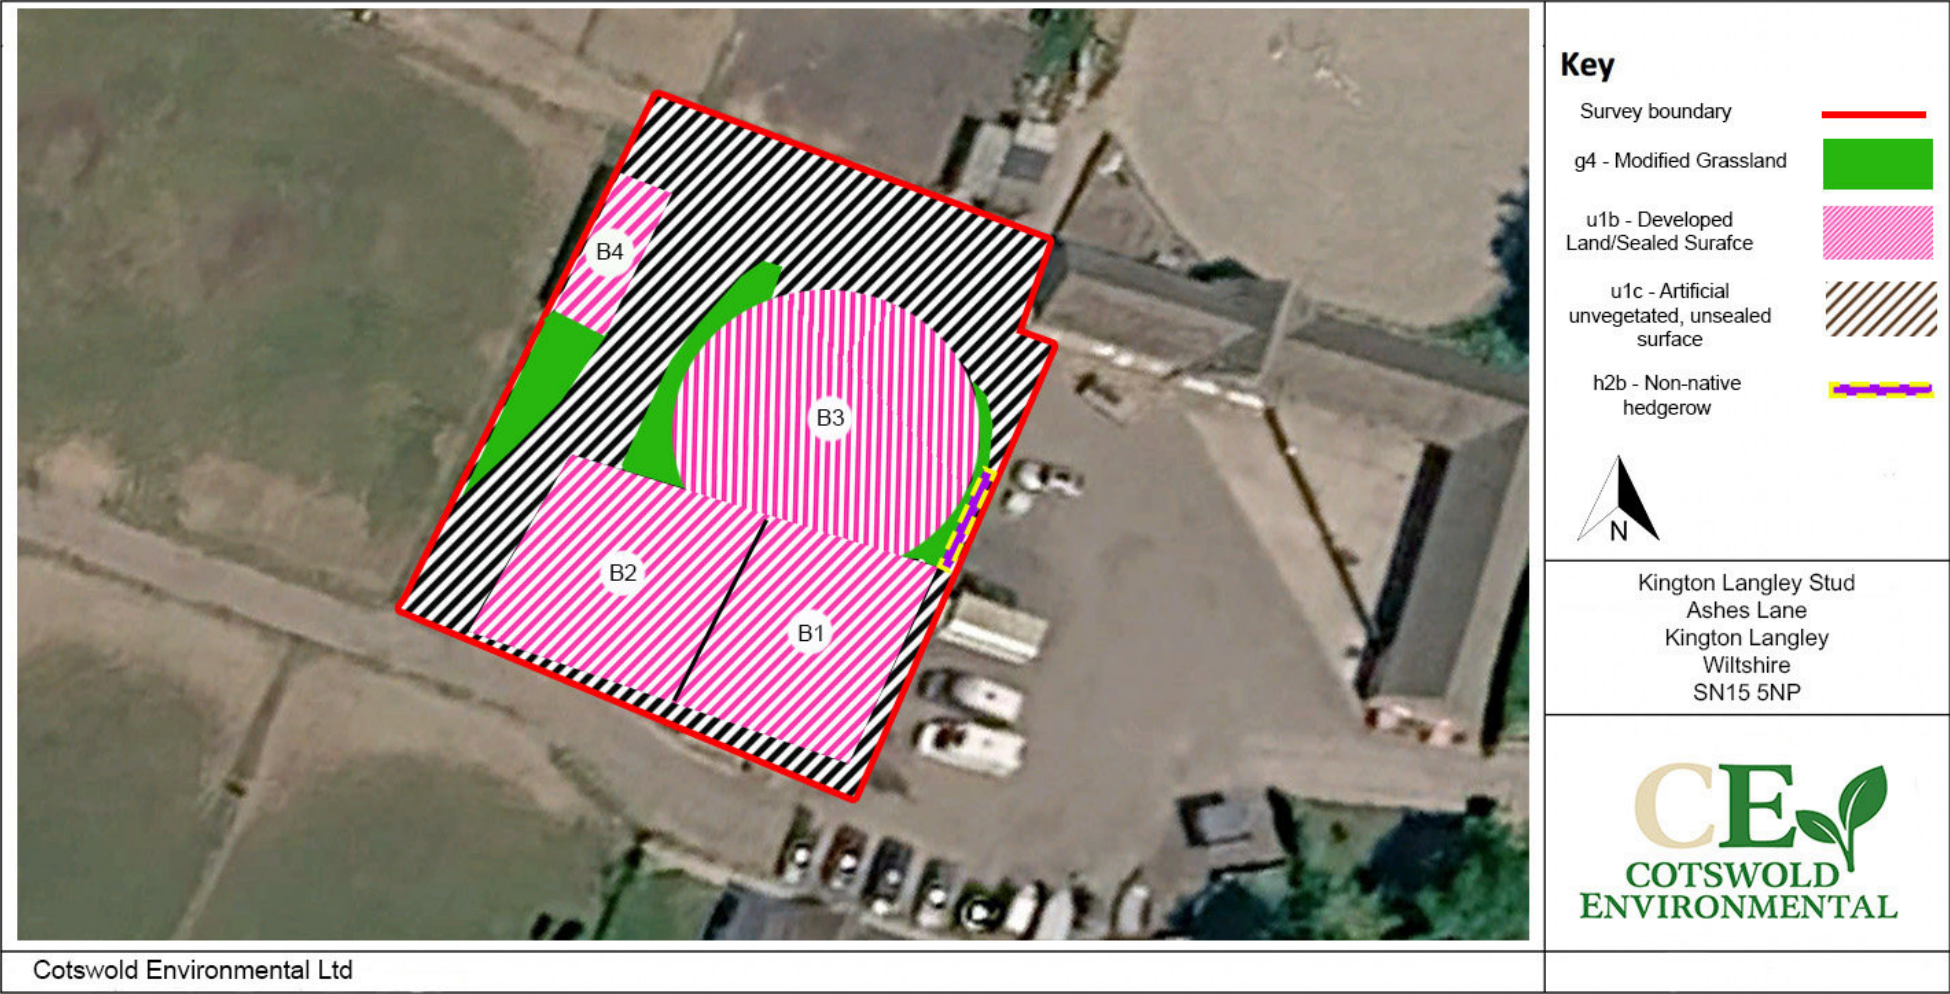
Figure 2: Habitat Map

- 3.8 Small areas of grassland are present around the edges of the site, although these are limited in extent and regularly managed, supporting a relatively species-poor assemblage of common grasses and ruderal herbs typical of equestrian land. An ornamental hedgerow lines a section of the site margins. No trees are present within the survey boundary.
- 3.9 No ponds or priority habitats exist within the survey area and no ponds are to be destroyed or impacted by the proposed works. The individual habitat types recorded at the site are described under the sub-headings below, using the UK Habitat Classification (UKHab) framework, with the location and extent of each illustrated in the Habitat Map in Figure 2.

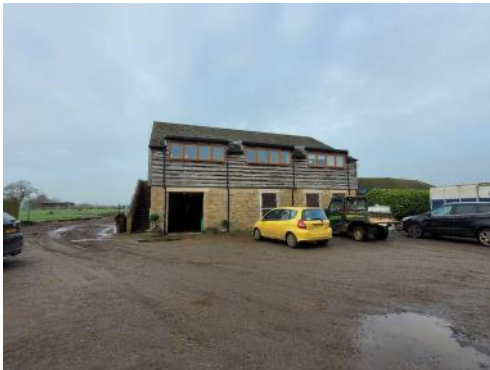
**Photo 1: A view of the surveyed building B1 from the east of the yard.**

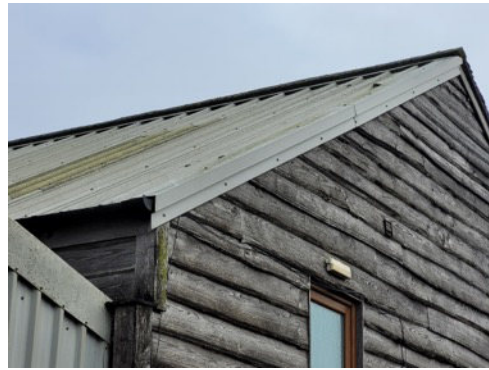
**Photo 2: B1 - metal sheet clad roof pitch.**

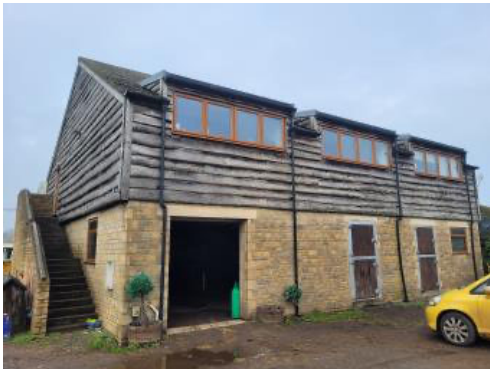
- 3.20 Externally, the stonework was found to be in good condition overall, with intact mortar joints and no significant cracks, gaps, or crevices identified within the masonry. The upper elevations are clad in waney-edge timber boarding, which displayed some localised gaps and irregularities. In addition, the concrete imitation roof tiles exhibited a small number of gaps and crevices beneath their edges. Collectively, these features represent a limited number of external PRFs that could be utilised by crevice-dwelling bat species, such as *Pipistrellus* spp. No evidence of bat activity, including droppings or staining was recorded on the exterior of the building.

**Photo 3: The east facing front elevation of B1.**

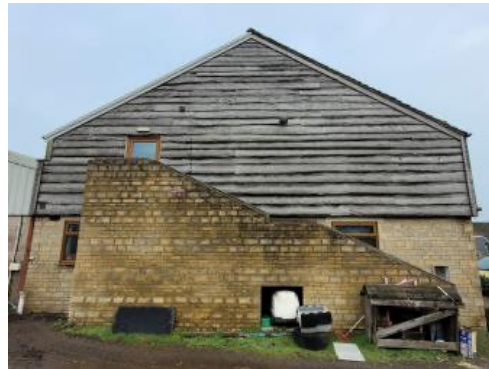
**Photo 4: B1 - The southern gable end with external steps to the first floor.**

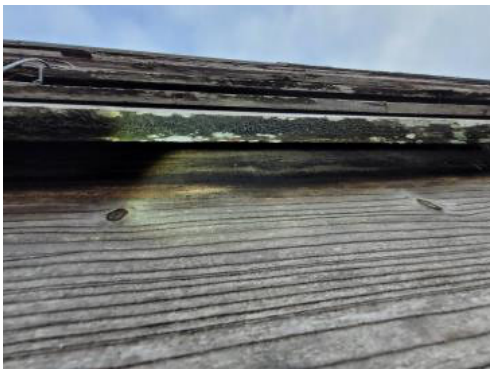
- 4.9 The masonry was found to be in good condition with no significant cracks or crevices, while the upper elevations clad in waney-edge timber boarding displayed localised gaps. In addition, a small number of crevices were present beneath the imitation stone roof tiles. These features collectively provide several external Potential Roosting Features (PRFs) suitable for crevice-dwelling bat species, such as *Pipistrellus* spp.

**Photo 5: B1 - an example of the gaps present beneath the waney edge timber boards.**

- 4.12 Under the current proposals, the conversion of the structure will comprise internal works only. No works are proposed to the roof covering, external timber cladding, soffits, fascias, or any other external building fabric associated with the identified Potential Roost Features (PRFs). Furthermore, no alterations to external access points or external lighting affecting these features are proposed as part of the scheme. On this basis, the proposals do not include works that would disturb, damage, obstruct, or otherwise affect features that could be utilised by crevice-dwelling bats.

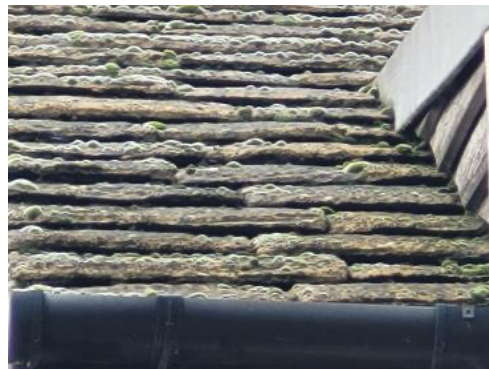
- 3.33 Small gaps beneath the roof tiles and within sections of timber cladding on Building B1 provide suitable nesting opportunities for small passerine birds. These sheltered features could be used by cavity-nesting species such as blue tit *Cyanistes caeruleus* and house sparrow *Passer domesticus*, which commonly utilise small gaps and concealed spaces within buildings for nesting. The features present are comparable to the naturally sheltered conditions provided by tree cavities and similar enclosed habitats.

**Photo 6: B1 - gaps present beneath the imitation stone tiles.**

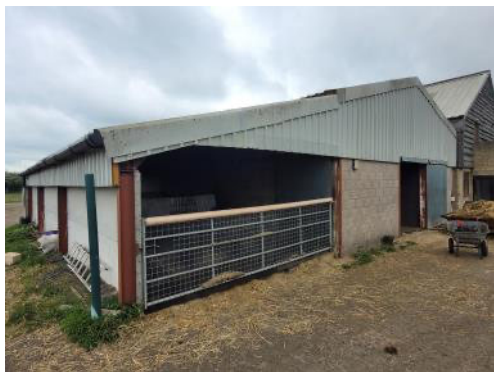
- 3.22 Building B2 is open along the northern and southern elevations, with wide open access points. It is currently utilised for equine housing and general storage. Externally, the steel cladding to both the roof and elevations is tightly fitted, with no lifted or displaced sheets. The concrete blockwork is in good condition, with no cracks, damage, or missing mortar identified.

**Photo 7: A view of the surveyed building B2 from the south-west of the yard.**

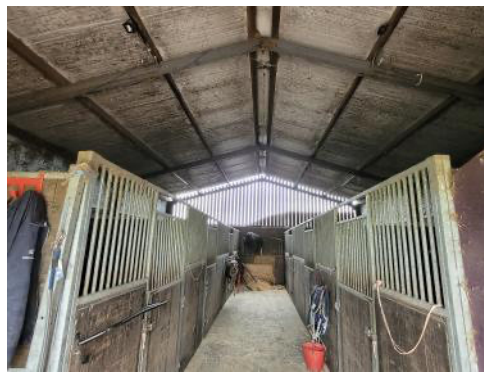
- 3.23 Internally, the building is open and well-lit due to the exposed elevations. No skylights are present; however, there is a high level of light ingress via the open elevations and gaps within the wall structure. The roof is not underlined, and the steel support framework is fully exposed throughout. No enclosed roof void or internal compartments are present. The building is subject to regular disturbance associated with its use for housing horses. No evidence of bats, including droppings, staining, or feeding remains, was identified during the survey. No gaps, crevices, or enclosed features were identified internally that could provide sheltering opportunities for bats.

**Photo 8: B2 – An internal view of the main structure.**

internal conditions, and regular disturbance, these buildings are considered to offer negligible potential for roosting bats. Consequently, no further bat survey effort is considered necessary in relation to these structures.

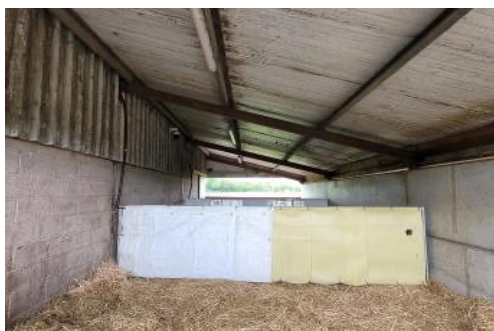
**Photo 9: B2 – An internal view of the lean to element.**

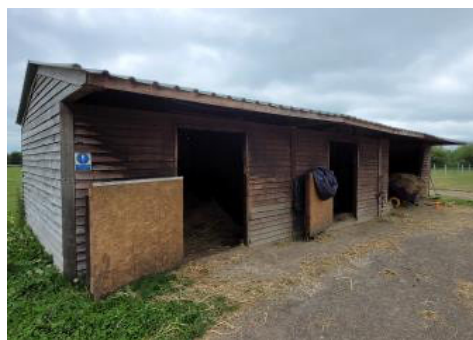
- 3.24 Building B3 comprises a timber-framed structure with partial open-sided sections along the eastern elevation and is currently used for equine housing and hay storage. Externally, the timber cladding was found to be well-maintained and tightly fitted, with no lifted boards, gaps, or crevices identified. The profiled metal sheet roofing was similarly in good condition, with no visible gaps between the roofing sheets or along the roofline.

**Photo 10: B3 – Viewed from the south-east.**

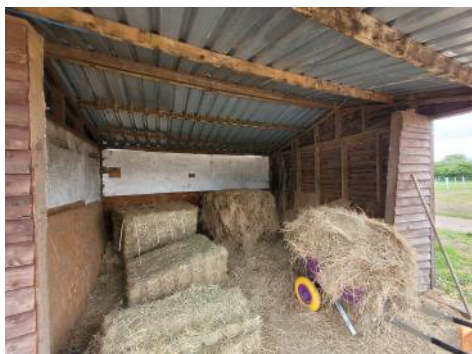
- 3.25 Internally, the building was relatively light and exposed due to the partially open elevations. The roof was not lined, and the timber framework remained fully exposed throughout, with no enclosed roof voids, soffits, or internal compartments present. The structure is subject to frequent disturbance associated with ongoing equestrian activity and daily use. No evidence of bats, including droppings, feeding remains, staining, or urine marks, was identified during the survey. Furthermore, no suitable features offering sheltering or roosting opportunities for bats were identified internally.

**Photo 11: B3 – An internal view of the structure.**

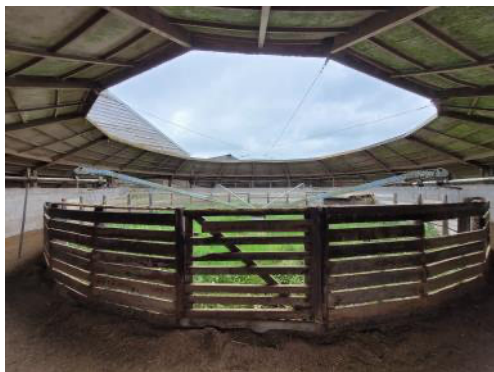
farmyards, such as robin *Erithacus rubecula*, wren *Troglodytes troglodytes*, and swallow *Hirundo rustica*. The horse walker structure (B4) is similarly open and exposed, although sections of the roof framework could occasionally be used for nesting by adaptable species.

**Photo 13: B4 – An internal view of the structure.**

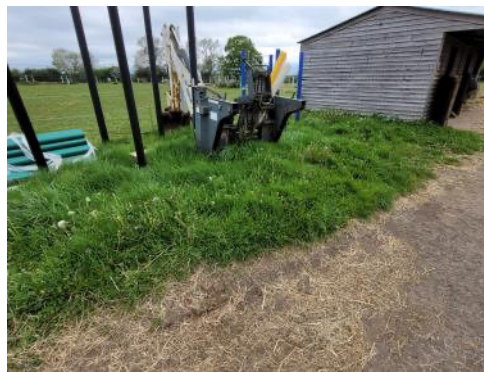
**Photo 14: An example of the marginal grassland.**

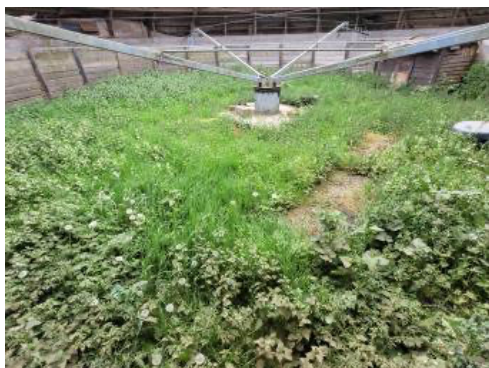
- 3.16 Limited areas of improved grassland are located around buildings B3 and B4. This is maintained at a sward height of less than 10 cm and dominated by perennial rye grass *Lolium perenne* and cocks foot *Dactylis glomerata*. Forb species consist of white clover *Trifolium repens*, common daisy *Bellis perennis*, creeping thistle *Cirsium arvense*, and common dandelion *Taraxacum officinale* agg. Localised patches of common nettle *Urtica dioica*, herb robert *Geranium robertianum* and garlic mustard *Alliaria petiolata* were observed at the edge of buildings and within the centre of building B4.

**Photo 15: Grassland within the centre of B4.**

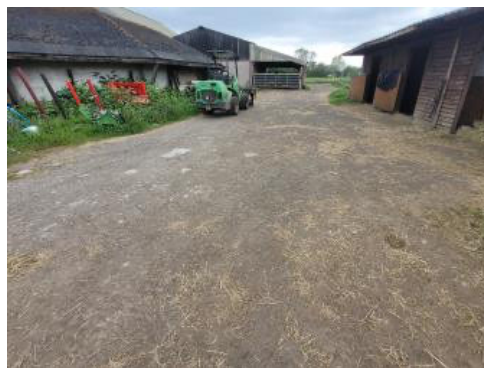
- 3.7 The site is located at the western end of an established equestrian yard and comprises a small group of equestrian buildings surrounded predominantly by gravelled hardstanding. The buildings onsite include a traditional stone-built accommodation and stables building, a steel-framed barn, a small timber-framed stable block, and a circular timber-framed horse walker. The majority of the site is used for access, parking, and general equestrian activity, resulting in extensive areas of compacted gravel and other artificial surfaces throughout.

**Photo 16: Compacted gravelled surface surrounding the buildings.**

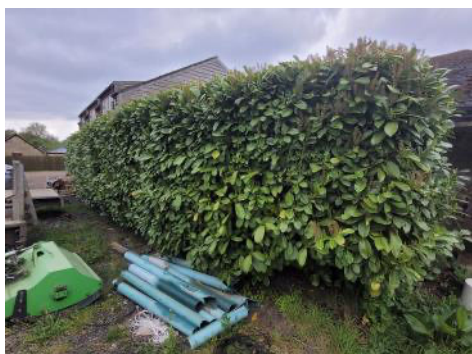
**Photo 17: Cherry laurel hedgerow located to the immediate east of B4.**
