## Drainage Strategy and Flood Risk Statement

**Opposite Jubilee Cottage, Witt Road,  
Winterslow, Hants**

**Reference:** 25168

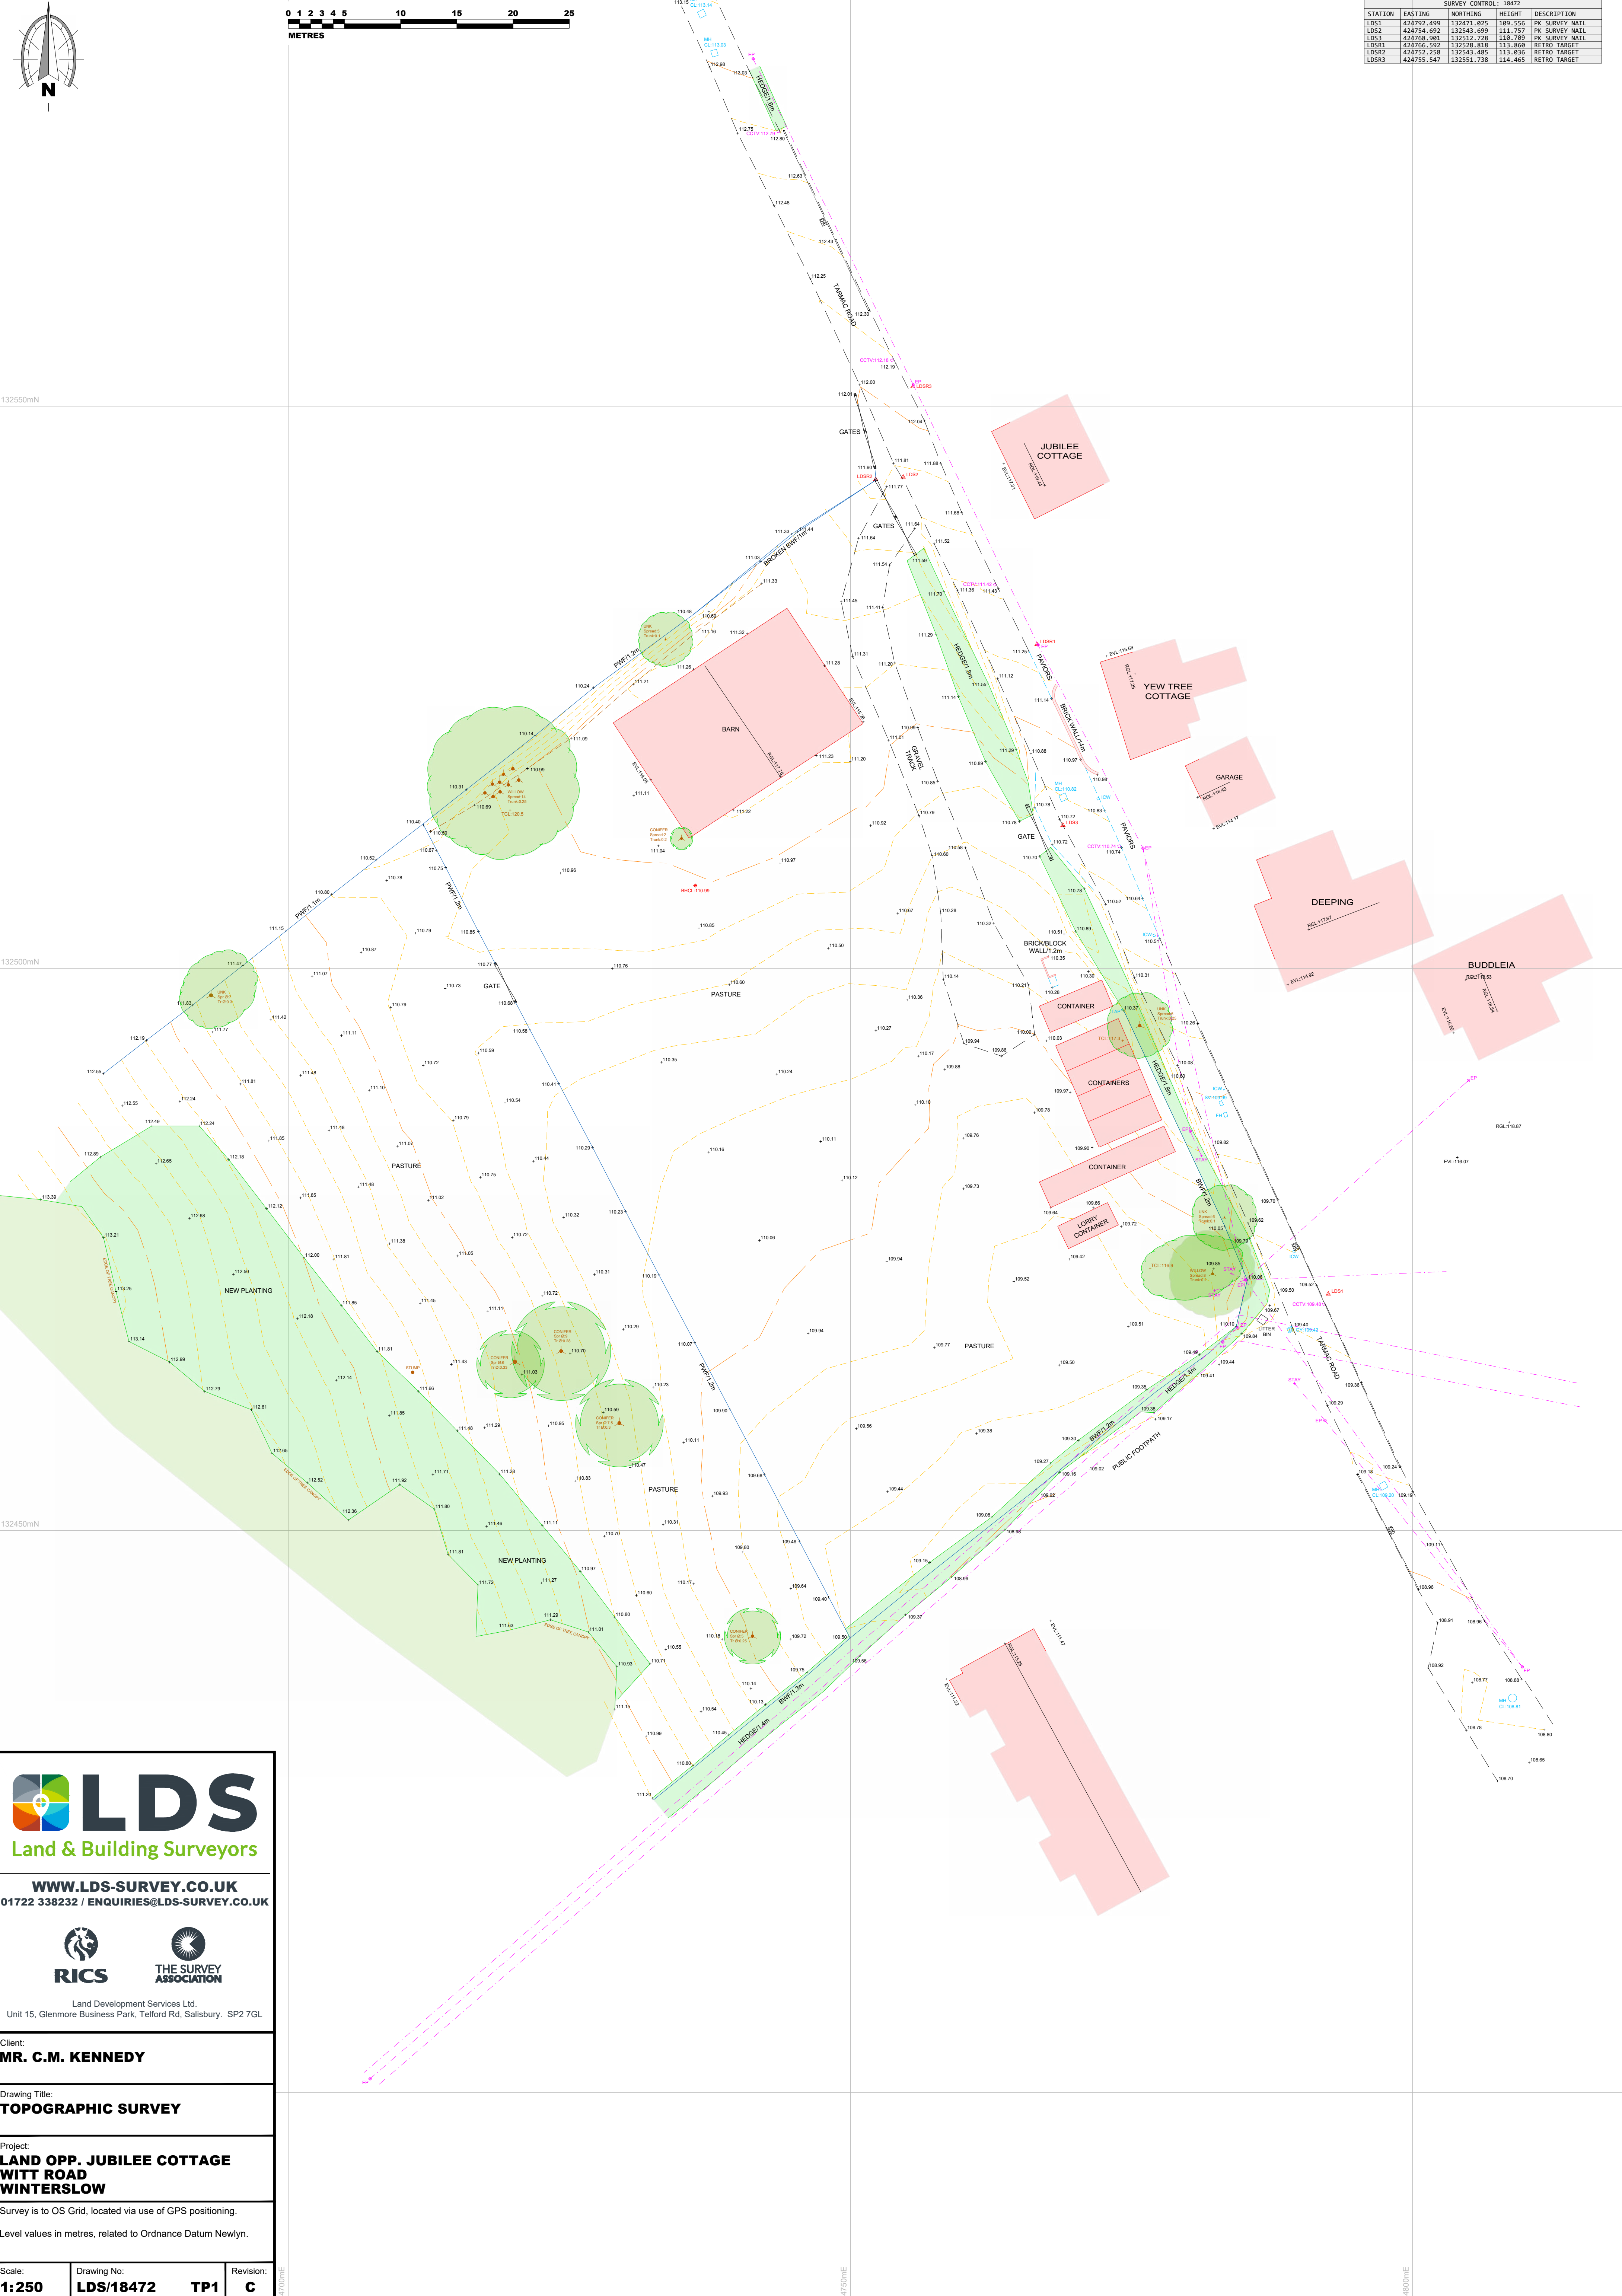
- 2.1 The site comprises a roughly rectangular approximately 0.43 Ha parcel opposite Jubilee Cottage, Witt Road, Winterslow, Wilts (grid ref 424750 132500). The existing topography is shown on LDS Survey drawing LDS-18472-TP1-C contained in Appendix A of this report.
- 2.2 It is proposed develop 5 dwellings on 0.36 ha of the land and to retain the remaining 0.07Ha in agricultural use including access. The proposed layout is identified on Bernard Cole site plan 9780-2-F contained in in Appendix A of this report

- 3.1 The site is currently comprises a grass paddock and barn. The site falls north east to south west from some 112m AOD to some 109m AOD.
- 3.2 There are no surface water drainage assets presently on the site.

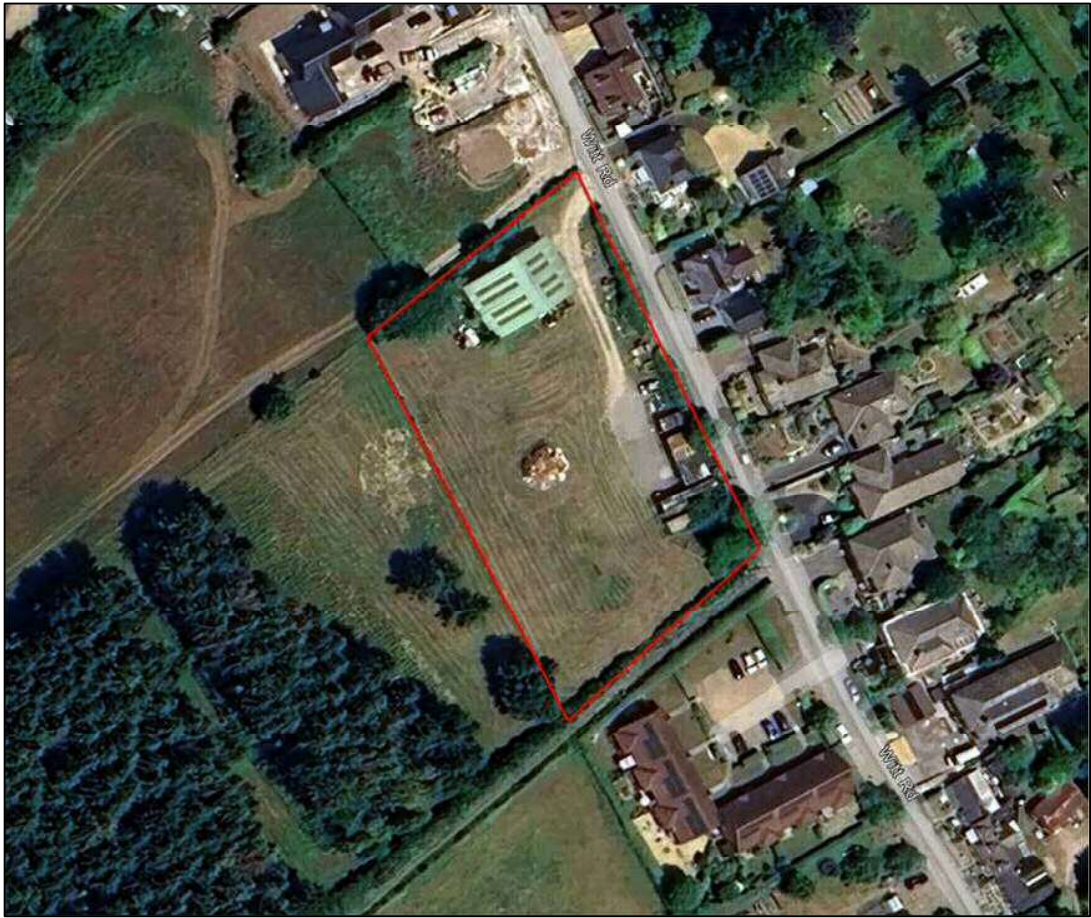
Figure 2 – Aerial Photograph

Figure 2 shows exploratory hole locations.

A site location plan is given in Figure 1. An aerial photograph of the site and its close environs has been included in Figure 2.

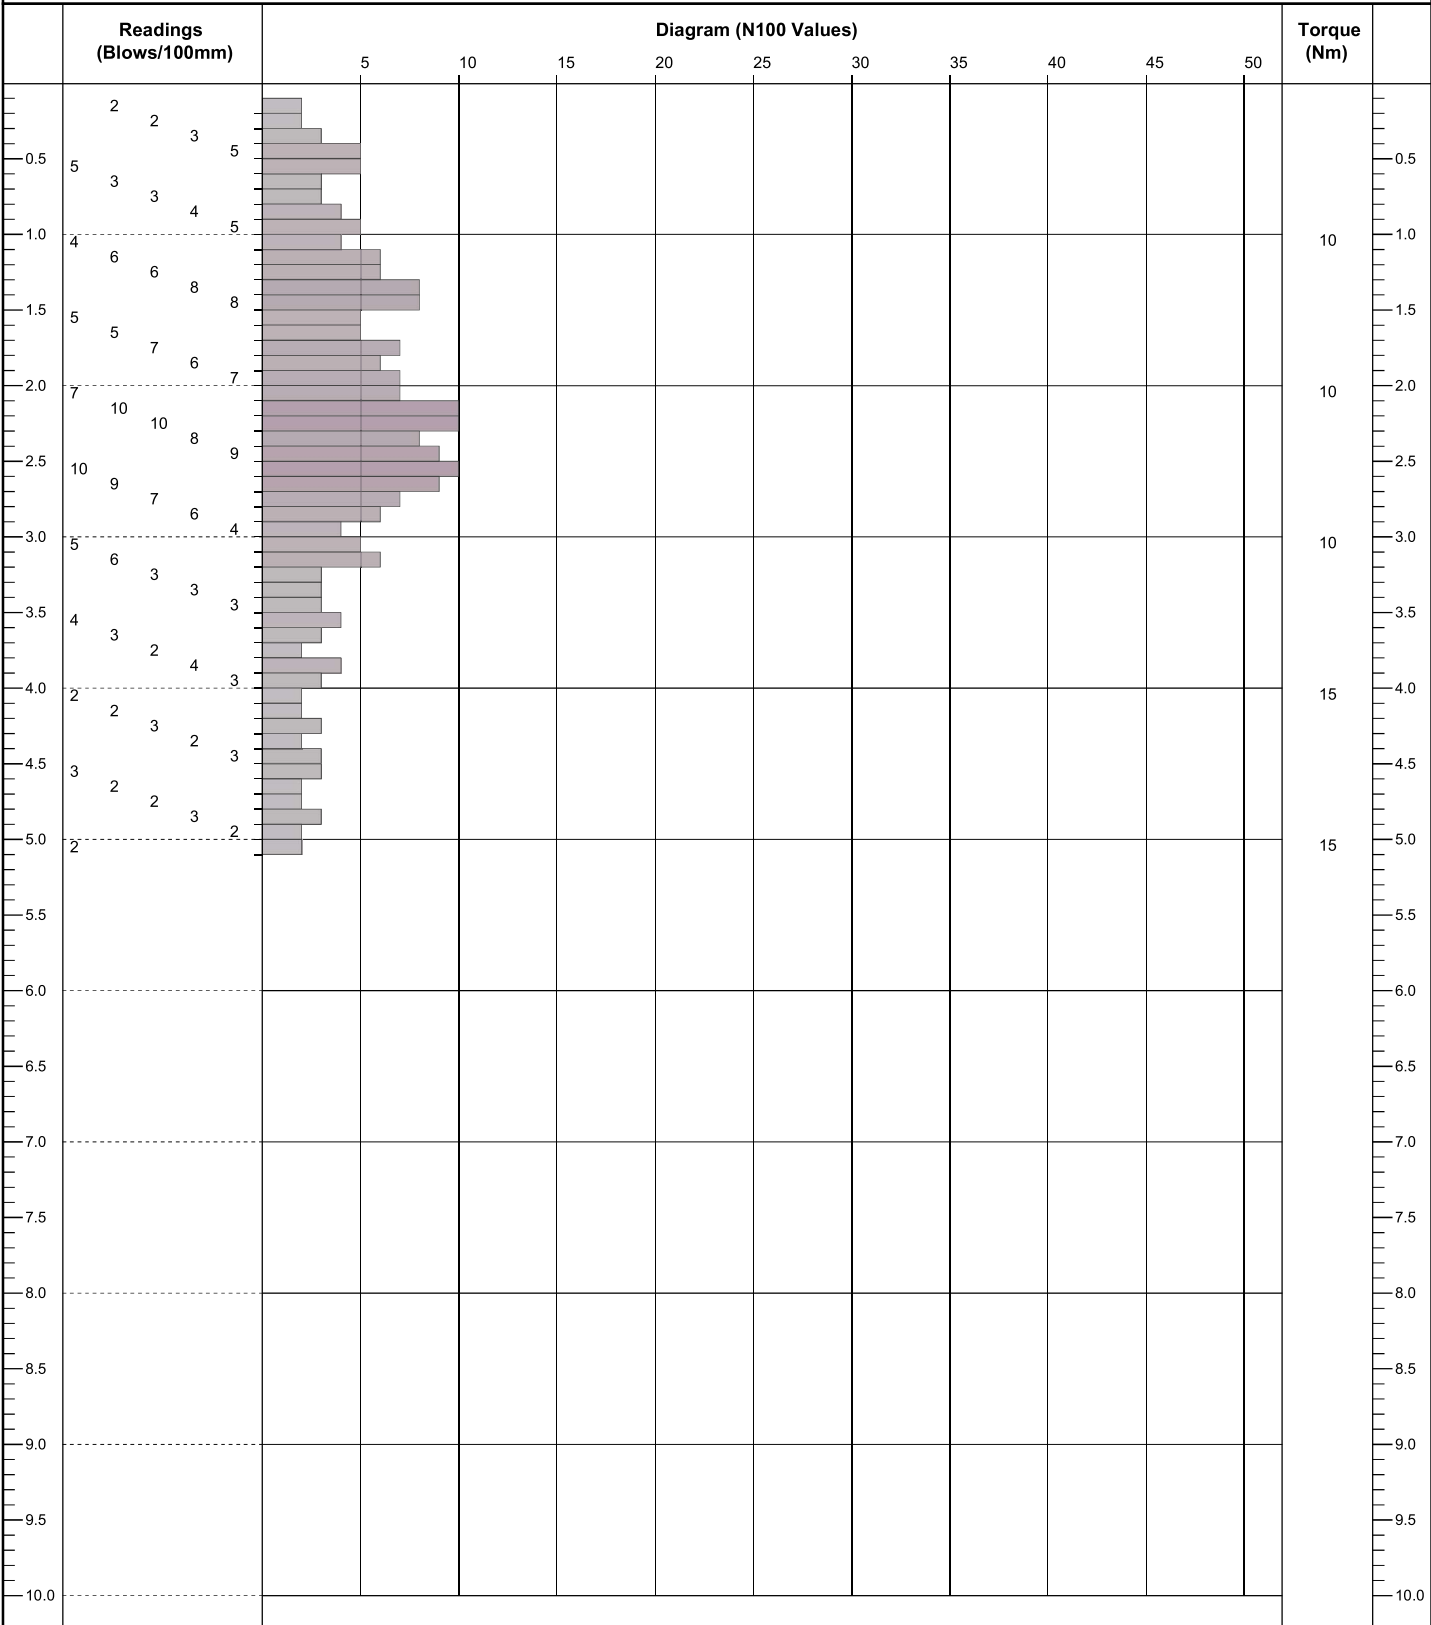
| Remarks<br>Energy Ratio 90.85 | Method, Plant<br>0.00 - 5.00m DP Premier 4 | Logger<br>CF |
| | Hammer Weight (kg) 63.5<br>Hammer Drop (mm) 760<br>Cone Diameter (mm) 55<br>Cone Angle<br>Rod Diameter (mm)<br>Damper | |

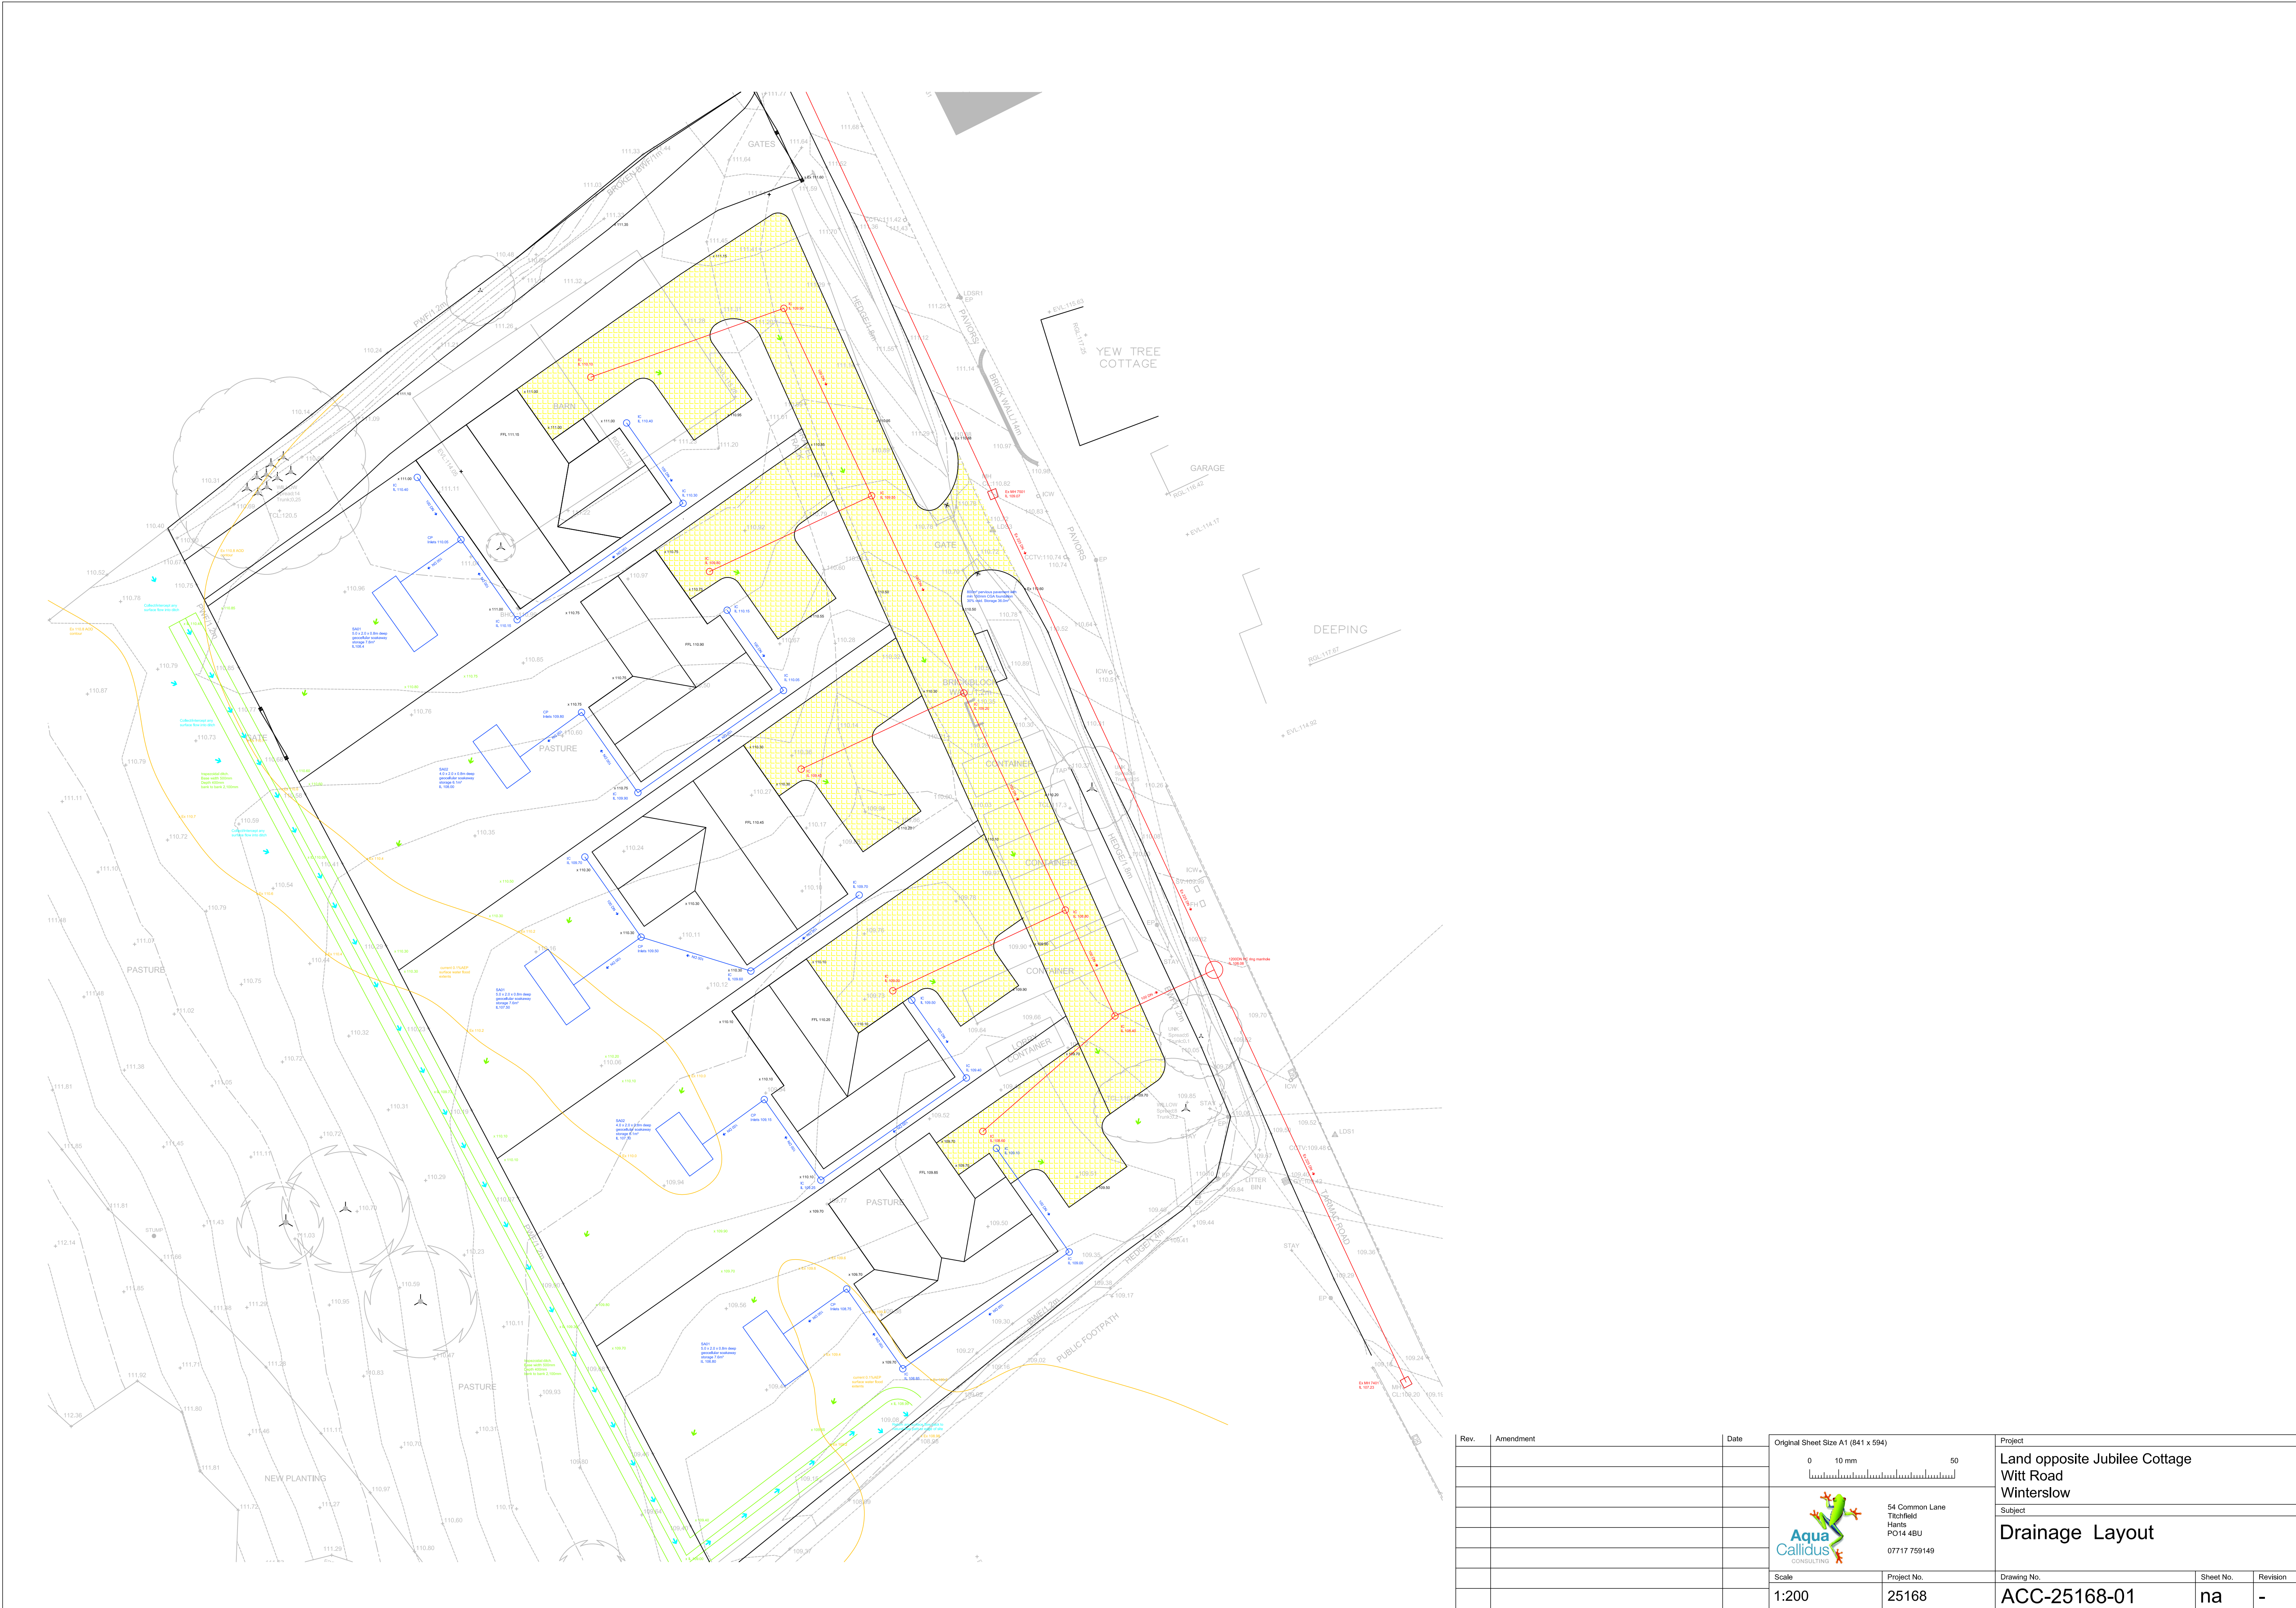
| Rev. | Amendment | Date | Original Sheet Size A1 (841 x 594) | Project | | |
|---|---|---|---|---|---|---|
| | | | 0 10 mm 50 | Land opposite Jubilee Cottage<br>Witt Road<br>Winterslow | | |

- 4.13 The rear edge of the site (western edge) is located on the base of a dry valley and Environment Agency surface water flood mapping from LIDAR in conjunction with the site specific topographic survey has been used to inform the current 0.1%AEP surface water flood extents. This passes west around the northwest corner of the site at a flood level of some 110.8m AOD ( approx. 0.05 m deep) and across the extreme southwest tip of the site and leaves the site close to the southwest corner at a flood level of some 19.2,m AOD ( approx. 0.10m deep). Planning application PL/2022/07116 drainage and flood statement 13/8/2019 for the immediately adjacent land determined a 211 l/sec 1%AEP +CC flow rate for surface water flow down the valley at this point and formation of a grassed earth channel at the rear ( western edge) of that development was proposed and permitted. The same approach is proposed on this site with a grassed earth channel formed at the rear edge of the site with a capacity of 900 l/sec ( calculations contained in Appendix C). This being coupled with slight ground raising in the south west corner of the site such that in combination: Surface flow from north and west of the site is intercepted by the new channel and controlled/managed on the modified alignment, issuing back to the original pathway at the original level all at the existing rates. Ie the pathway is moved slightly to the western edge of the site and there is no change in flow path or flow rates or level outside the site. Within the site the proposed dwellings will be at very low risk of surface water flooding ( <0.1% AEP) The proposed channel, ground levels, fall direction and flow path are indicated on drawing ACC25168-01.
