# Preliminary Bat Roost Assessment & Nesting Bird Survey Report

Highway Barn, Highway Common,  
Calne, Wiltshire, SN11 8SR

| Reference | 2025-049 |

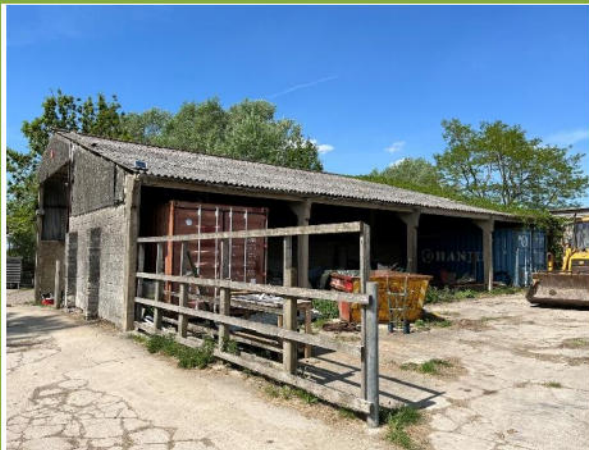
| General Photographs | |
|---|---|
| South-east and south-west elevations | North-east and part of the north-west elevation |

| General | Building description | Concrete framed agricultural building with a storage container and several trees and shrubs located immediately adjacent to the north-west elevation. |
| | Elevation construction | Blockwork with no cavity, and unlined corrugated metal and cement fibre sheets. |
| | Roof material | Cement fibre corrugated sheets. Unlined. |

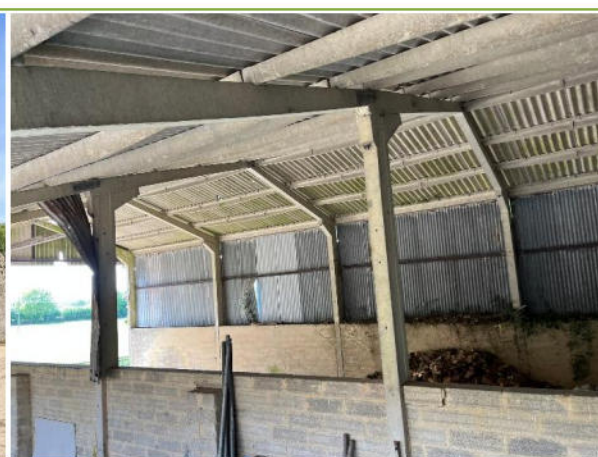
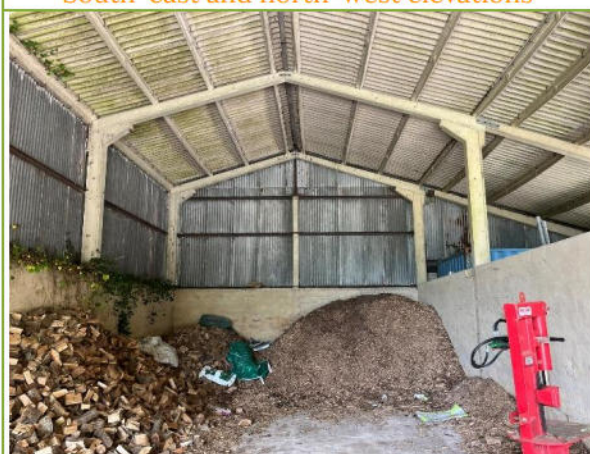
Interior

| <b>Potential Bird Nest Sites</b> | <p>Potential for nesting on top of roof support beams. Swallows could potentially nest within the building. The interior of the storage container was potentially accessible to birds, but high levels of disturbance would likely deter nesting.</p> <p>Trees and shrubs adjacent to the north-west elevation of the building and climbing vegetation (Virginia creeper) growing over the northern part of the roof provided suitable nesting habitat.</p> |
| <b>Evidence of Birds</b> | One old pigeon nest on top of a pillar within the interior, adjacent to the northern elevation. |

| Species/<br>Group | Suitability<br>Assessment | Survey/Mitigation Requirements | Timing |
|---|---|---|---|
| Birds | Confirmed | <p><b>Mitigation</b> - If possible it is recommended that obstructive and destructive works to the building/storage container and the removal of trees and shrubs is carried out outside the nesting season.</p> <p>If this is not possible then the building/storage container and trees/shrubs must be checked by an ecologist for active nests immediately before works start; if active nests were then present they would have to be left undisturbed until the young had left the nest.</p> | If works to the building are carried out between March and September inclusive or trees and shrubs are removed between March and August inclusive then a nesting bird survey must be carried out by an ecologist. |
