## STRUCTURAL ENGINEER'S REPORT

## INSPECTION OF EXISTING BUILDING

**RAF MESS BUILDING, THE OLD AIRFIELD, HONEYSTREET SN9 5PS**

Ref: 18176/EO/RPT/02

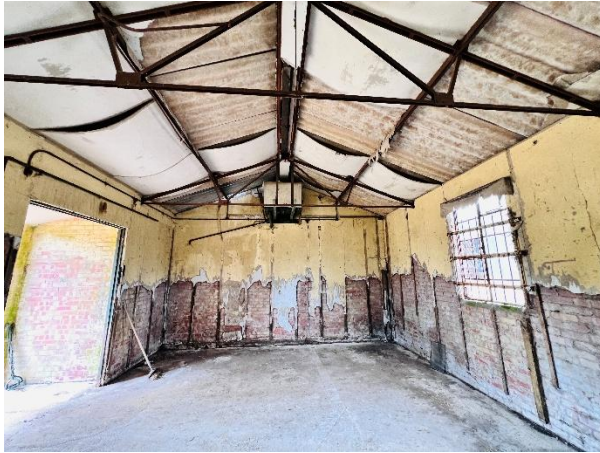
- 5.1 No plan bracing could be seen in the roof structure planes, which indicates the stability of the roof is reliant on the existing roof cladding panels to form diaphragms to enable horizontal load transfer through to the foundations accordingly.

- Plan bracing should be locally inserted in the roof planes, preferably on the 2No end bays to ensure that horizontal load transfer is not reliant on the roof cladding elements;
- Areas of the brickwork that have been exposed due to deteriorated render should be repointed accordingly; where individual bricks have deteriorated, these can be replaced with like for like units;
- The brickwork on the internal wall elevations should be appropriately repointed as a prudent measure, to ensure long-term durability of the structure.

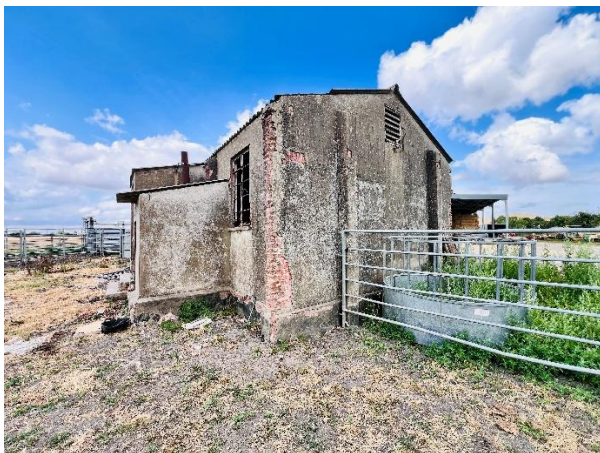
- 5.2 The brickwork could be seen to be exposed, where the external render had deteriorated in places. The extent of the deteriorated brickwork is, however, limited due to the area of exposed brick and localised repairs would be sufficient and can be carried out practically.

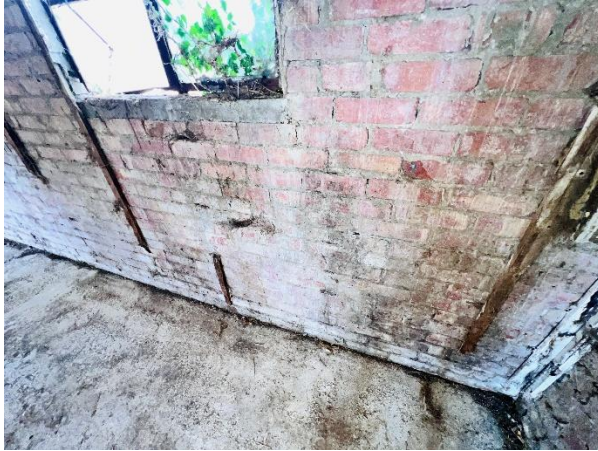
- 5.3 The mortar joints on the internal wall elevations appeared to have deteriorated generally. The mortar joints can be easily raked out and repointed to ensure long-term durability of the structure, and this can be undertaken in a piecemeal fashion.
