## PRELIMINARY BAT ROOST ASSESSMENT (PRA)

Proposed Demolition of Existing Outbuilding & Erection of Replacement Outbuilding at Framfield,  
Church Lane, Trowbridge, Wiltshire, BA14 0EH

**Planning Application Reference:** PL/2026/01921

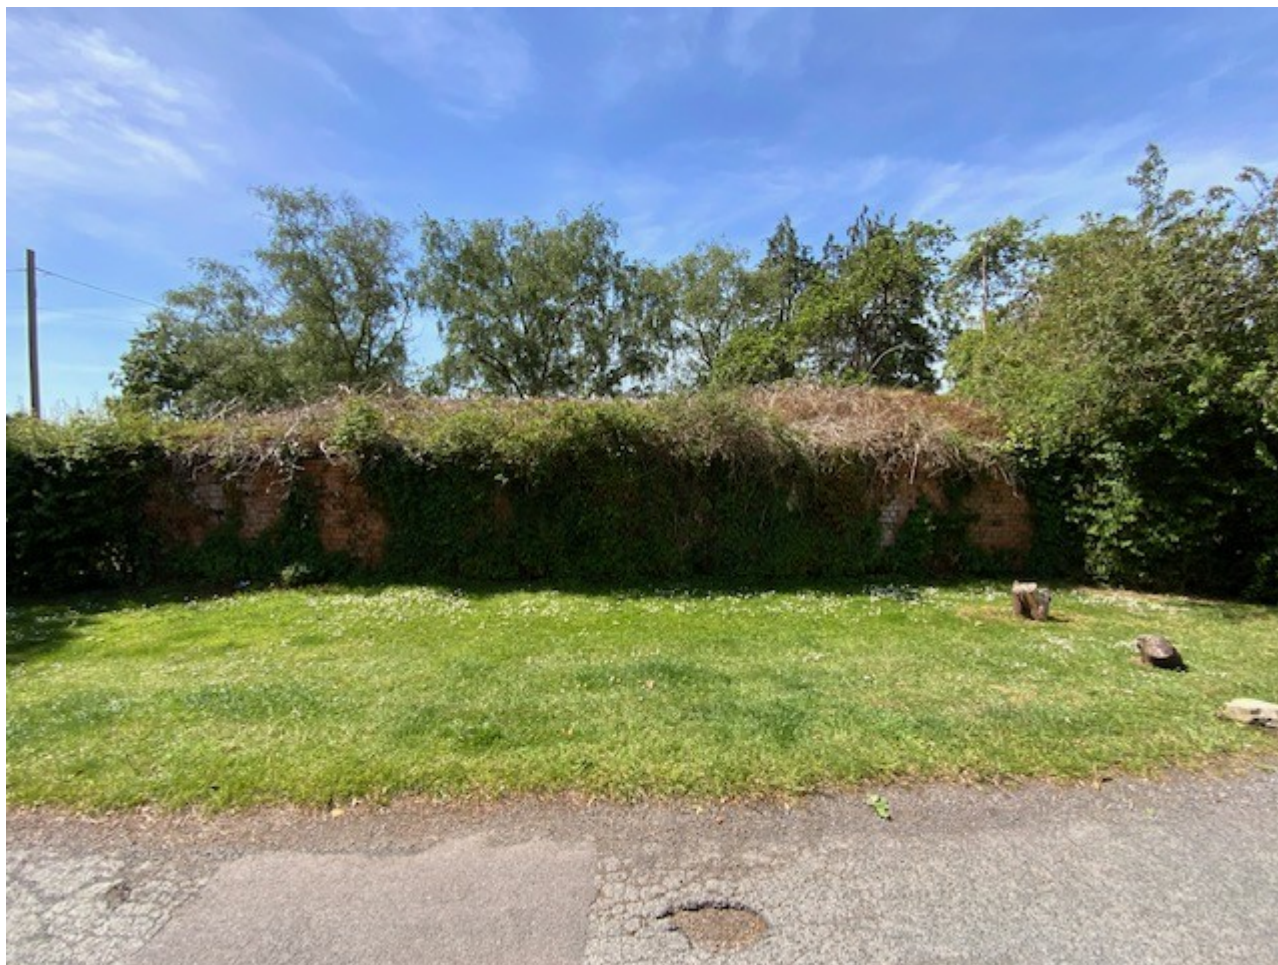
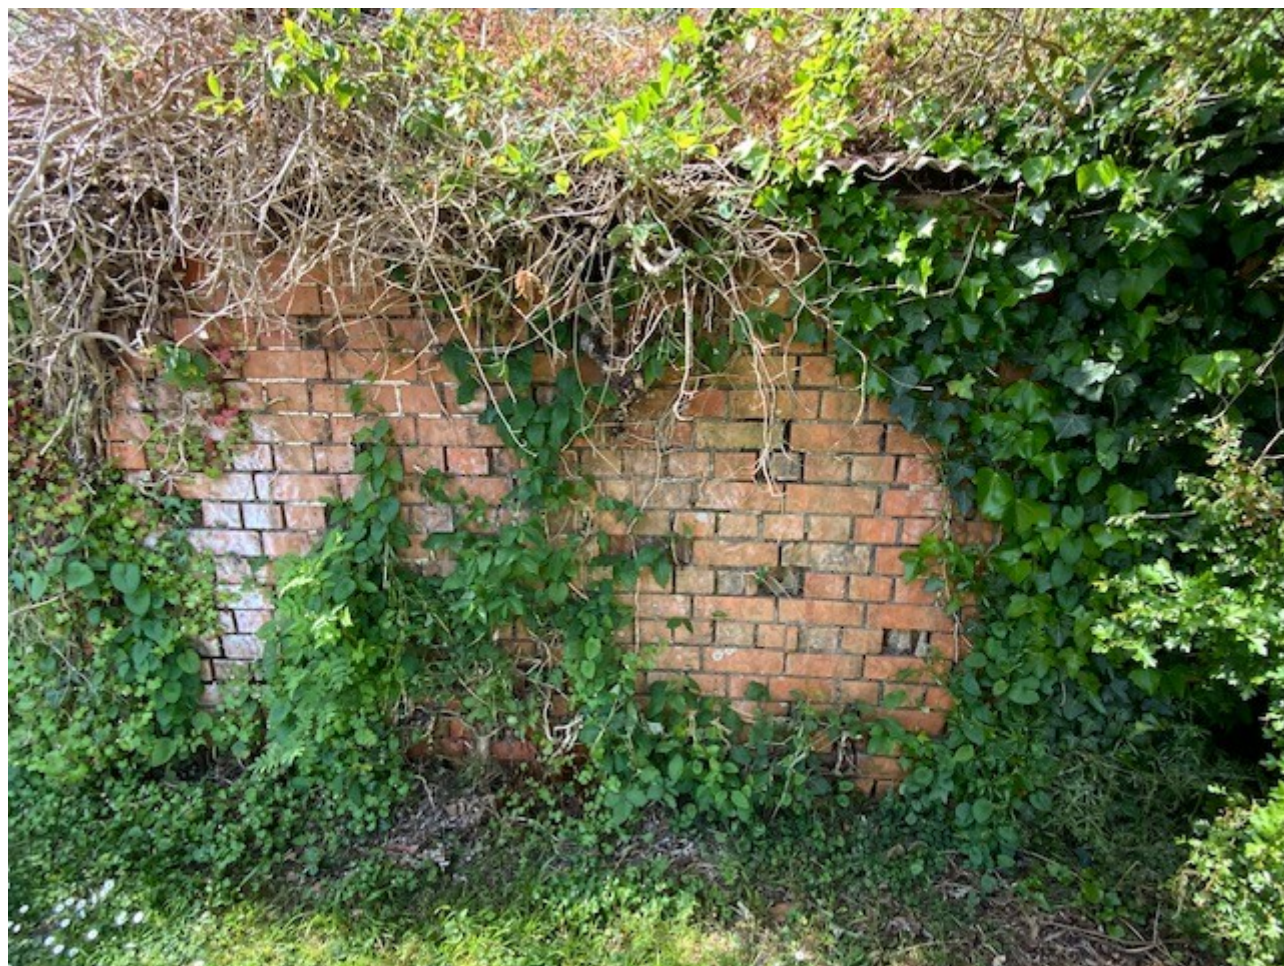
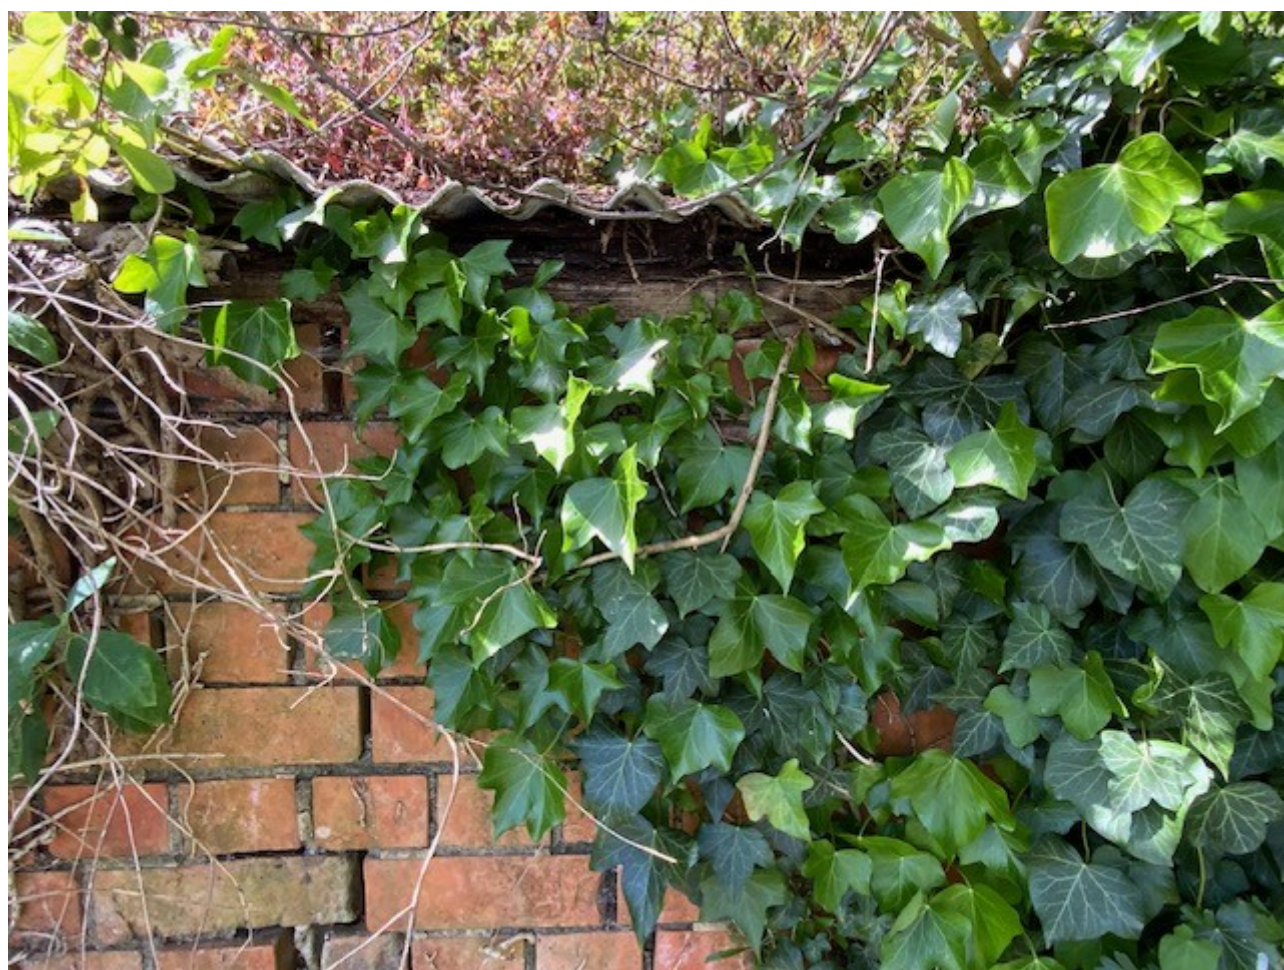
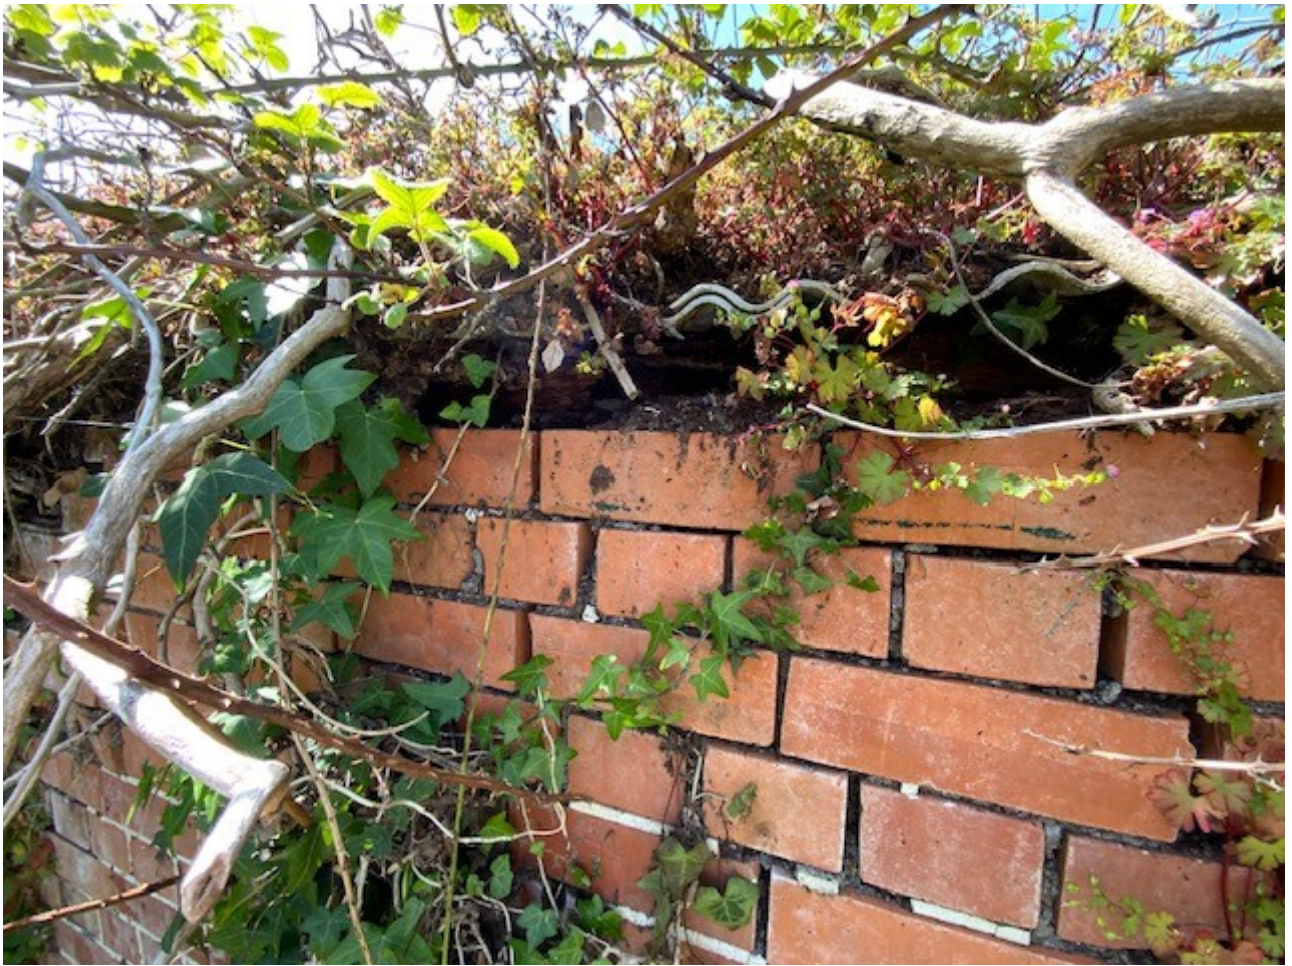
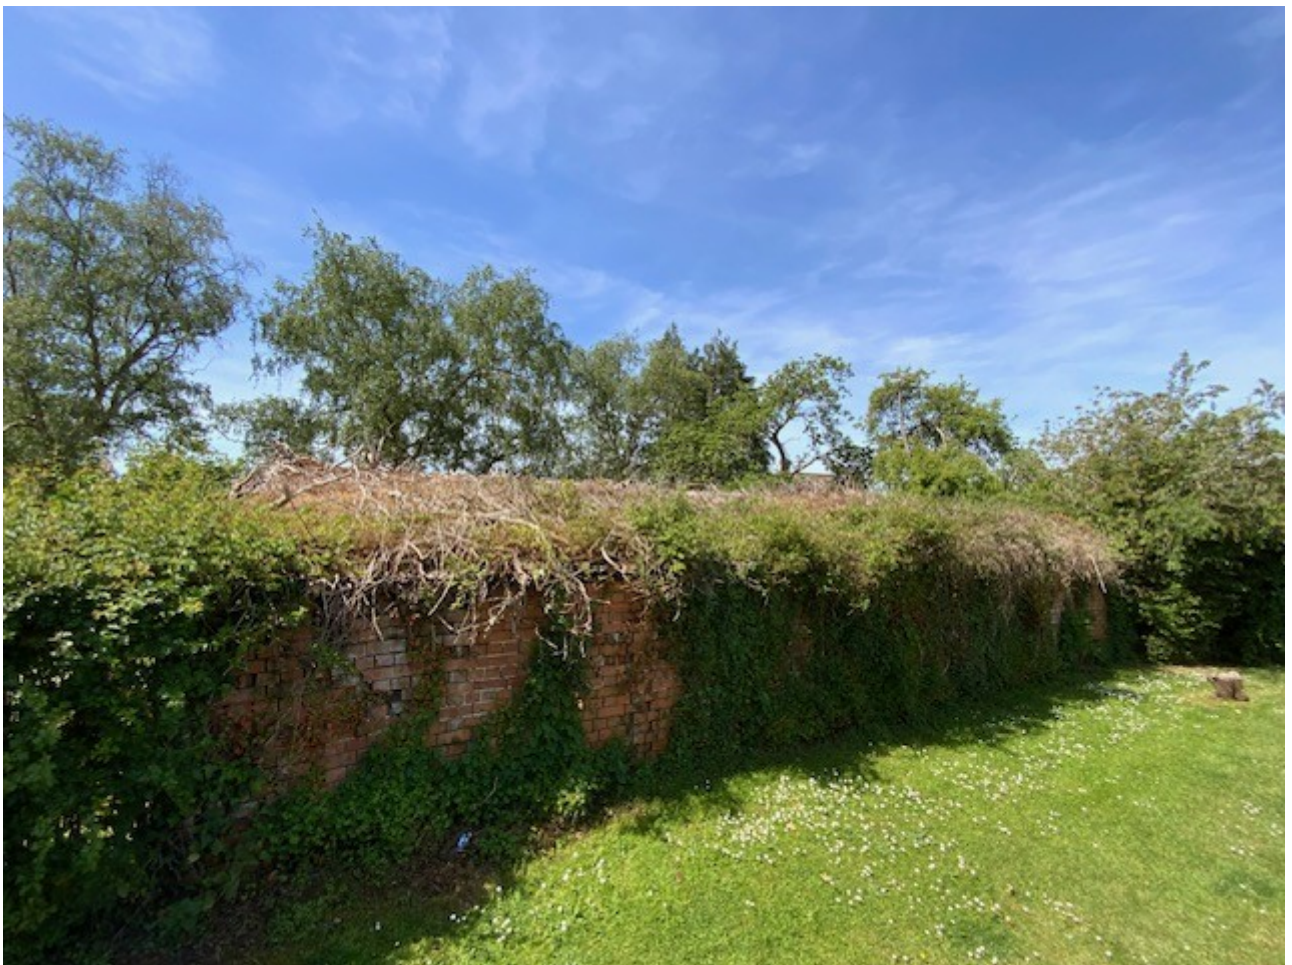
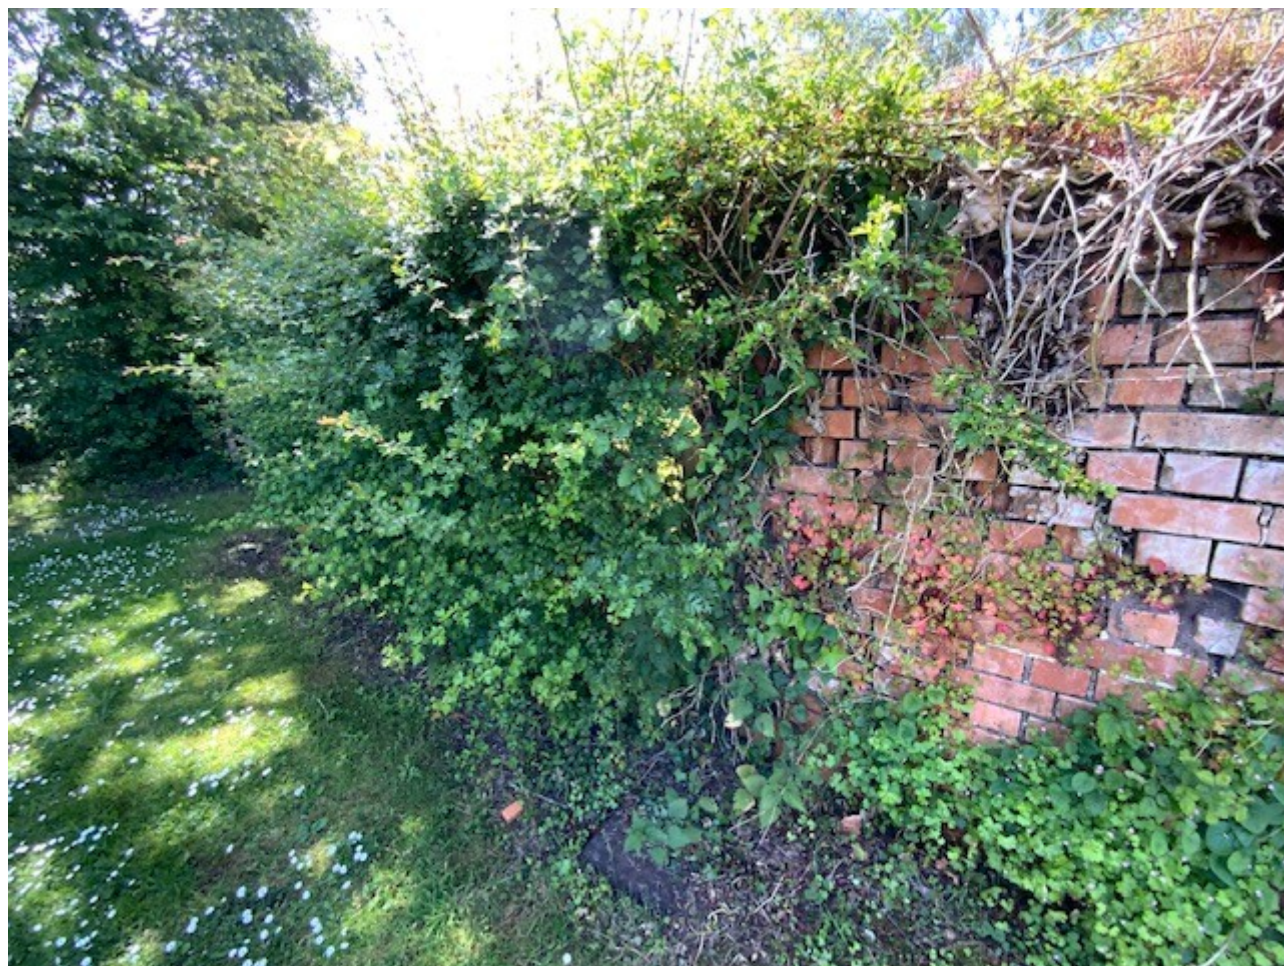
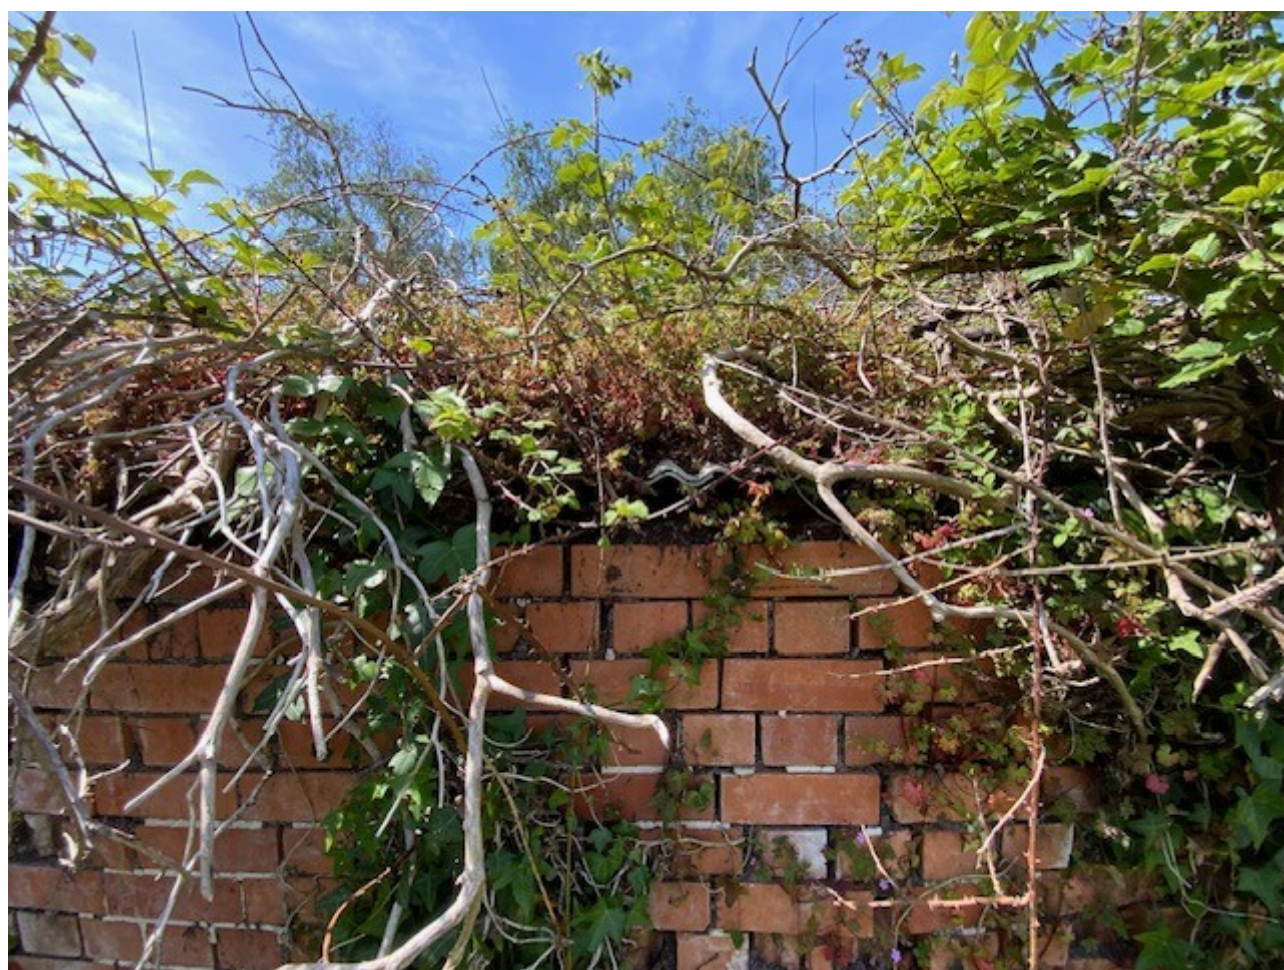
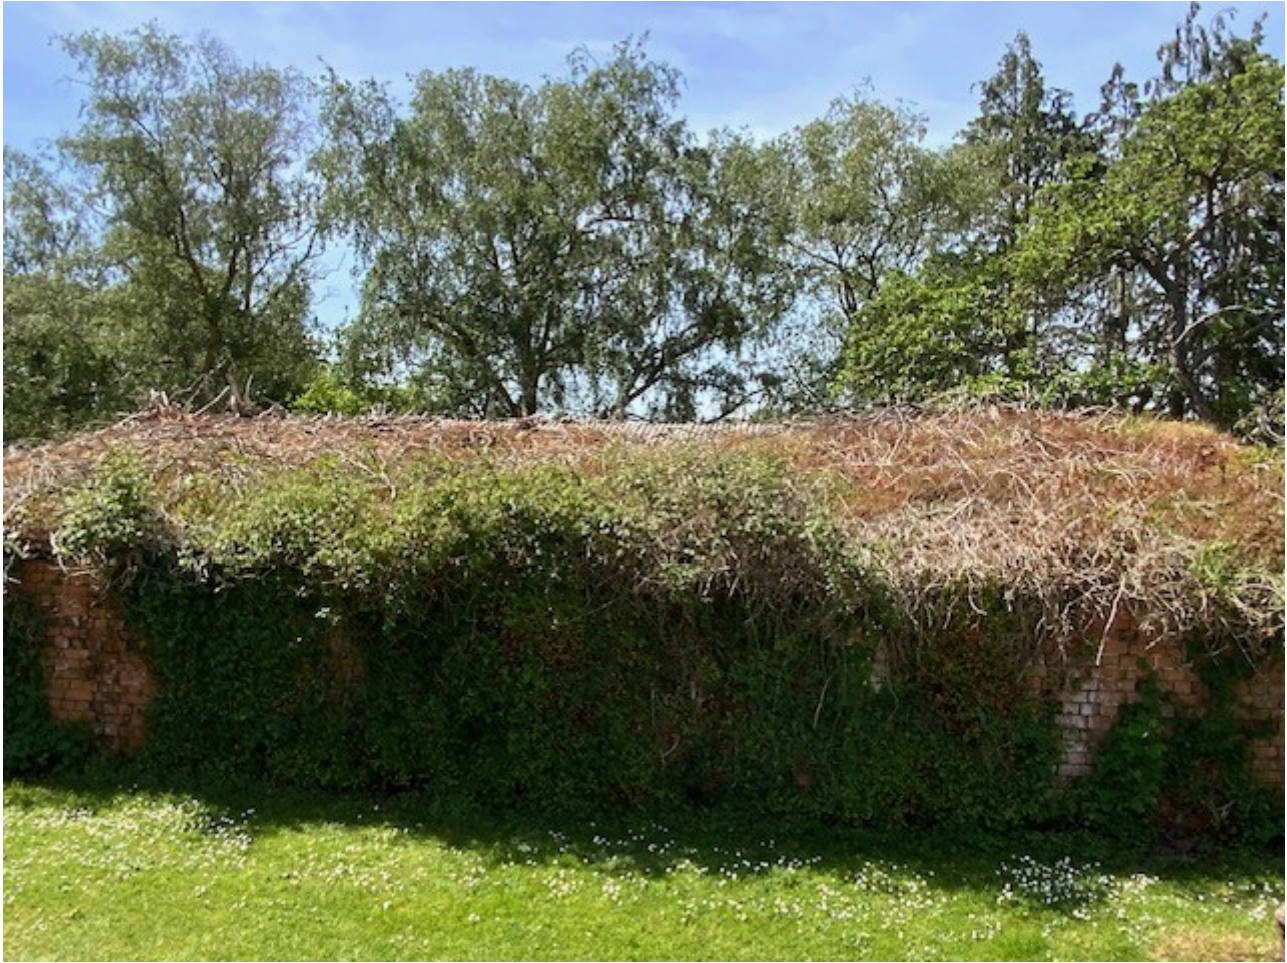
### 1. North-East Elevation photos

The building contains numerous openings and defects within the masonry including:

- Missing bricks;
- Cracks within brickwork;
- Localised mortar loss;
- Gaps at wall heads.

However, many openings were found to be occupied or obstructed by mature ivy stems and root growth.

At the time of survey the building was extensively covered by mature ivy (some dead sections).

The roof covering was almost entirely obscured by dense ivy growth and woody stems.

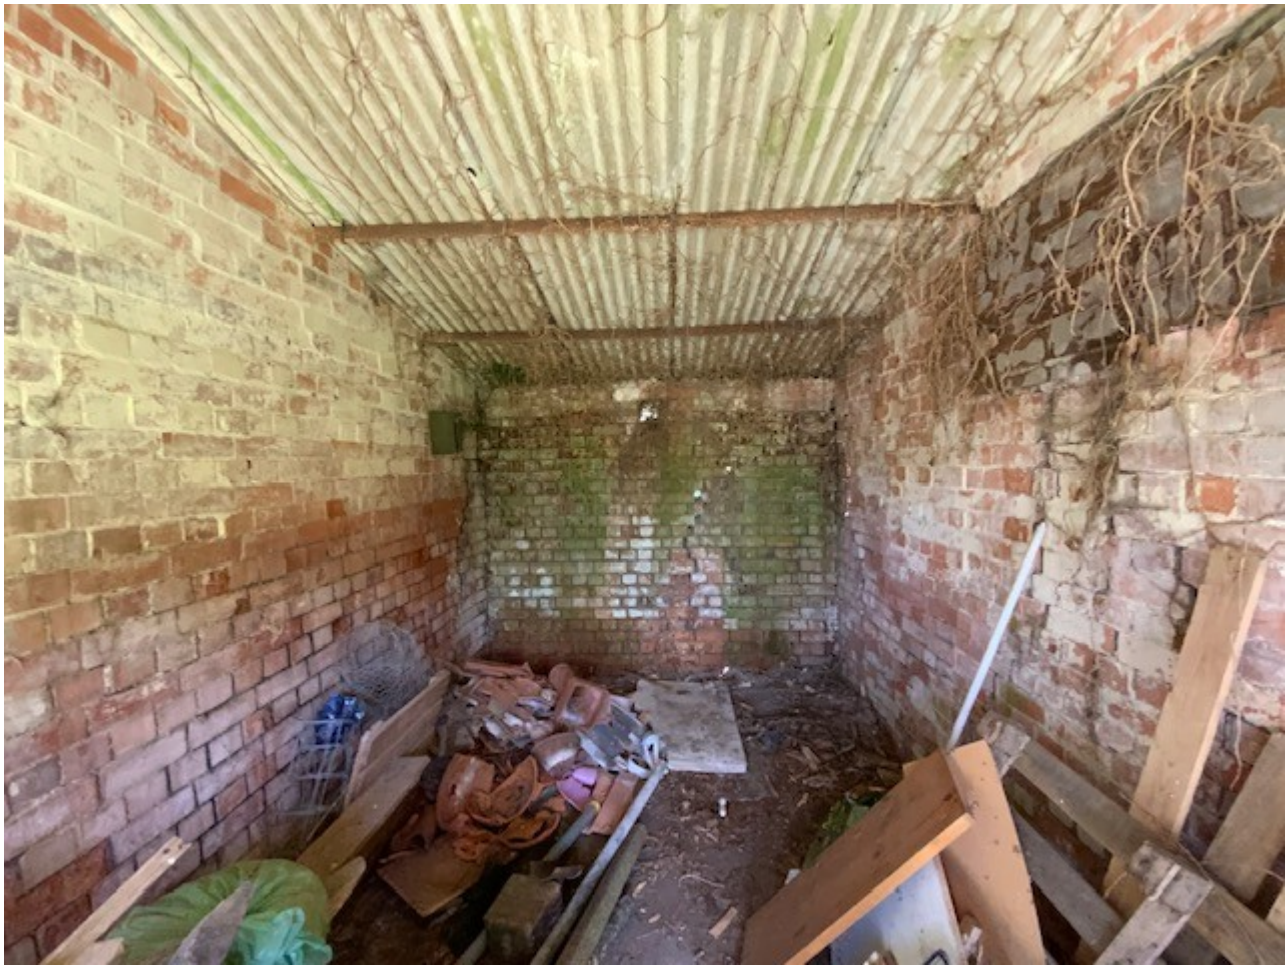
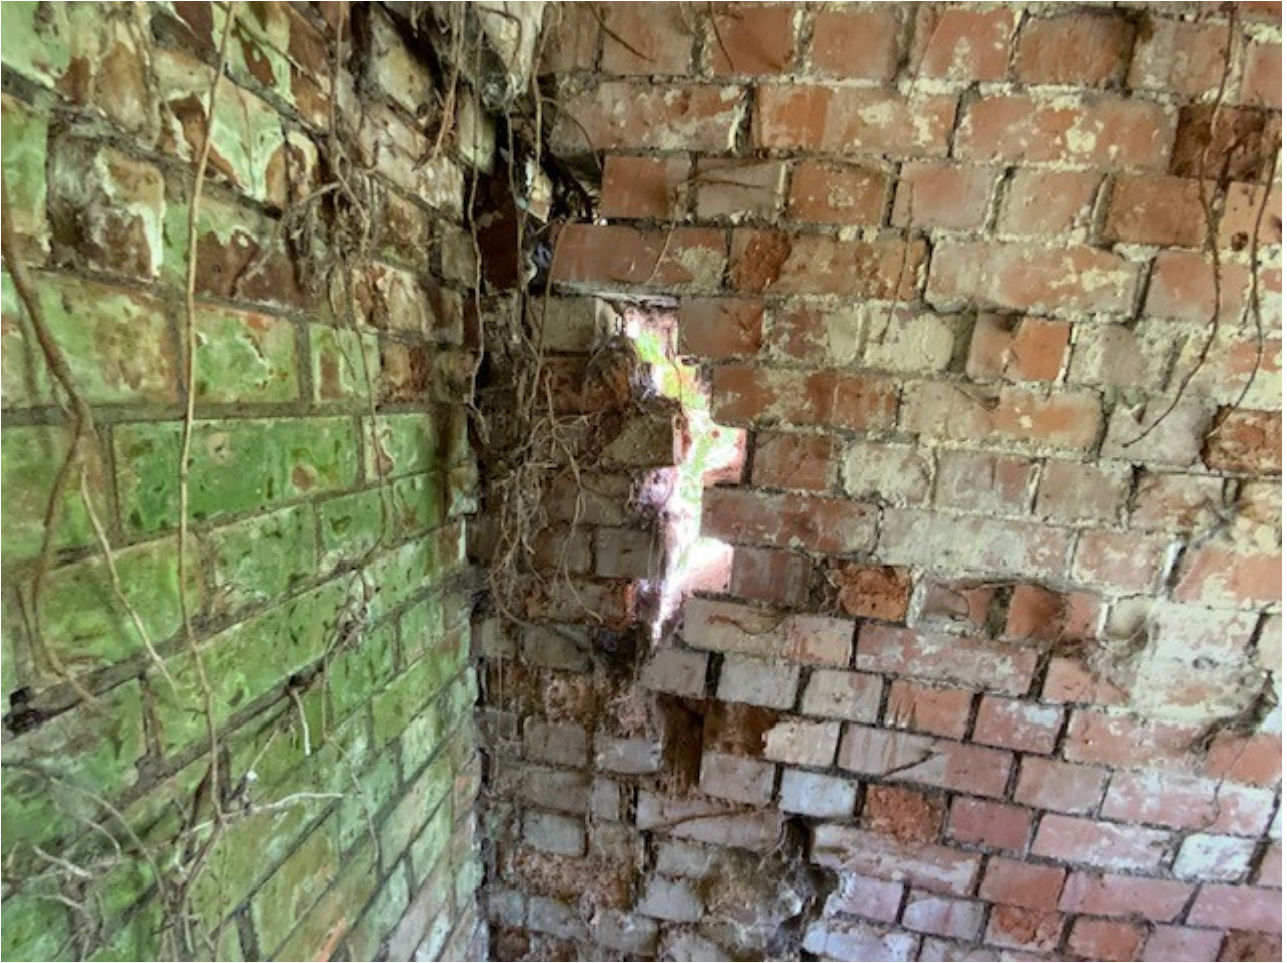
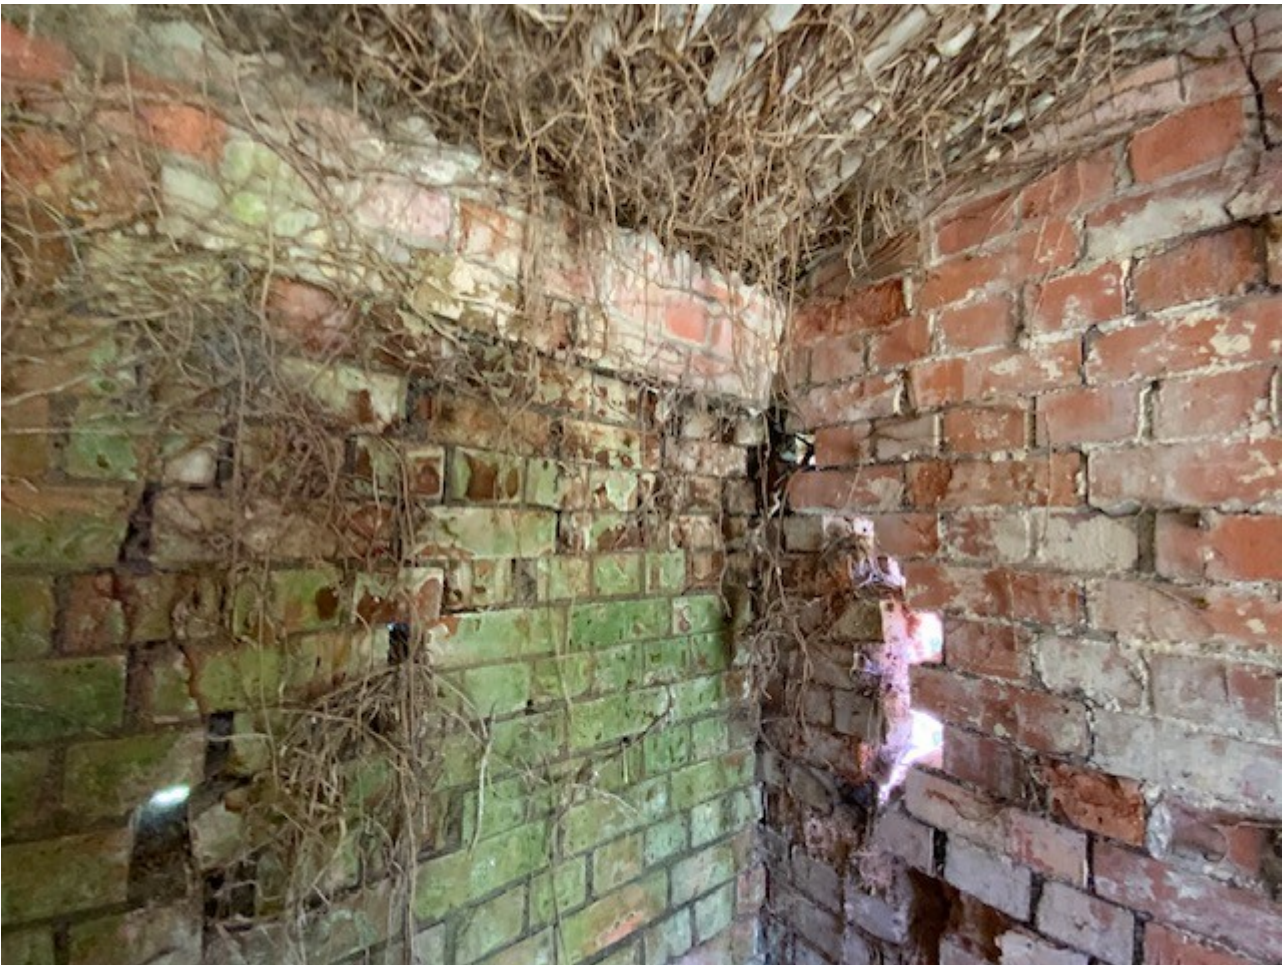
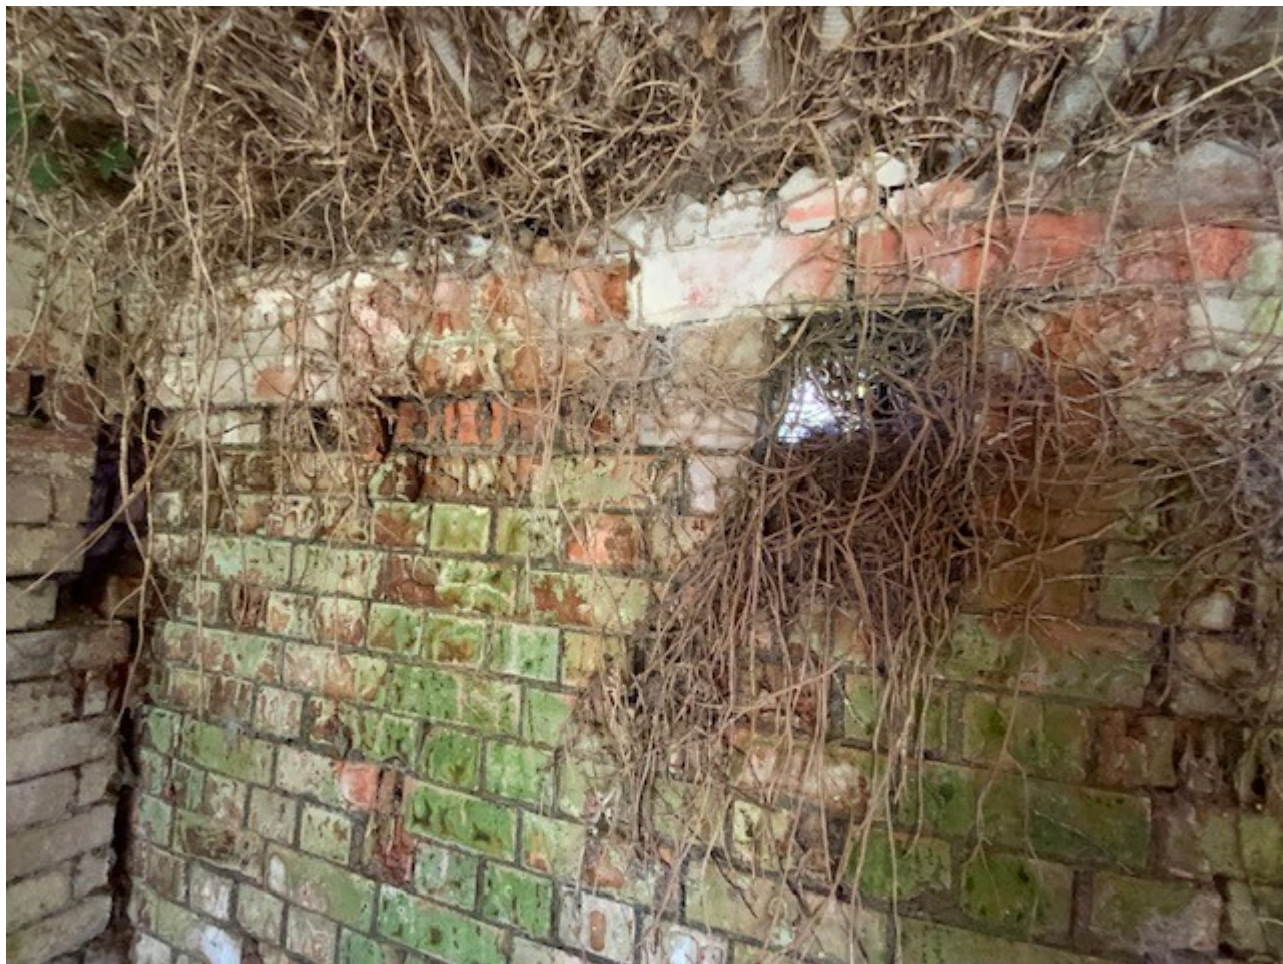
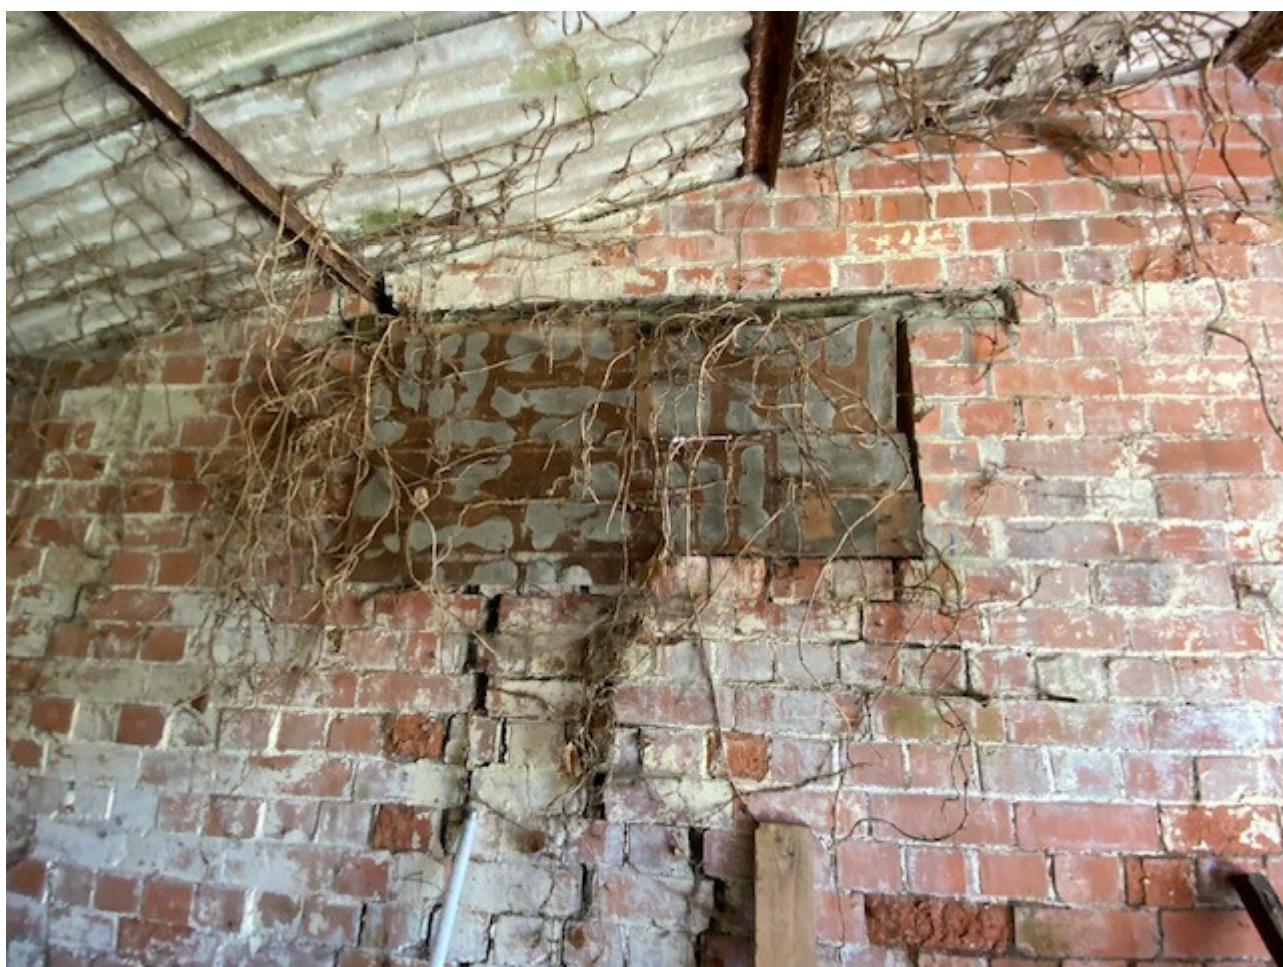
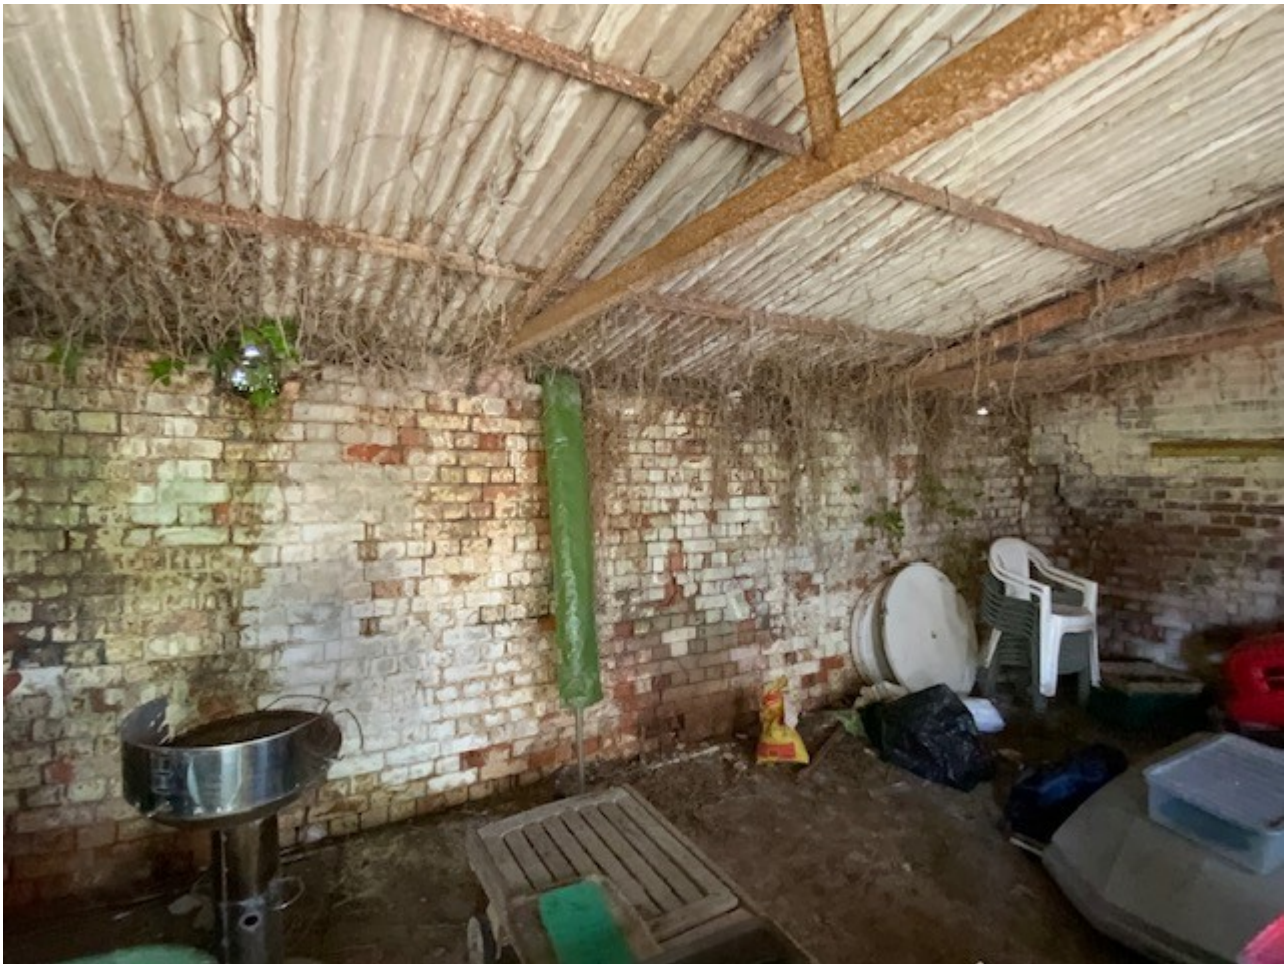
## 5. Internal Photos

Internally, substantial quantities of ivy stems and tendrils were observed hanging beneath the corrugated roof covering.

The hanging vegetation creates a cluttered environment beneath the roof and substantially reduces unobstructed flight space.

- No loft space present;
- No roof void present;
- No suspended ceiling;
- No enclosed cavity spaces;
- Open access to underside of roof sheeting throughout.

The corrugated roof covering is directly visible from floor level.

The internal environment is therefore highly ventilated and thermally unstable.
