# Heritage Impact Assessment

The Chough, Castle  
Street, Salisbury

May 2026 | Project Ref 12090A

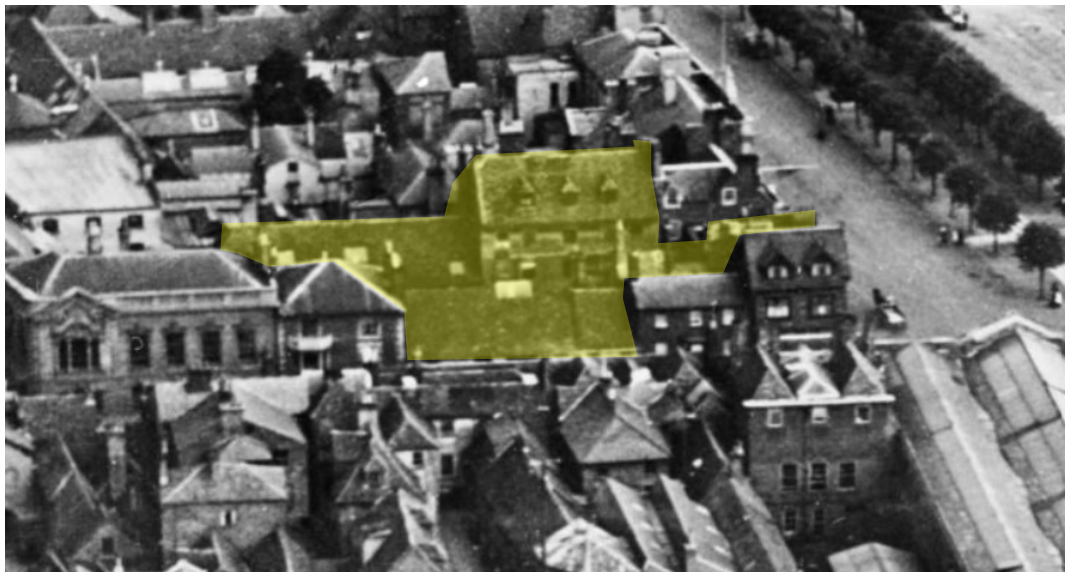
An aerial photograph from 1924 looks from the west over Blue Boar Chequer and shows the Castle Street façade apparently unbuilt – certainly no dormers are present suggesting it had not yet been reconstructed. The taller building within the yard area does have three dormers though, as well as a regular pattern of upper windows. The lower roof to the left was presumably the stabling range. A similar photographic angle some 20 years later shows the façade as it is today.

*Figure 6: 1924 Aerial photograph looking east over Blue Boar Chequer.*

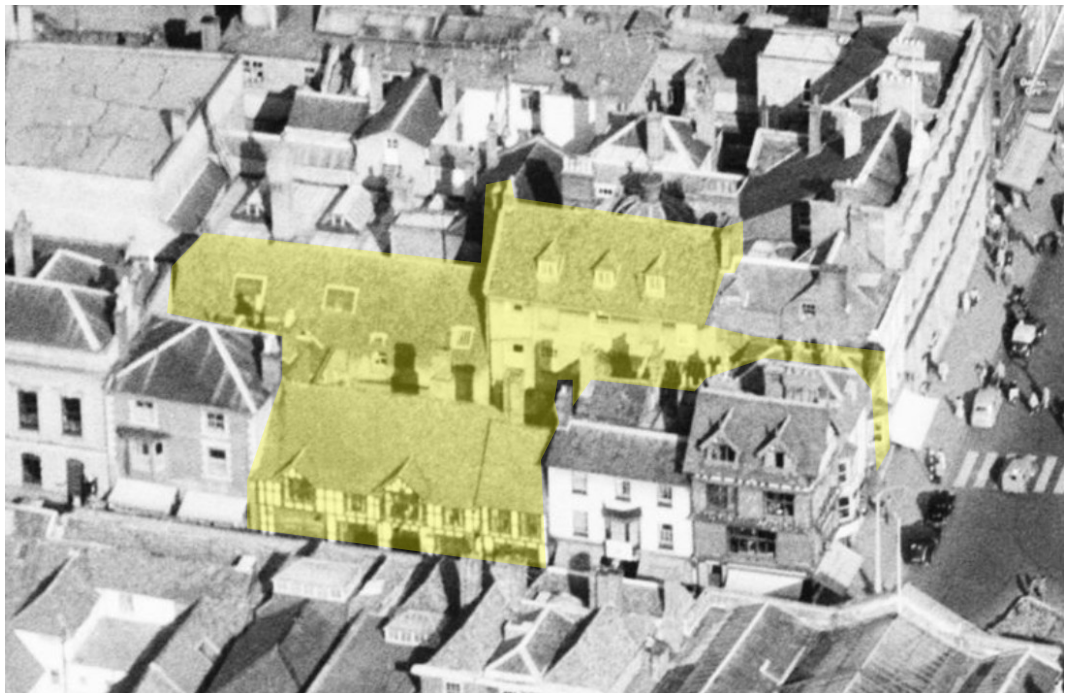
*Figure 7: 1953 Aerial Photograph showing the front façade reconstructed*

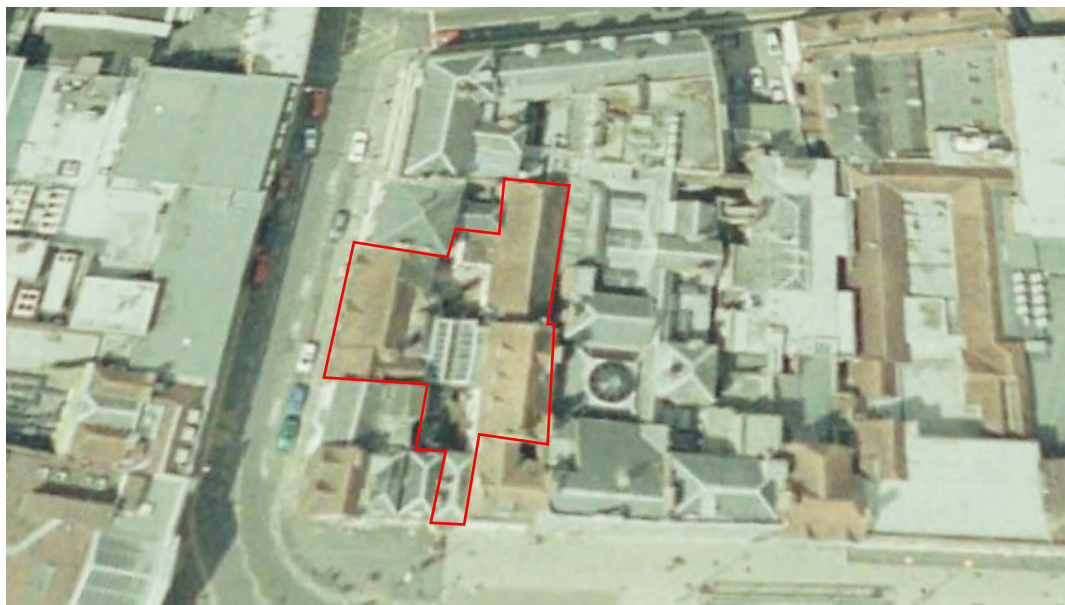
The maps show little change until 1953 when a raised walkway connection is shown across the yard. This walkway appears to have been incorporated into the current structure within the former yard, the exact date of this structure is not known but it was certainly in place by the end of the 20<sup>th</sup> century to be captured in a 2002 Google earth image:

Figure 9: 2002 Google Earth Aerial Photograph showing glazed link in place.

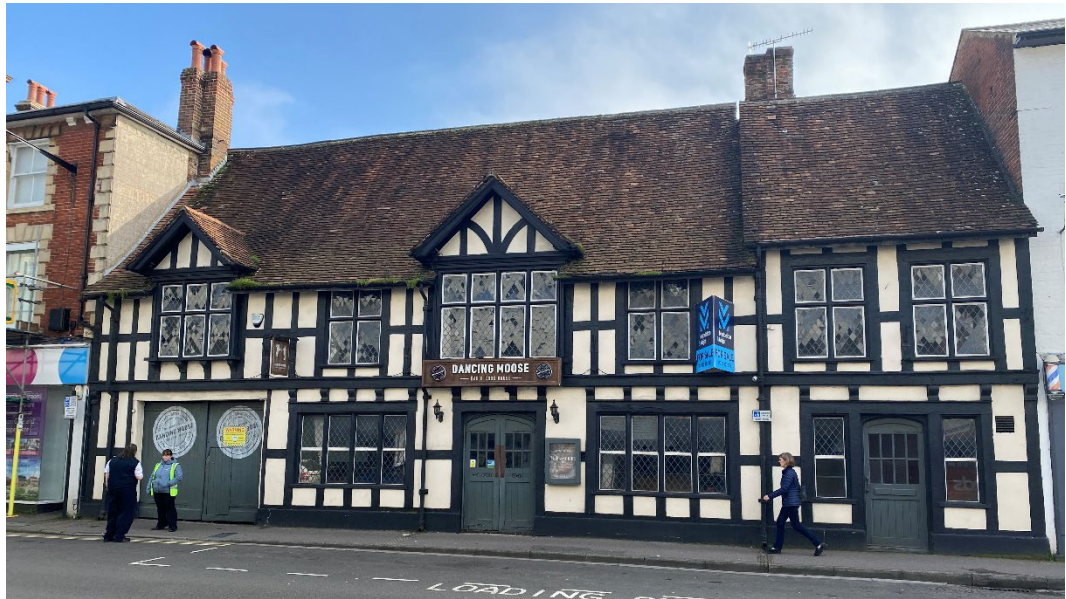
*Figure 10: The Chough, castle street elevation. The right hand portion retains a greater degree of historic fabric behind this façade.*

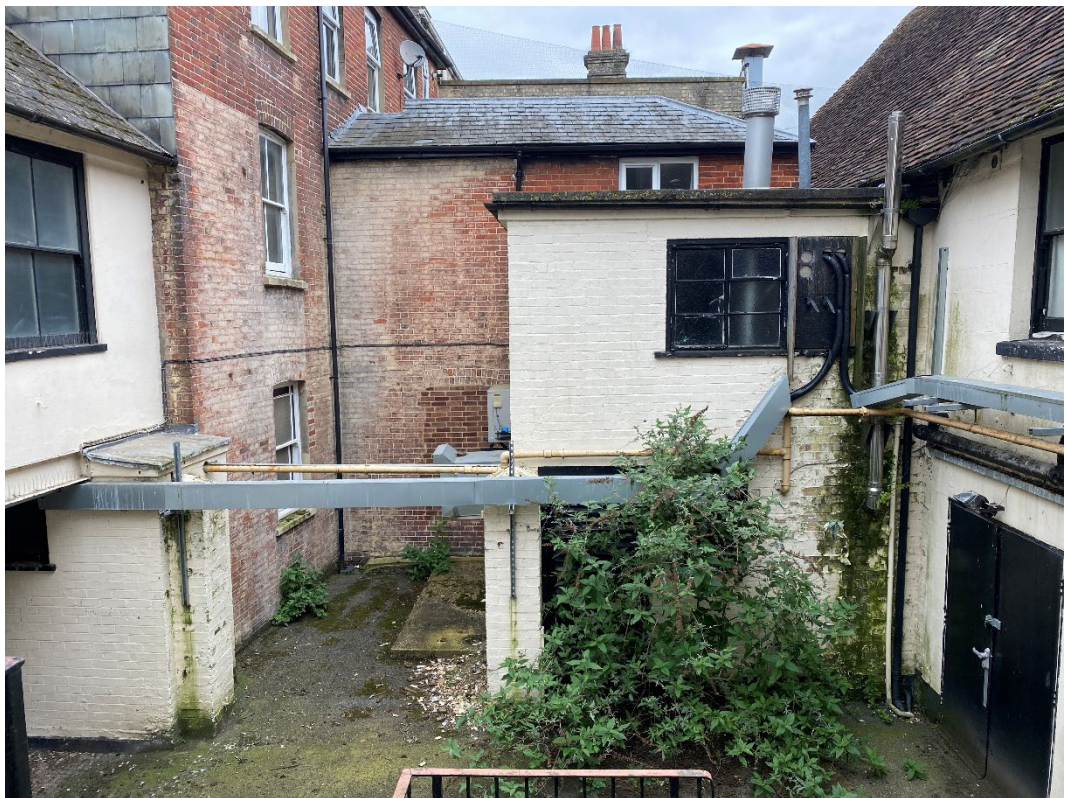
*Figure 11: The northern yard, arch to Castle Street on left, former stable range on right.*

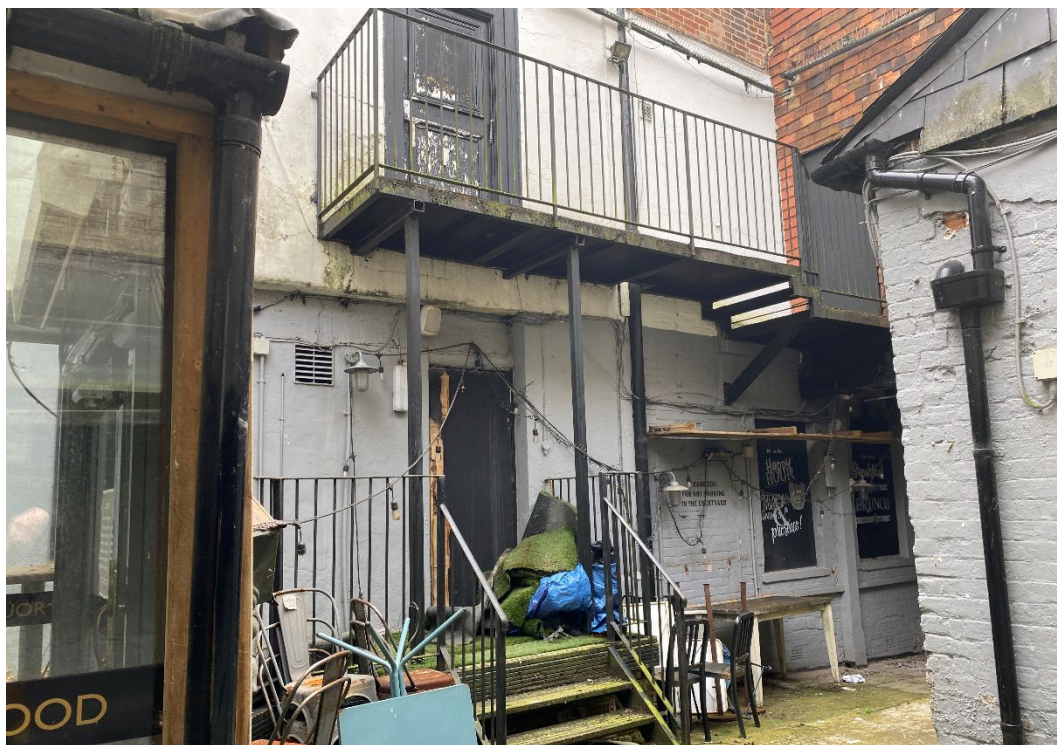
*Figure 12: The southern yard, Blue Boar arch on the right.*

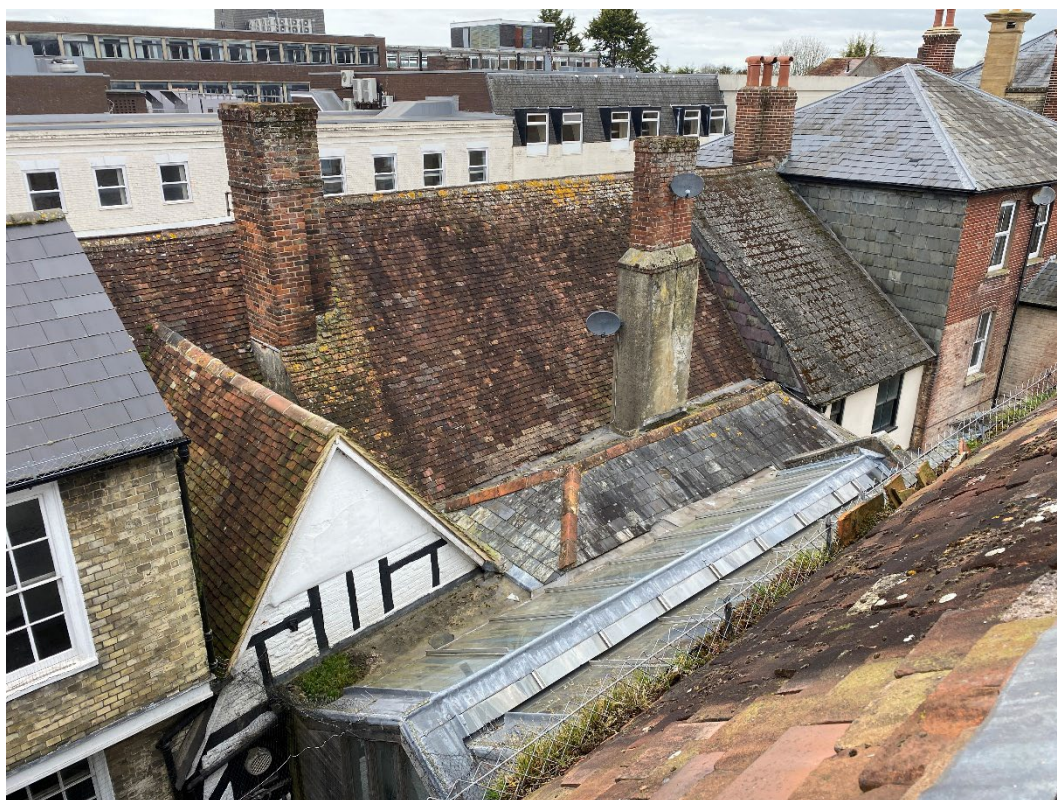
*Figure 13: the roof scape of the central and Castle Street ranges. Note timber framed gable to left.*

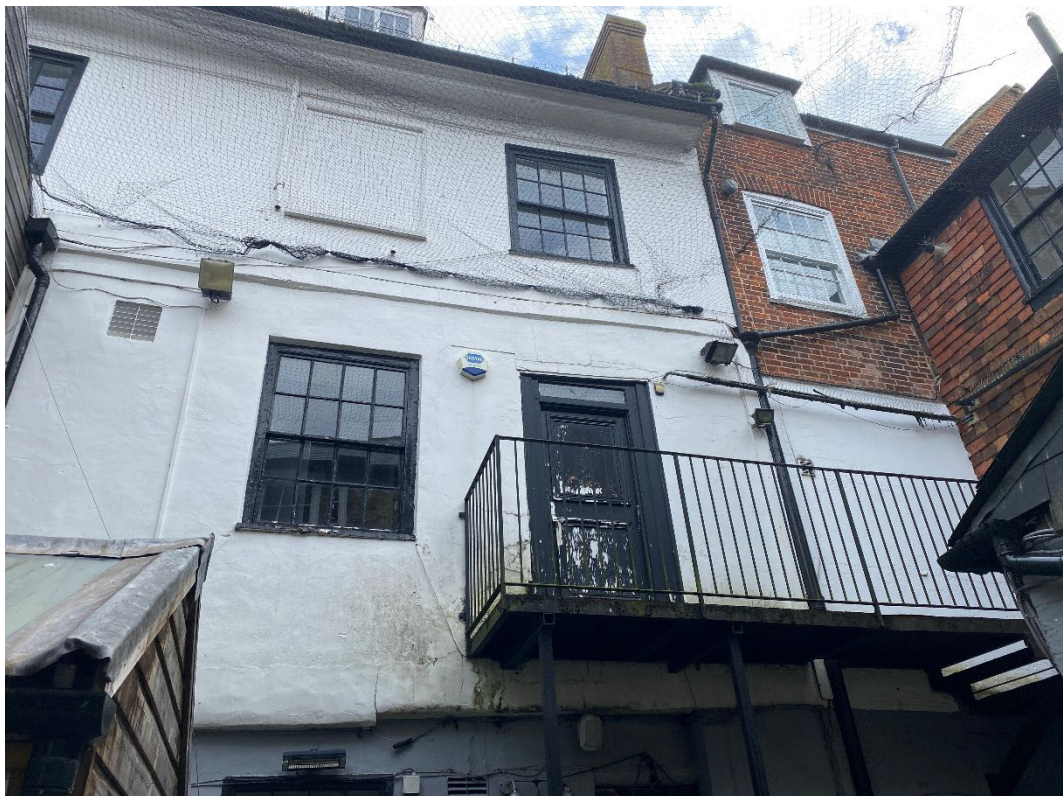
*Figure 15: 18<sup>th</sup> century façade of the eastern range.*

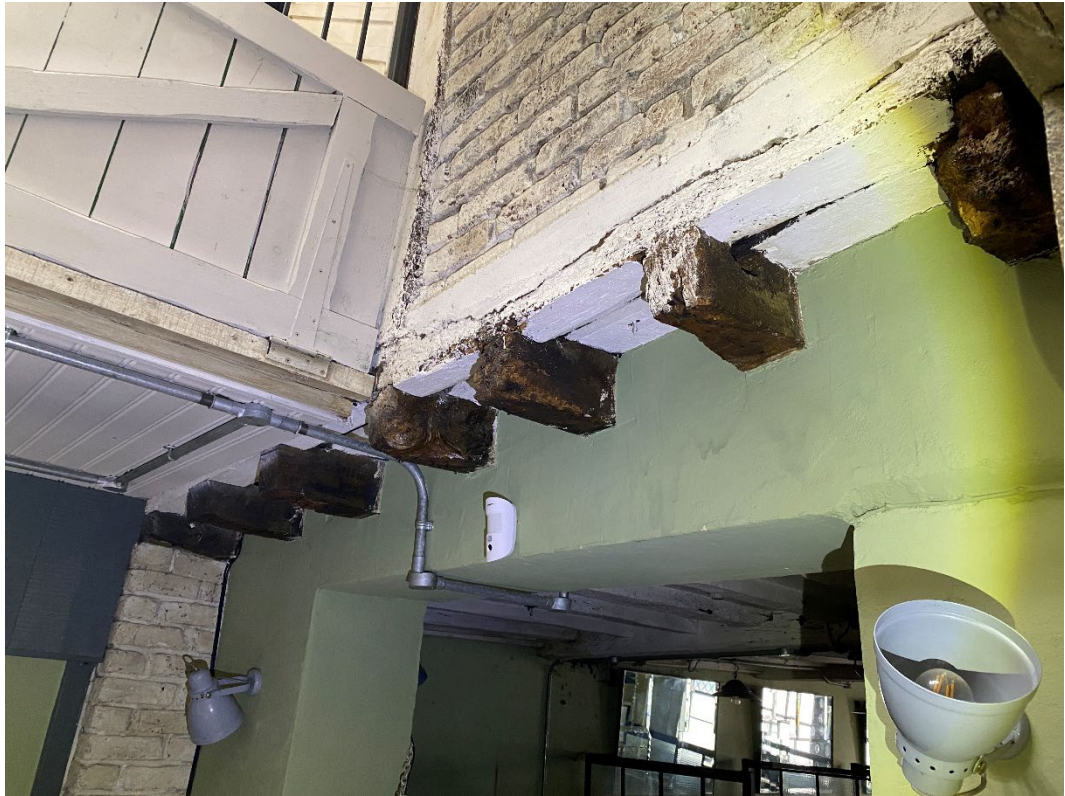
*Figure 16: Retained external jetty of the south western structure, probably 16<sup>th</sup> century, now enclosed within the central linking structure.*

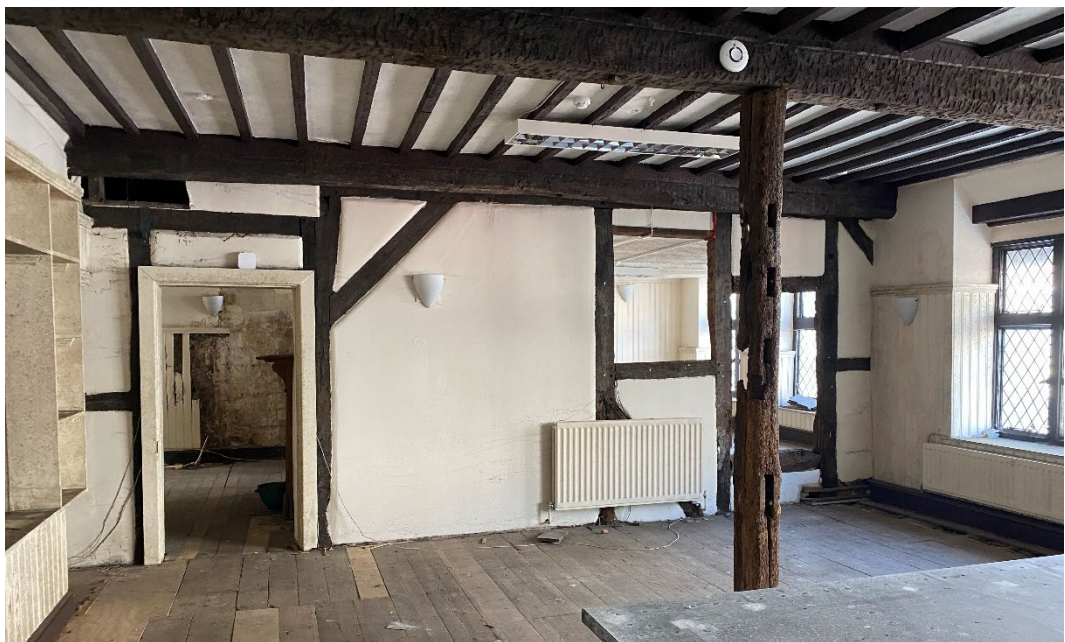
*Figure 17: an early structural wall with angled bracing between the main portion of the Castle Street range and the south western portion.*

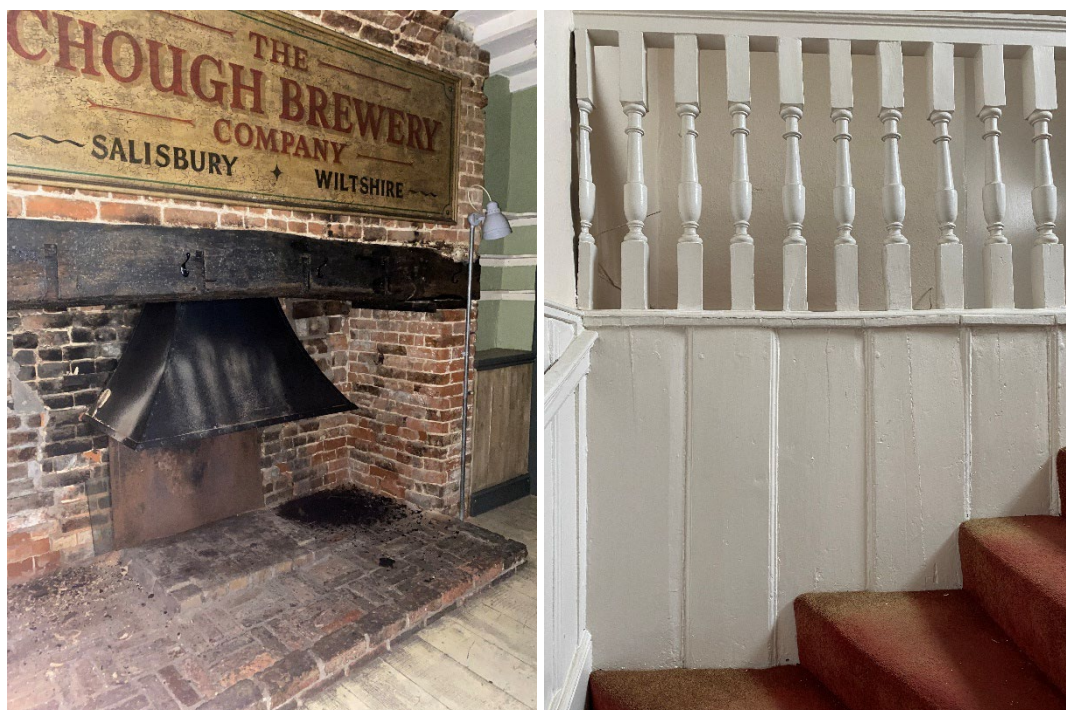
Figure 18-19: (Left) large open fireplace in the rear part of the eastern range; (right) stair balustrade and historic panellled wall at attic level.

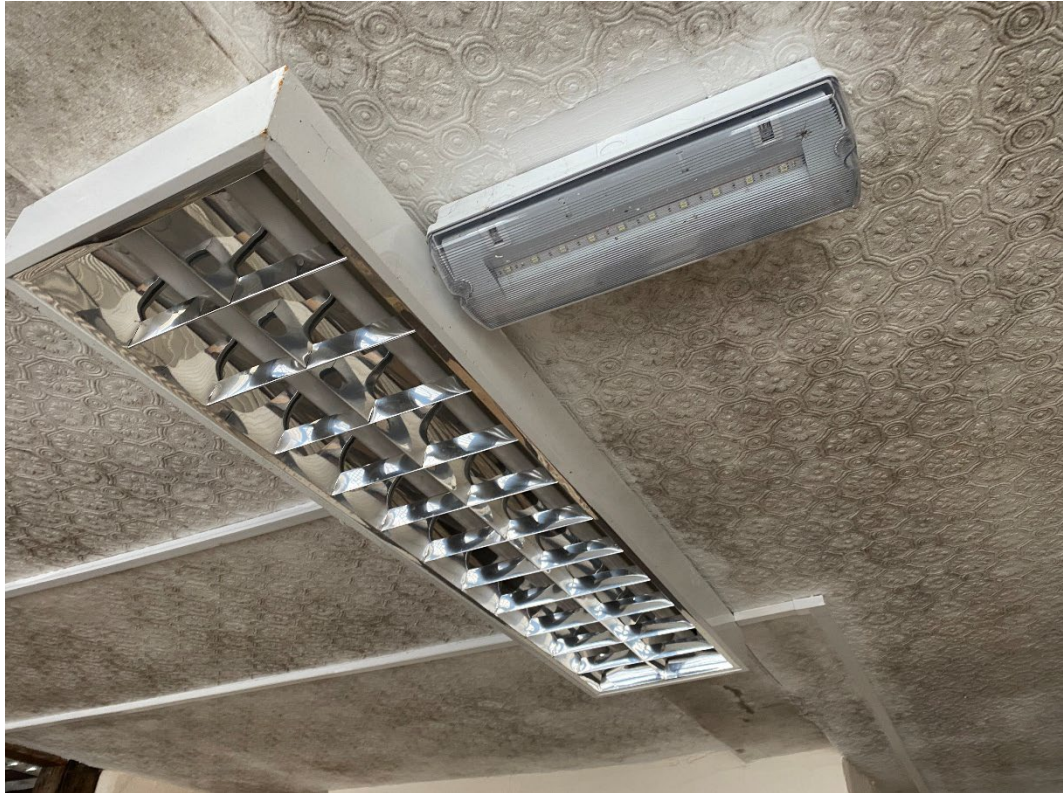
- 4.12** A more recent cluttered approach to surface mounted wiring, and general accumulation of mixed quality fixtures and fittings provides a degree of intrusive visual clutter which detracts from the period quality of the spaces. While surface mounting wiring over historic timber framing avoids physical impact on significant fabric, the approach taken appears in general to have been ad hoc and with little consideration of the aesthetic result.

*Figure 21: Relatively typical intrusive approach to surface mounted lights of multiple styles, plastic ducted wiring.*

- 5.6** It is proposed to re-wire the building, chasing wiring in to walls or ceilings wherever possible while avoiding those areas which retain historic timber framing. Any plaster walls that saw chasing in would be repaired and refinished in a like for like manner including utilising lath and lime plaster where necessary.

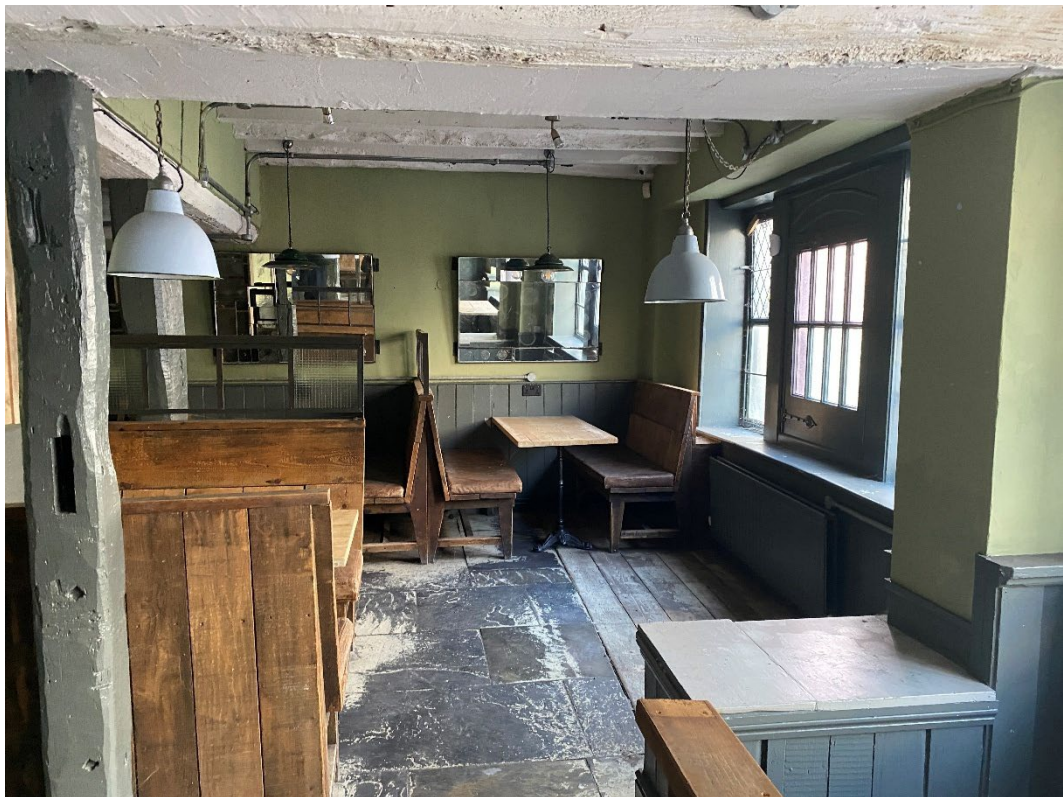
*Figure 22: Typical modern fixed customer seating can be changed with no effect on significance.*

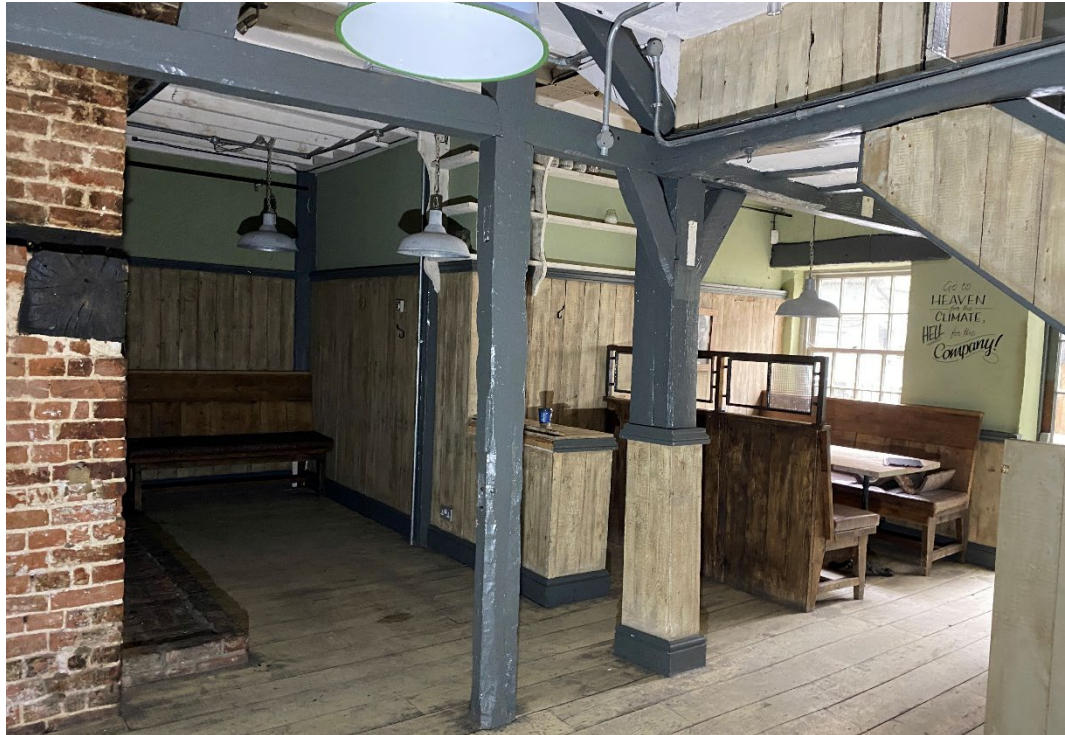
*Figure 23: The southern end of the western range, large stack on the left and in the centre the intruding fire escape compartment hard against the historic window. Removal will reinstate this floor plan.*

- 5.9** The only major structural work will see the removal of 20<sup>th</sup> fire escape stair which already intrudes into the historic planform of this part of the building as a detracting feature. Restoration of the floor deck accessed by the primary historic stair and restoration of the ground floor plan with a deep front to rear room depth is a distinct heritage benefit.

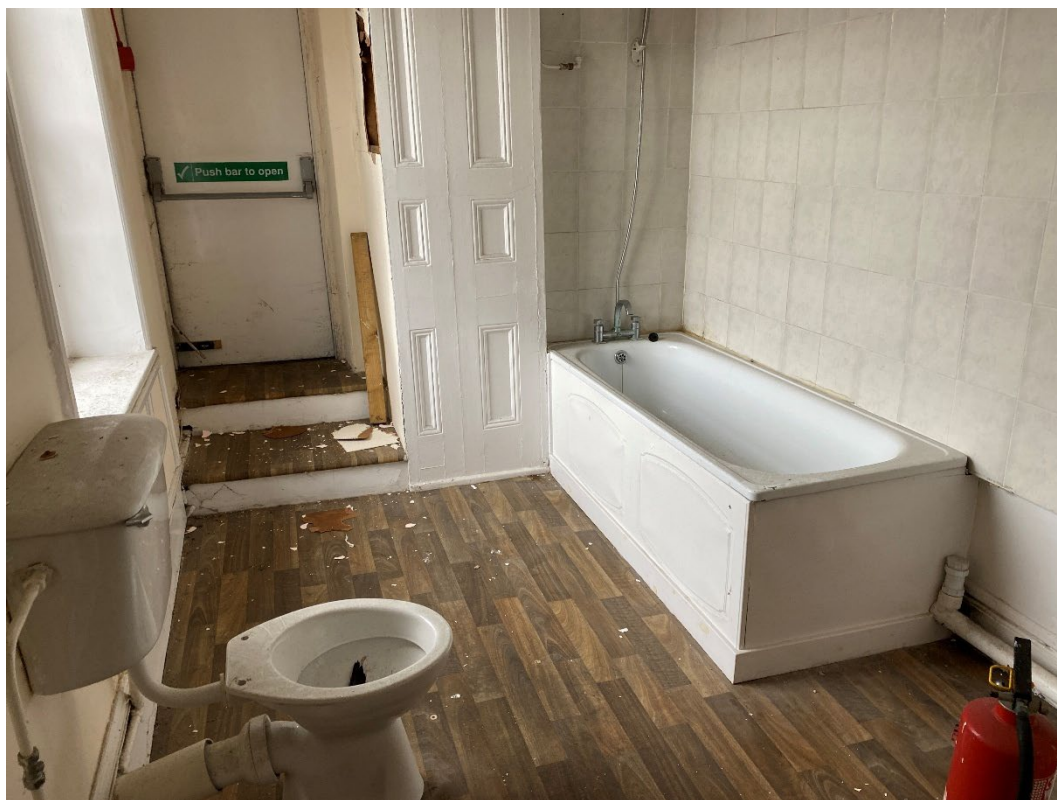
*Figure 24: second floor bathroom, a new wall proposed to divide the WC from the fire escape stair will not affect heritage values.*

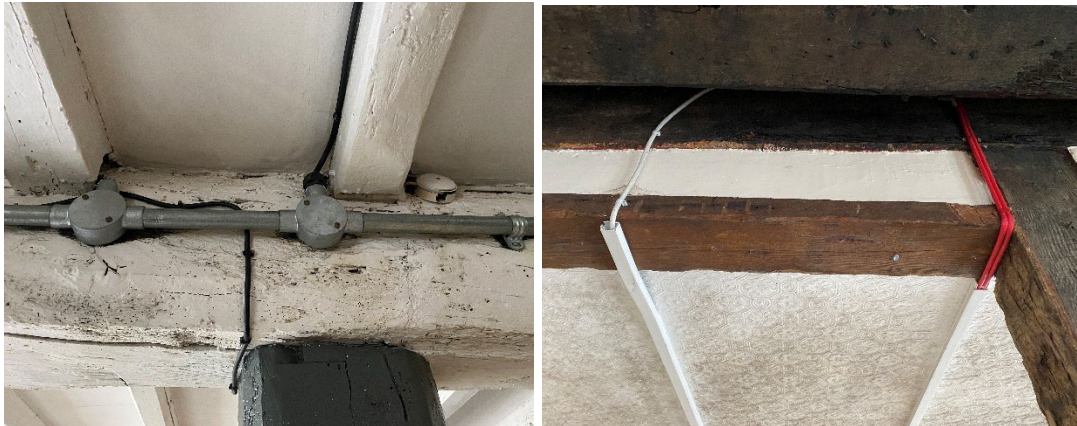
*Figure 25: surface mounted wiring avoids impact to timber frame, but a holistic approach to wiring the building utilising floor voids or some chased in wiring may avoid the need for any surface mounting, improving the aesthetic of the spaces.*

**5.12** The proposed re-wiring offers distinct opportunity to enhance the aesthetic appearance of the building over the most recent finish. The opportunity presented is to take a holistic approach to the re-wiring. Areas of sensitive timber framing can still be avoided, but where possible, wiring could be chased into plaster work and made good in a like for like manner. This would avoid the ad hoc approach currently in the building where some wiring is mounted exposed, some is in plastic ducting, some in metal, all of it appears run without any sense of holistic approach.
