Sparrow Farm, Wiltshire  
Preliminary Roost Assessment (PRA)  
*For James Bloomer*

23<sup>rd</sup> March 2026

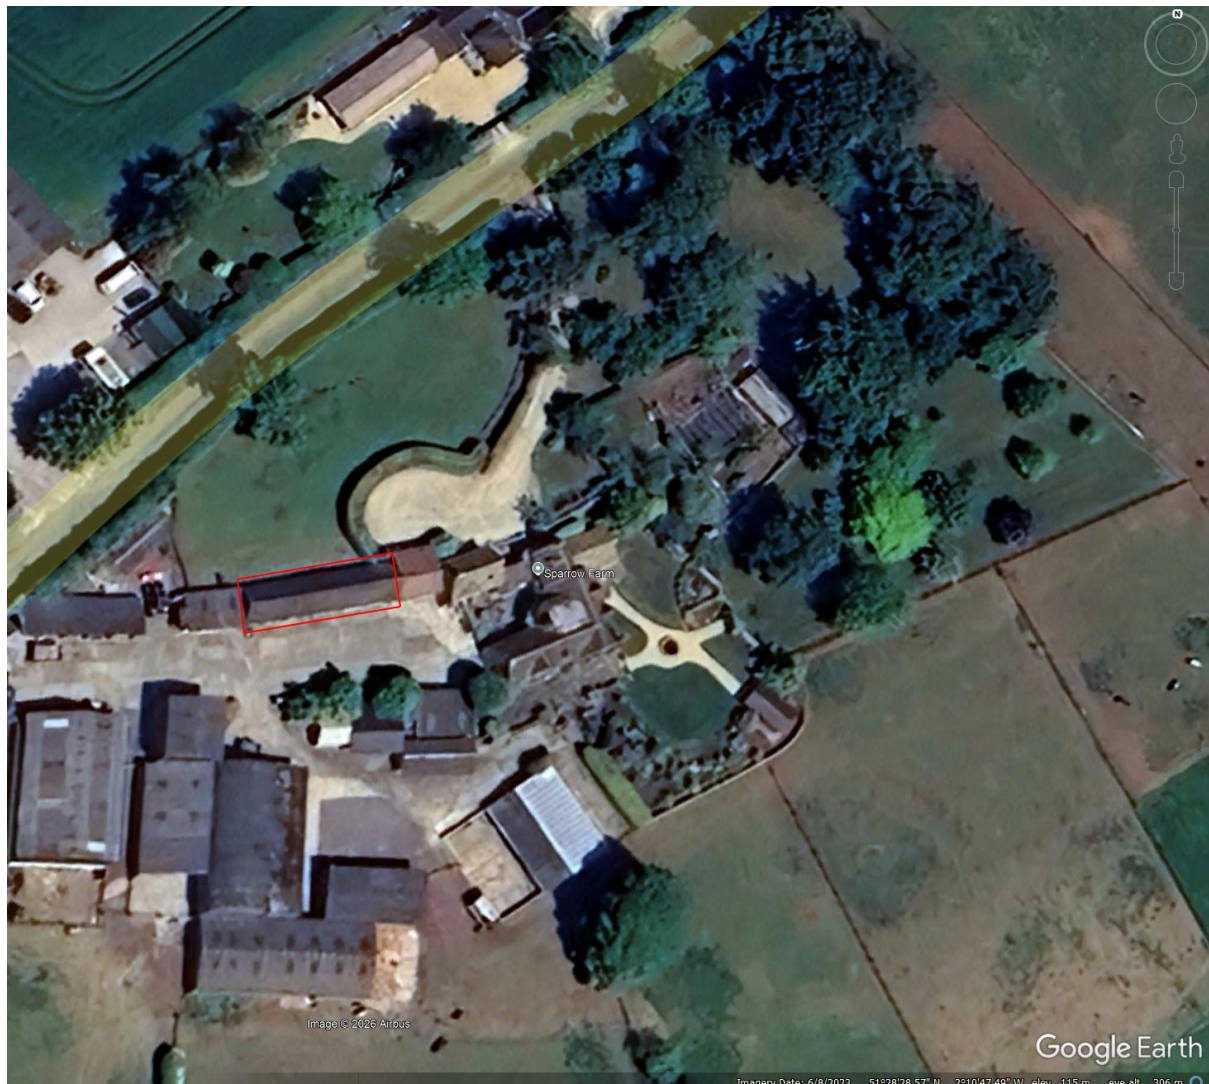
*Figure 1: target building & red line boundary (Google Earth Pro latest imagery 06/08/2023)*

There is an access road hardstanding area to the south of the building, and to the north there is an area of semi-improved grassland (mown and managed) and a hedge. The wider landscape is primarily agricultural with areas of hedgerow, woodland, grassland, wood pasture and parkland, some residential properties, and the A420 approximately 300m to the south.

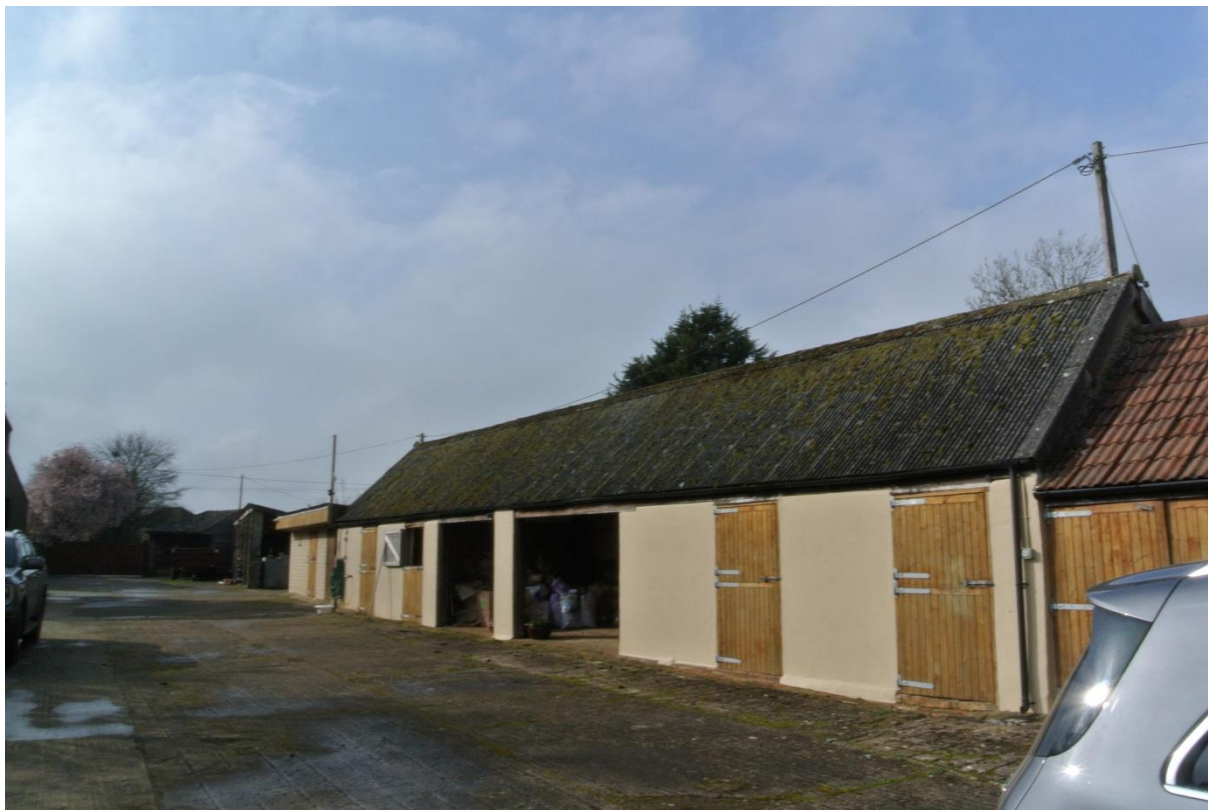
*Photograph 1: showing external view of the target building (facing north-west)*

The external walls of the target building are constructed primarily from stone with a concrete block upward extension, and the walls have been rendered on the southern side. These external walls are intact with no visible cracks or gaps where bats could gain access for roosting.

The external roof is constructed of corrugated cement sheets, with some areas covered in moss and lichen, suggesting that it is wet. There are no sections of the roof that had lifted or appeared loose from a ground-level inspection; however, there is a gap to the east at the apex of the gable where the roof overhangs the end wall of the building.

No evidence of bat activity was found on the external area of the target building to indicate that bats are using these areas for roosting.

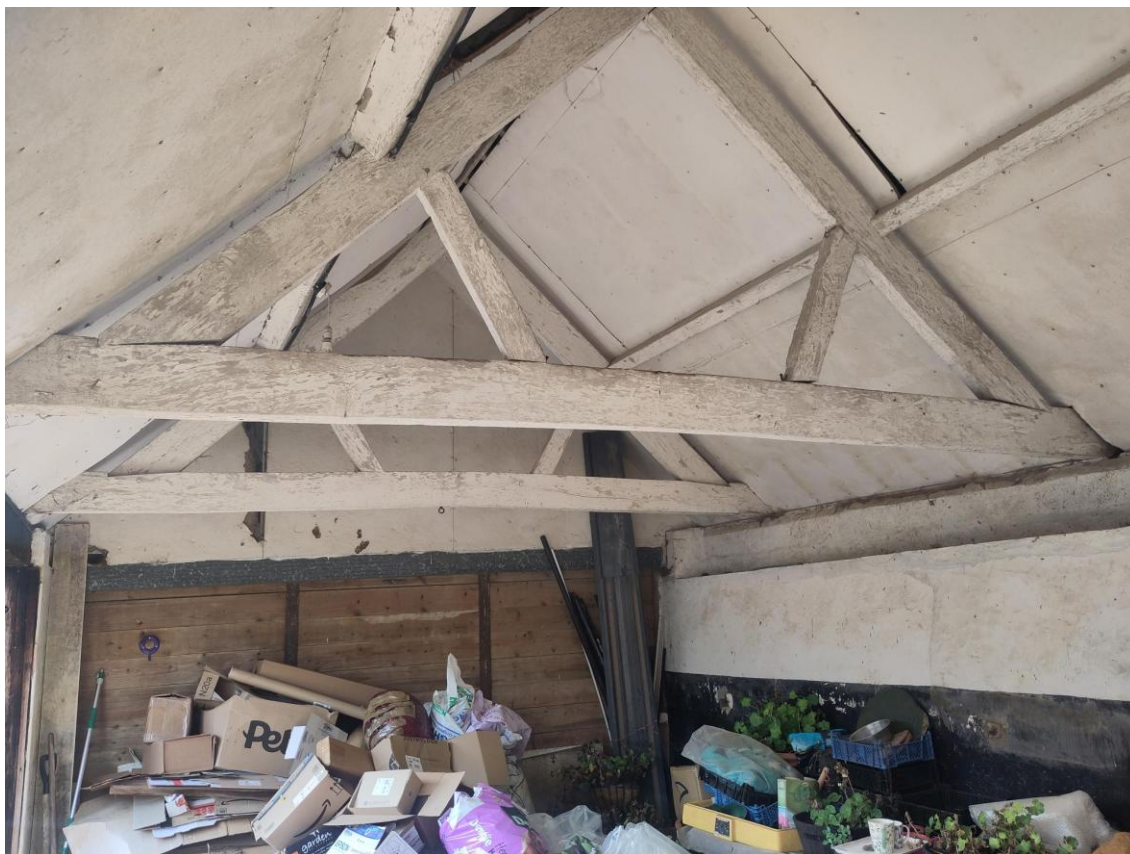
*Photograph 2: showing an internal view of the target building (facing west)*

The internal roof structure of the building is constructed from a traditional timber frame that has been painted. The ceiling is comprised of painted plasterboard panels, some of which are broken and have gaps exposing the single layer of corrugated cement sheets above. The plasterboard ceiling panels and timber frame shows signs of damp and mold, indicating water ingress from the cement sheets above making them unsuitable for roosting bats that require dry and stable conditions for roosting.

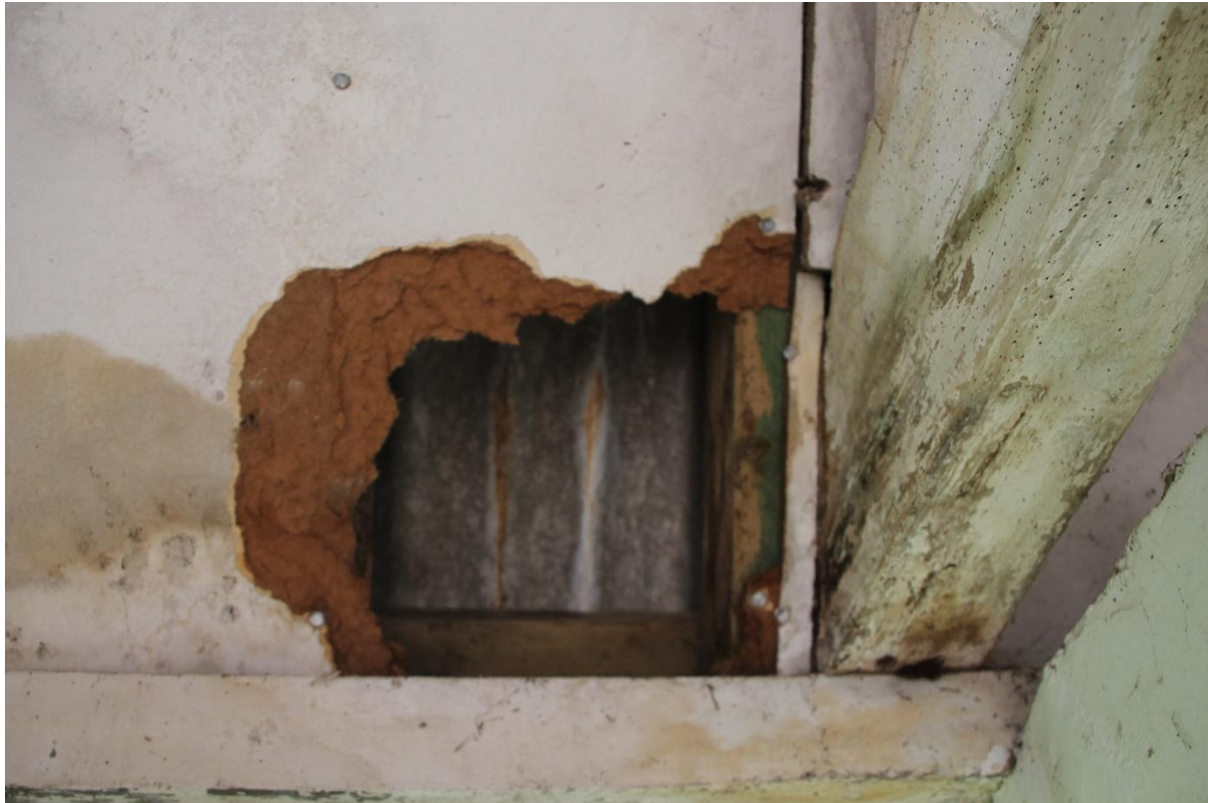
*Photograph 3: showing gap in a ceiling panel within central garage area*

These plasterboard walls had some large cracks and gaps. There is clay brick flooring throughout the building, and at the time of the survey, all the building areas were being used for storage.

In addition, the presence of dense areas of cobwebs in the plasterboard panel gaps suggests that these are not used by bats to access the roof space.

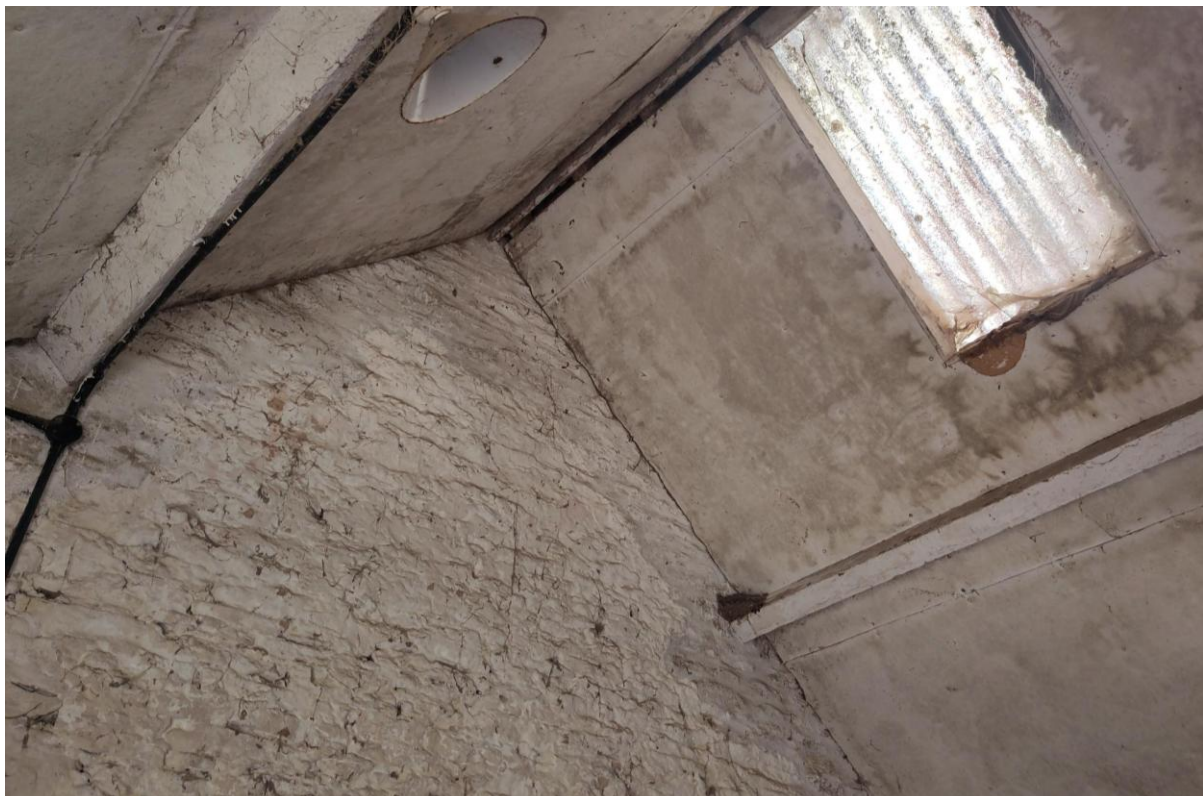
*Photograph 4: showing an old birds' nest in the stable area, most likely barn swallow*

At the time of the survey, bird foraging activity in the immediate area of the site was minimal; however, a robin *Erithacus rubecula* was seen and heard on the roof of the barn. No signs of active nesting were recorded during the survey; however, three old birds' nests were found in both stable areas and in the central garage area. Two of these appear to be barn swallow *Hirundo rustica* nests, while another is likely a wren *Troglodytes troglodytes* nest, based on the size, shape, nesting materials and locations.

Physical measures could be considered to prevent access for birds and deter nesting prior to the nesting season (i.e., from March) following best practice guidance. Old bird nests that are not in use can be removed outside of the breeding bird season.

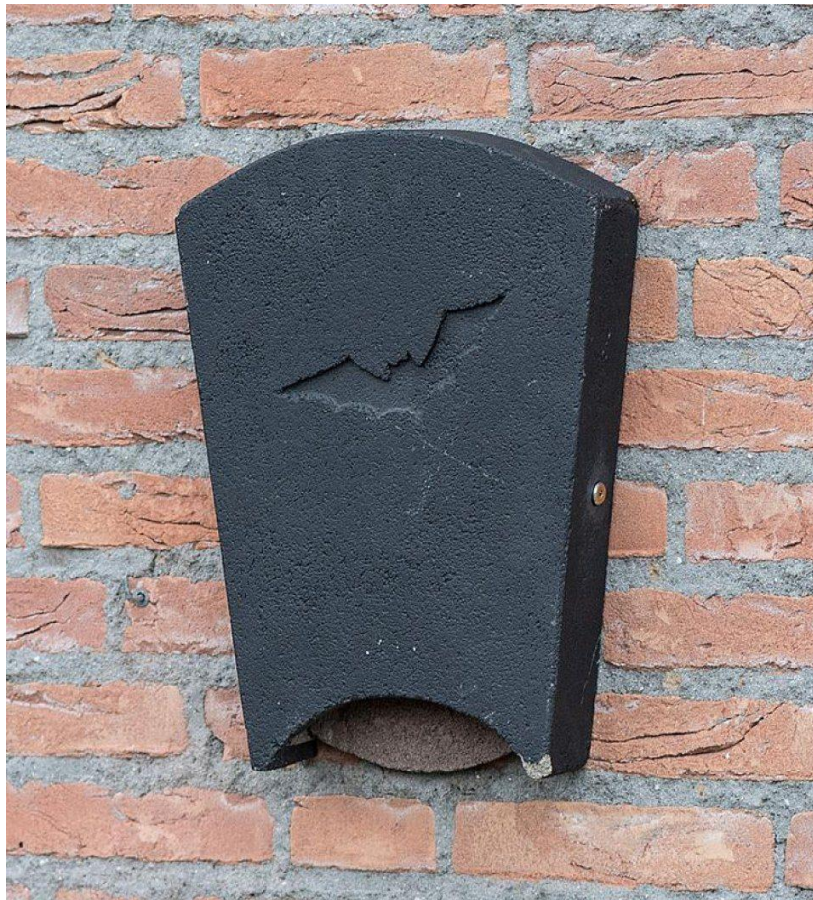
*Figure 2: showing a Beaumaris Woodstone® bat box*

This box is made entirely from Woodstone®, a robust material comprising concrete and wood fibres. This means that the box has excellent insulating properties maintaining a more consistent temperature throughout the year and provides excellent protection from predators. The Beaumaris box has a single narrow entrance, making it suitable for crevice-roosting bats such as common pipistrelle, soprano pipistrelle, Nathusius's pipistrelle, Brandt's bat and whiskered bat. The box's interior has a rough surface for bats to cling to and the front of the box features a subtle but attractive imprint of a bat in flight.

In addition to these avoidance and mitigation measures, to enhance roosting opportunities for bats, it is recommended that a Beaumaris Woodstone® Bat Box<sup>6</sup> is installed on the western gable of the target building.

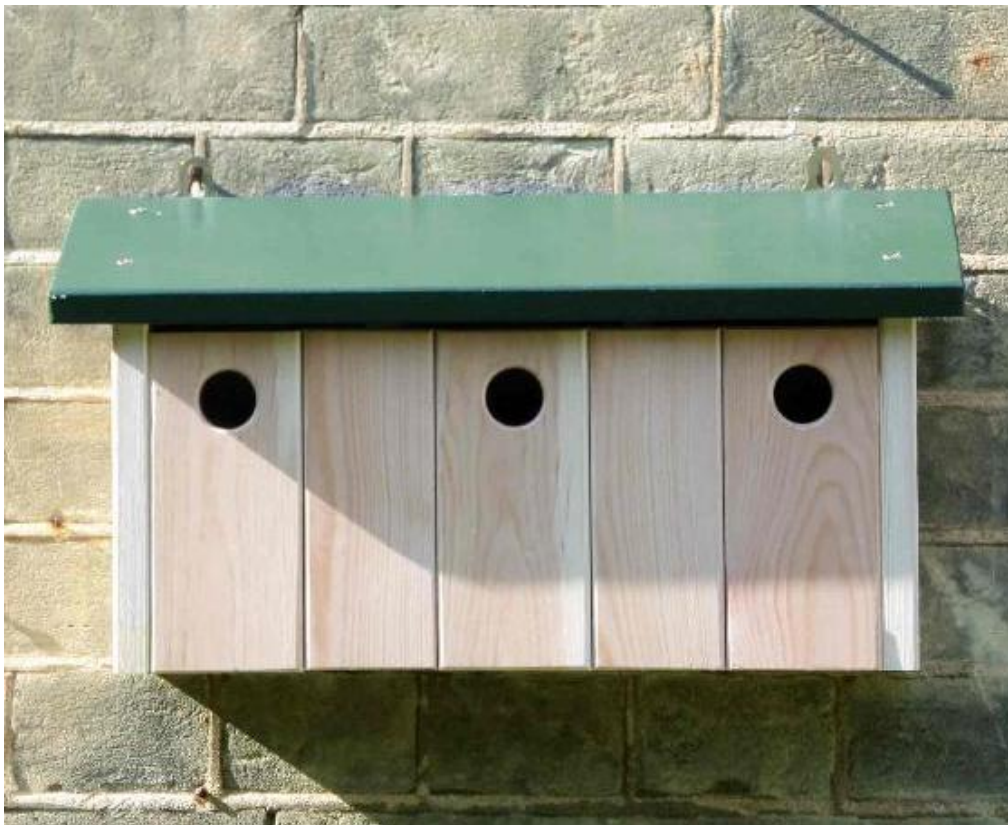
*Figure 3: sparrow terrace nest box (from RSPB website)*

The RSPB Sparrow Terrace Nest Box<sup>7</sup> with 32mm entrance holes is recommended. This box can fit three families of sparrow and is designed to prevent intruder birds from perching at the entrance. It is constructed of FSC-certified pine wood grown in the UK that contains natural resins that protects and preserves the wood. The pine wood and the design of the box also creates an internal environment that is well ventilated and insulated.

As such, it is recommended that a bird box for house sparrow *Passer domesticus* is installed on the northern façade of the building, which would provide nesting opportunities for this red-listed species of conservation concern.
