Reybridge Farm Sables  
Preliminary Ecological Assessment (PEA)  
*For CMS Architects*

14<sup>th</sup> July 2023

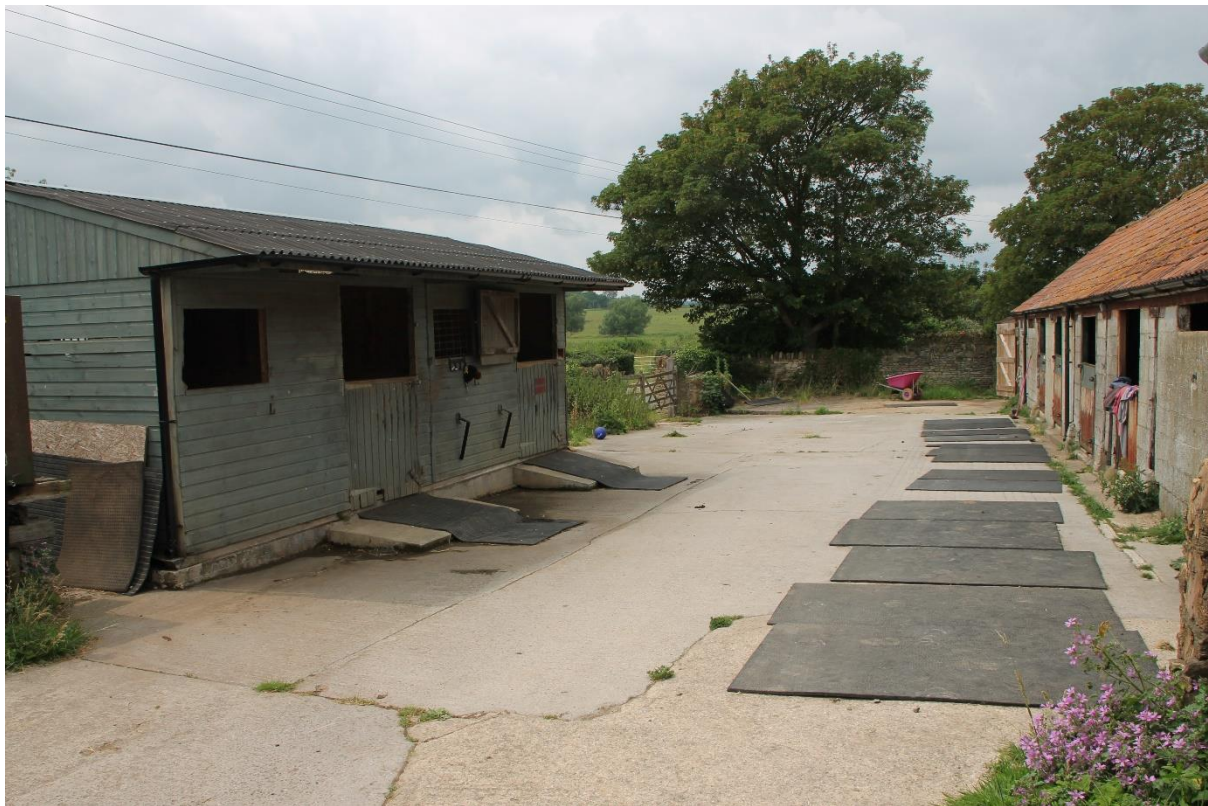
The main area of the site is dominated by hard standing which provides access to the buildings present and is used for car parking.

*Photograph 1: showing a view of the site*

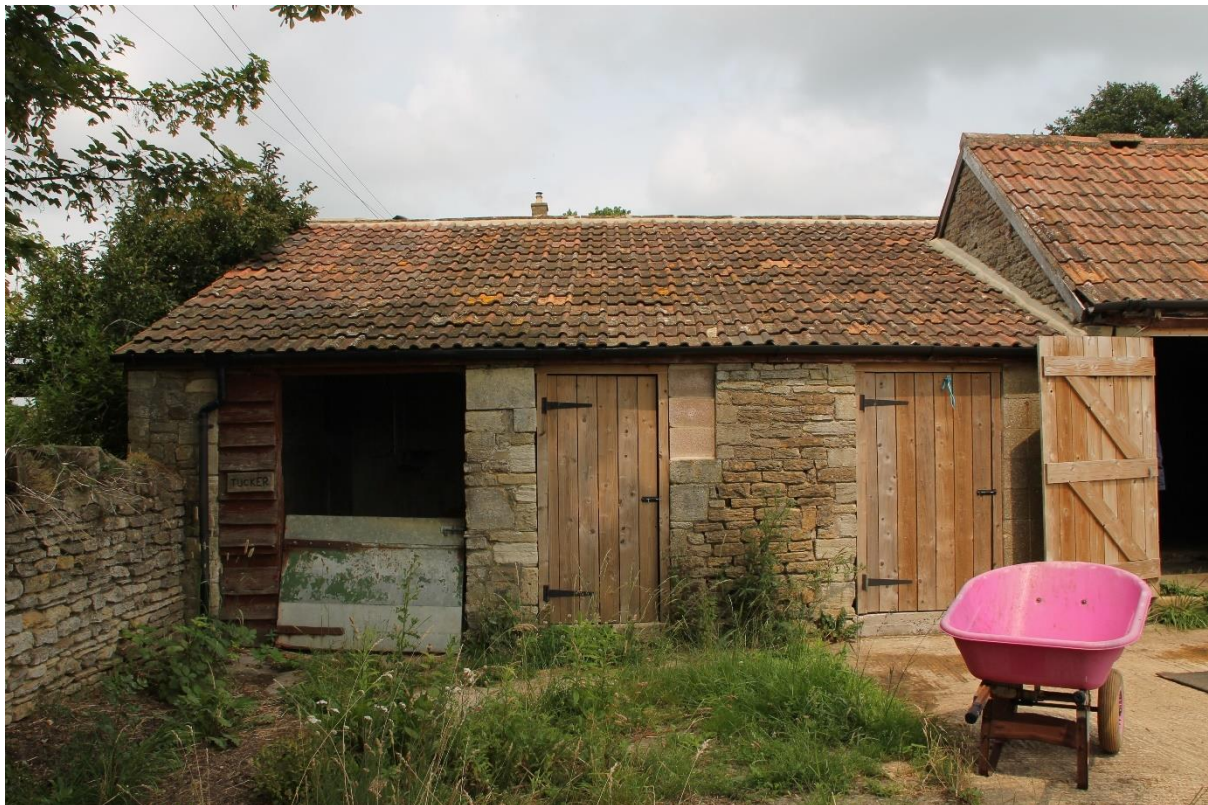
At southern boundary of the site there is a strip of ruderal vegetation along the boundary wall. Species present include perennial rye-grass *Lolium perenne*, yarrow *Achillea millefolium*, red valerian *Centranthus ruber*, willow herb *Epilobium* sp., ribwort plantain *Plantago lanceolata*, cock's-foot grass *Dactylis glomerata*, creeping buttercup *Ranunculus repens*, daisy *Bellis perennis* and dandelion *Taraxacum officinale*. Small patches of bramble *Rubus fruticosus* L. agg are also present.

A small area of ruderal vegetation is also present at the north-west of the site adjacent to the stable building.

*Photograph 2: showing a view of the ruderal vegetation*

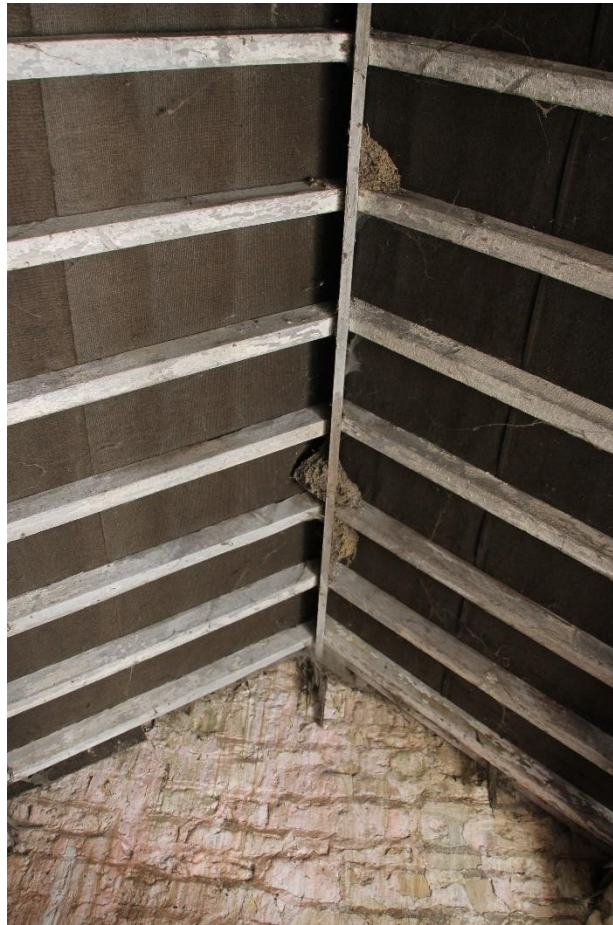
Evidence of swallow *Hirundo rustica* nests was found in the stable building, and these were active at the time of the survey.

*Photograph 3: showing the swallow nests within the stable building*

If works are undertaken within this period, a nesting bird survey would be required no more than 24 hours prior to the works. If nesting birds were found, these areas of the site would need to be protected from disturbance until the young have fledged naturally.

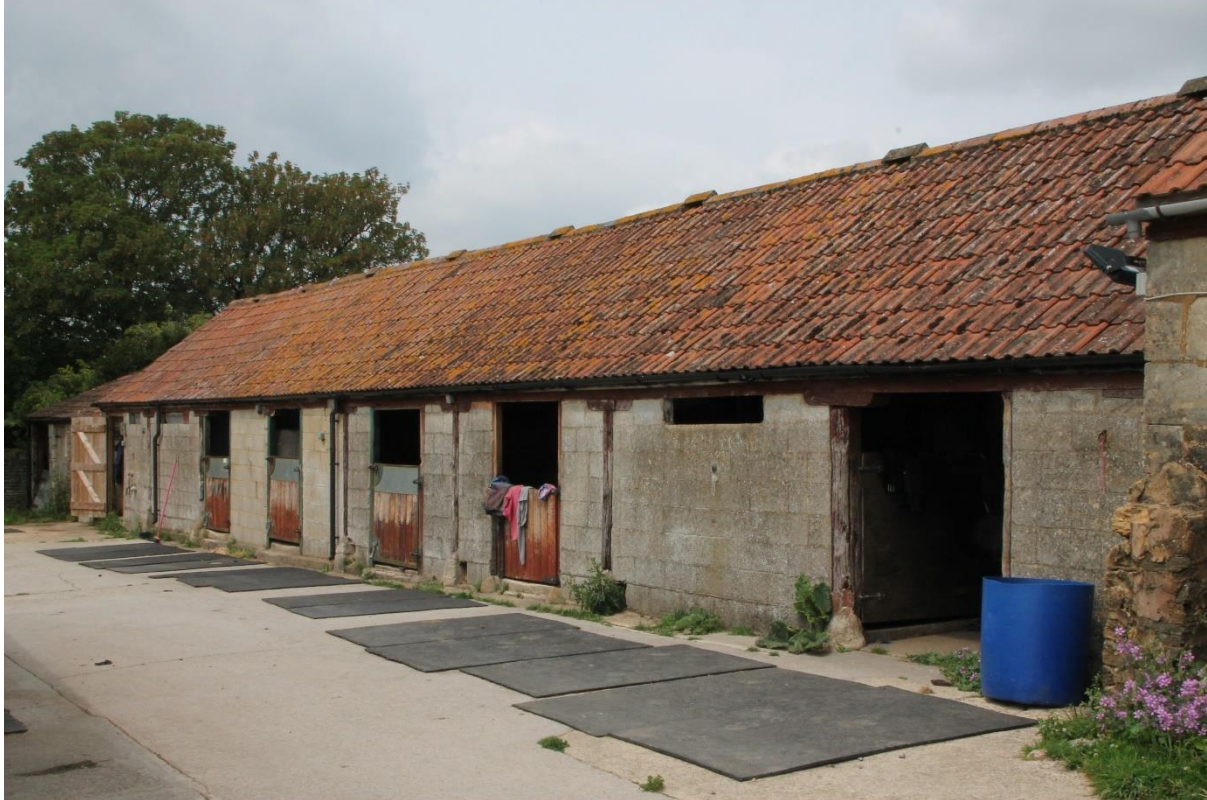
Building 1 is a block built, single storey stable block with a pitched, tiled roof along the northern boundary of the site. The building is 43m long by 5m wide and 3m tall; however, it is only proposed to develop approximately 32m of the building, with the remainder of the building continuing with its current use.

Externally the walls of the building were noted to be in a good condition with no areas of missing mortar where bats could gain access for roosting. No evidence of bat activity was found on the outer walls of the building during the survey. On the southern elevation of the building there are stable doors which are usually open and provide access to the internal spaces.

The roof of the building is covered with tiles on the southern side and by slate tiles on the northern side. These were noted to be in a good condition at the time of the survey, but a few slightly lifted tiles were found to be present on the northern side of the barn.

Internally the roof is lined with bitumen felt that was found to be in a good condition.

*Photograph 4: showing a view of Building 1*

The building is used for horses and for storage, and is regularly cleaned, meaning that any evidence of bat activity, such as droppings, would be regularly cleared.

No evidence of bat activity was found during the survey of Building 1; however, the roof structure does provide low roost suitability for bats and one dusk survey is recommended to confirm the presence/likely absence of bats.

A further survey for bats should be undertaken of Building 1 to confirm the presence/likely absence. A single dusk survey of the building should be undertaken during the optimal survey period, which is May to September, and in line with the Bat Conservation Trust guidelines.

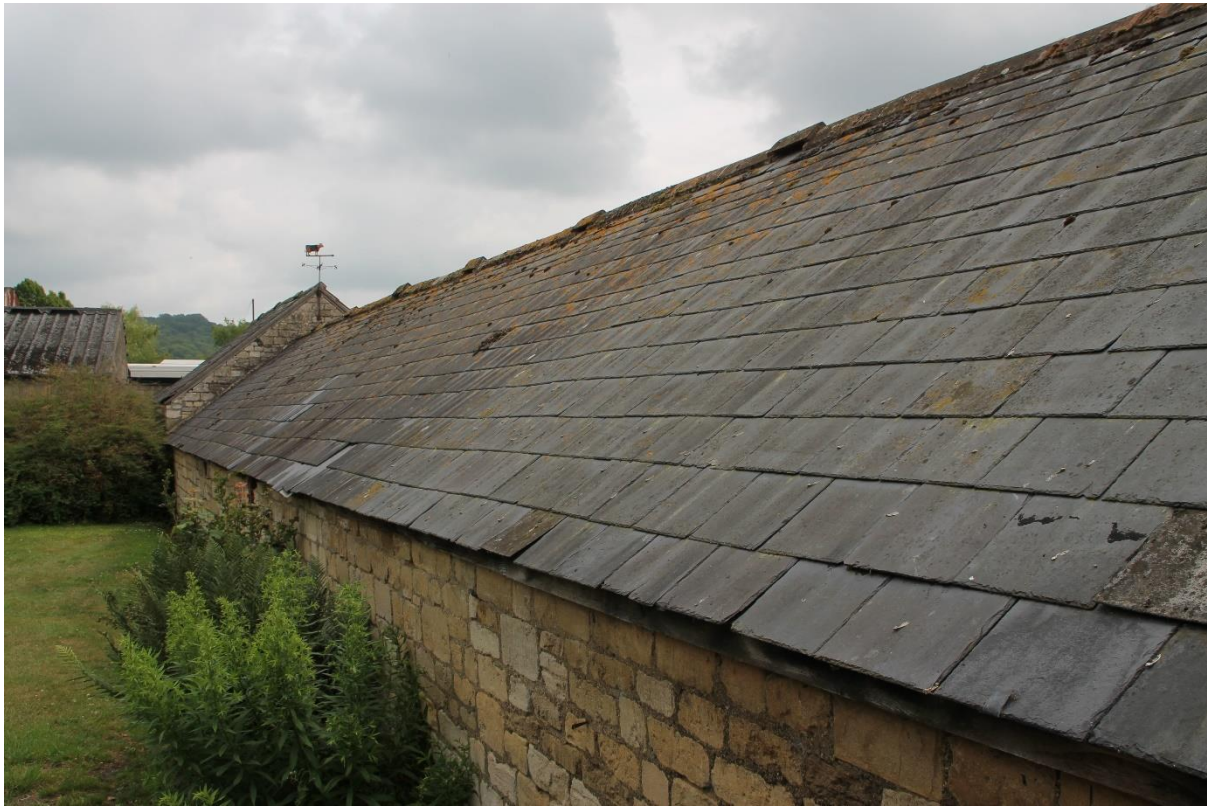
*Photograph 5: showing a view of the rear (northern) view of Building 1*

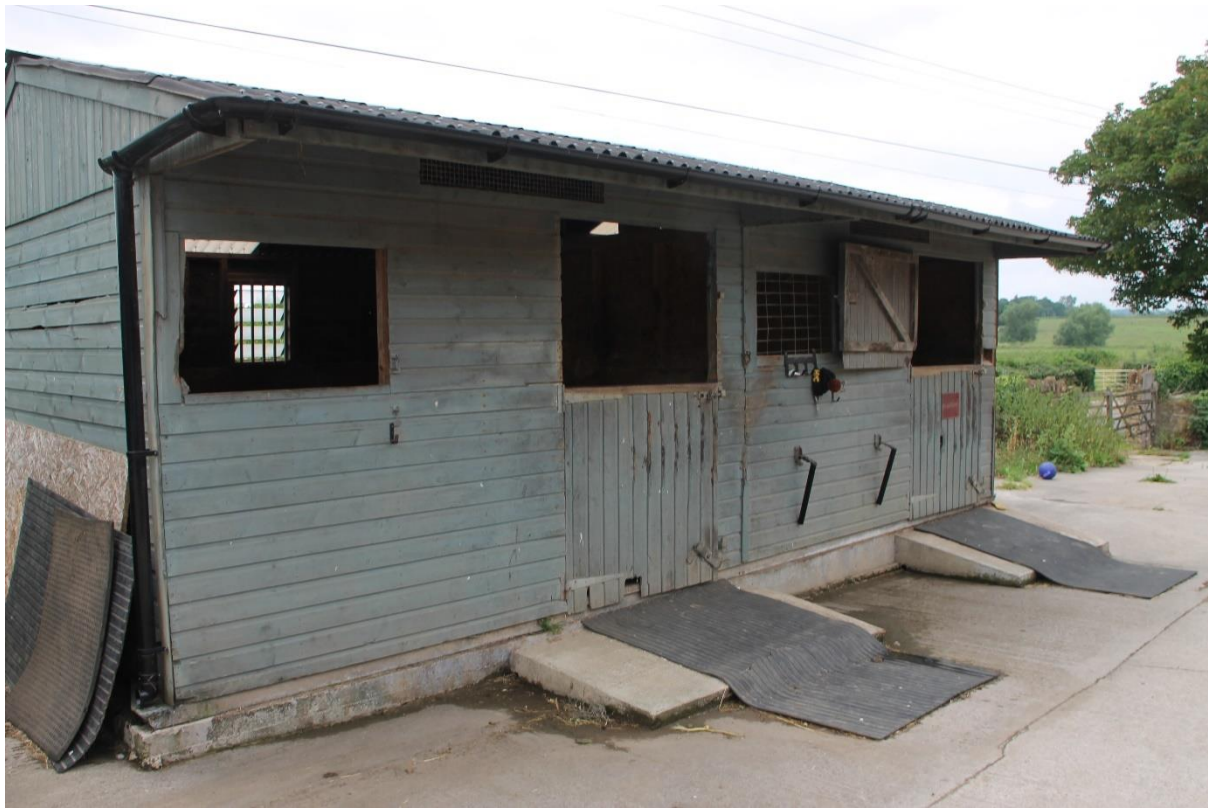
Building 2 is located along the south-eastern boundary of the site and is a wooden stable building approximately 8m long by 5m, wide with a pitched roof covered in corrugated sheets. The building was found to be open with windows and doors present on the north and south side.

The building was found to be limited in its suitability to support bats, with no opportunities for roosting in the walls of the building and no evidence of bat activity was found during the survey.

The roof structure of the building does not provide suitable roosting habitat for bats and no evidence of bat activity was found.

*Photograph 6: showing a view of Building 2*

Open windows and doors on the building will allow in wind and rain making the internal structure cold and damp and therefore unsuitable for roosting bats that require dry and stable conditions for roosting. The building does not provide suitable roosting habitat for bat species.

It is therefore assessed as providing Negligible Roost Potential and no evidence of bat activity or roosting bats was found during the survey. Internally and externally, there was no evidence of roosting bats in the building, and it is considered unsuitable for roosting bats. No further surveys for bats are recommended for Building 2.
