# Bat Emergence and Re-Entry Survey

**7 Stoke Mead, Limply Stoke, Bath,  
Somerset  
BA2 7GX**

**This report is prepared to inform a planning application for the proposal described as erection of single storey rear extension, along with demolition of existing extension.**

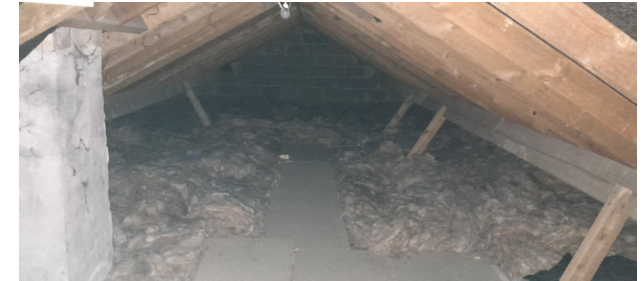
**Figure 1a:** Loft Void

Loft space was measured to be 1.6m in height and lined with bitumen felt appearing in good condition with only a few gaps and tears present. No droppings were recorded nor other any evidence of bat roosting activity. No light spill from the eaves. Temperature was recorded above 25 degrees celsius with high humidity levels. The loft was consistent with the photos shown in the PRA. Site inspection was conducted by Georgina Rennie, BSc (Hons), MSc. CL17 Bat Survey Licence at BCT Level 2 competence.
