PRELIMINARY ECOLOGICAL APPRAISAL AND  
BAT SURVEY REPORT

CLEEVE ROCKS, MIDFORD LANE, WILTSHIRE

stark ecology<sup>ltd</sup>

JUNE 2026

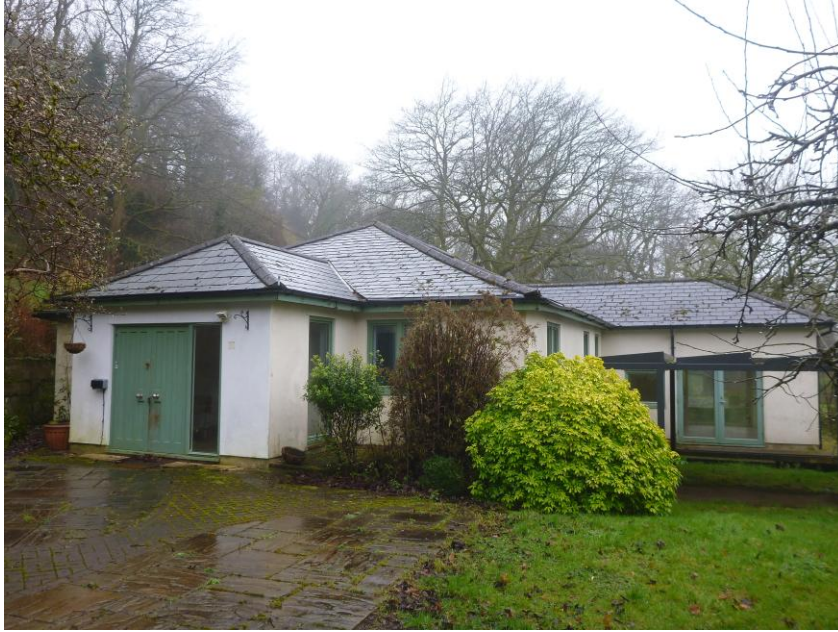
The house is a single storey property which has rendered block walls and a slate roof which is lined with a breathable membrane. The property had been unoccupied for a period before this survey was undertaken in February 2025 and there was evidence of damp throughout (including areas of mouldy breathable membrane lining the roof).

**Fig 4:** The house at Cleeve Rocks is a single storey property with rendered block walls and a slate roof.

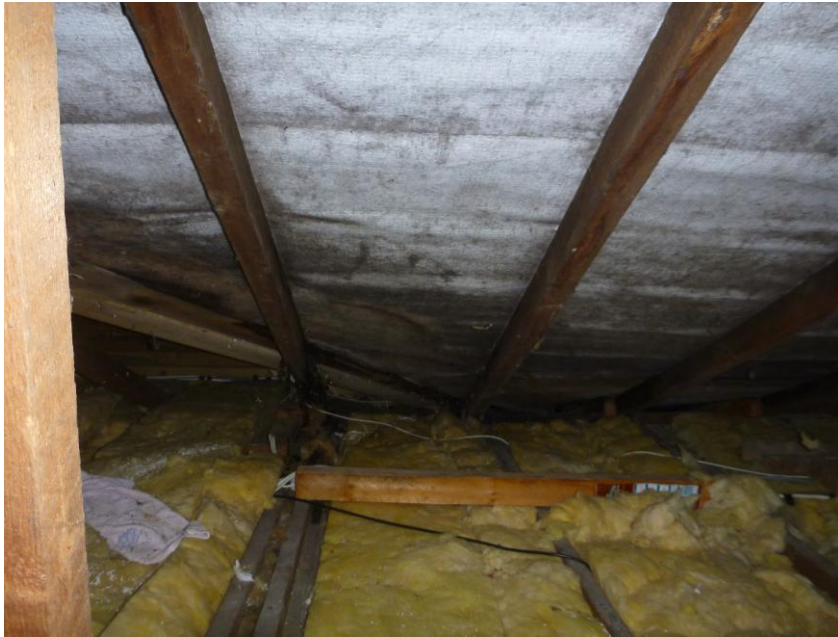
**Fig 5:** The property suffers from damp, which has caused some of the breathable membrane lining the roof to go mouldy.

A small number of crevices were noted in the roof of the house and these could be used by roosting bats, although their suitability for this purpose is diminished by the extent of the damp which has started to degrade the membrane which lines the roof.

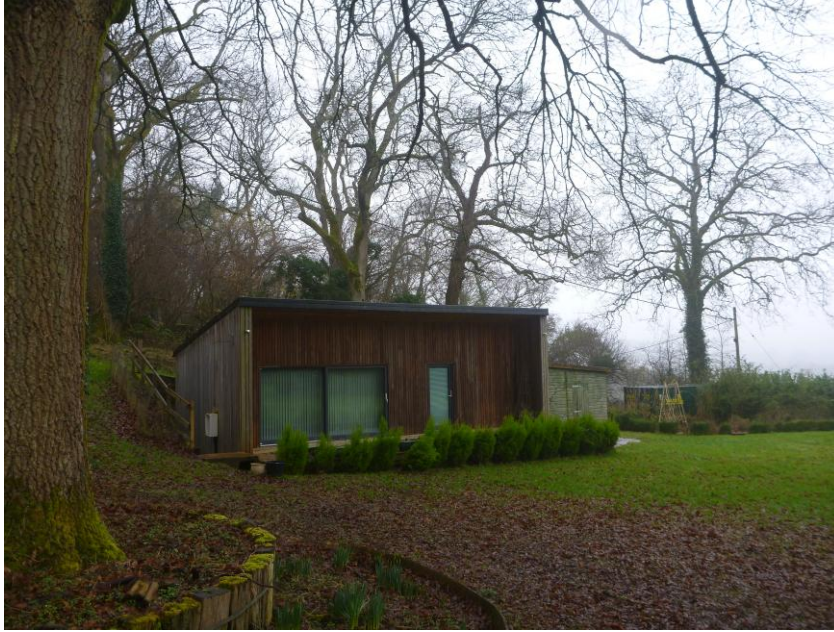
In the western part of the garden is a purpose-built studio building which has a timber frame and is clad with timber. The building includes no enclosed void spaces and is fully converted to the mono-pitch roof.

**Fig 6:** A purpose-built studio in the western part of the garden of Cleeve Rocks.

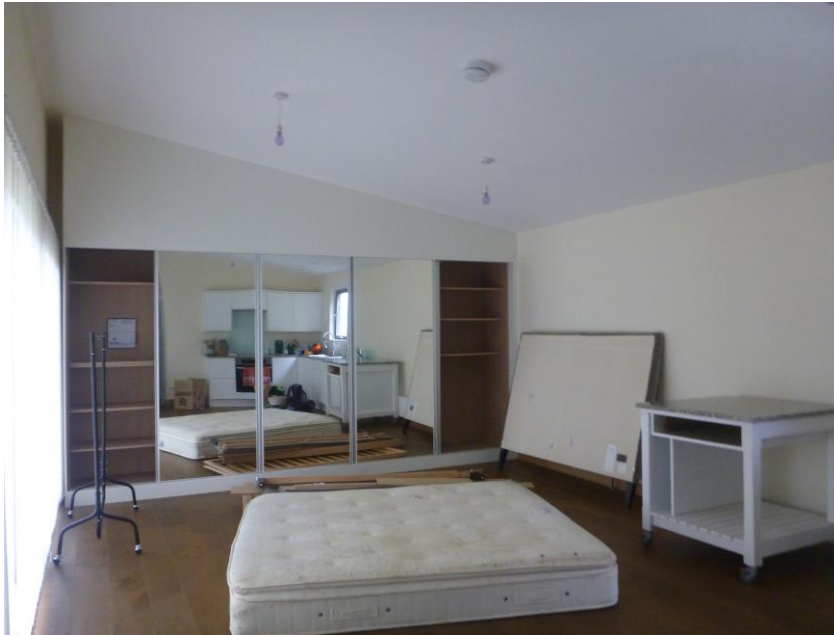
**Fig 7:** The studio is fully boarded internally, leaving no enclosed void spaces.

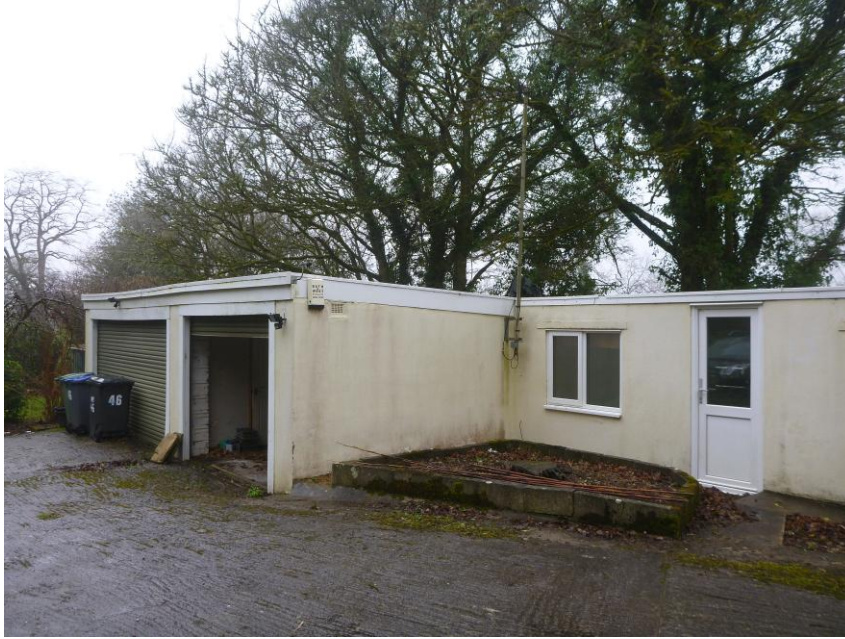
At the eastern end of the site is a single storey garage/store/office building which has rendered block walls and a shallow, mono-pitch roof. Doors and windows are uPVC and are kept closed and secured.

**Fig 8:** The garage/store/office building at the eastern end of the site.

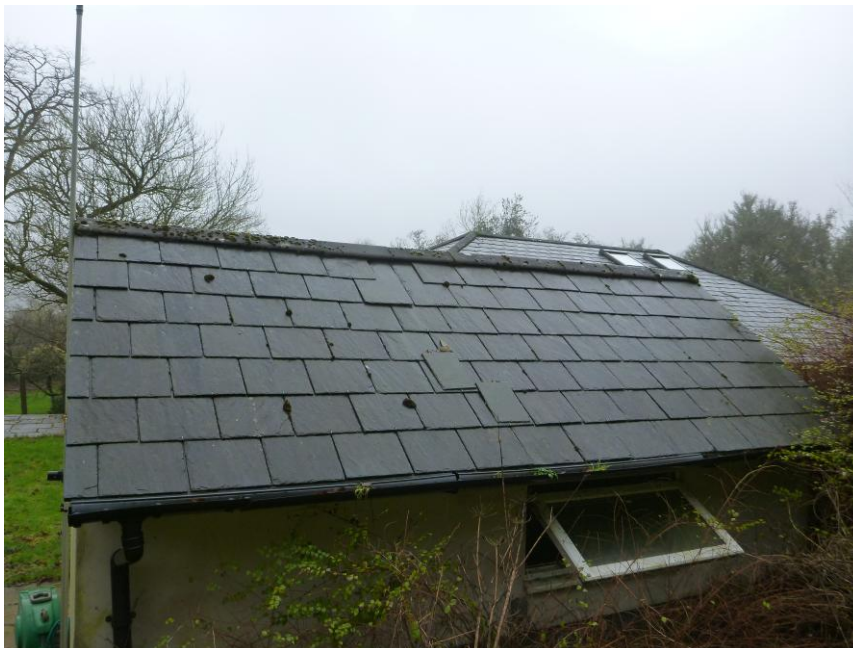
The Pool Building is of the same construction as the house (rendered block walls with a slate roof that is also lined with breathable membrane).

**Fig 9:** The pool building has the same construction as the house.

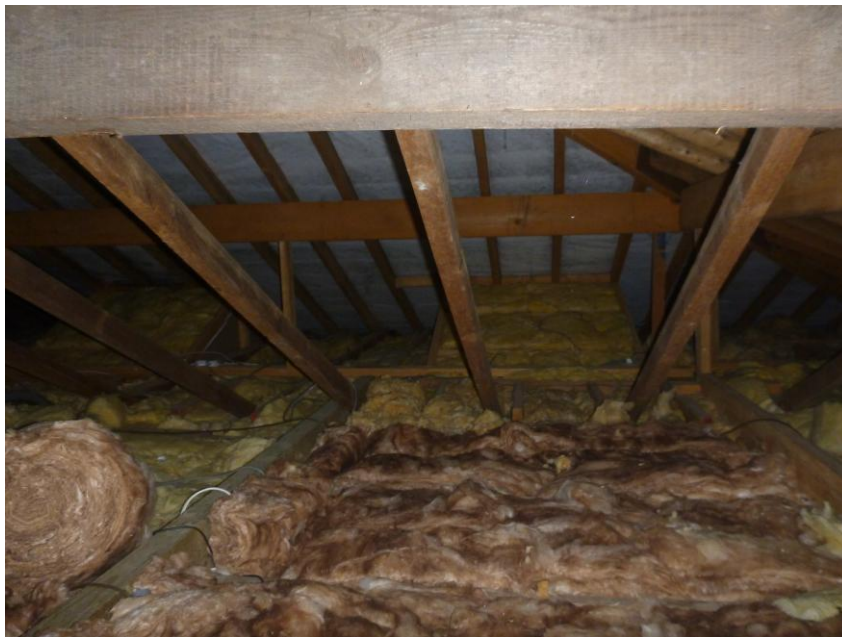
Internally no evidence of bats roosting in the house was found. All areas of the loft space were accessible to the surveyor and no droppings, feeding remains or other evidence of bats was identified, including on top of roof timbers, on the fibreglass insulation or below it.

**Fig 10:** All areas of the loft space of the house were accessible and no evidence of bats was found.

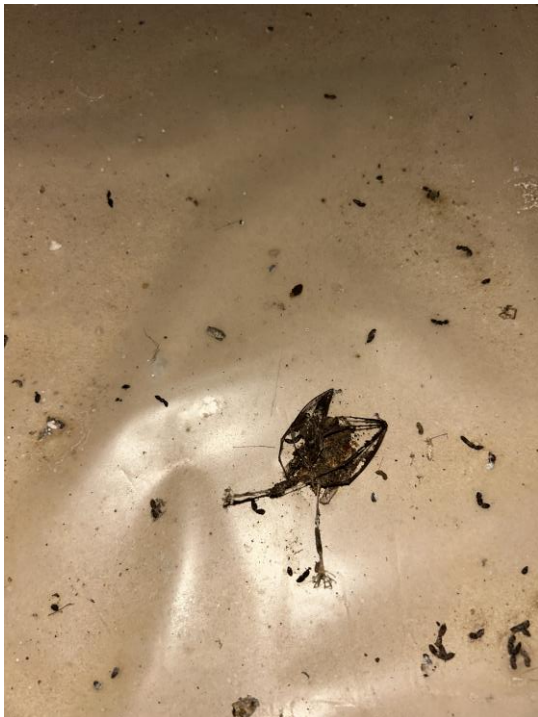
The Pool Building was not accessible during visits to site in February and July 2025 but access became available in August 2025. At this time a full building inspection was undertaken and evidence of lesser horseshoe bats was found in the loft space of this building. Droppings (c.500 in total) were scattered throughout the loft space of the building and a sample was collected and sent for DNA analysis to confirm species identification. The skeletal remains of a lesser horseshoe bat were also found in the loft space.

**Fig 11:** The skeletal remains of a lesser horseshoe bat were found in the loft space of the Pool Building in August 2025 and scattered droppings from lesser horseshoe (identified through DNA analysis) were noted throughout the loft space.

An application to Natural England for a licence can be made once any necessary planning permission has been granted and all conditions relating to wildlife have been discharged. When the licence is granted, and before any work to the Pool Building is carried out, the ecologist will carry out an inspection survey of this area of the property, looking for any evidence of lesser horseshoe bats using the building at this time. If none are visible the doors, windows and any other features which could provide fly-in access to the building will be blocked and a static detector will be left in the building overnight. If the detector has recorded no bat activity within the building the following morning work can go ahead to demolish the building immediately. If bat activity within the building is detected further steps to exclude horseshoe bats will be taken and a second night of static monitoring completed. Demolition of the Pool Building will not commence until the ecologist has confirmed that lesser horseshoe bats have been excluded.

A replacement bat loft will be created in the new dwelling at this site to replace the night roost in the Pool Building which is to be lost. The bat loft will be in an enclosed void on the northern aspect of the new dwelling and in a location which will not be disturbed by light spill or any other human activity.
