# Sandyrood, Giles Lane, Landford, SP5 2BG.

## Preliminary Roost Assessment (PRA)

Date: 06/06/26

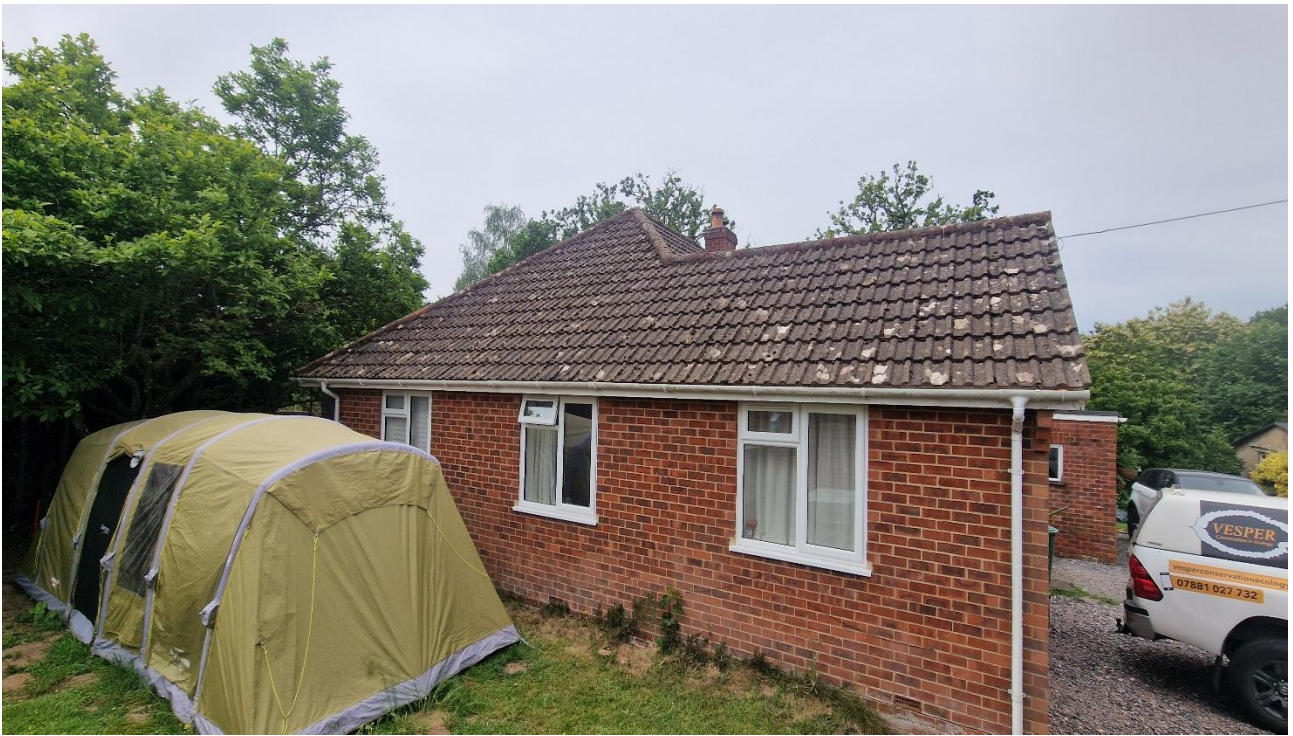
**Picture 1:** The front of the property

- 3.2 The site comprises a detached dwelling with an attached single-storey garage structure beneath a flat roof.
- 3.3 The main roof is clad with interlocking machine-made tiles. The covering was observed to be generally tight and well maintained throughout, with no lifted tiles, open joints or other defects likely to permit bat ingress.

- 3.4 The roof ridge is finished with cement-bedded ridge tiles, which appeared sound and intact at the time of survey, with no obvious cracks, voids or missing mortar that would be likely to provide access into the roof structure.

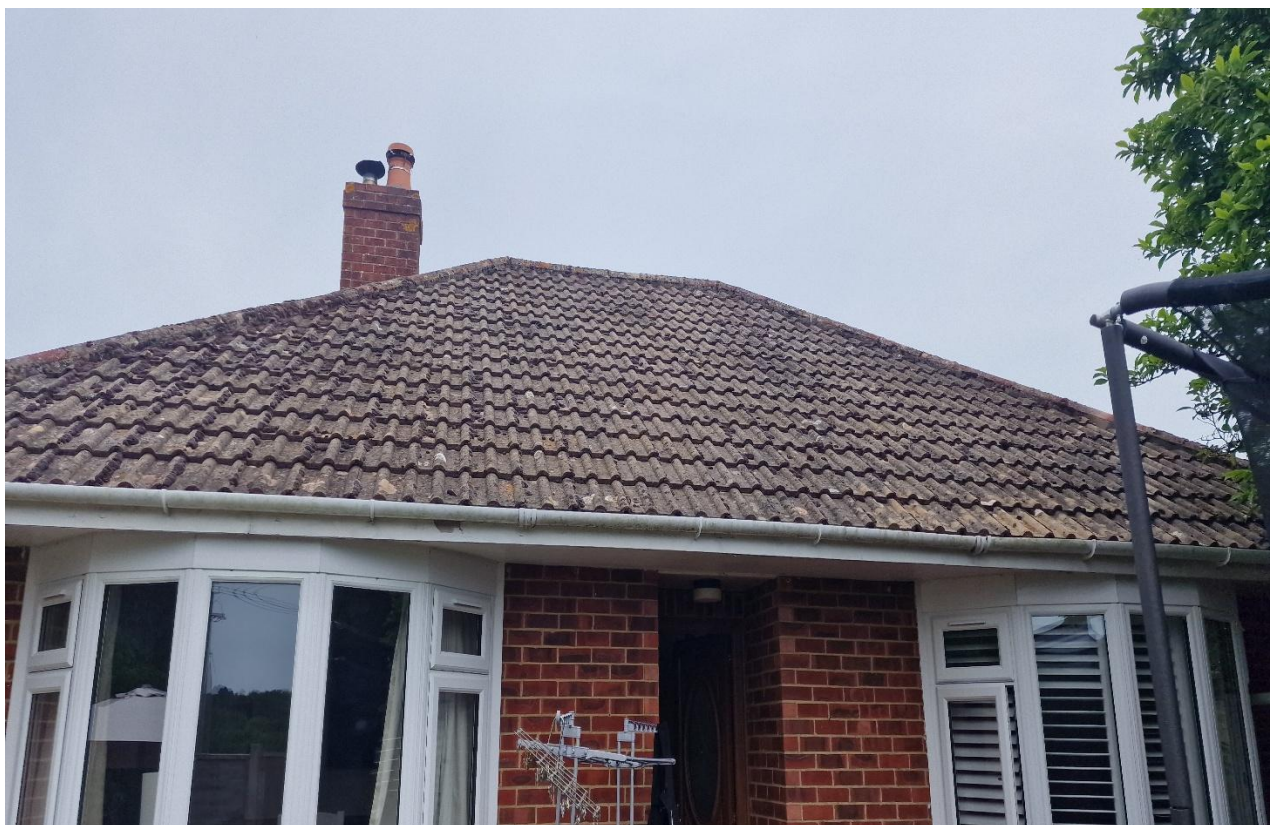
**Picture 3:** The side elevation of the property

- 3.6 The tile verges were observed to be tight and intact, with no discernible gaps or openings likely to provide access for bats.
- 3.7 The main house has enclosed timber eaves, while the garage is finished with timber bargeboards. No obvious gaps, lifted sections or defects were identified within these features that would be likely to provide access for bats.

- 3.8 All windows and doors were observed to be close-fitting, with no obvious gaps or openings around the frames that would be likely to permit bat ingress.

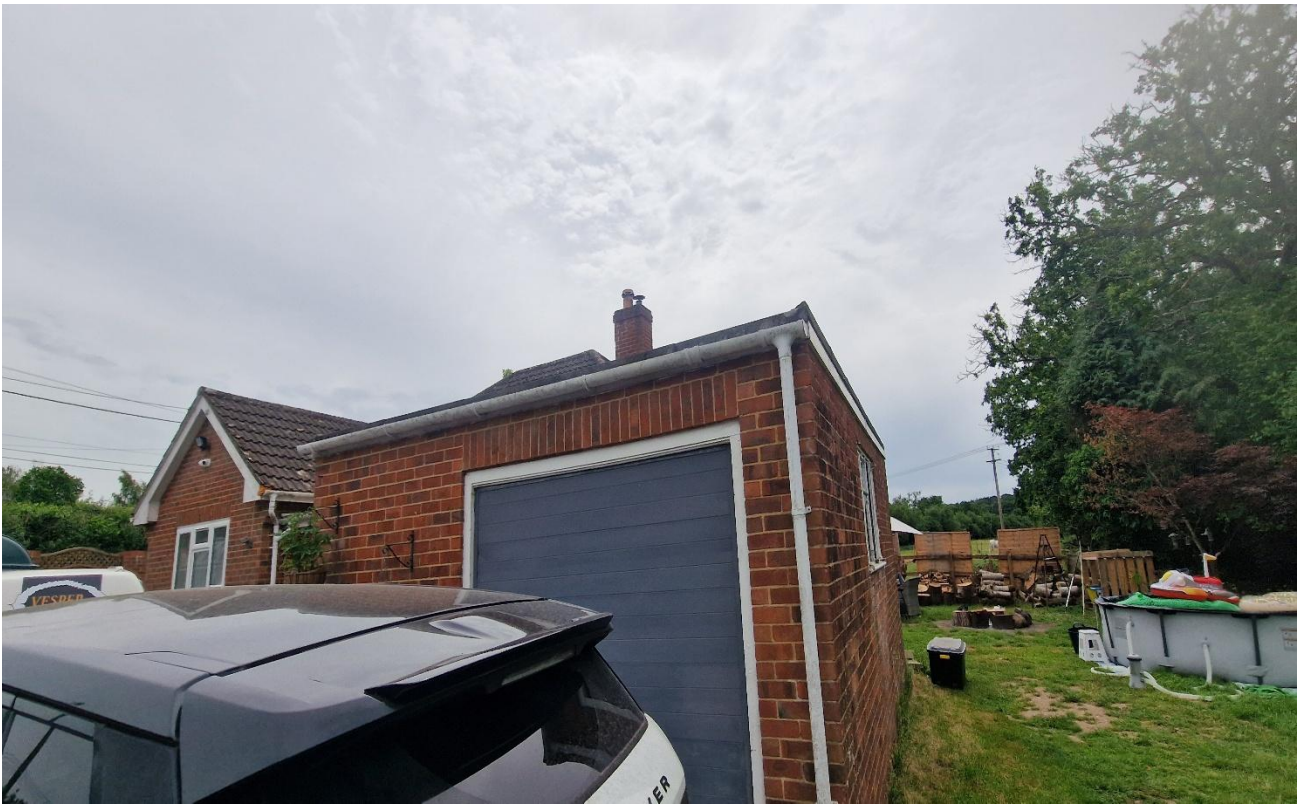
**Picture 5:** The old garage building

- 3.5 The single-storey garage has a bitumen felt roof which appeared to be in good condition, with no obvious gaps, splits or holes that would be likely to permit bat ingress.

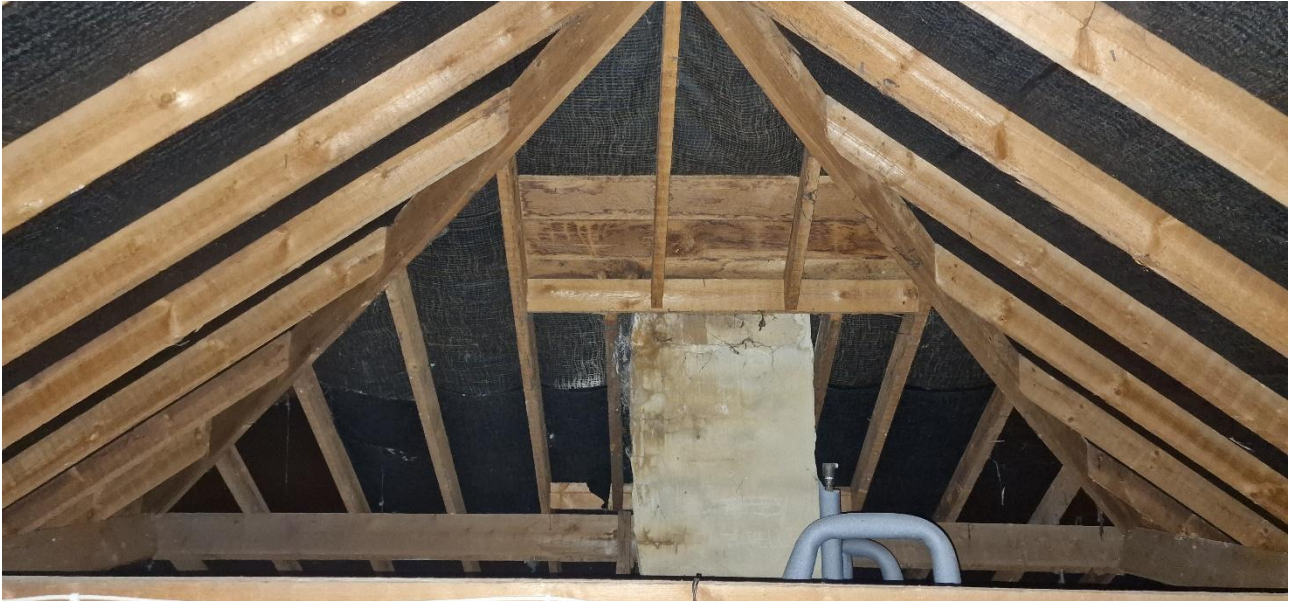
**Picture 9:** Showing the internal structure of the roof

- 3.10 The building contains a single roof void above the main house; no equivalent roof void is present above the garage structure.
- 3.11 The main roof void extends to approximately 1.8m at the ridge. The underside of the roof covering is lined with a bitumen felt membrane which was observed to be in good order, with no obvious holes, tears or gaps. Access within the loft space was adequate at the time of survey. The loft floor was insulated with fibre insulation, which extended into the eaves.
- 3.12 No physical evidence of bat use was identified within the roof void at the time of inspection. In particular, no droppings, feeding remains, staining or other field signs associated with bat presence were observed. There was also no evidence of rodent, wasp or other animal activity within the loft space.
