**2029 Horton Road, Devizes**

**Bat Survey Report**

**On behalf of  
McDonald's Restaurants Ltd**

**Version 3 | May 2026**

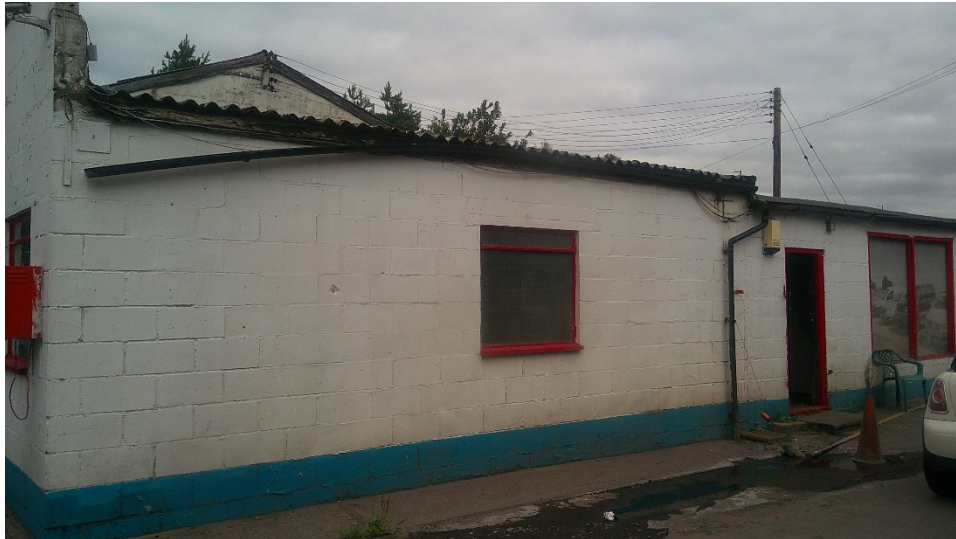
Northern Elevation of Building B4

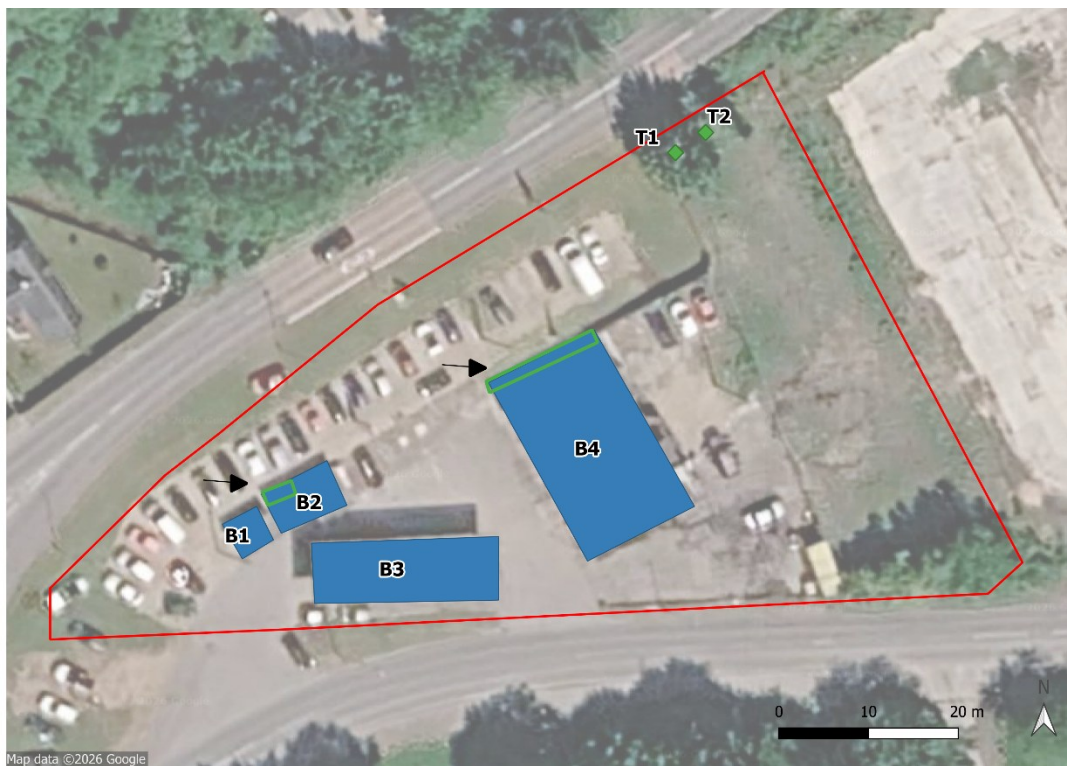
Figure 2: Surveyor and NVA Locations.

Figure 2 overleaf shows the potential roost features on B2 and B4 (marked in green) and the surveyor positions (black arrow). Each night vision aid (NVA) was positioned immediately adjacent to the surveyors.

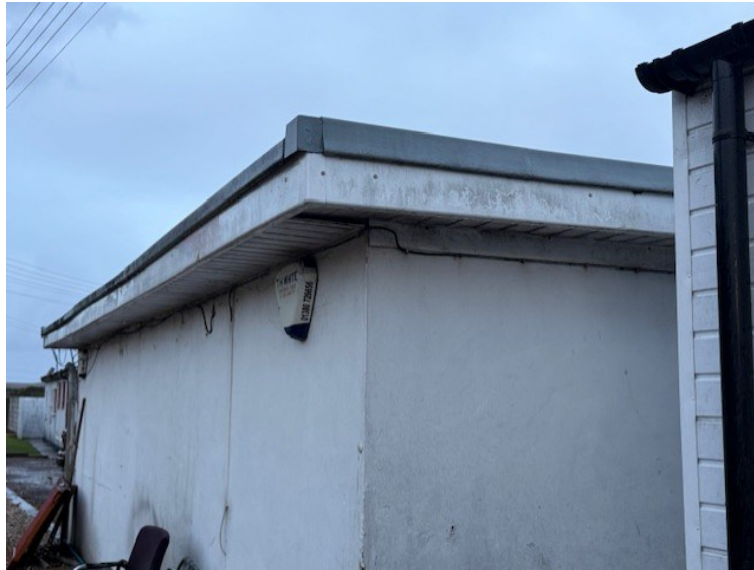
Building 2 is a single storey, rendered building with a flat roof used as a shop for the petrol station. Building 2 has plastic soffits, with one section slightly lowered on the north west of the building providing a narrow gap (see Figure 3). The northern elevation of the building was illuminated by the adjacent street lighting and from vehicle headlights along the main road to the north of the Site. Internally, no loft voids are present. Building 2 was assessed to have *Negligible to Low Suitability* for roosting bats

**Figure 3: North western aspect of Building 2 with potential roosting features**

Due to the low residual risk to bats during construction, the construction will require a non-licensed method statement and soft-strip around the PRFs in Building 2 and Building 4 with supervision by a suitable experienced and bat licensed Ecological Clerk of Works. Although unlikely, if a bat is found during the soft strip, then works must cease immediately, a licensed bat ecologist contacted for advice. Additionally, in the highly unlikely event that a bat is injured, the Helpline (0345 1300 228) run by the Bat Conservation Trust should be contacted so it can be taken immediately into care.

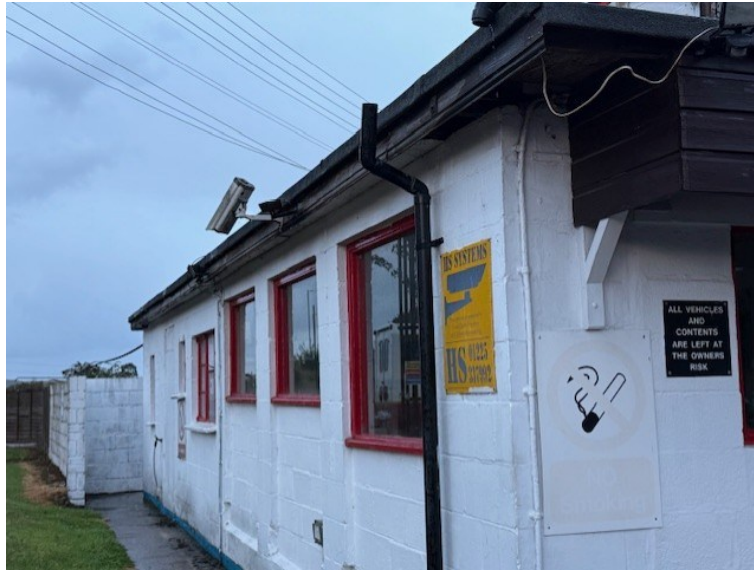
Building 4 is an active garage comprising breeze block walls within a multi-pitched corrugated asbestos roof on the main area of the building with flat roof, bitumen felt sections to the southeast and north. Wooden soffits are present around the building which are generally in a good state of repair. The soffit on the northern elevation have a small gap between the wall and soffit, creating a crevices which could be used as a potential roosting feature (PRF) (see Figure 4). A small security light was located on the western elevation of the building, above large roller access doors. The northern elevation of the building was illuminated by the adjacent street lighting and from vehicle headlights along the main road to the north of the Site. Internally, no loft voids are present. Building 4 was assessed to have *Low Suitability<sup>5</sup>* for roosting bats.

**Figure 4: Northern aspect of Building 4 with potential roosting feature between the wall and soffits**
