## Design and Access Statement

- The Site: 23 Vicarage Street, Warminster BA12 8JG Grade II, listed.
- The Proposal: This application seeks Listed Building Consent to remove harmful 1970s non-original windows and reinstate traditional slimline timber sash windows. The replacement windows will mirror the original historic design surviving on the adjacent property at 25 Vicarage Street, Warminster BA12 8JG.

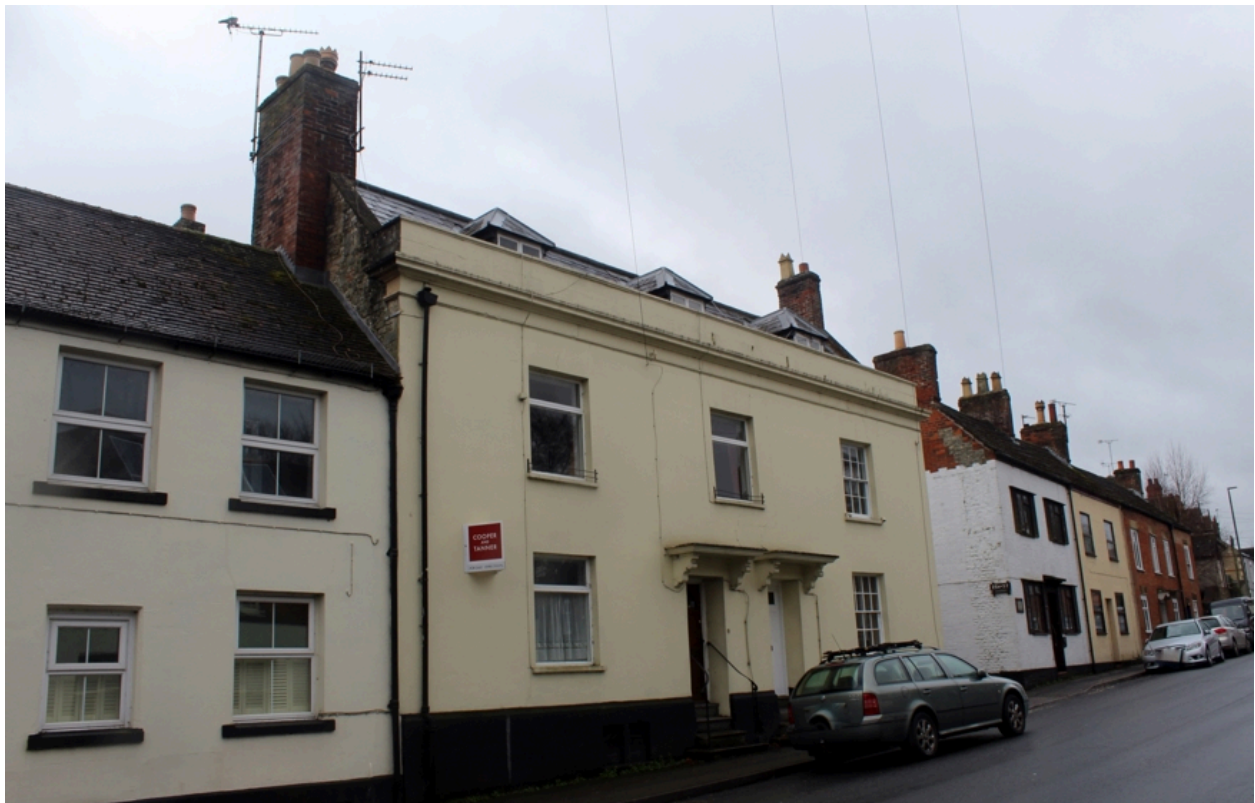
WARMINSTER VICARAGE STREET 1. 5411 (South Side) Nos 23 and 25 including boundary wall to south of No 25 ST 8645 SE 5/292

Late C18, altered. 2 storeys and attic with astragal type cornice, rendered on stout plinth with moulded capping. Slate roof with stone verges and brick gable end. Chimneys and 3 hipped dormers with 2 light casements. 3 windows 1st floor, 2 on ground floor, right hand range (No 25) retains 4 pane glazing bar sashes, other windows recently altered by

insertion of aluminium casements. 2 separate doors in centre with cut stone brackets to moulded flat hoods, No 23 has glazed door, No 25 a 6 panel door (upper 2 glazed) and cast iron knocker. Originally one house, No 25 retains the original staircase, mullioned openings to cellar. No 25 has a 2 storey coursed small rubble extension to rear with old tile roof and 3 light wooden casements (one per floor) to left. The garden wall continues from the south-west corner, about 100 yds long, also coursed small rubble, with brick patches. Height varies from about 15 to about 5 ft from north to south; ramped up to 8 ft over 20 yds. 3 entrances - 2 doors and a gate. Listing NGR: ST8679145068
