**All Saints Church,  
Church Lane, Middle  
Woodford, Salisbury,  
Wiltshire.**

ARCHAEOLOGICAL  
MONITORING &  
RECORDING

**REPORT**

**C1 project code: C1/AMR/25/SMW**

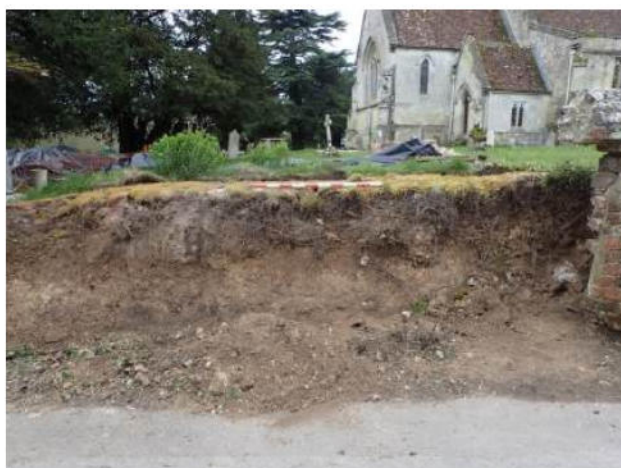
Figure 2. Location of collapsed wall (1m scale, looking S)

- 5.2 The churchyard wall was found to have no foundation and narrowed towards the base, sloping out towards the road. It comprises stone rubble bonded with yellow lime mortar and constructed directly against the cemetery soils (**Figures 2 & 3**). The rounded parapet is disproportionately large, built of flint set in cement with a brick course at the lower edge. Attempts to strengthen the wall are represented by the brick buttresses ranged along the outer face and, more recently, concrete blocks inserted within the surviving section adjacent to the collapse.

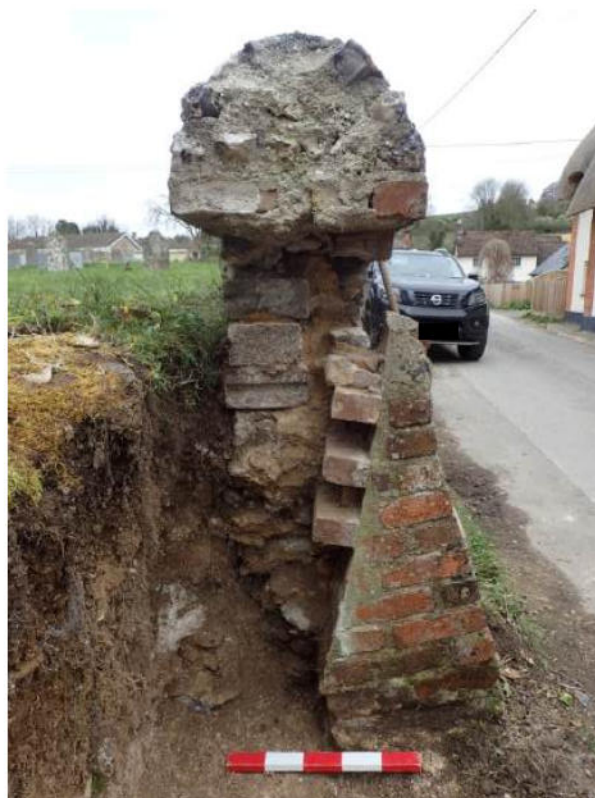
Figure 3. Cross-section of wall (1m scale, looking W)

- 5.3 The deposit sequence in the exposed cemetery section comprised 0.15m of topsoil and turf (100), a very dark yellowish brown (10YR 3/2) soft silt loam with sparse flint and chalk fragments (**Figures 2 & 4**). This covered a 0.25m deep subsoil (101) of friable dark greyish brown (10YR 3/4) silt loam containing a moderate amount of large flint nodules and chalk fragments. Below this was a further 0.35m deep subsoil (102) of friable greyish brown (10YR 5/2) loam; this resembled the overlying subsoil (101) but with a notably higher chalk content presumably derived from upcast during the digging of graves. This is in keeping with a cemetery soil and directly covered the natural chalk (107).

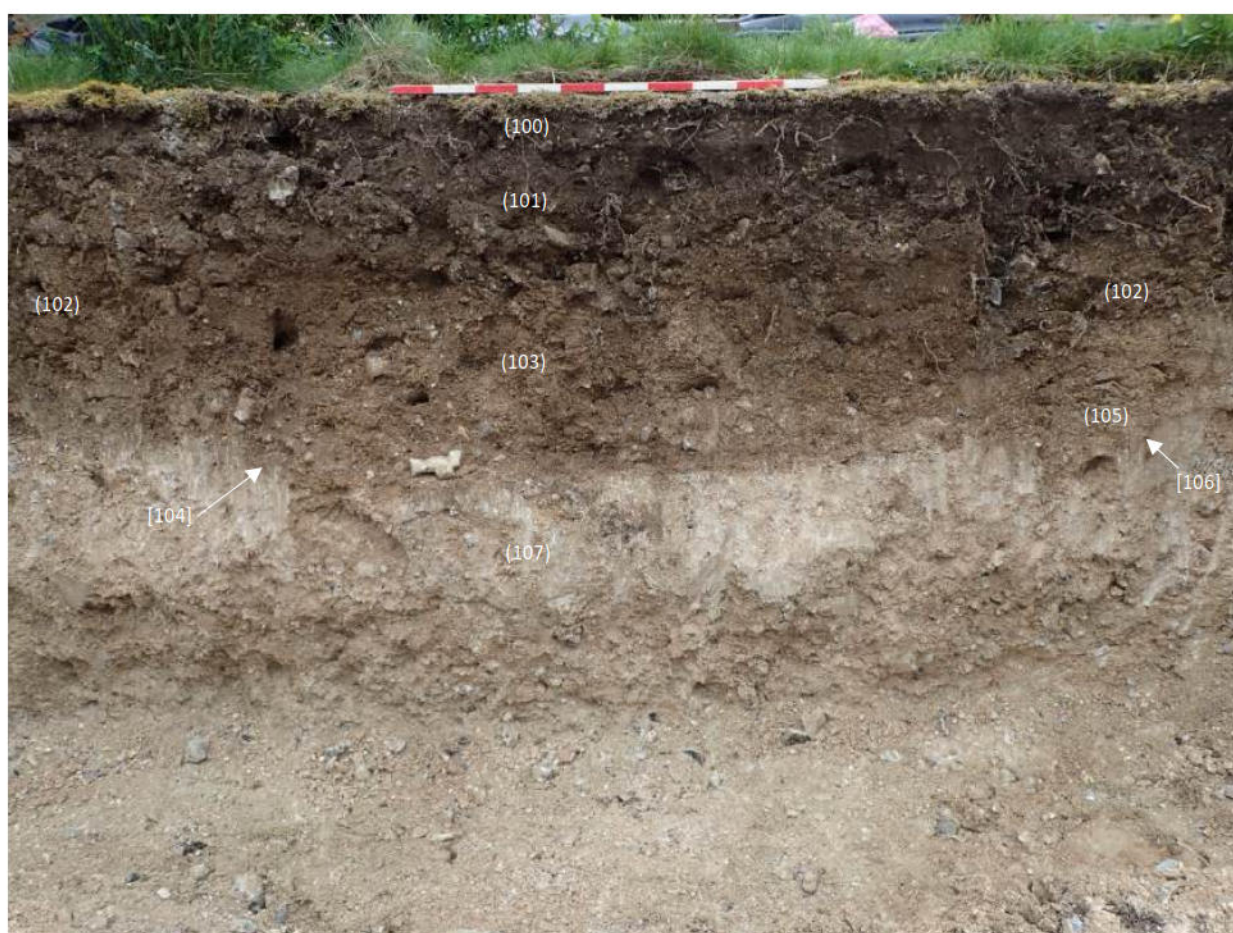
Figure 4. Excavated section behind collapsed wall showing unmarked graves (1m scale, looking S)

- 5.4 An unmarked grave [104] was exposed within the excavated cemetery section (**Figure 4**); several bones were dislodged by the machine but may have been previously disturbed by the construction of the churchyard wall (see below). The left foot of the individual within the grave was very slightly exposed, re-buried and left *in-situ*; the position near the east end of the grave suggests a west to east alignment for the burial. The grave, measuring 1.75m long and 0.50 deep with a slightly concave base and moderately sloping ends, cut through the earlier cemetery soil (102) and was sealed below the subsoil (101). The backfill (103) comprised a soft very pale brown (10YR 7/3) sandy silt loam with chalk gravel; this gravel was abundant near the base, a common feature of chalk-cut burials, and was very loose with a few voids in the section suggesting the skeleton lay immediately beyond a thin soil interface. At the east end, the grave [104] appeared to cut the east end (0.50m) of an earlier grave at the same horizon, also sealed by the cemetery soil (102). This feature had a paler chalky backfill (105) and was cut [106] straight into the chalk (107).

- 6.1 The archaeological monitoring and recording identified a well-developed cemetery soil (102) at approximately 0.40m below the modern ground level along with the surface of an unmarked grave [104]. The fact that this grave cuts through an earlier burial ([106]) at the same horizon suggests a sustained period of interment in this specific area of the churchyard. The shallow nature of the burial presents two possibilities: either the remains are of significant antiquity (perhaps medieval), or the graveyard has undergone substantial ground reduction, a common occurrence in the 19<sup>th</sup> century. Given the position of the grave at the boundary of the churchyard, the interment of a subadult in this peripheral location is consistent with established medieval and post-medieval burial practices.

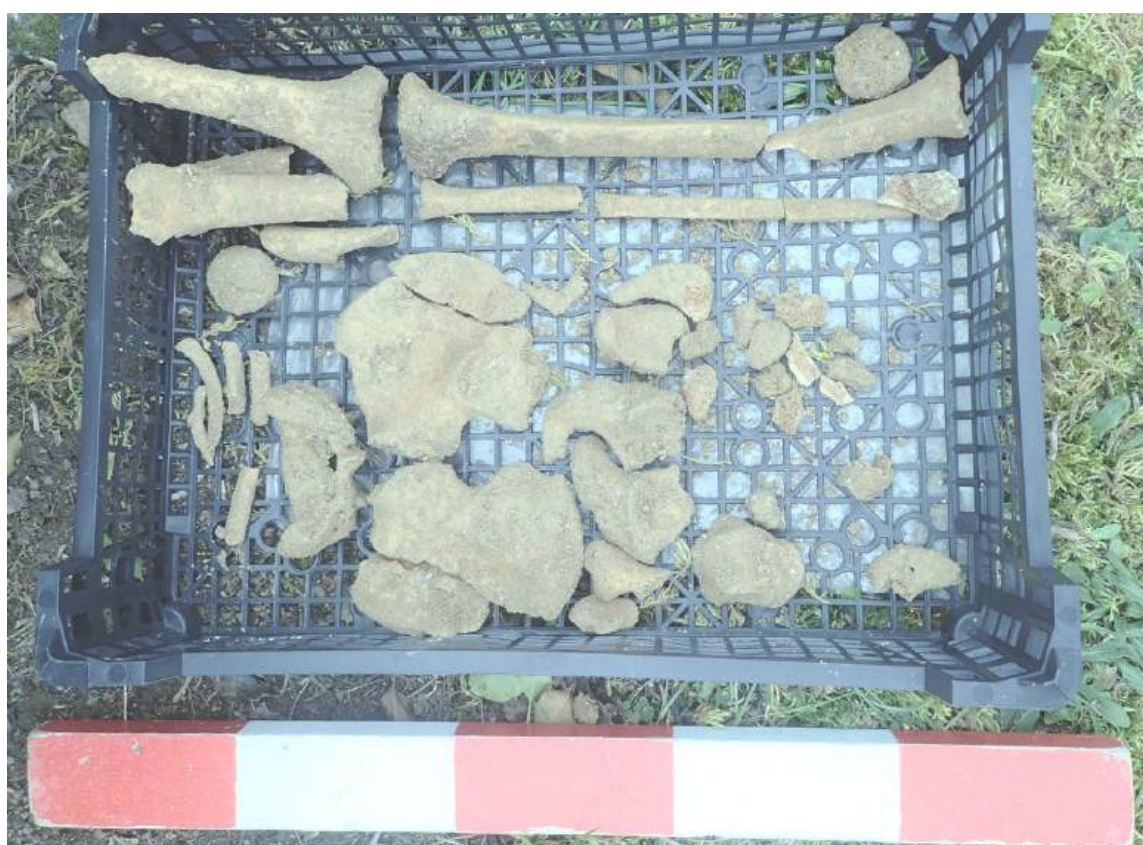
Figure 5. Human bone from N edge of grave [104] (0.5m scale)

- 5.5 A small assemblage of human skeletal remains were dislodged from the fill (103) of unmarked grave [104] (**Figure 5**), and likely associated with the associated interment. The assemblage was subject to a rapid visual assessment to determine the minimum number of individuals (MNI), skeletal representation, and preservation condition, prior to immediate re-burial. The recovered remains comprised the left lower limb (specifically the femur, tibia, and fibula) alongside fragments of the ilium, ischium, sacral vertebrae, and several probable ribs. The overall condition of the bone was fair to poor, exhibiting moderate cortical weathering and evidence of post-mortem breakage. Biological analysis indicates the individual was a subadult, as evidenced by the relatively small long bone diaphyses (with the femur measuring 27.5cm) and the fact that all visible epiphyses remained unfused. Based on the morphology of the pelvic elements and the overall size of the long bones, the remains are consistent with an older child or early adolescent. No macroscopically visible trauma or pathological lesions were noted on the surviving cortical surfaces.

- 6.2 Osteological assessment of the dislodged remains from grave [104] indicates they belong to a single subadult, likely an older child or early adolescent. Local accounts indicate that a fence occupied this boundary until the mid-20<sup>th</sup> century, at which point the flint wall may have been constructed suggesting a later date than the lychgate. It is highly probable that the original construction of the wall dislodged the left leg and pelvic elements of the individual in grave [104]. These elements appear to have been crudely redeposited into voids behind the wall fabric at that time. In accordance with Diocesan Faculty conditions, all dislodged remains were securely stored during the works and subsequently reinterred as close to their original location as possible within the base of the new foundation trench.
