## Kennet & Avon Canal Trust - Crofton Beam Engines

### Pumphouse Cottage : Listed Building Consent Application

#### *Method Statement for South and West Wall Render Removal*

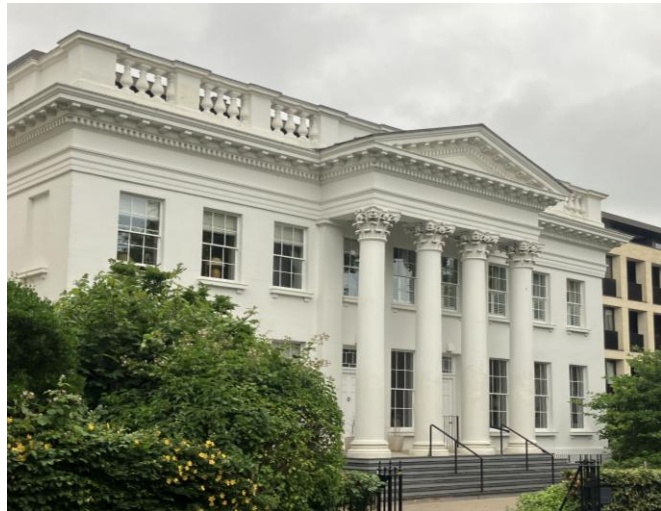
Council Conservation Officer, in this case retaining areas of sound historic render formed in decorative features such as Corinthian and Composite column capitals. The result after cement render removal and re-rendering in a traditional lime/sand render can be seen to the right. In this case some experimentation was necessary in order to discover the optimal technique to avoid any damage to a limestone rubble plinth and a soft red brick upper wall construction, some of which had been damaged when the hard render had been applied in the late 20<sup>th</sup> century, after removal of the original Regency stucco finish using unskilled labour.

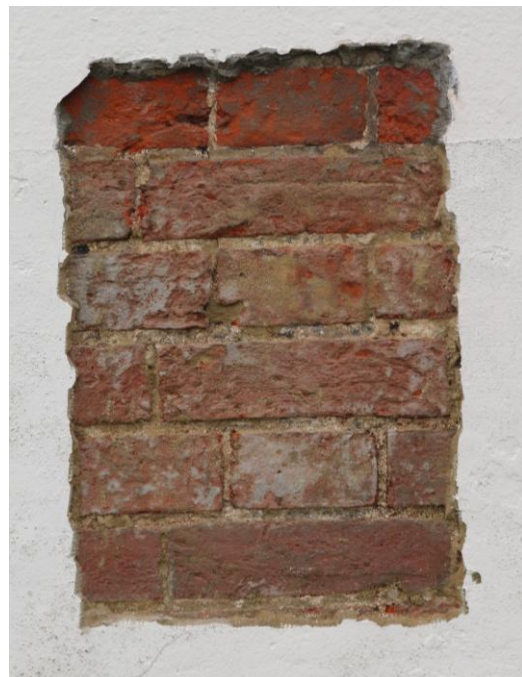
This approach was used at the Crofton site in the initial trials, where small rectangles such as that to the right were exposed. As can be seen, not only did this minimise any surface damage to the brickwork but it was also possible to preserve the majority of the original pointing without the need to repoint, which clearly has major advantages. This is therefore the proposed method to be used in render removal at Pumphouse Cottage. It is accepted that, particularly at low levels, there will be locally damaged or frost-affected bricks which will require renewal, but good local sources of matching salvaged bricks are being identified. The existing render is not well keyed, which means brickwork joints are not recessed, requiring little repointing.

What became clear after numerous trials with the leading stonemason was that using a sharp chisel driven at an acute angle to the masonry face, although seeming intuitively the best option was *not a reliable technique* to avoid surface damage. Where the render mix was particularly hard this tended to be *more* likely to cause surface damage to the brick face. What was found to be most successful was to use a less sharp chisel driven in short 'punching' taps at an angle of about 70° to 80° to the wall surface, which would loosen the render by fracturing it locally and breaking its bond to the brickwork. It could then be removed in small areas without any serious surface damage to the underlying brickwork.
