AN ARCHAEOLOGICAL DESK BASED ASSESSMENT STUDY  
OF LAND AT NETHERAVON HOUSE,  
NETHERAVON, WILTSHIRE (VERSION 2).

**[Site Centred at National Grid Reference: SU 1486 4823]**

PREPARED FOR MR. ANDREW WATTON OF BOURNE VALLEY ASSOCIATES ON  
BEHALF OF HIS CLIENTS - MR. & MRS. VEITCH

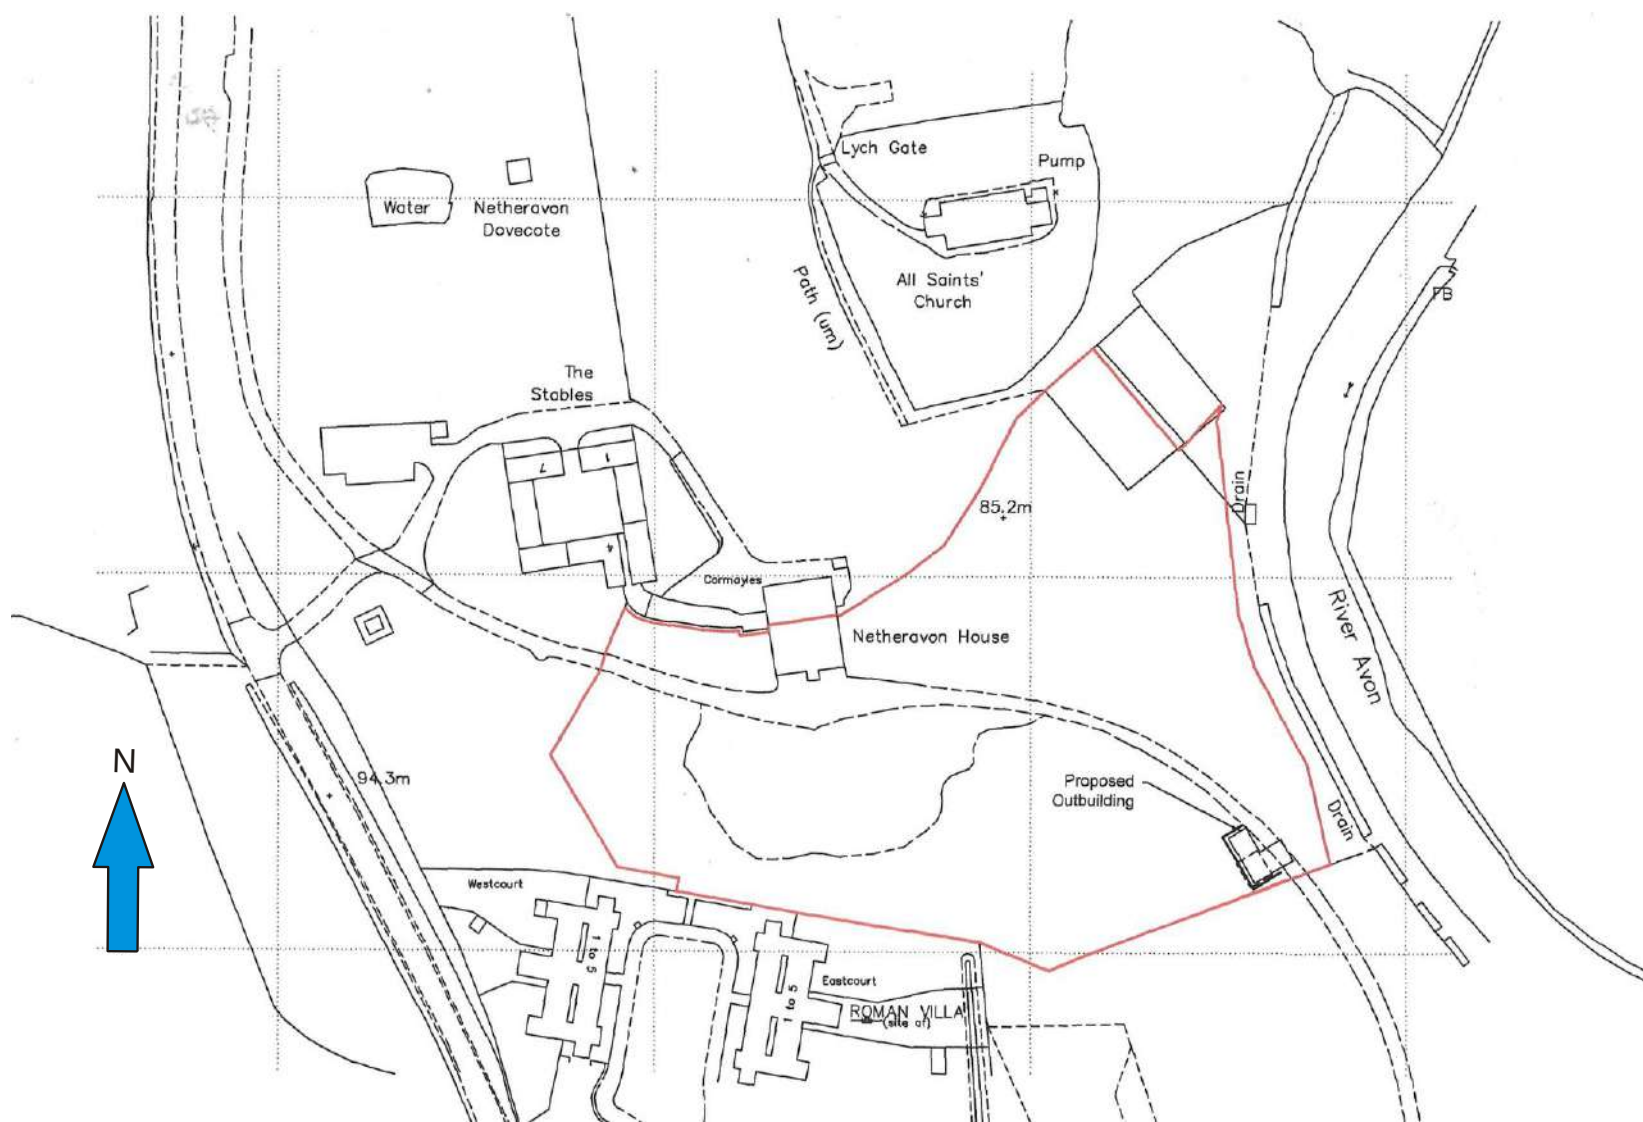
**Figure 2:** Plan showing the site location and the existing layout of the assessment site at an original scale of 1:1,250 at A3, (extract from Architects plan). The assessment site is shown outlined in red.

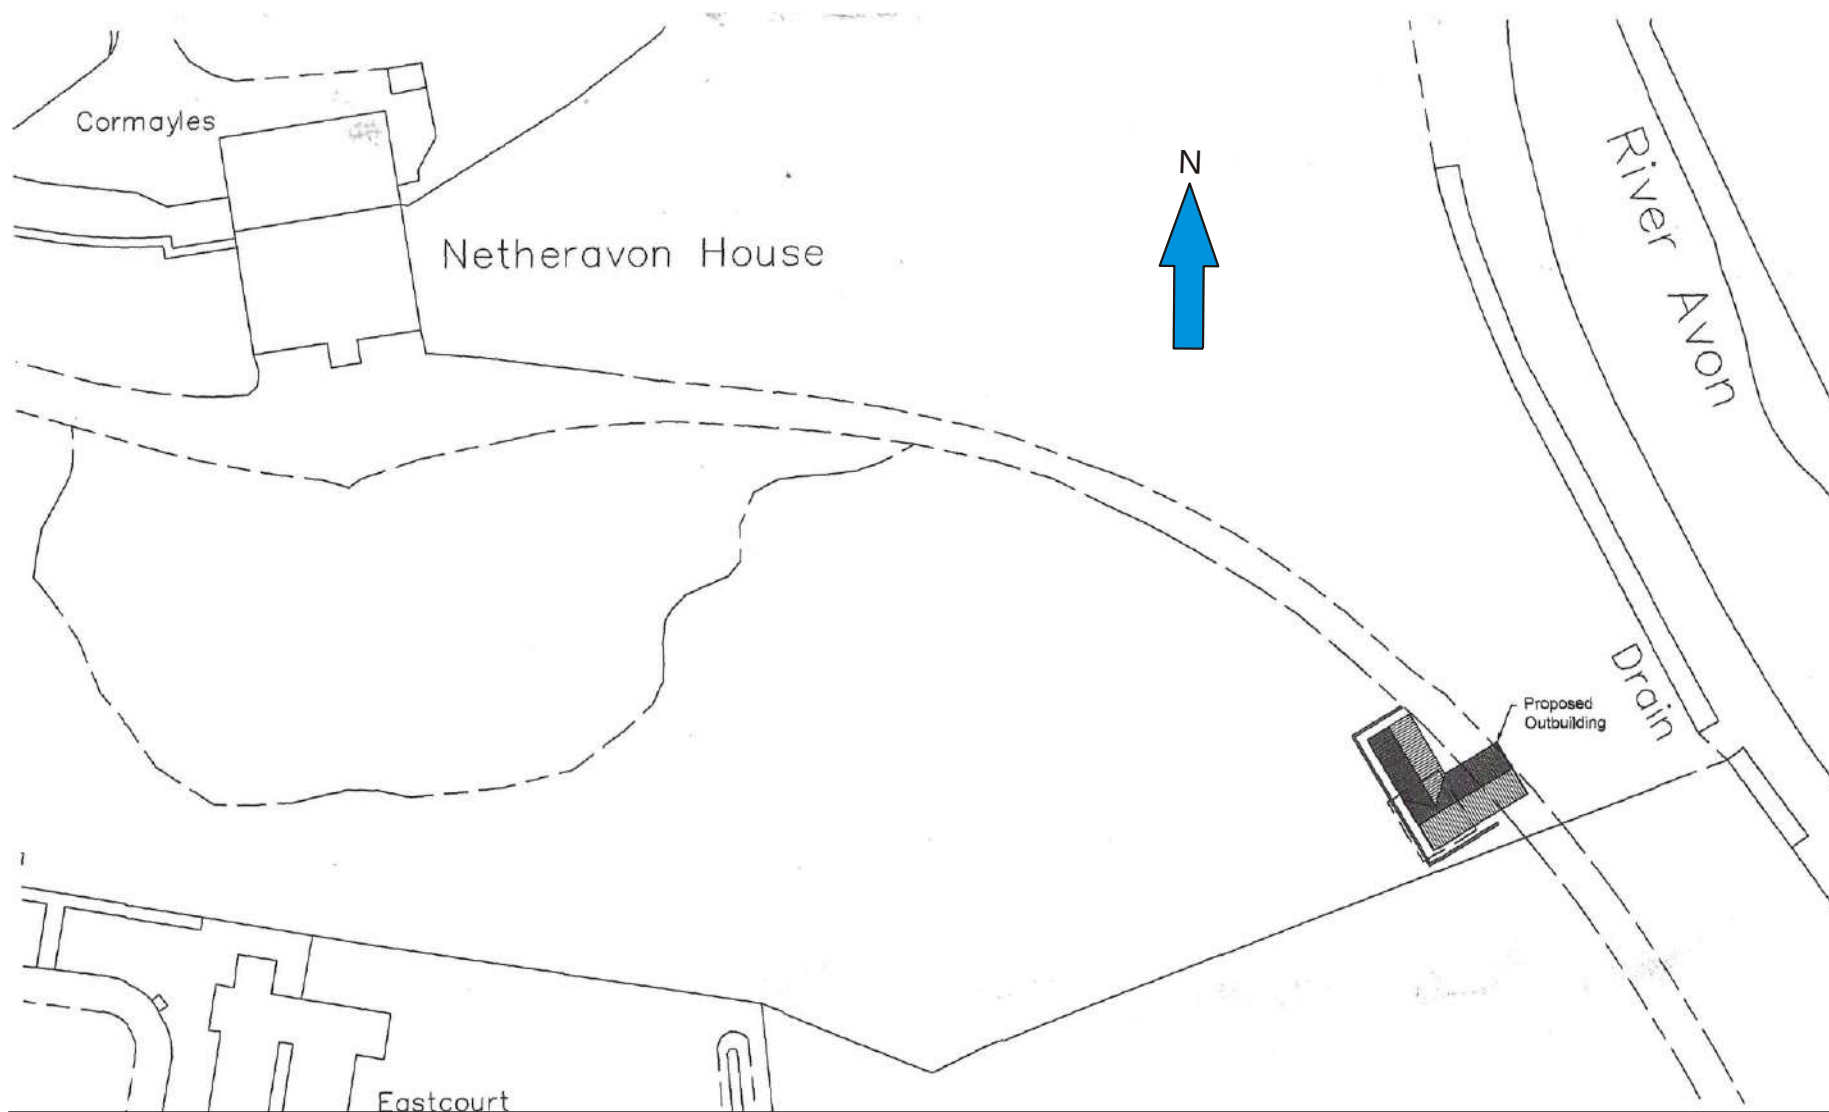
**Figure 3:** Plan showing the proposed layout of the development site at an original scale of 1:500 at A3 (extract from Architects plan).

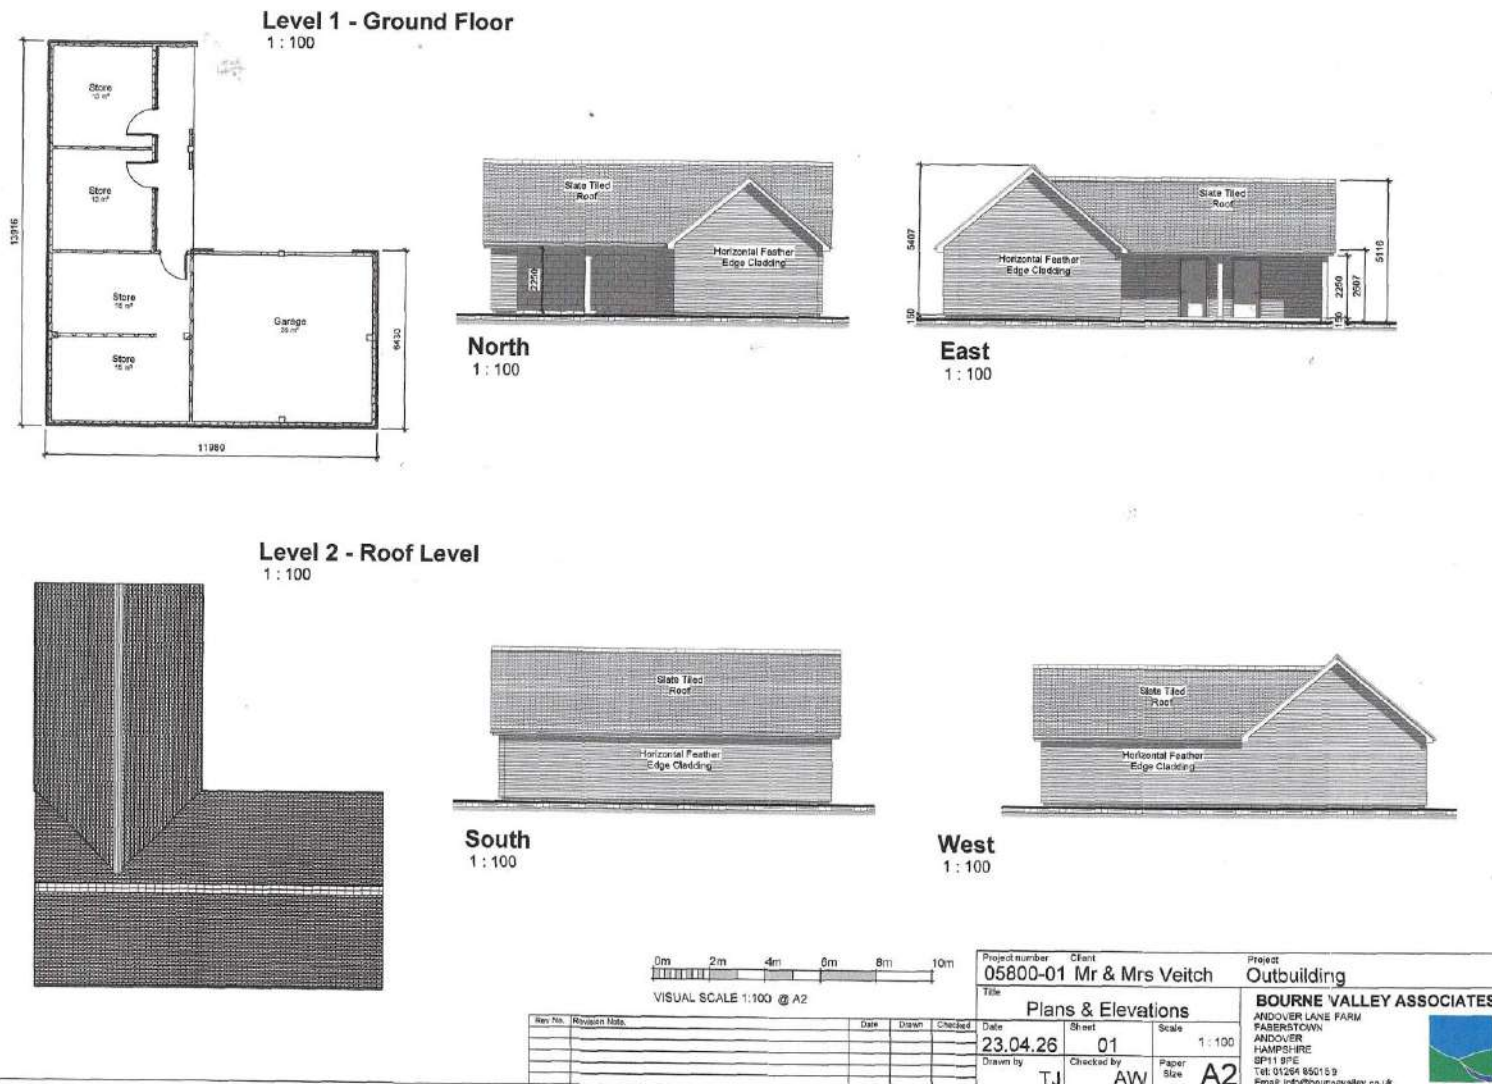
**Figure 4:** Plan showing the proposed ground floor layout and elevations of the proposed development site at original scales of 1:100 at A2 (extracts from Architects plans).

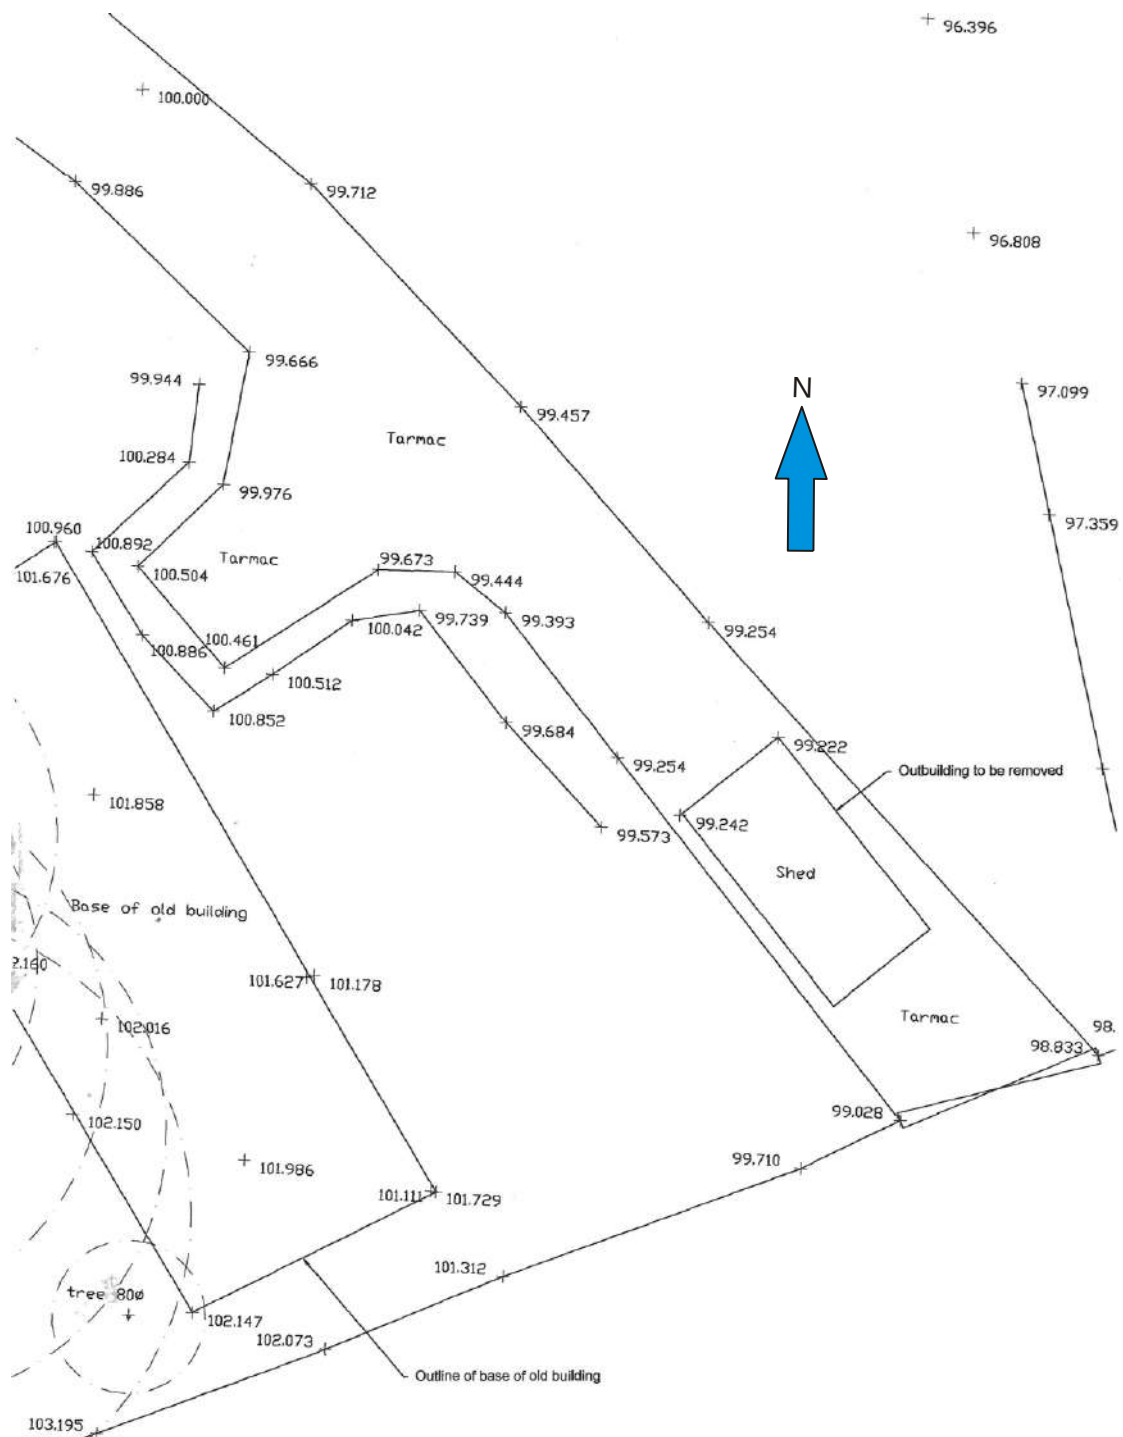
**Figure 5:** Plan showing the existing layout of the area of the proposed development site at an original scale of 1:100 at A3, (extract from Architects plan).

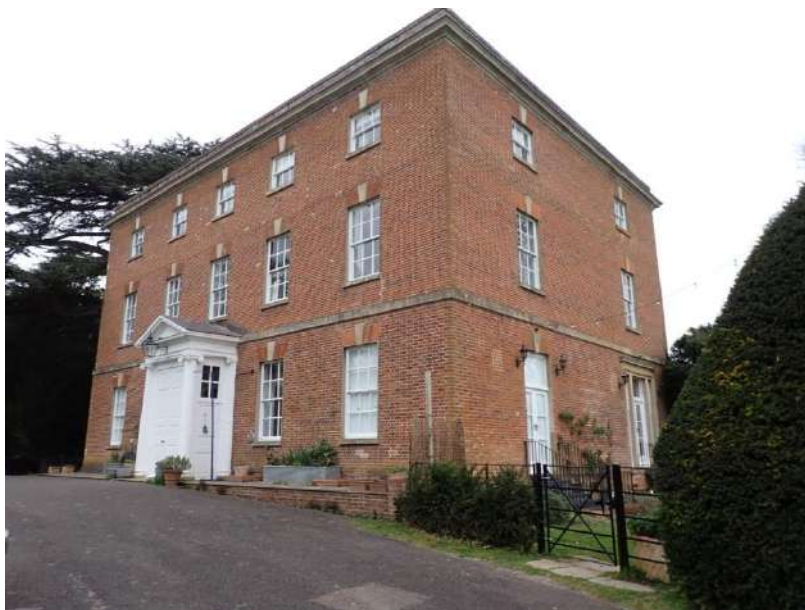
6.2.6 **Plates 1 and 2** present detailed views of the Grade II\* listed Netheravon House (**Site No. 16**), and particularly of its South and East Elevations.

**Plate 1:** View of the Grade II\* listed Netheravon House, (Site No. 16), within the area of the assessment site, from the south-east

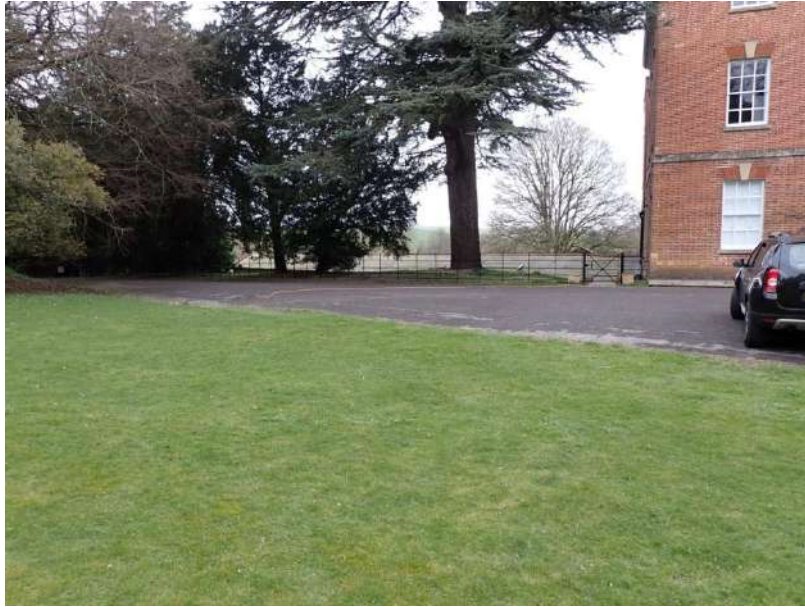
**Plate 3: View of the assessment site, from the south**

6.2.7 **Plate 3** features the western access into the area of the assessment site and of the modern tarmac driveway that extends south-eastwards from it.

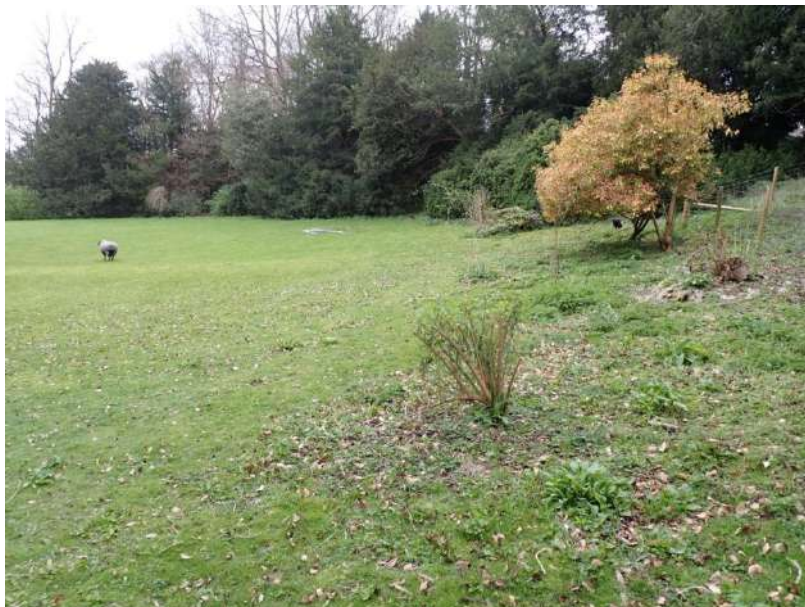
**Plate 4: View of the assessment site, from the north-west**

6.2.8 **Plates 4-6** provide several views of the western end of the assessment site and of the grassed areas with the 100% ground cover. **Plate 4** shows the dense and mature tree and bush cover along the southern site boundary here. **Plate 5** also features this dense and mature vegetation cover along with a view of the Grade II\* listed Netheravon House to the left (north) (**Site No. 16**). **Plate 6** presents a further view of the Grade II\* listed Netheravon House (**Site No. 16**).

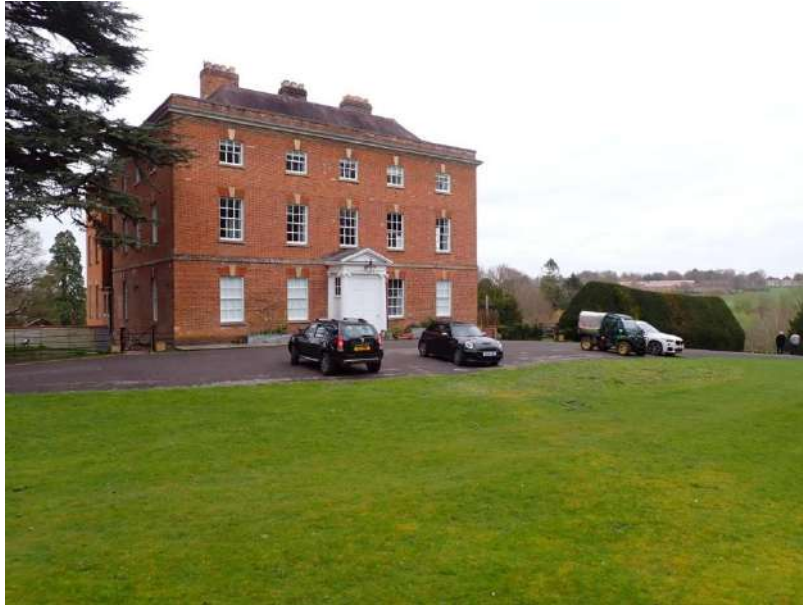
**Plate 7: View of the Grade II\* listed Netheravon House, (Site No. 16), within the area of the assessment site, from the south-west**

6.2.9 **Plate 7** presents a further detailed view of the Grade II\* listed Netheravon House (Site No. 16).

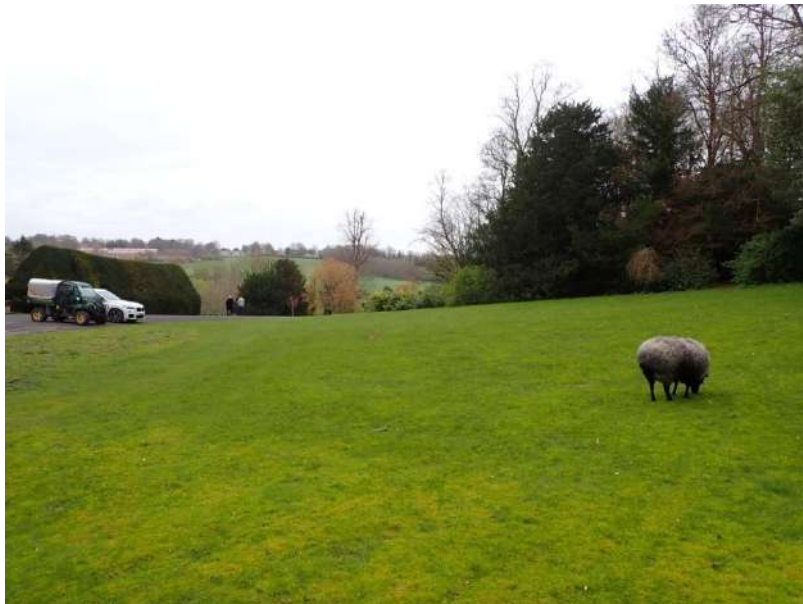
**Plate 8: View of the assessment site, from the west**

6.2.10 **Plates 8 and 9** provide further images of the western end of the assessment site and of the 100% grassed ground cover here. They show the dense and mature tree and bush cover along the southern site boundary to the right (south).

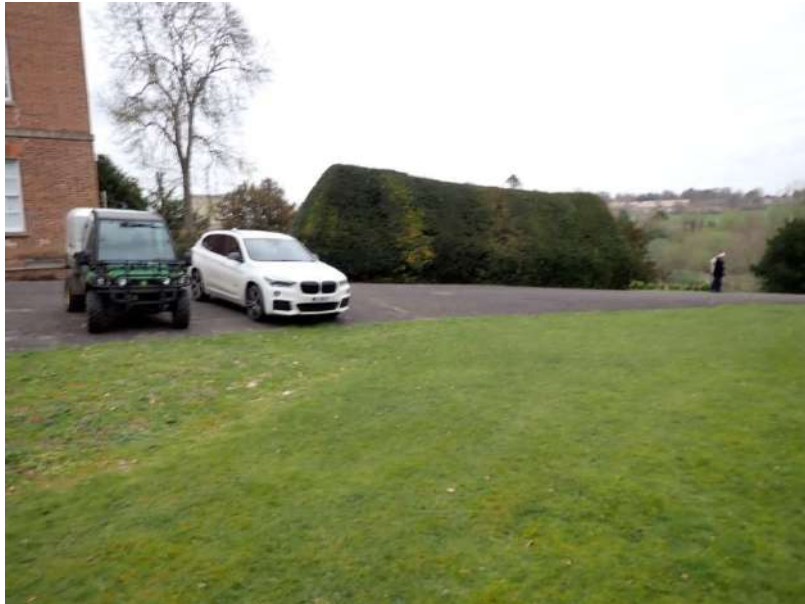
**Plate 10: View of the assessment site, from the south-west**

6.2.11 **Plates 10-12** furnish further views of the western end of the assessment site and of the 100% grassed ground cover here. **Plates 11 and 12** in particular feature the dense and mature tree and bush cover along the southern site boundary.

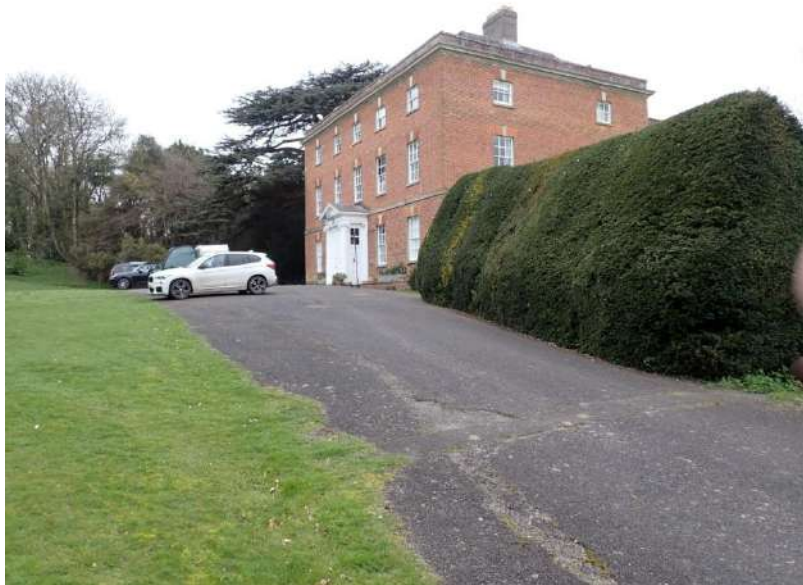
**Plate 13: View of the Grade II\* listed Netheravon House, (Site No. 16), within the area of the assessment site, from the east**

6.2.12 **Plates 13-16** provide further views of the western portion of the assessment site from different eastern positions and of the 100% grassed ground cover here. **Plate 13** presents a further view of the Grade II\* listed Netheravon House (**Site No. 16**) to the right (north) along with the dense and mature tree cover at the western boundary of the assessment site in the background. **Plates 14-16** present further images of the dense and mature tree cover at the western boundary of the assessment site in the background along with part of the further dense and mature tree and bush cover of the southern site boundary to the left (south).

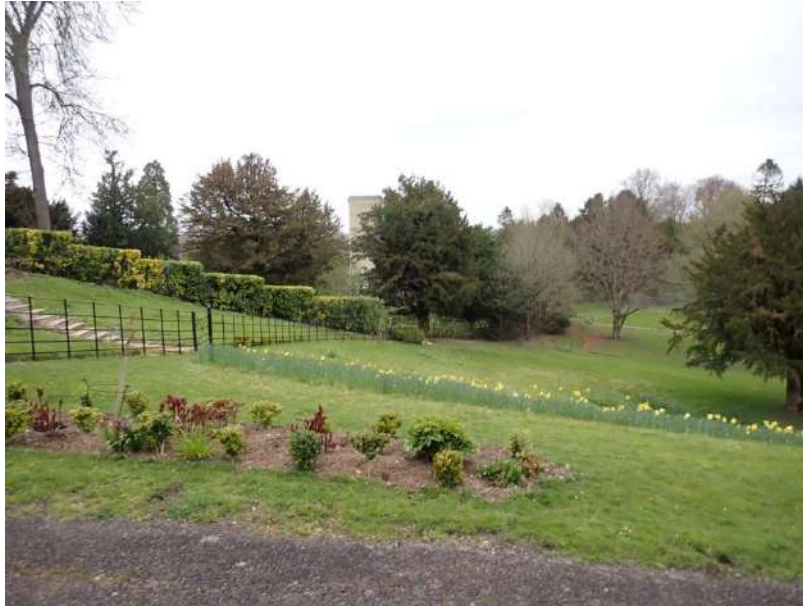
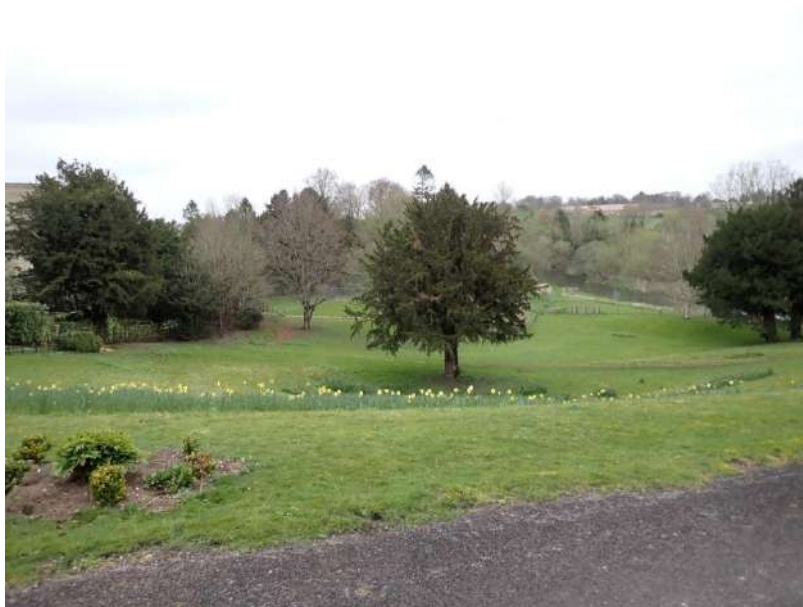
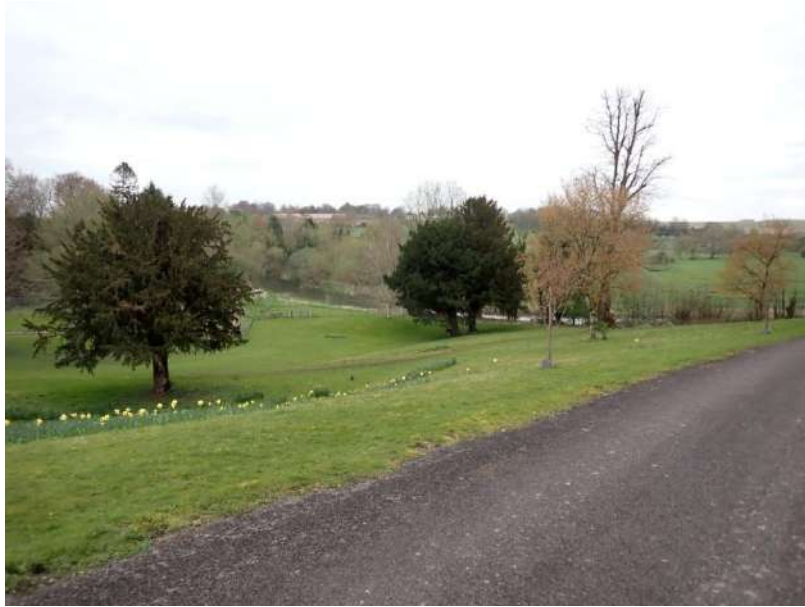
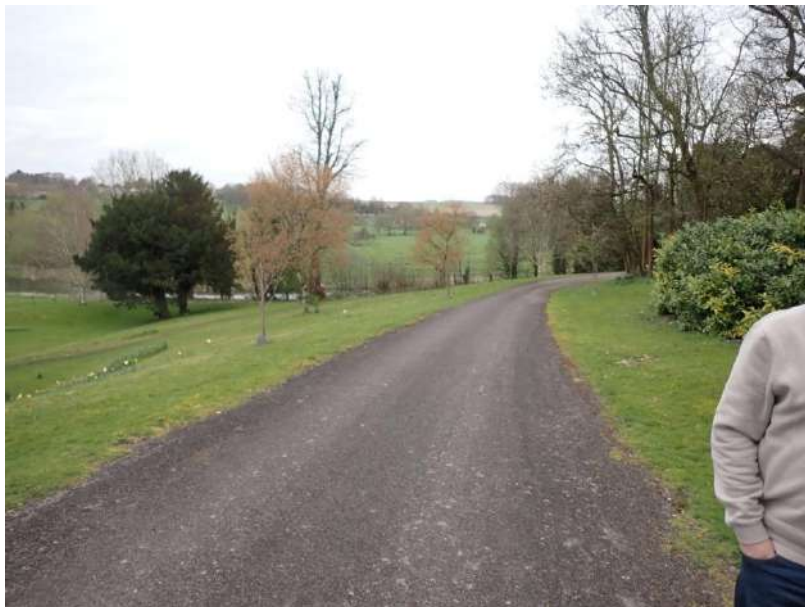
6.2.13 **Plates 17-20** furnish views of the eastern portion of the assessment site from various western perspectives and of the 100% grassed ground cover here. **Plate 17** features a view of the formal gardens of Netheravon House (**Site No. 73**) along with portions of the northern site boundary with their dense and mature tree cover along with a view of the Grade I listed parish church of All Saints (**Site No. 5**), in the background. **Plates 18 and 19** present further views of the eastern portion of the assessment site with images of the northern site boundary with their dense and mature tree cover and of the eastern end of the assessment site, which leads down onto the River Avon, further to the east. **Plate 20** shows the eastern portion of the assessment site, the modern tarmac driveway that extends to the south-east along with a portion of the dense and mature tree and bush cover of the southern site boundary to the right (south).

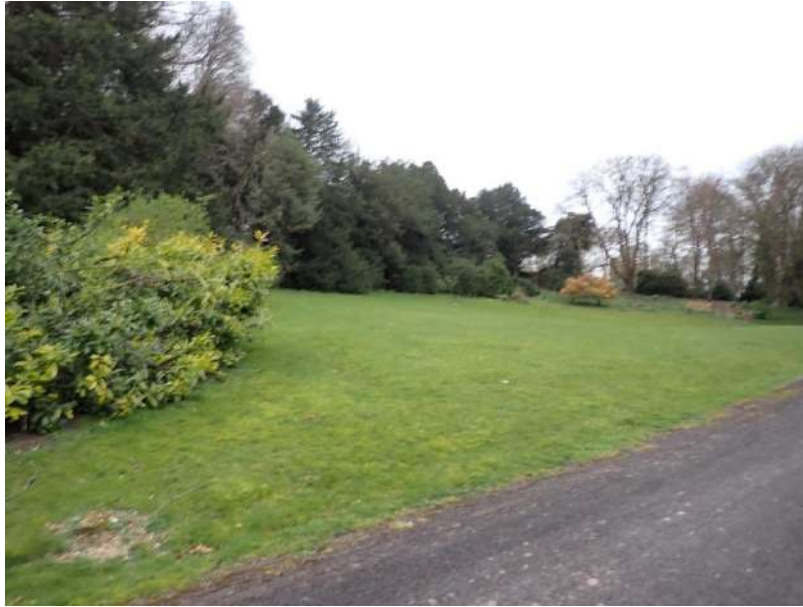
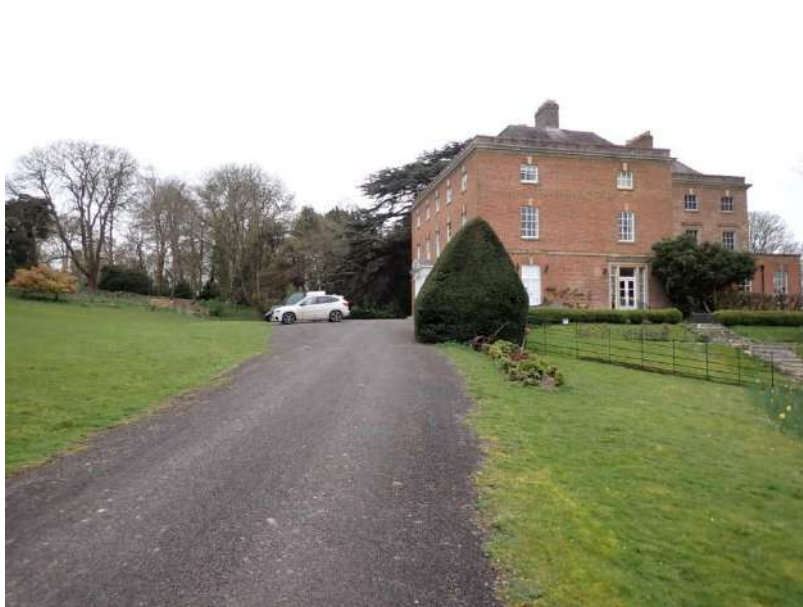
6.2.14 **Plates 21 and 22** provide further views of the western portion of the assessment site from eastern viewpoints and of the 100% grassed ground cover here. **Plate 21** features the dense and mature tree and bush cover of part of the southern site boundary and of the western site boundary in the background. **Plate 22** shows a further view of the western site boundary in the background along with the Grade II\* listed Netheravon House (**Site No. 16**), to the right (north).

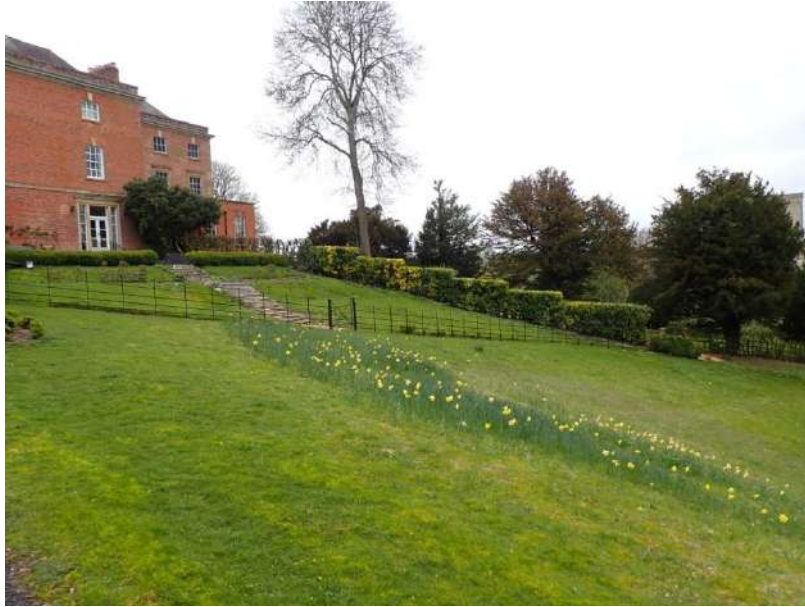
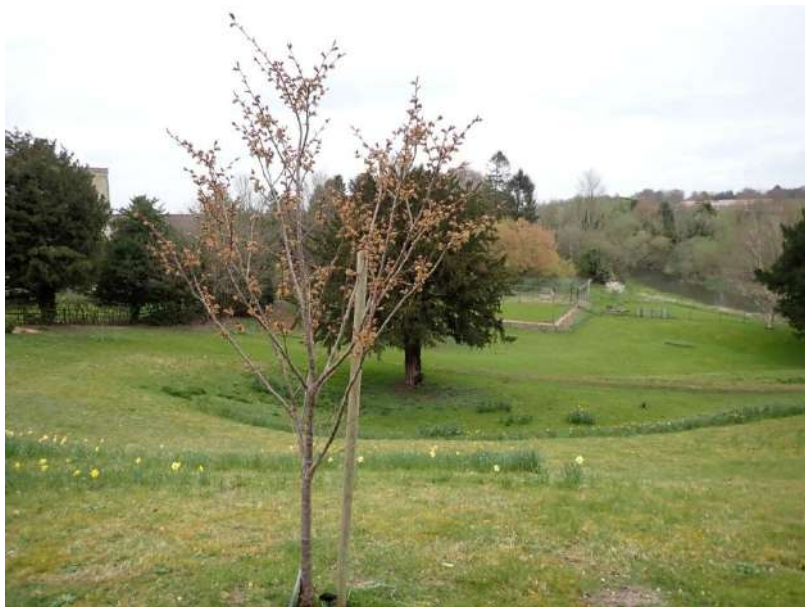
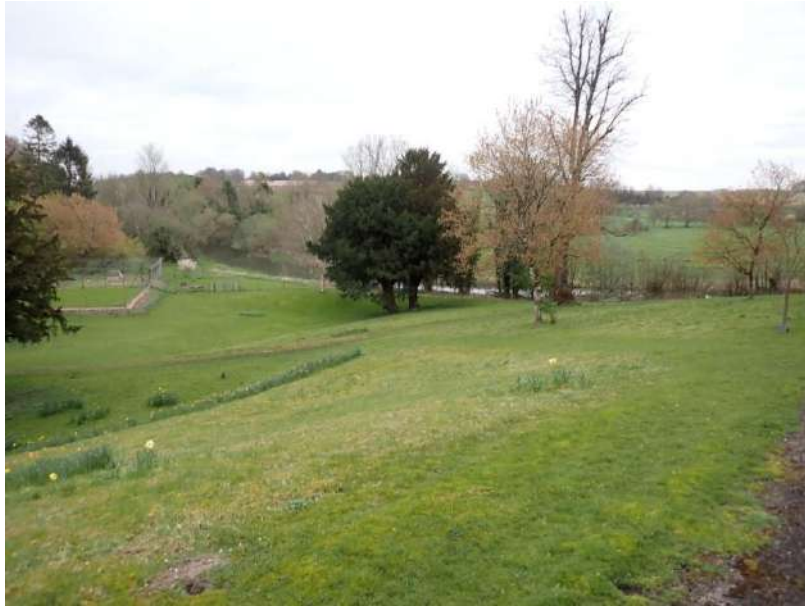
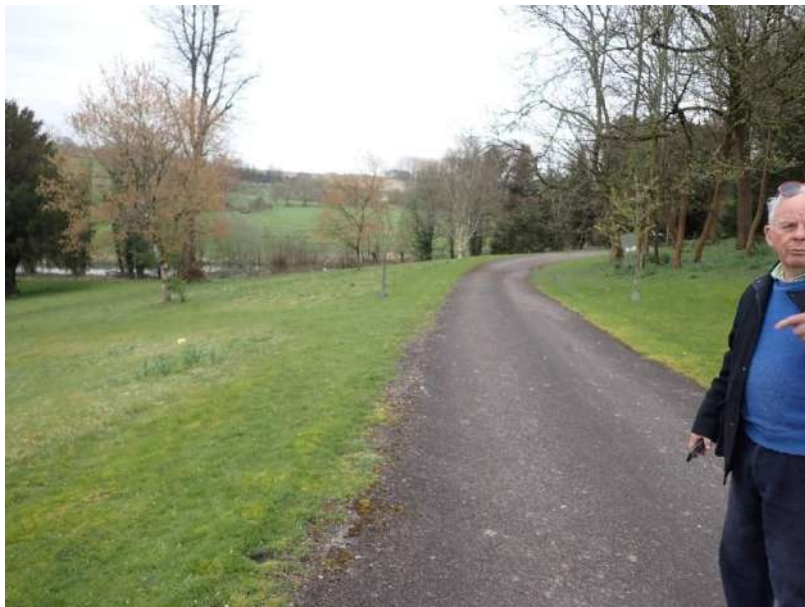
6.2.15 **Plates 23-26** provide further views of the eastern portion of the assessment site from various southern and western positions and of the 100% grassed ground cover here. **Plate 23** features the Grade II\* listed Netheravon House (**Site No. 16**), to the left (west) along with part of the formal gardens of Netheravon House (**Site No. 73**), in the background. **Plates 24-26** present further views of the eastern portion of the assessment site with images of the northern site boundary with their dense and mature tree cover and of the eastern end of the assessment site, which leads down onto the River Avon, further to the east. **Plates 23 and 24** feature the Grade I listed parish church of All Saints (**Site No. 5**), in the background. **Plates 24 and 25** show the modern tennis courts to the north-east in the background. **Plate 26** shows the modern tarmac driveway that extends onto the south-eastern corner of the assessment site along with part of the southern site boundary with its dense and mature tree and bush cover.

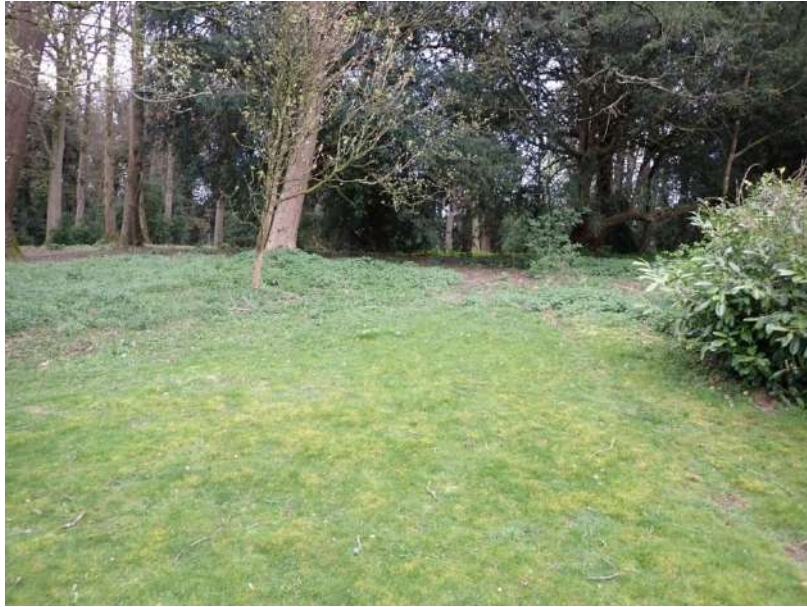
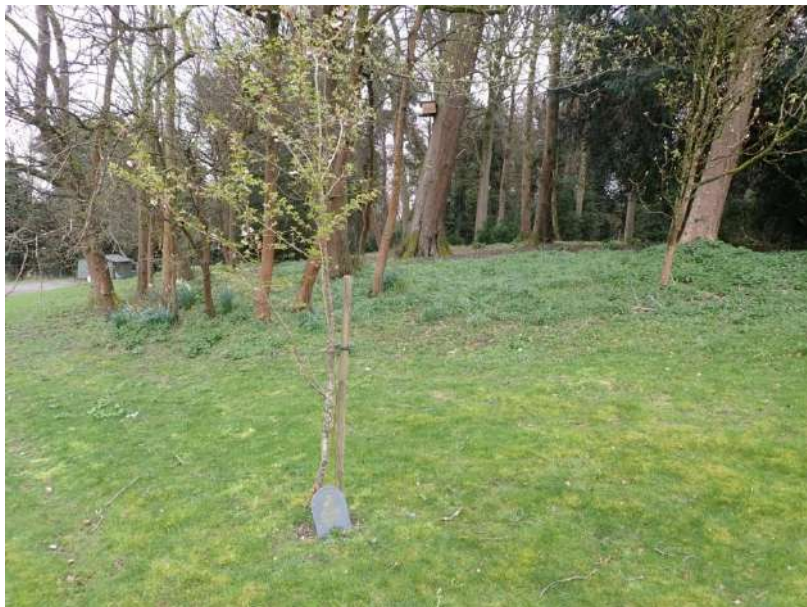
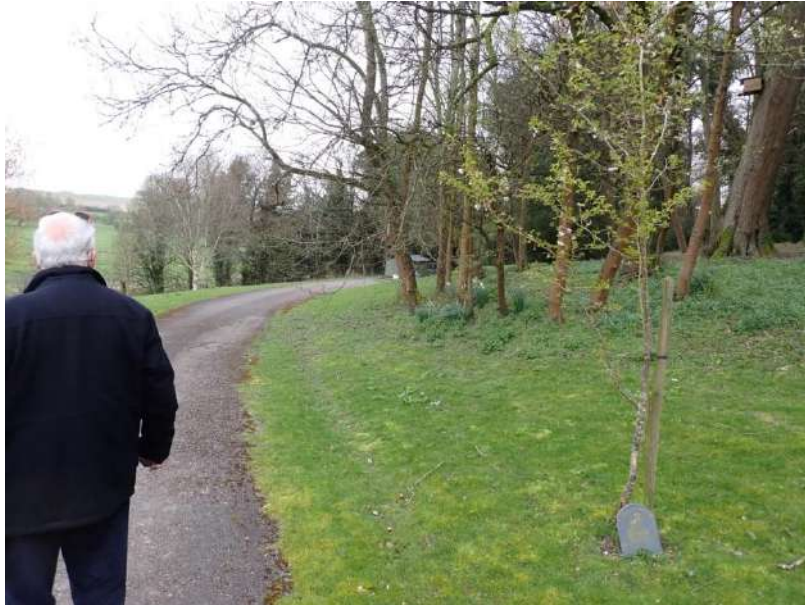
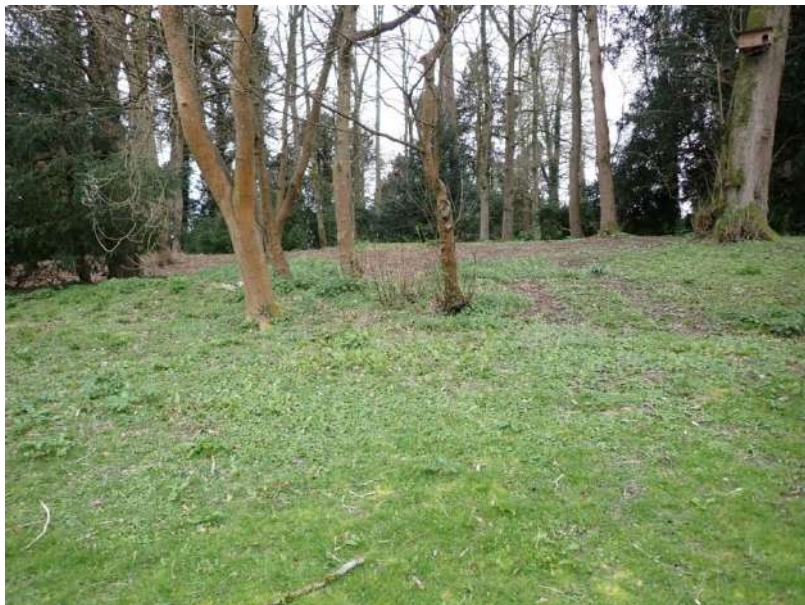
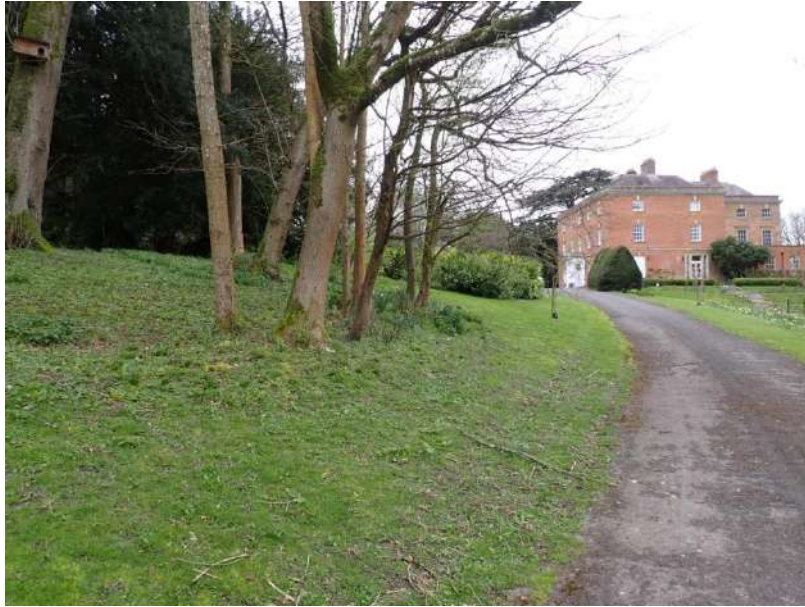
6.2.16 **Plates 27-31** provide further various images from differing positions of the dense and mature tree and bush cover along the southern site boundary in the background along with the 100% grassed ground cover here in the foregrounds. **Plate 31** also features the Grade II\* listed Netheravon House (**Site No. 16**), to the right (north) along with the modern tarmac driveway that extends from it to the south-east.

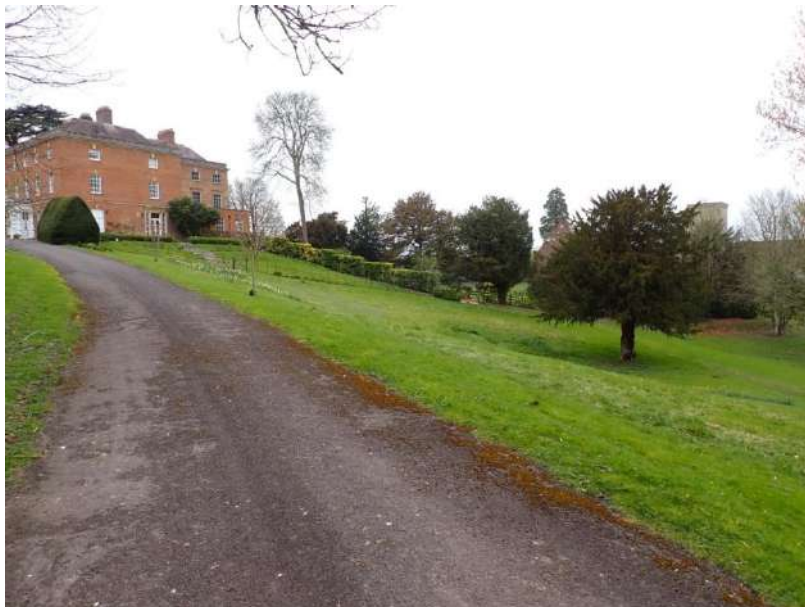
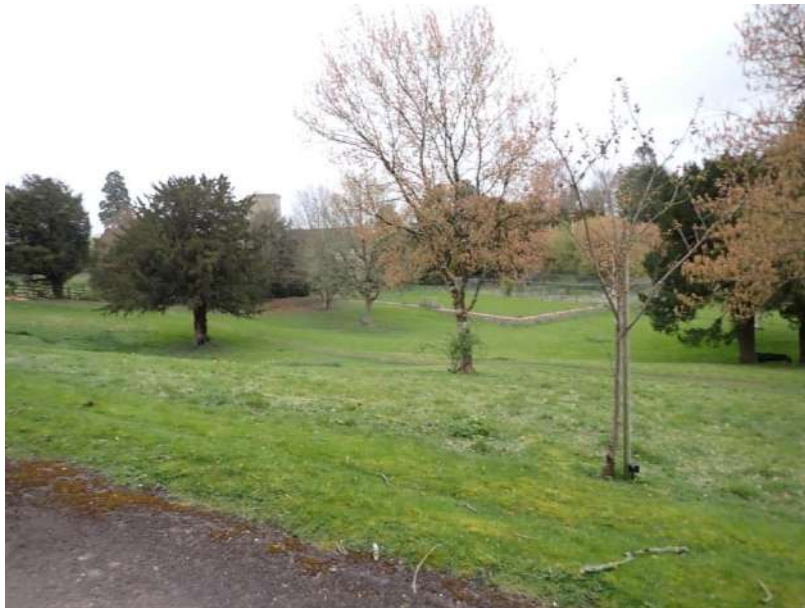
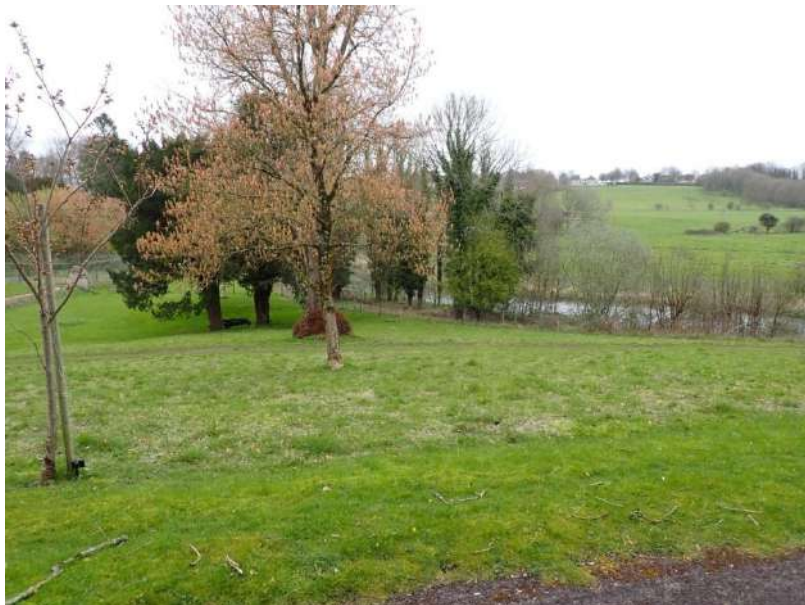
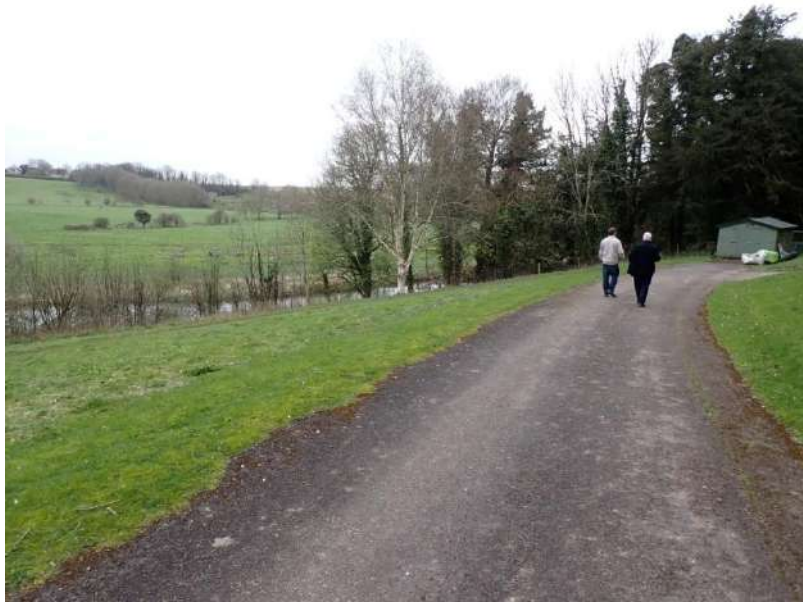
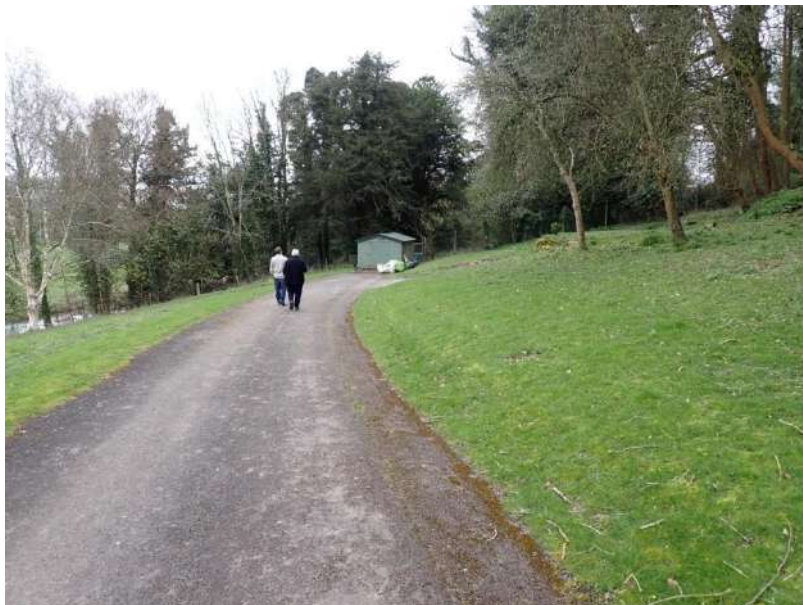
6.2.17 **Plates 32-36** present further views from differing positions of the eastern portion of the assessment site and of the 100% grassed ground cover here. **Plate 32** features the Grade II\* listed Netheravon House (**Site No. 16**), to the right (north) along with the modern tarmac driveway that extends from it to the south-east. **Plate 33** shows the Grade I listed parish church of All Saints (**Site No. 5**), in the background along with the modern tennis courts to the north-east. **Plates 34 and 35** feature the eastern end of the assessment site, leading onto the River Avon, further to the east. **Plates 35 and 36** show the modern tarmac driveway that extends south-eastwards to the south-eastern corner of the assessment and of a modern shed/outbuilding that currently stands here. **Plate 36** also shows the area of the proposed development site along with part of the dense and mature tree and bush cover of the southern site boundary of the assessment site.
