AN ARCHAEOLOGICAL DESK BASED ASSESSMENT STUDY  
OF LAND AT NETHERAVON HOUSE,  
NETHERAVON, WILTSHIRE (VERSION 2).

**[Site Centred at National Grid Reference: SU 1486 4823]**

PREPARED FOR MR. ANDREW WATTON OF BOURNE VALLEY ASSOCIATES ON  
BEHALF OF HIS CLIENTS - MR. & MRS. VEITCH

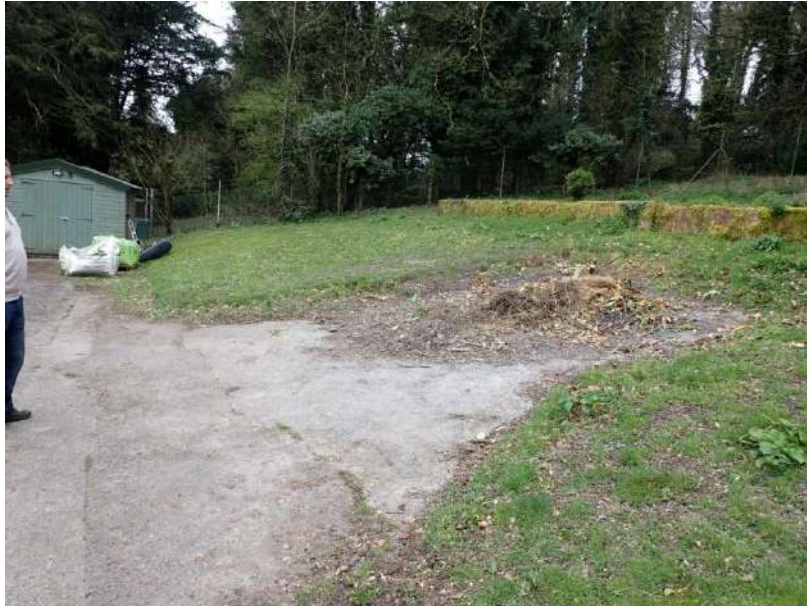
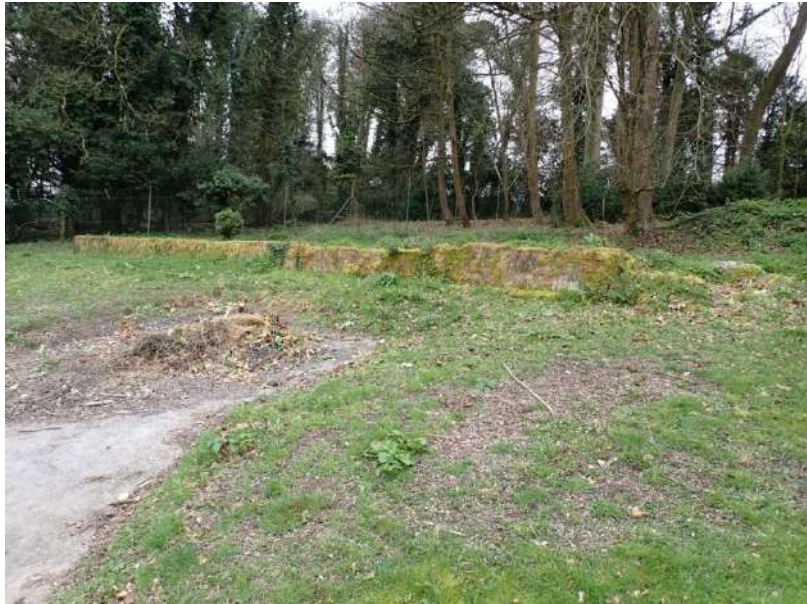
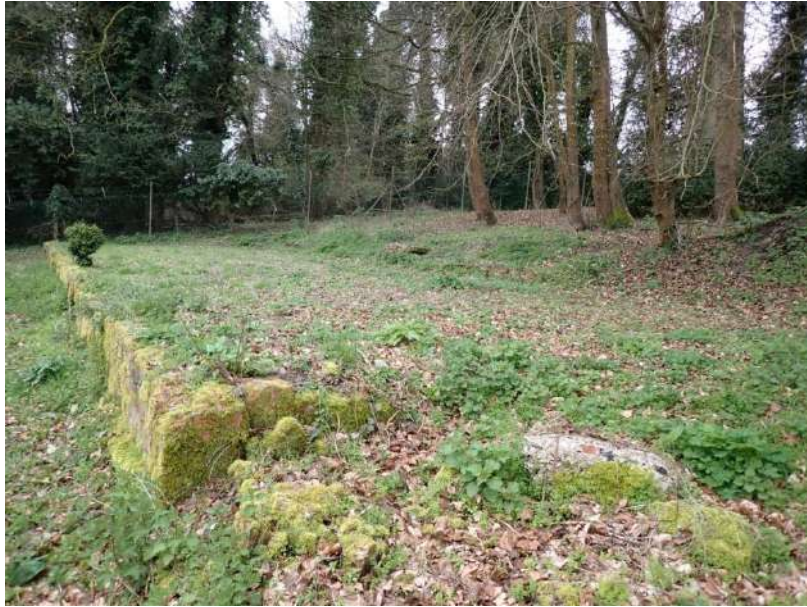
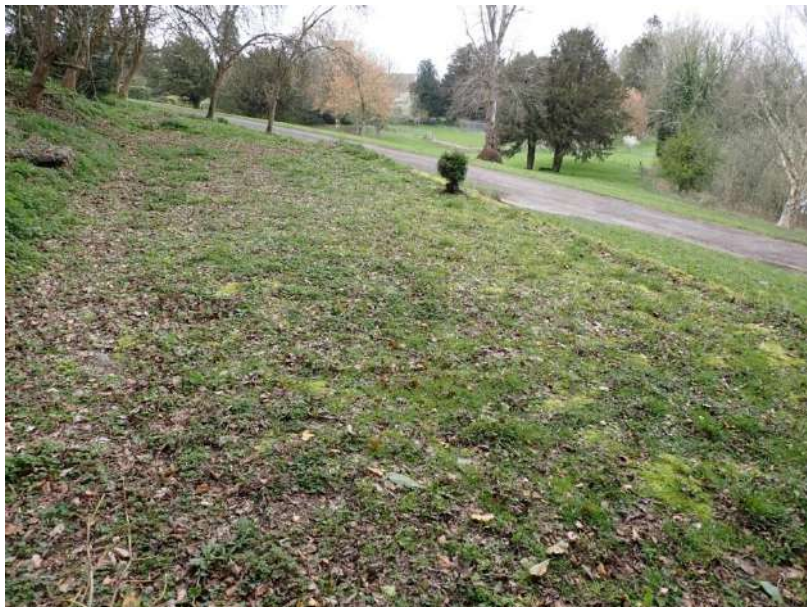
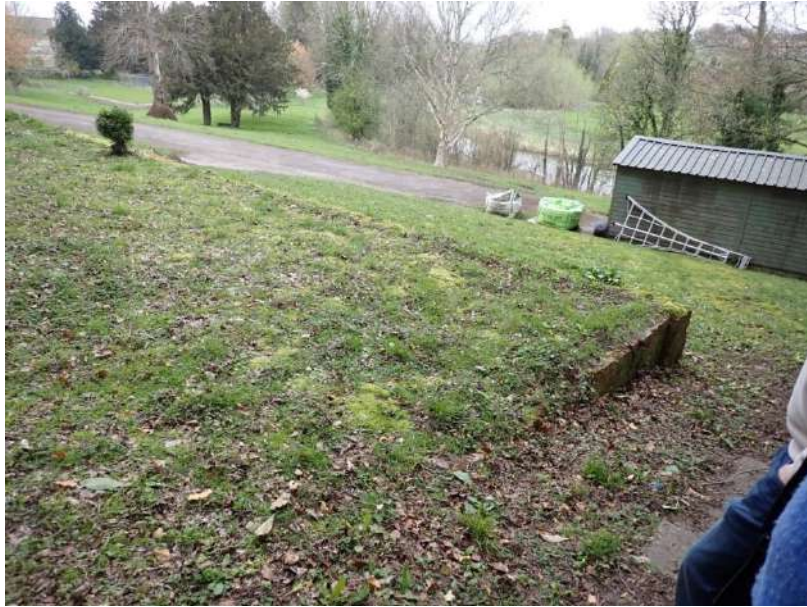
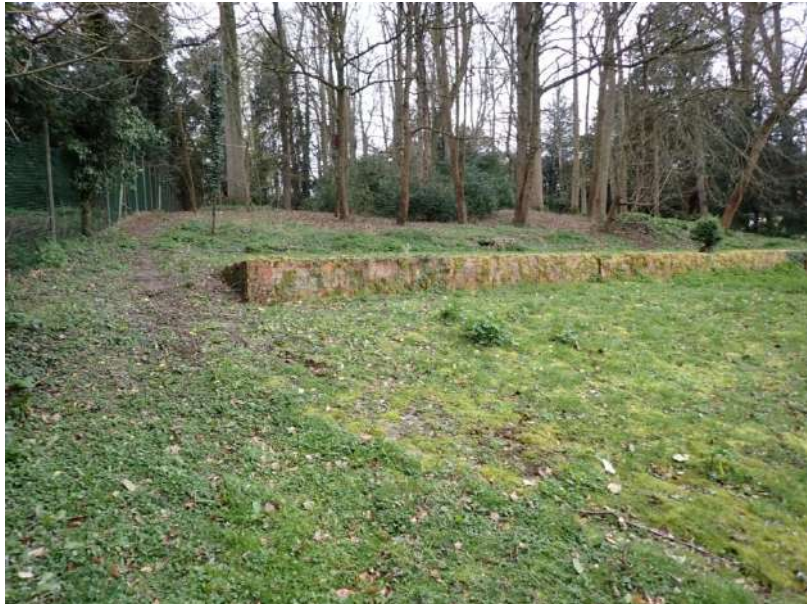
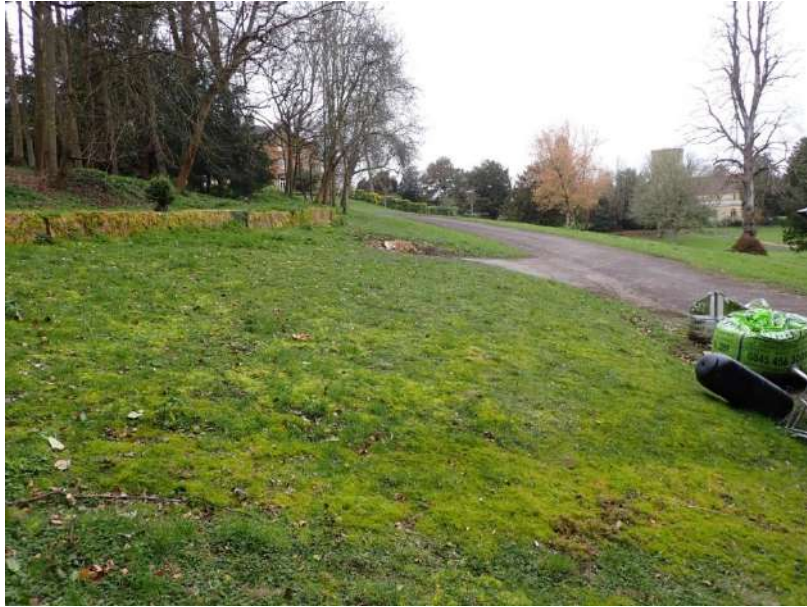
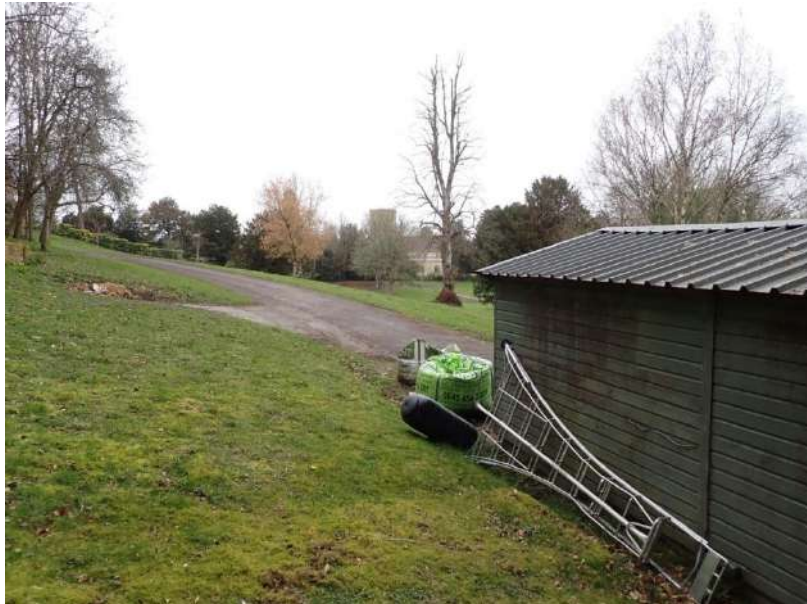
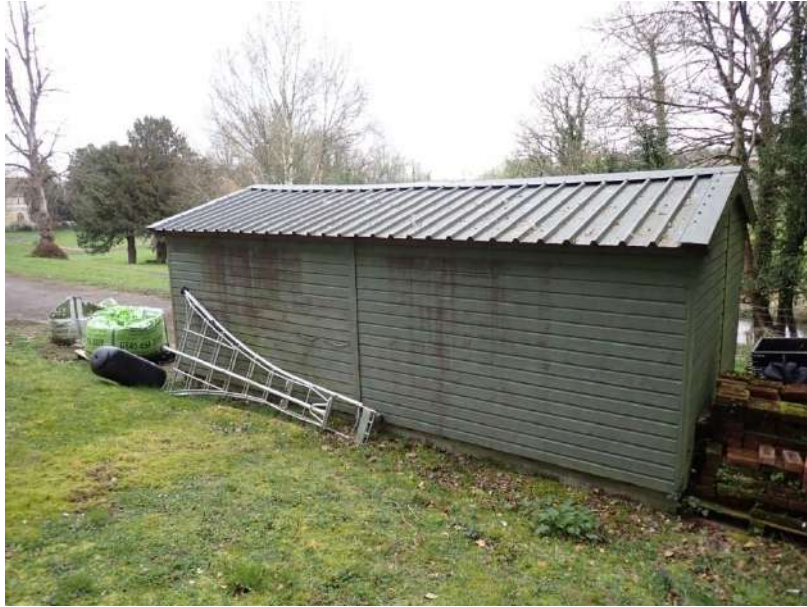
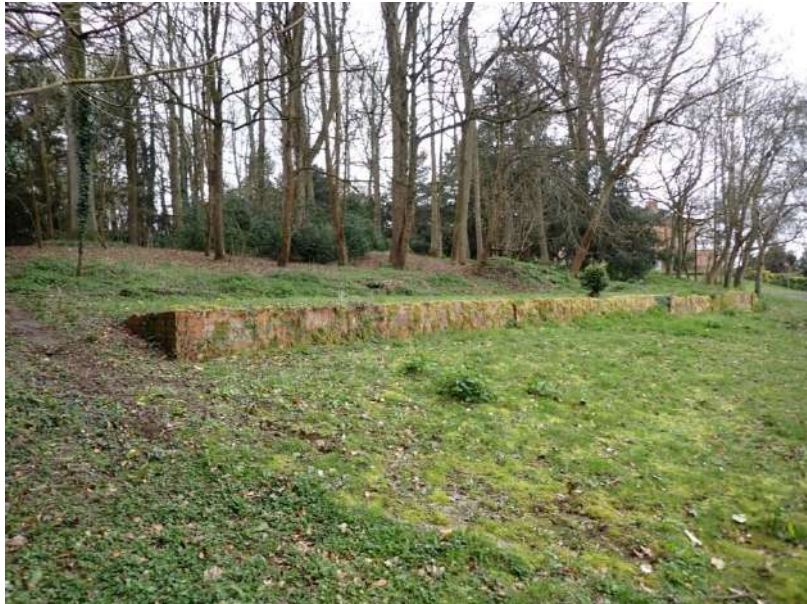
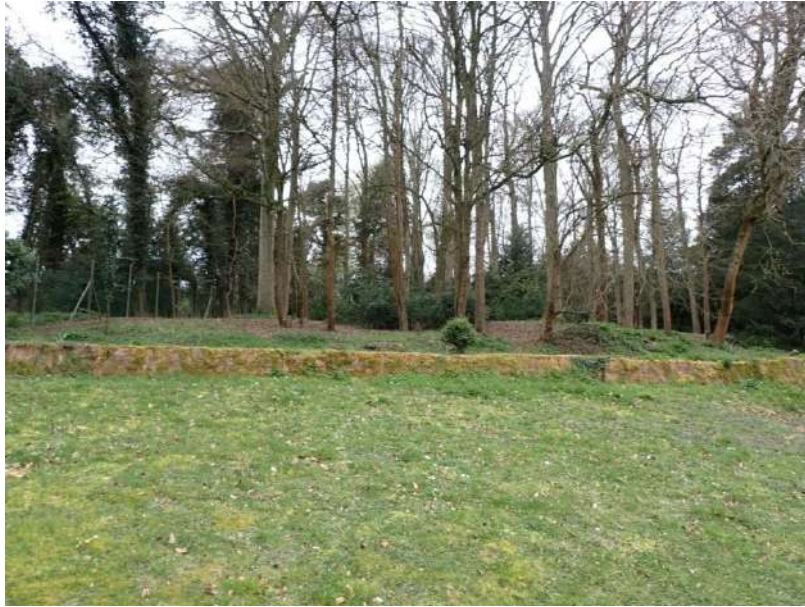
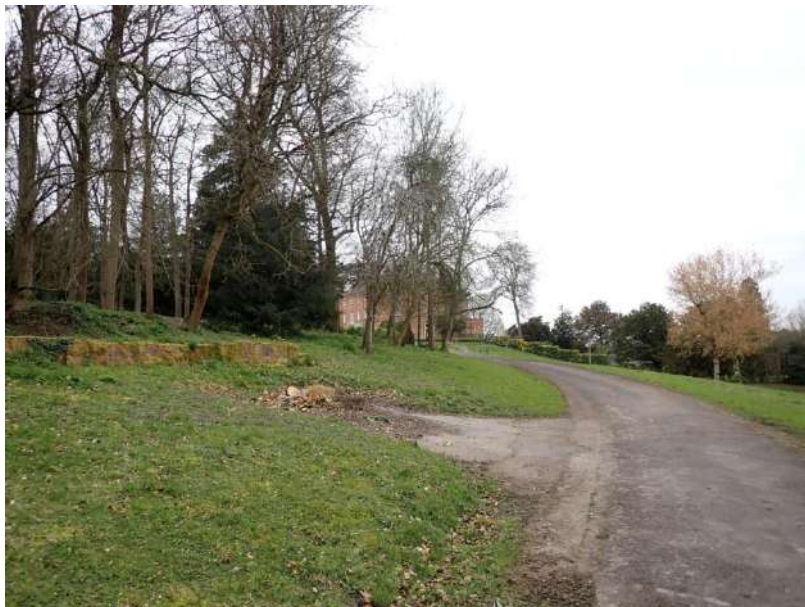
6.2.18 **Plates 37-48** present a number of images from many differing positions of the area of the proposed development site and of the site of the aforementioned early modern brick built structure (**Site No. 129**), that currently occupies this area, along with further views of the modern shed/outbuilding that currently stands at this south-eastern corner of the assessment site. **Plates 37-39 and Plates 42 and 43** provide further views of the dense and mature tree and bush cover of the southern site boundary in the background. **Plates 43 and 44** also show the Grade I listed parish church of All Saints (**Site No. 5**) in the background. **Plates 46-48** provide further views of the dense and mature tree and bush cover of the southern site boundary in the background. **Plate 48** also shows the Grade II\* listed Netheravon House (**Site No. 16**) in the background.

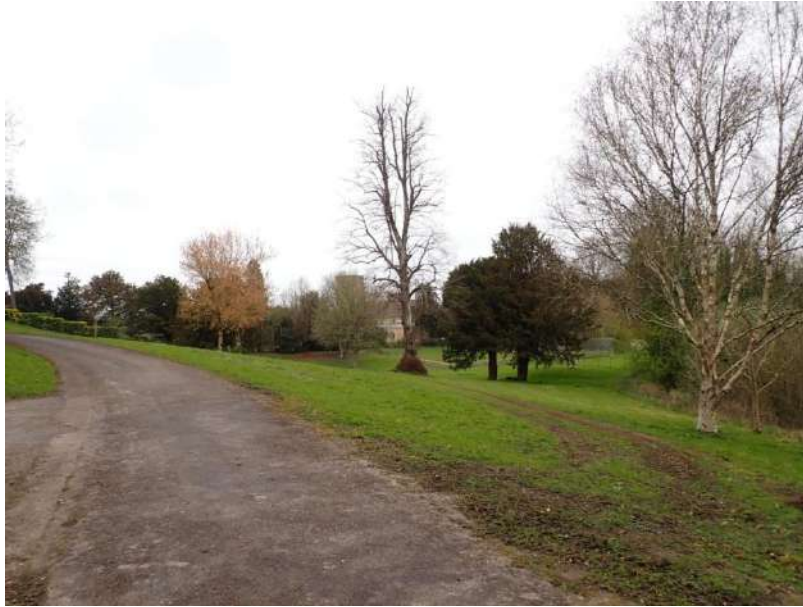
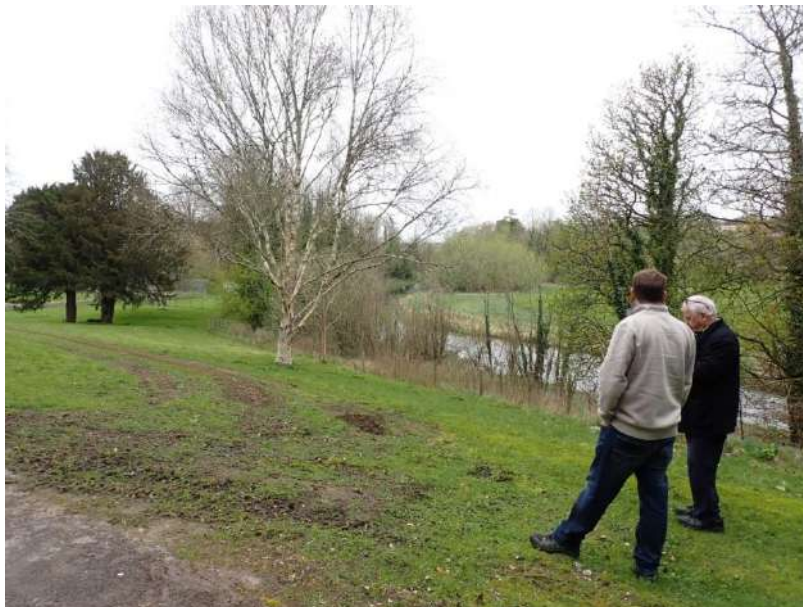
6.2.19 **Plates 49 and 50** feature the eastern portion of the assessment site from eastern and southern positions and show the 100% grassed ground cover here. **Plate 49** shows the line of the modern tarmac driveway that extends to the south-eastern corner of the assessment site along with a view of the Grade I listed parish church of All Saints (**Site No. 5**), in the background. **Plate 50** shows the eastern end of the assessment site and of the River Avon, beyond this, further to the east.

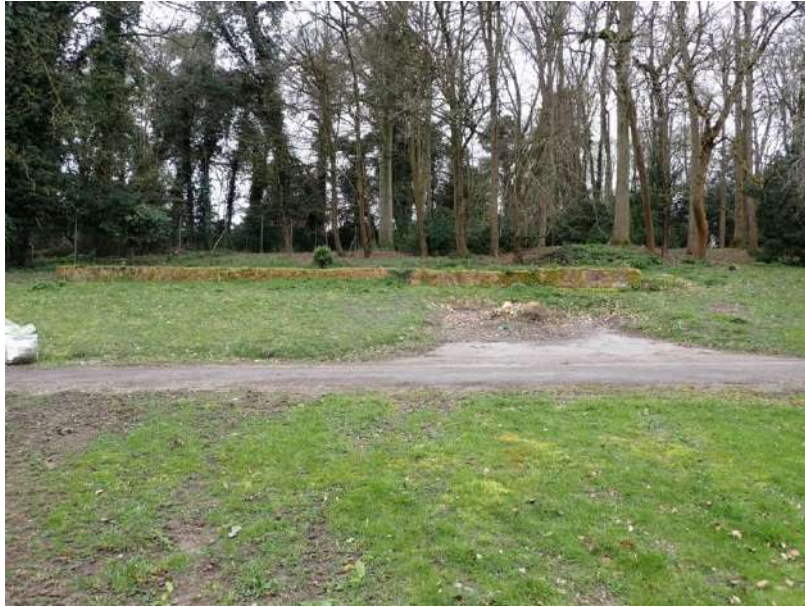
**Plate 51: View of the assessment site, from the north**

6.2.20 **Plate 51** presents a further view of the area of the proposed development site from a northern position, of the early modern brick built structure that currently occupies this area (**Site No. 129**) and of the dense and mature tree cover of the southern site boundary in the background.

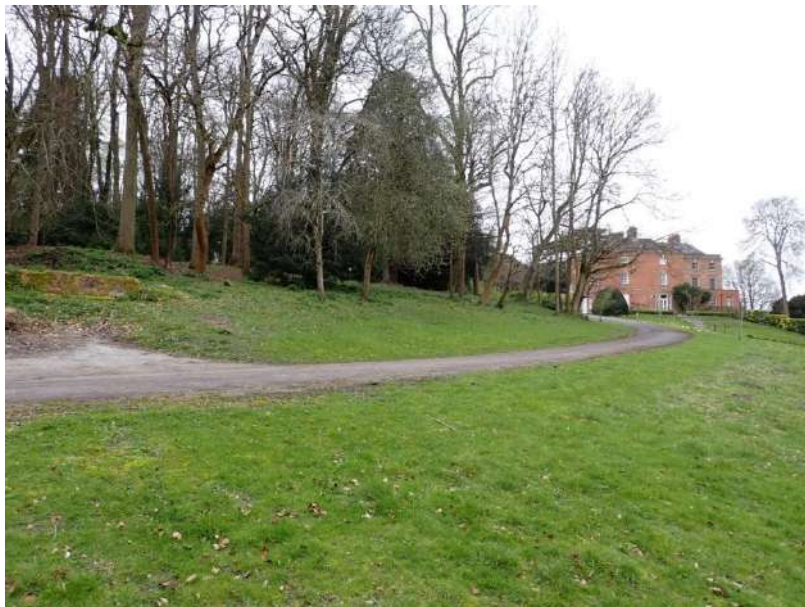
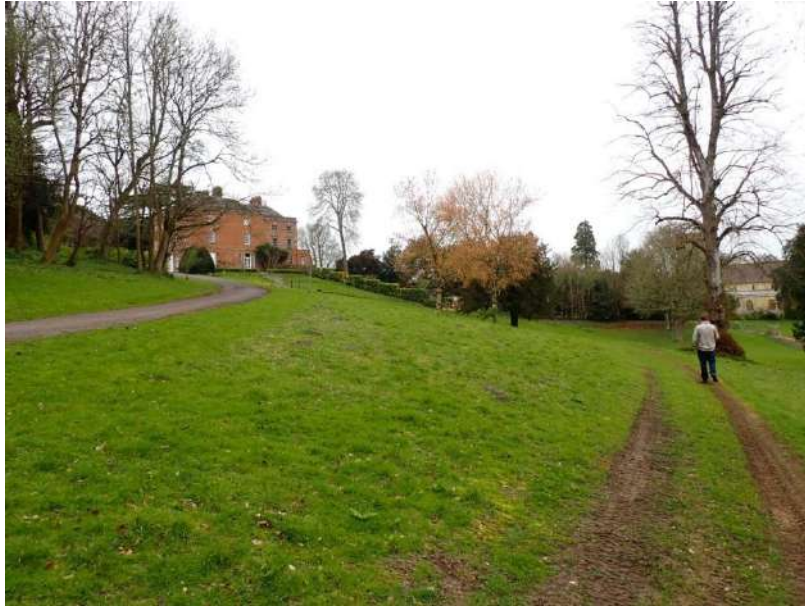
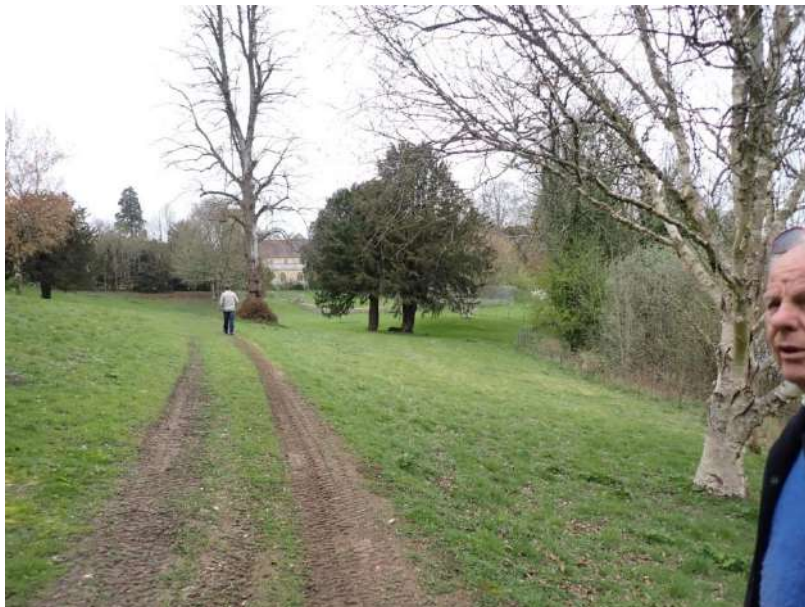
6.2.21 **Plates 52-54** present further images of the eastern portion of the assessment site from various eastern viewpoints and of the 100% grassed ground cover here. **Plates 52 and 53** feature the dense and mature tree and bush cover of the southern boundary of the assessment site along with further views of the Grade II\* listed Netheravon House (**Site No. 16**), in the background. The modern tarmac driveway that extends to the south-east from Netheravon House is also shown. **Plates 53 and 54** also show the eastern end of the assessment site, that leads onto the River Avon further to the east and of the various tree planting that has taken place in association with the landscaping of the grounds of Netheravon house (**Site No. 73**). The Grade I listed parish church of All Saints (**Site No. 5**) is also featured in the background.

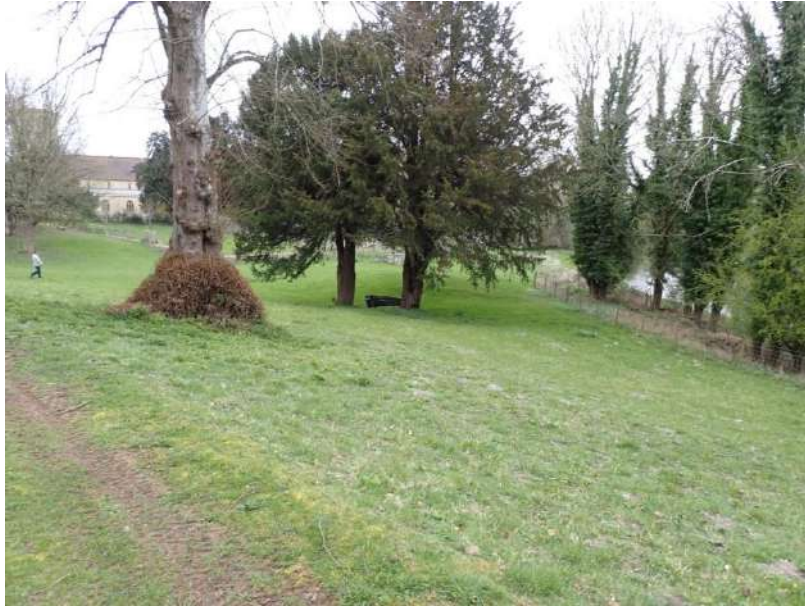
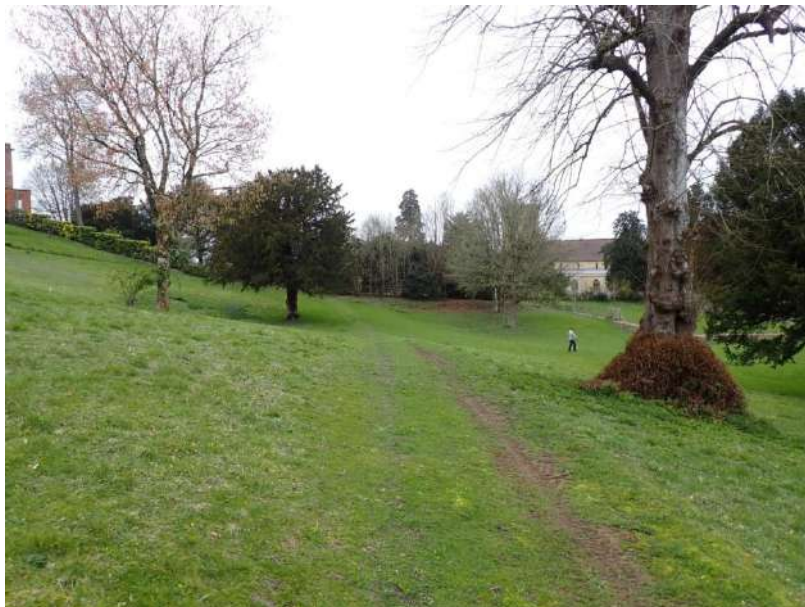
6.2.22 **Plates 55 and 56** furnish further images of the eastern portion and eastern end of the assessment site from several south-eastern viewpoints and show the 100% grassed ground cover here. These images also show the tree planting associated with the landscaping of the grounds of Netheravon house (**Site No. 73**). The Grade I listed parish church of All Saints (**Site No. 5**) is also featured in the background.

**Plate 55: View of the assessment site, from the south-east**

**Plate 56: View of the assessment site, from the south-east**

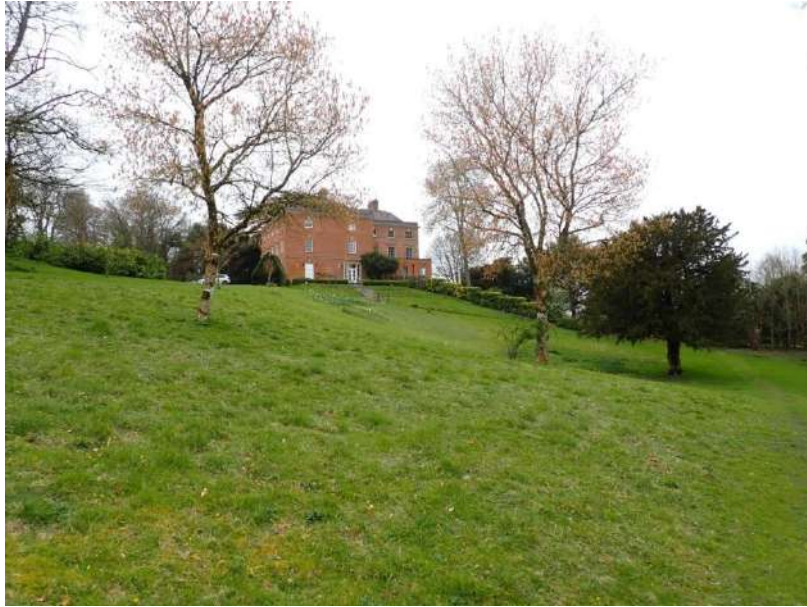
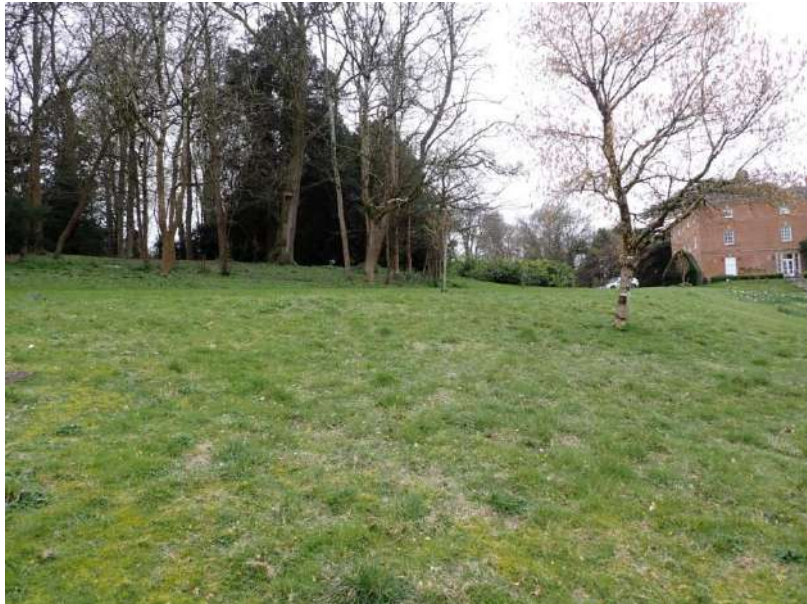
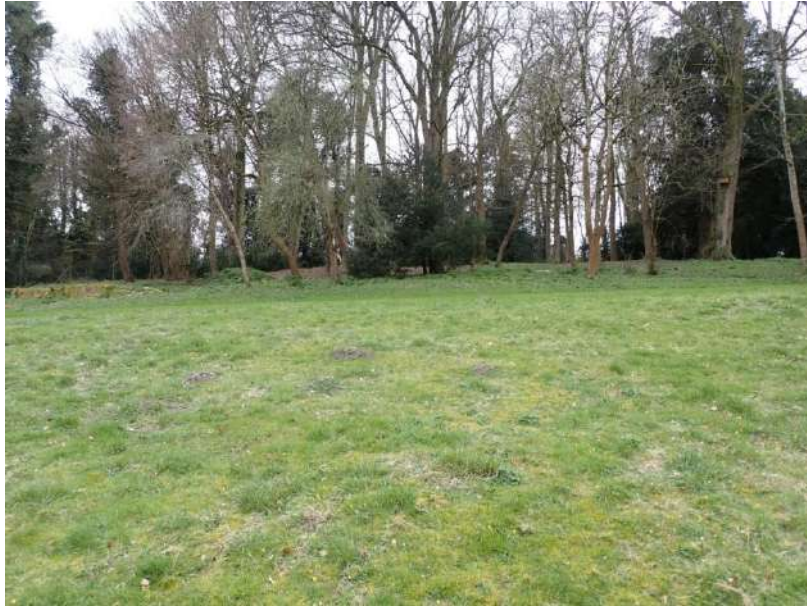
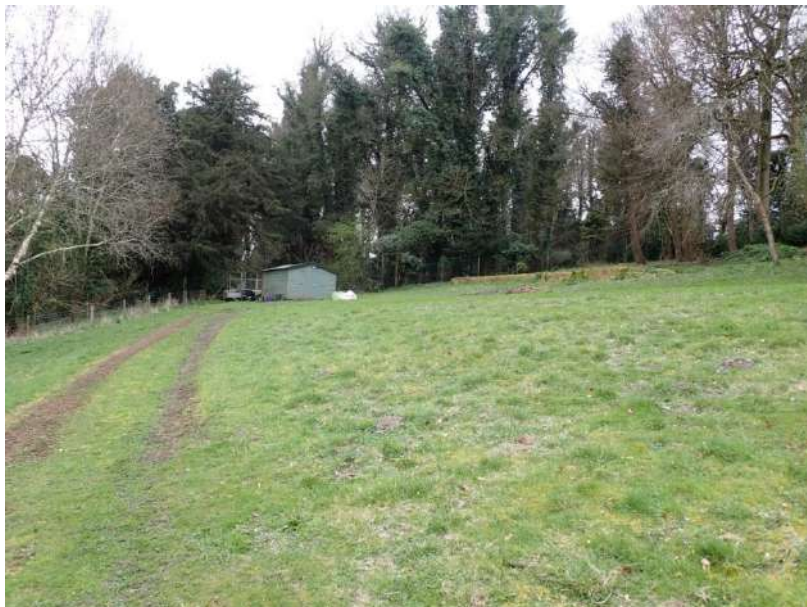
6.2.23 **Plates 57-60** present further views of the eastern portion of the assessment site from differing northern vantage points and show the 100% grassed ground cover here. **Plate 57** shows the Grade II\* listed Netheravon House (**Site No. 16**), in the background. **Plate 58** also shows the Grade II\* listed Netheravon House (**Site No. 16**), in the background along with the dense and mature tree and bush cover of the southern boundary of the assessment site. **Plate 59** also shows this southern site boundary in the background. **Plate 60** further shows this southern site boundary along with the area of the proposed development site and of the modern shed/outbuilding that currently stands here, all in the background.

**Plate 57: View of the assessment site, from the north-east**

**Plate 58: View of the assessment site, from the north-east**

**Plate 59: View of the assessment site, from the north**

**Plate 60: View of the assessment site, from the north-west**

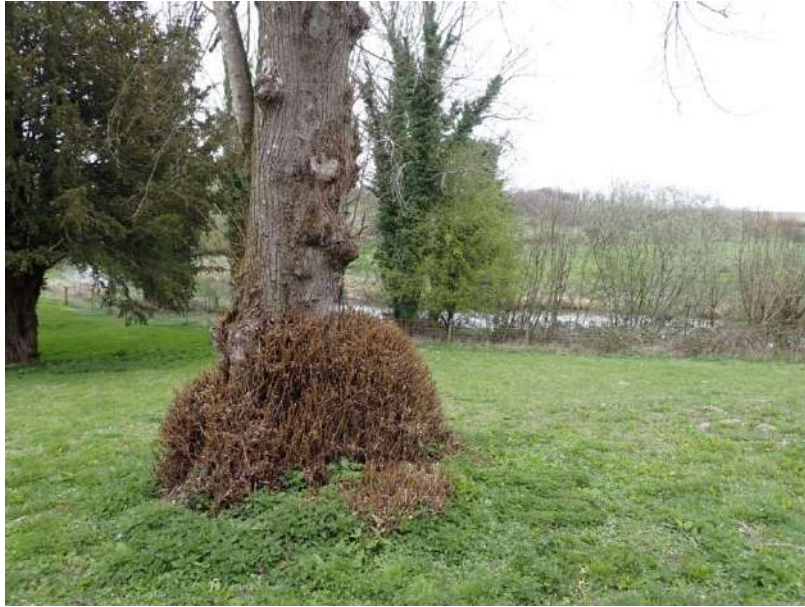
**Plate 61: View of the assessment site, from the south-west**

6.2.24 **Plate 61** features the eastern end of the assessment site, with the River Avon in the background, to the east.

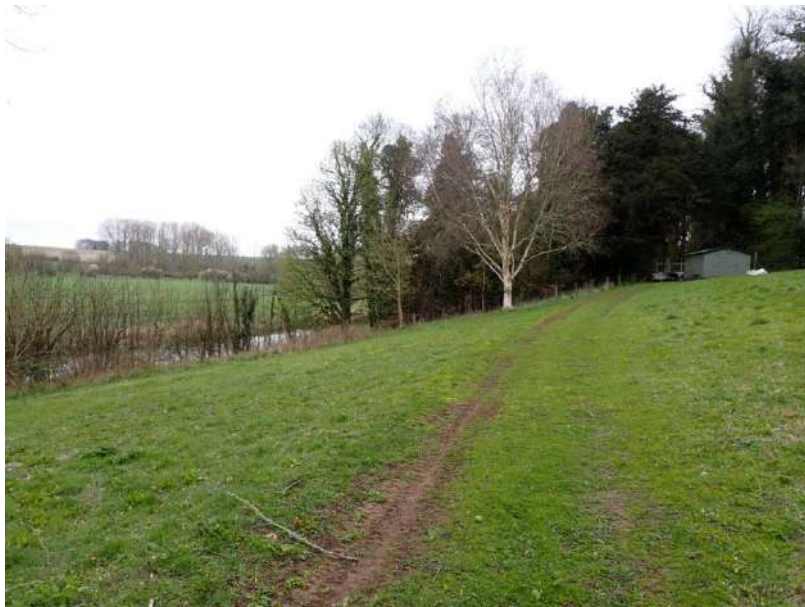
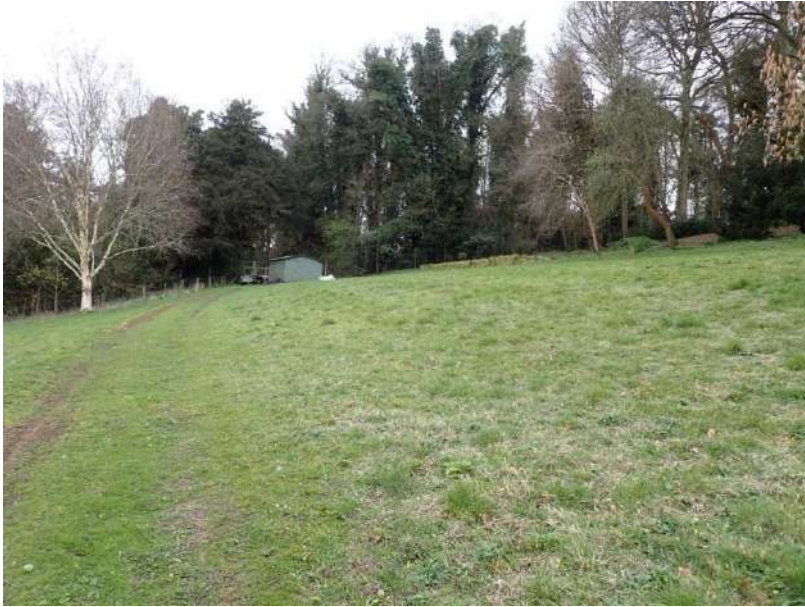
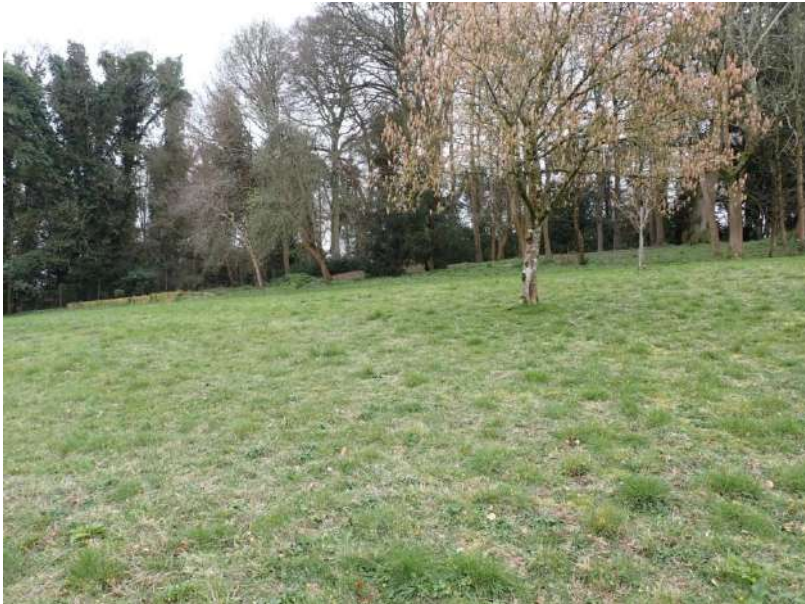
**Plate 62: View of the assessment site, from the north-west**

6.2.25 **Plates 62-64** provide further views of the eastern portion of the assessment site from various northern positions and show the 100% grassed ground cover here. **Plates 62 and 63** feature the dense and mature tree and bush cover of part of the southern boundary of the assessment site along with the area of the proposed development site and of the modern shed/outbuilding that currently stands here, all in the background. **Plate 64** also shows the southern site boundary in the background.

**Plate 63: View of the assessment site, from the north-west**

**Plate 64: View of the assessment site, from the north**

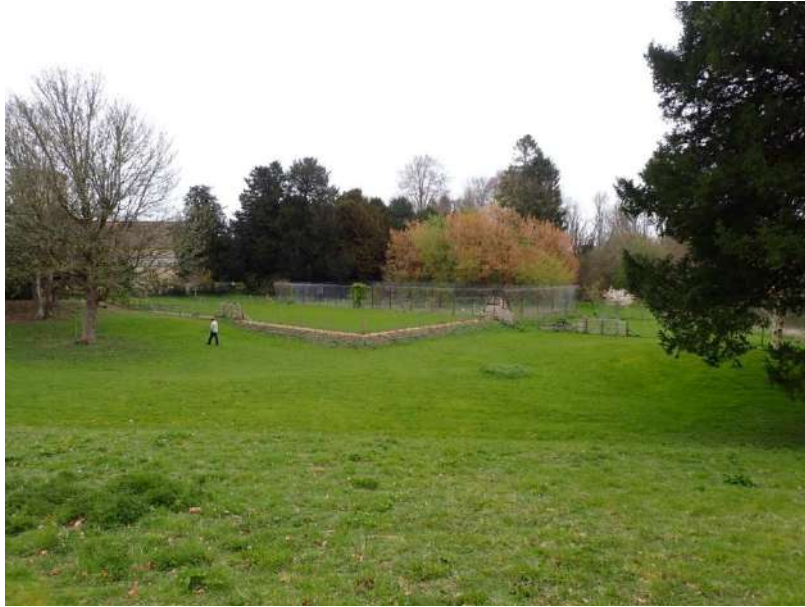
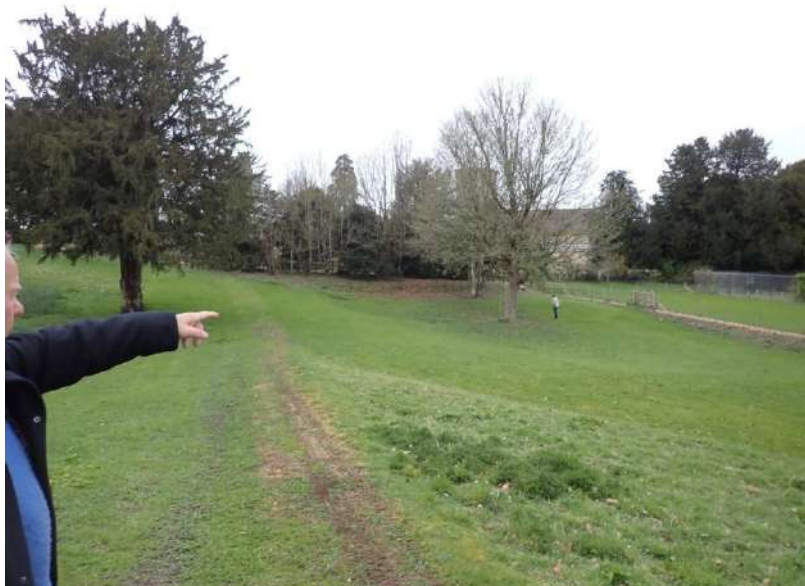
6.2.26 **Plates 65 and 66** show further views of the eastern portion of the assessment site from several south-eastern perspectives and the 100% grassed ground cover here. The Grade I listed parish church of All Saints (**Site No. 5**) is also shown along with the modern tennis courts to the north-east and the dense and mature tree cover of the northern site boundary, all in the background.

**Plate 65: View of the assessment site, from the south-east**

**Plate 66: View of the assessment site, from the south-east**

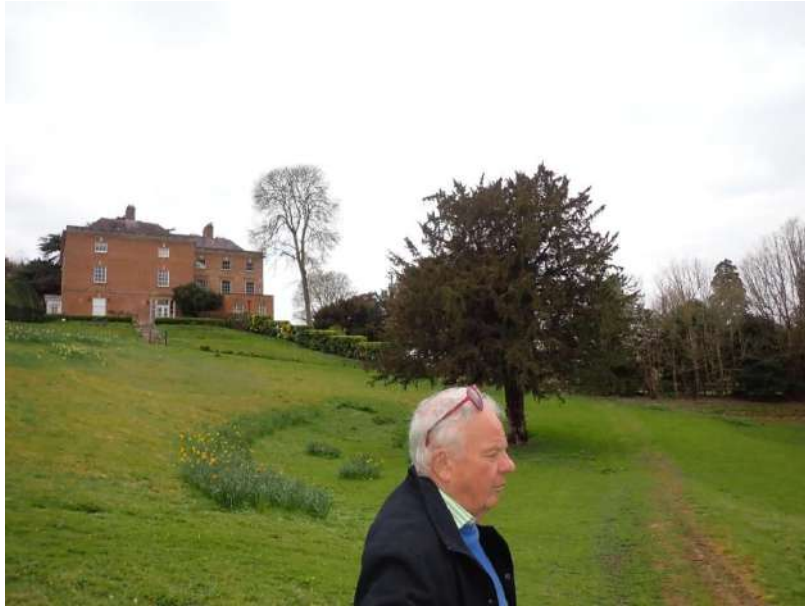
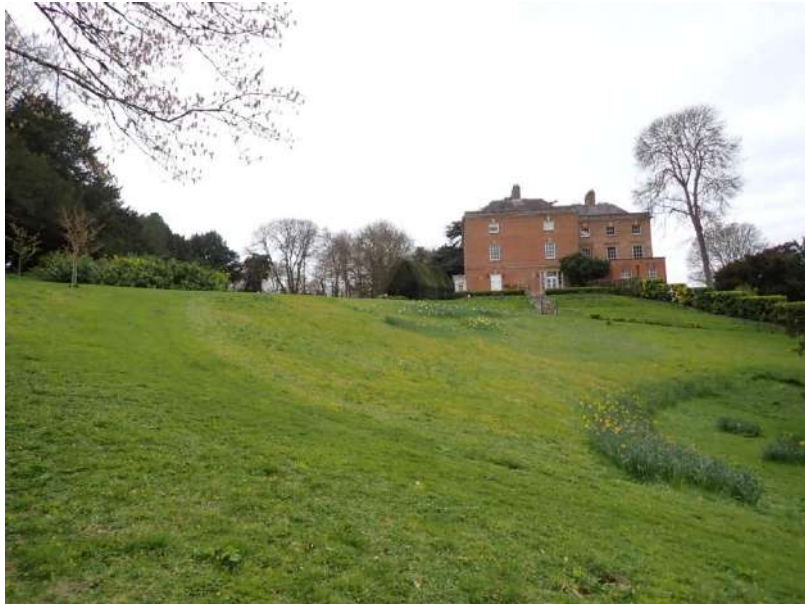
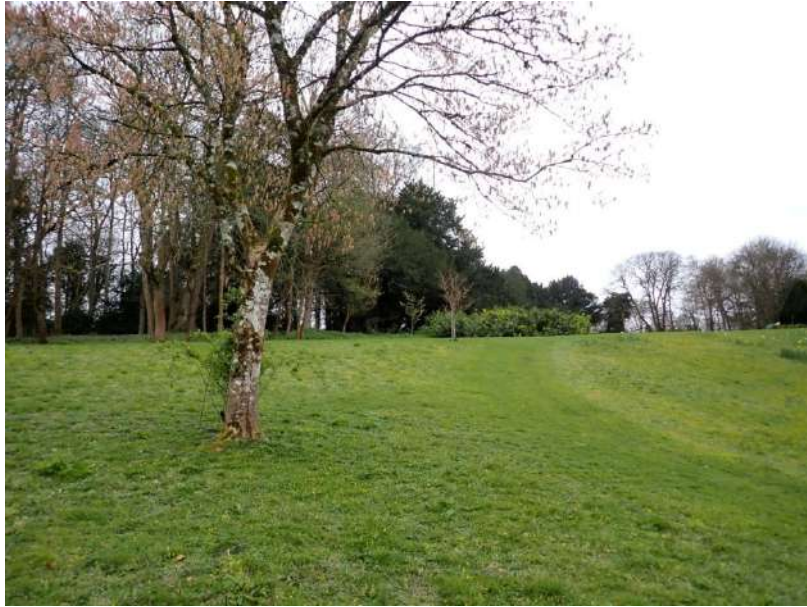
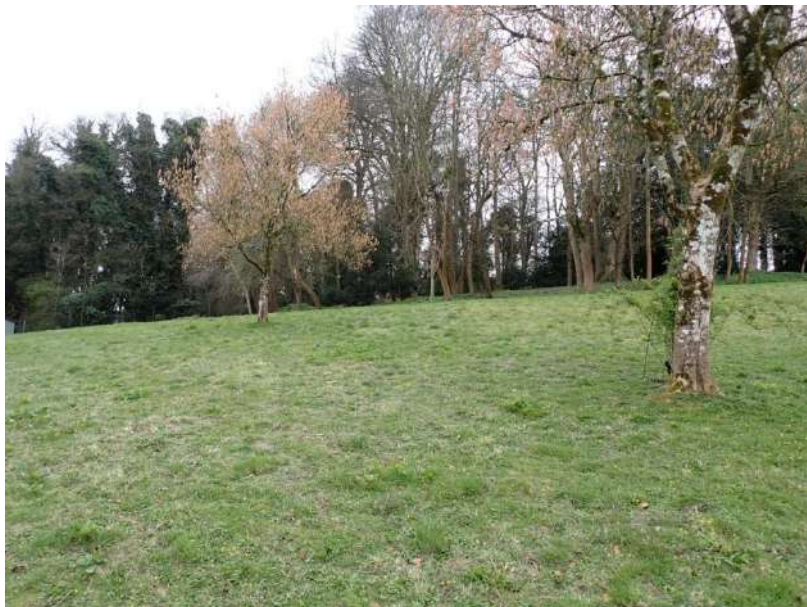
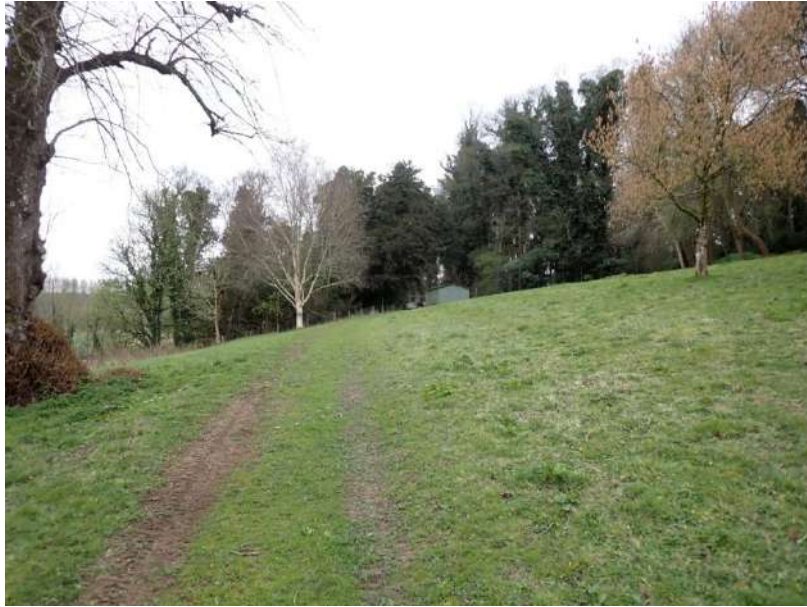
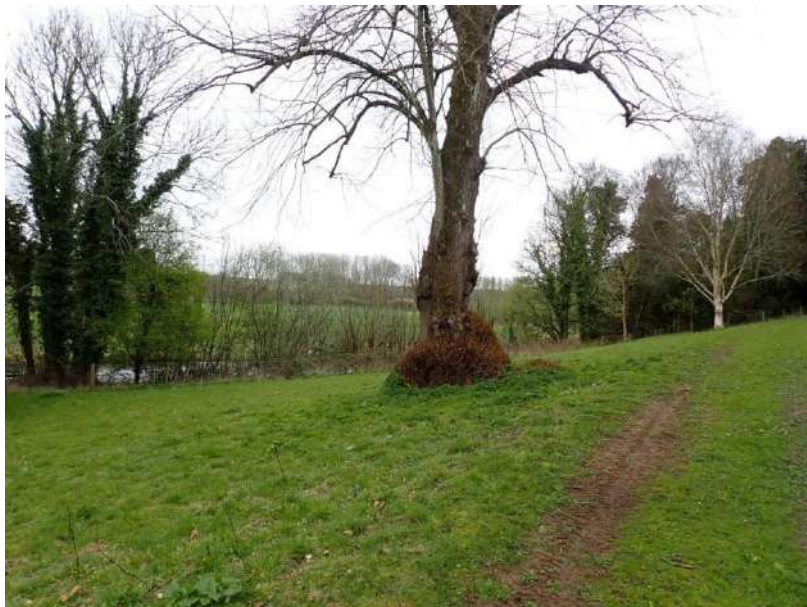
6.2.27 **Plates 67-79** present a number of further views of the eastern portion of the assessment site and of the 100% grassed ground cover here. **Plates 67 and 68** feature the Grade II\* listed Netheravon House in the background (**Site No. 16**). **Plates 69-72** show the dense and mature tree and bush cover of the southern boundary of the assessment site in the background. **Plates 72-75 and 78-79** feature the eastern end of the assessment site and the line of the River Avon beyond this, further to the east. **Plates 74 and 76-77** show the modern tennis courts to the north-east in the background. **Plates 76 and 77** also show the dense and mature tree cover of the northern site boundary and the Grade I listed parish church of All Saints (**Site No. 5**), all in the background.

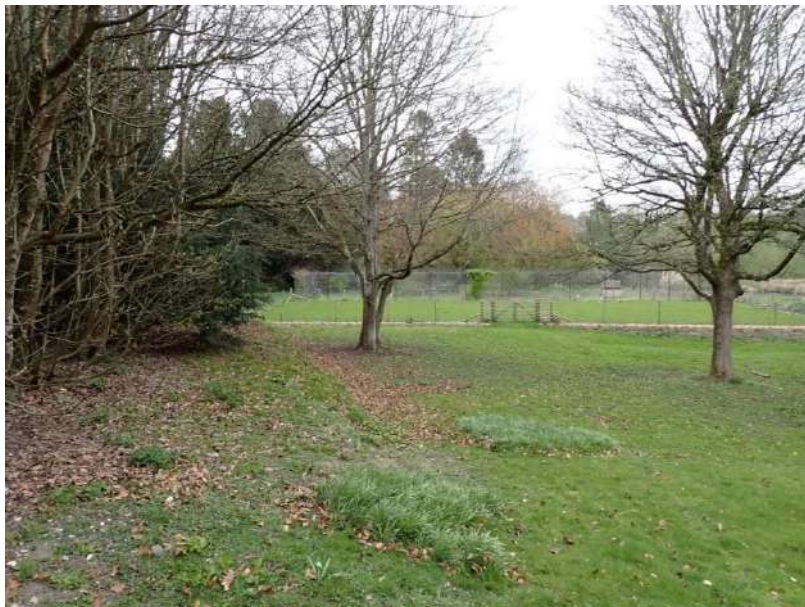
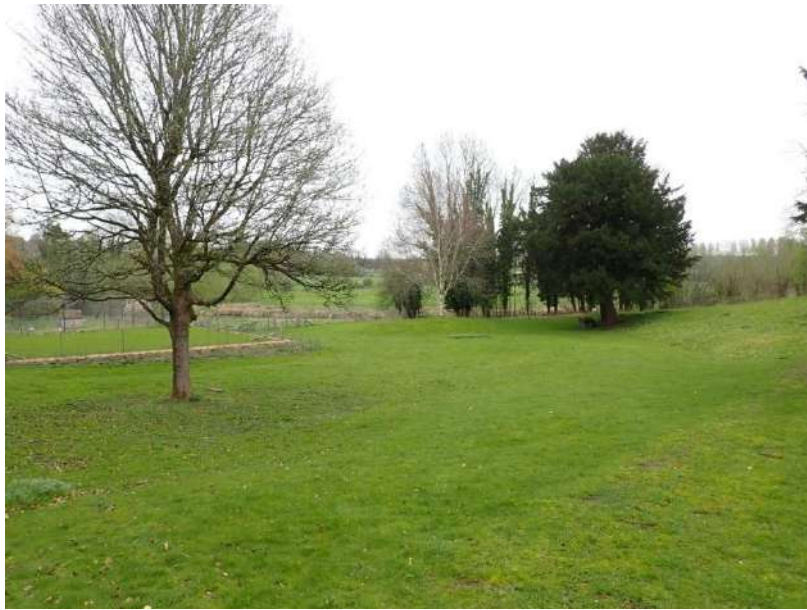
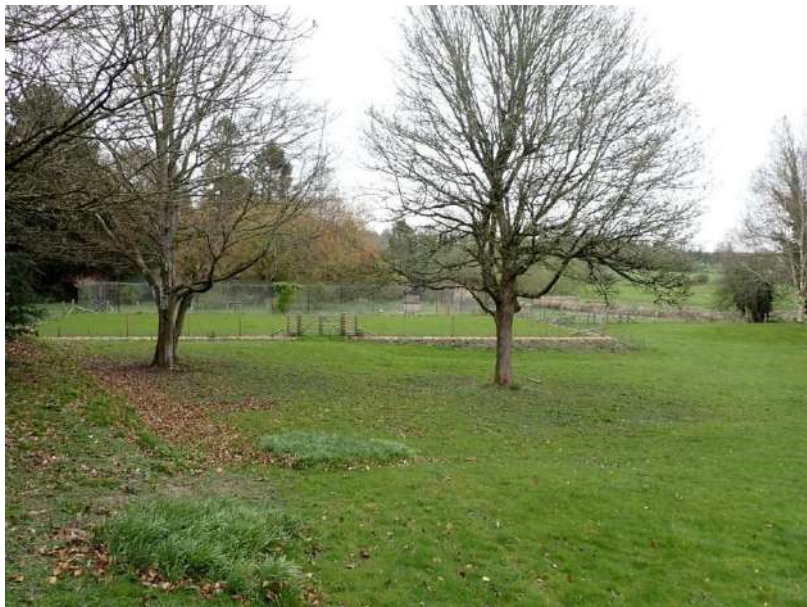
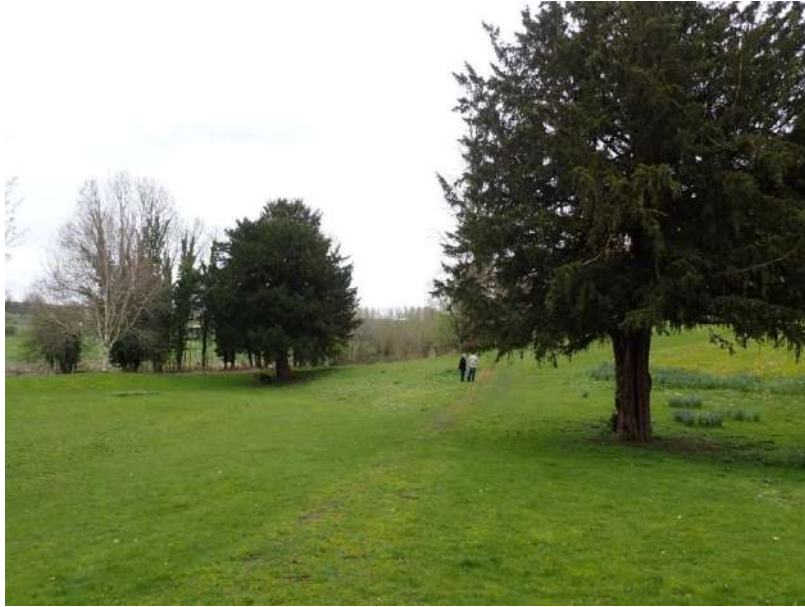
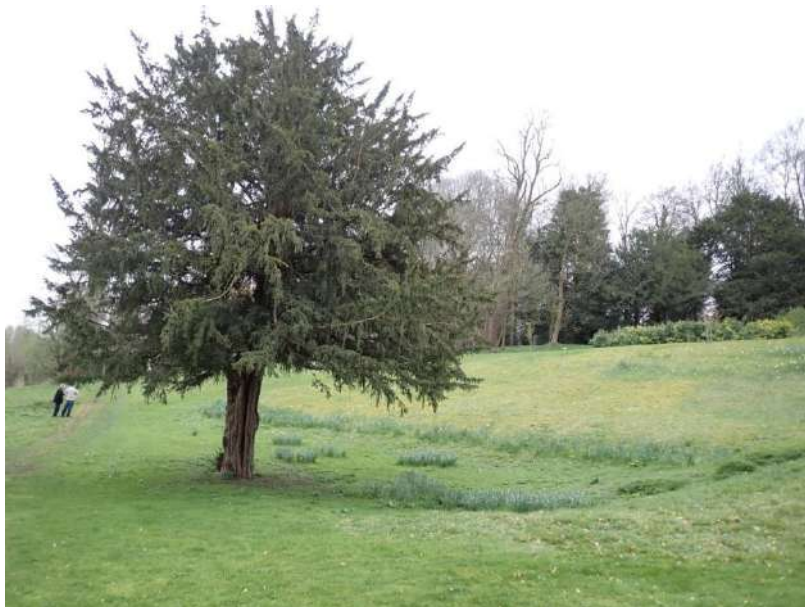
**Plate 80: View of the assessment site, from the south-west**

6.2.28 **Plates 80-84** furnish further images of the eastern portion of the assessment site from differing vantage points and show the 100% grassed ground cover here. **Plates 80-82** feature the modern tennis courts to the north-east along with the dense and mature tree cover of the northern site boundary in the background. **Plates 83 and 84** show the eastern end of the assessment site with **Plate 84** showing the southern site boundary in the background.

**Plate 81: View of the assessment site, from the west**

**Plate 82: View of the assessment site, from the south-west**

**Plate 83: View of the assessment site, from the north-west**

**Plate 84: View of the assessment site, from the north-west**

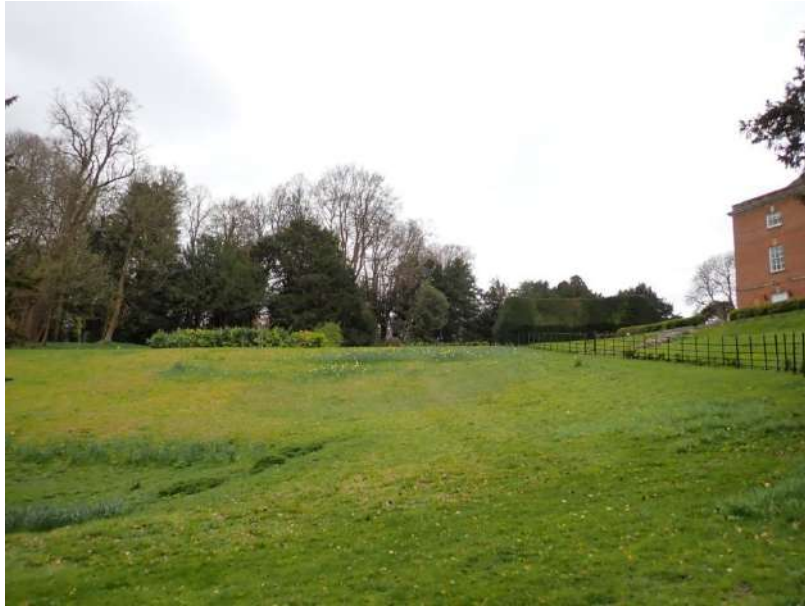
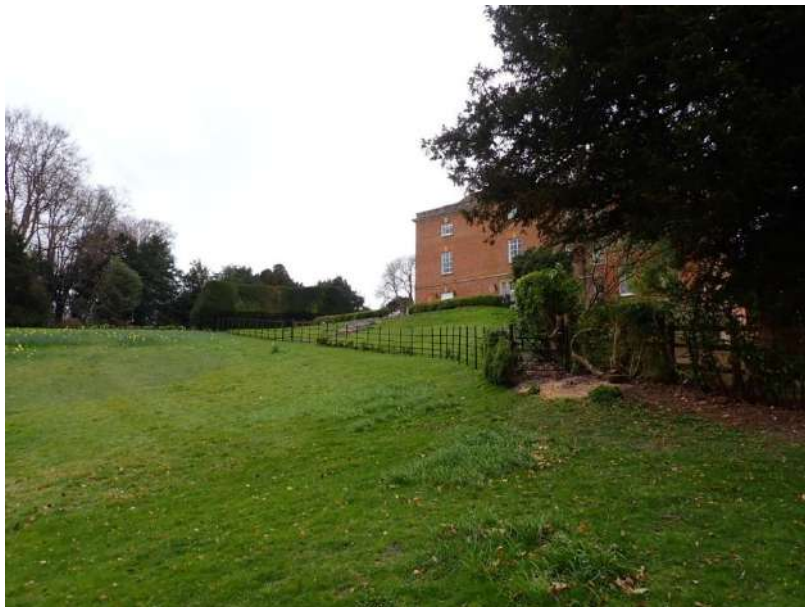
6.2.29 **Plates 85 and 86** were taken to the north-east of Netheravon House and show this designated heritage asset (**Site No. 16**) in the background, along with the dense and mature tree and bush cover of the southern site boundary of the assessment site in the background and the 100% grassed ground cover in the foreground here.

**Plate 85: View of the assessment site, from the north-east**

**Plate 86: View of the assessment site, from the north-east**
