AN ARCHAEOLOGICAL DESK BASED ASSESSMENT STUDY  
OF LAND AT NETHERAVON HOUSE,  
NETHERAVON, WILTSHIRE (VERSION 2).

**[Site Centred at National Grid Reference: SU 1486 4823]**

PREPARED FOR MR. ANDREW WATTON OF BOURNE VALLEY ASSOCIATES ON  
BEHALF OF HIS CLIENTS - MR. & MRS. VEITCH

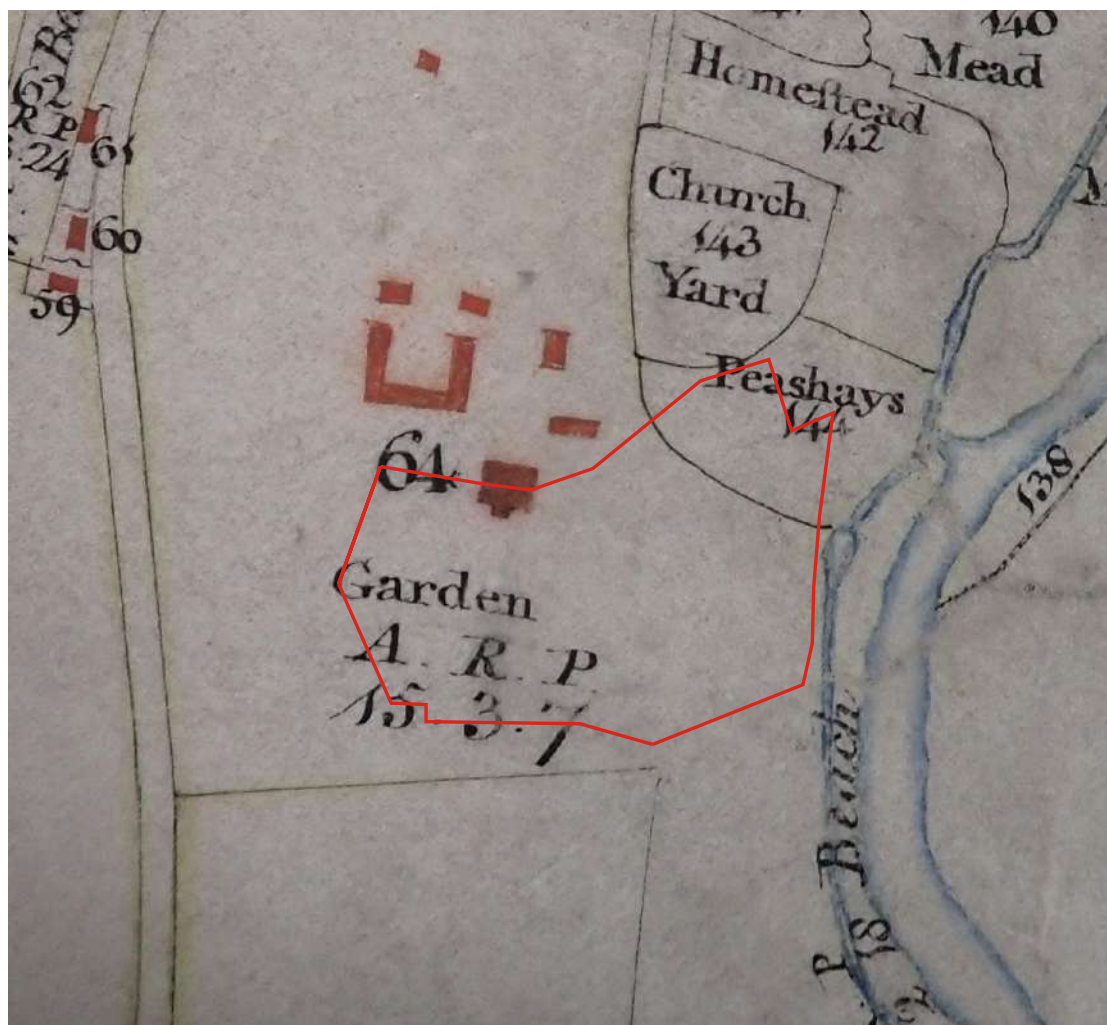
**Figure 7:** Extract from the Enclosure Award map for the parish of Netheravon of 1790, scale ten chains to one inch, (Archive ref: AEA31. The approximate boundaries of the assessment site are shown outlined in red.

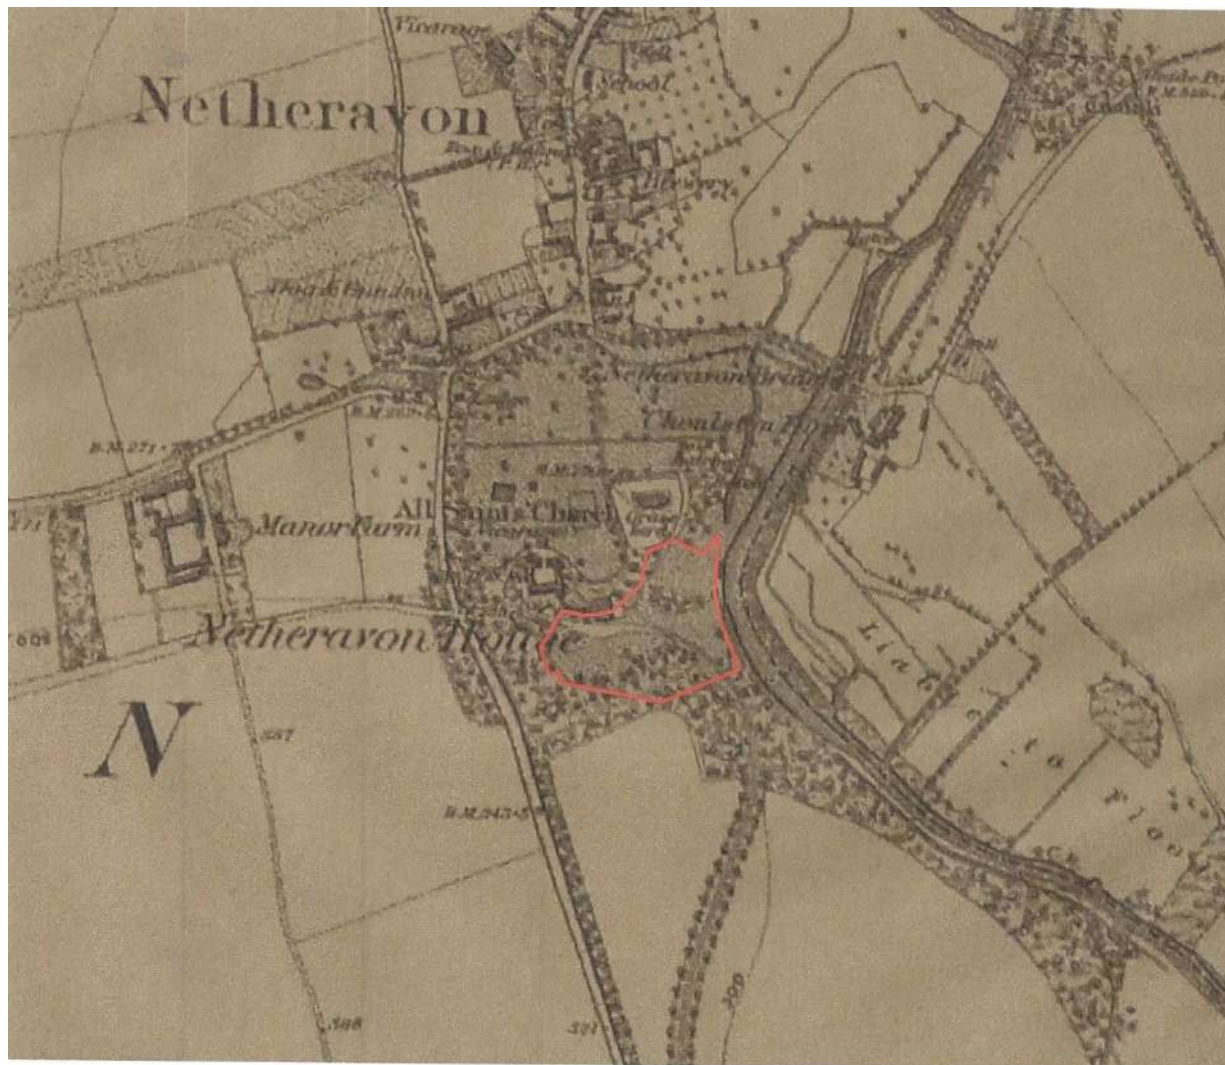
**Figure 8:** Extract from the First Edition 25 inch to one mile scale Ordnance Survey (O.S.) map of 1889, map sheet no. Wiltshire 47.5. The approximate boundaries of the assessment site are shown outlined in red.

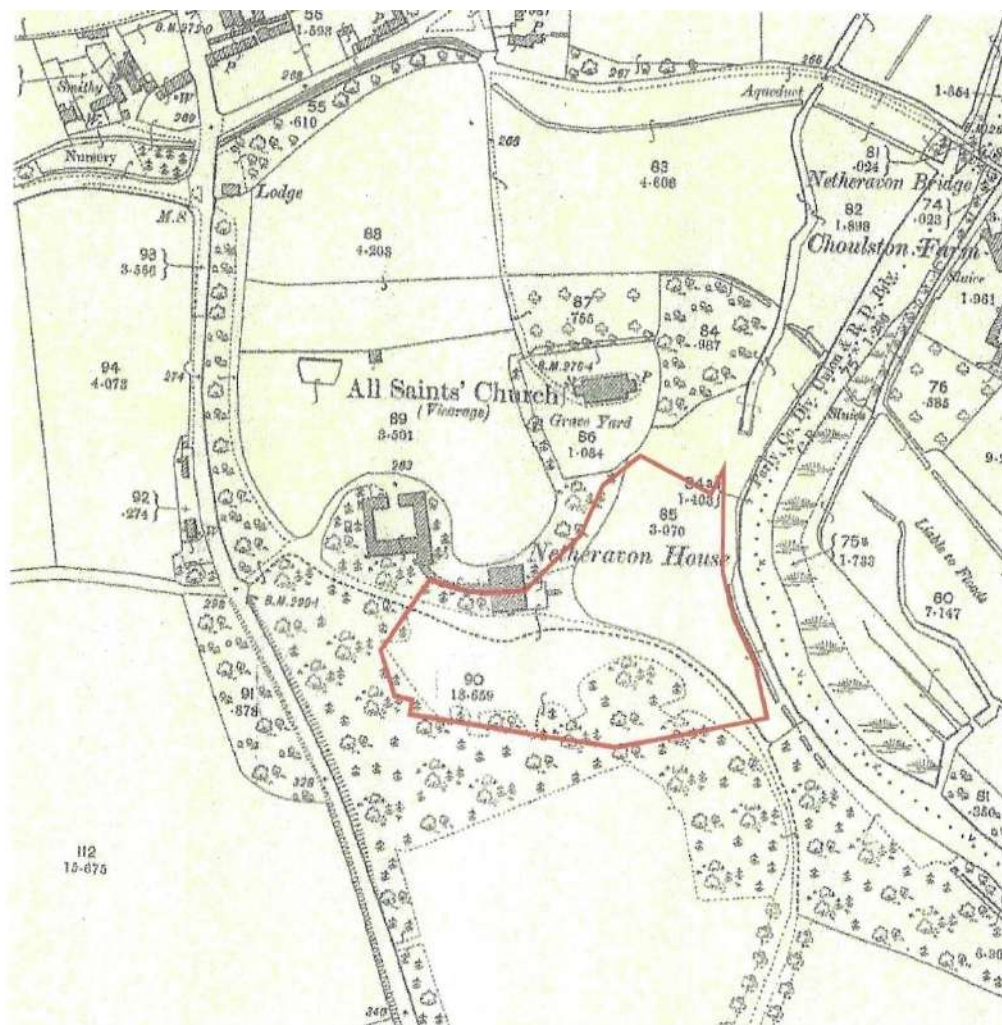
**Figure 9:** Extract from the Second Edition 25 inch to one mile scale Ordnance Survey (O.S.) map of 1901, map sheet no. Wiltshire 47.15. The approximate boundaries of the assessment site are shown outlined in red.

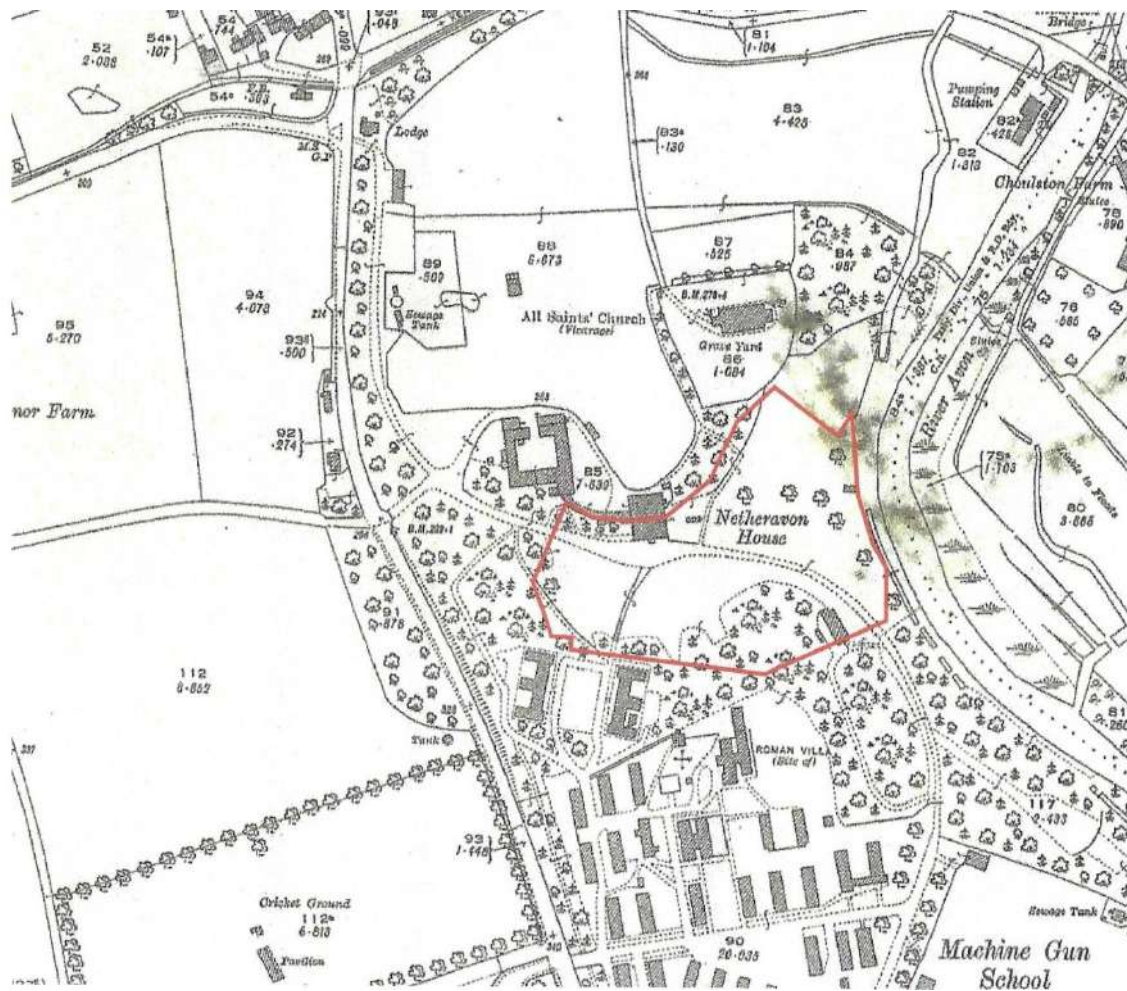
**Figure 10:** Extract from the Third Edition 25 inch to one mile scale Ordnance Survey (O.S.) map of 1924, map sheet no. Wiltshire 47.15. The approximate boundaries of the assessment site are shown outlined in red.

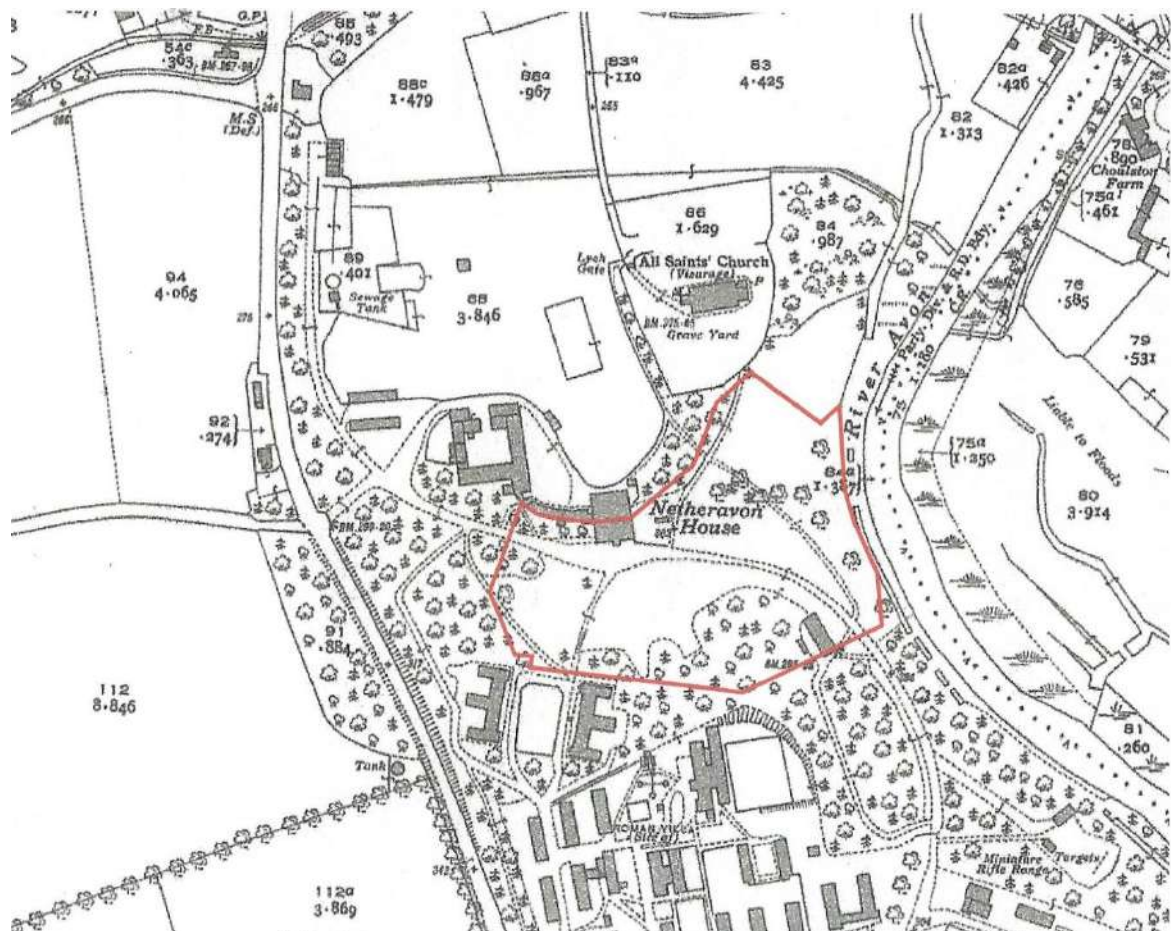
**Figure 11:** Extract from the Fourth Edition 25 inch to one mile scale Ordnance Survey (O.S.) map of 1938, map sheet no. Wiltshire 47.15. The approximate boundaries of the assessment site are shown outlined in red.

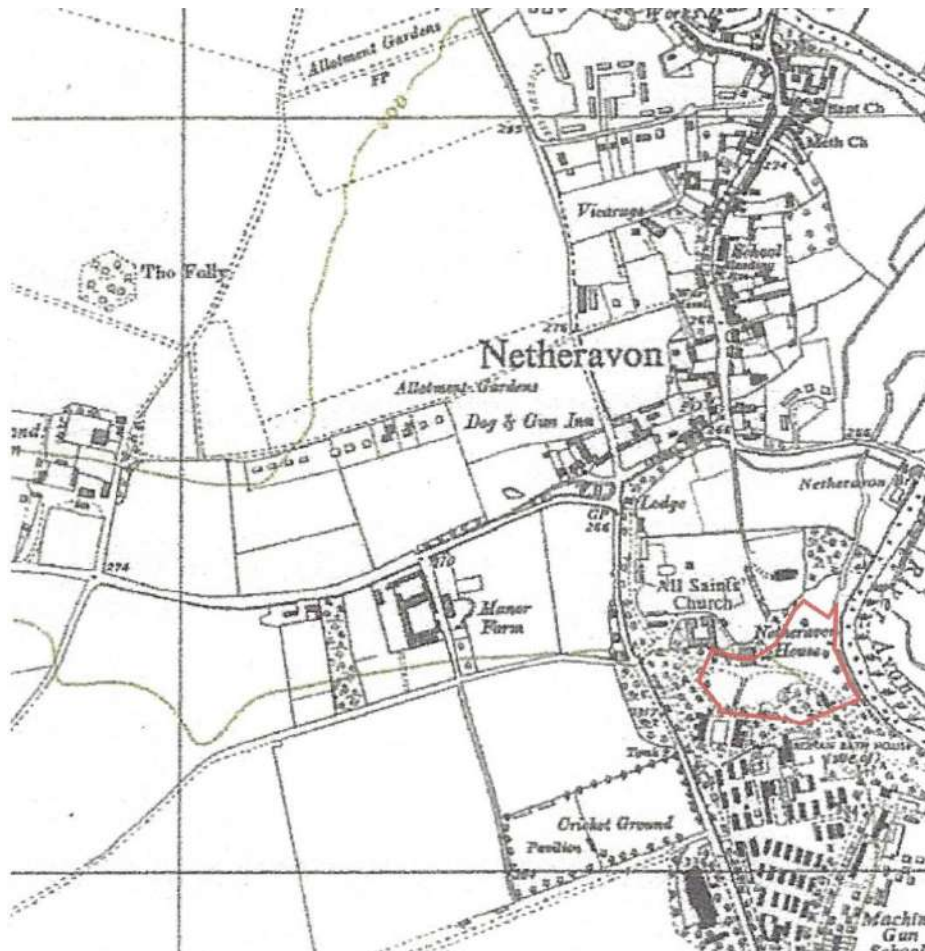
**Figure 12:** Extract from the 1:10,560 scale Ordnance Survey (O.S.) map of 1961, map sheet no. SU 14 NW. The approximate boundaries of the assessment site are shown outlined in red.

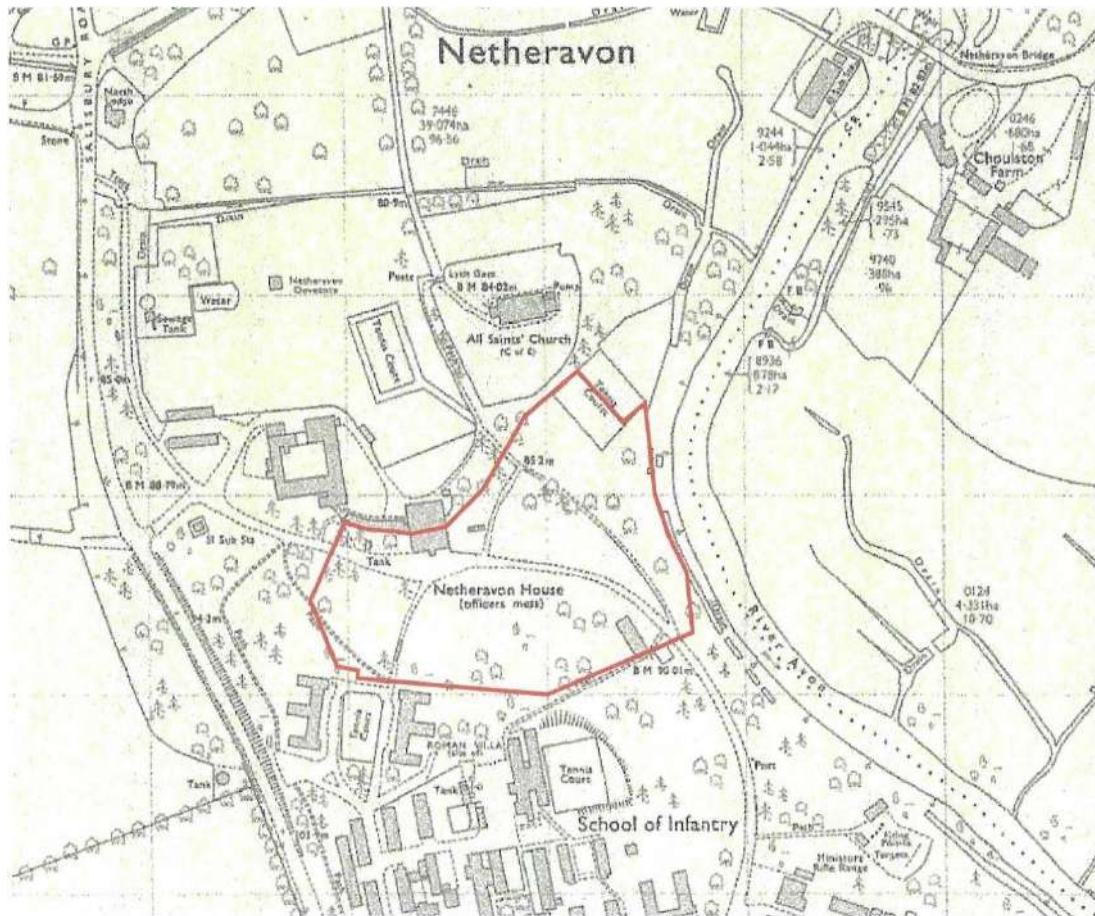
**Figure 13:** Extract from the 1:2,500 scale Ordnance Survey (O.S.) map of 1973, map sheet no. SU1448-SU1548. The approximate boundaries of the assessment site are shown outlined in red.

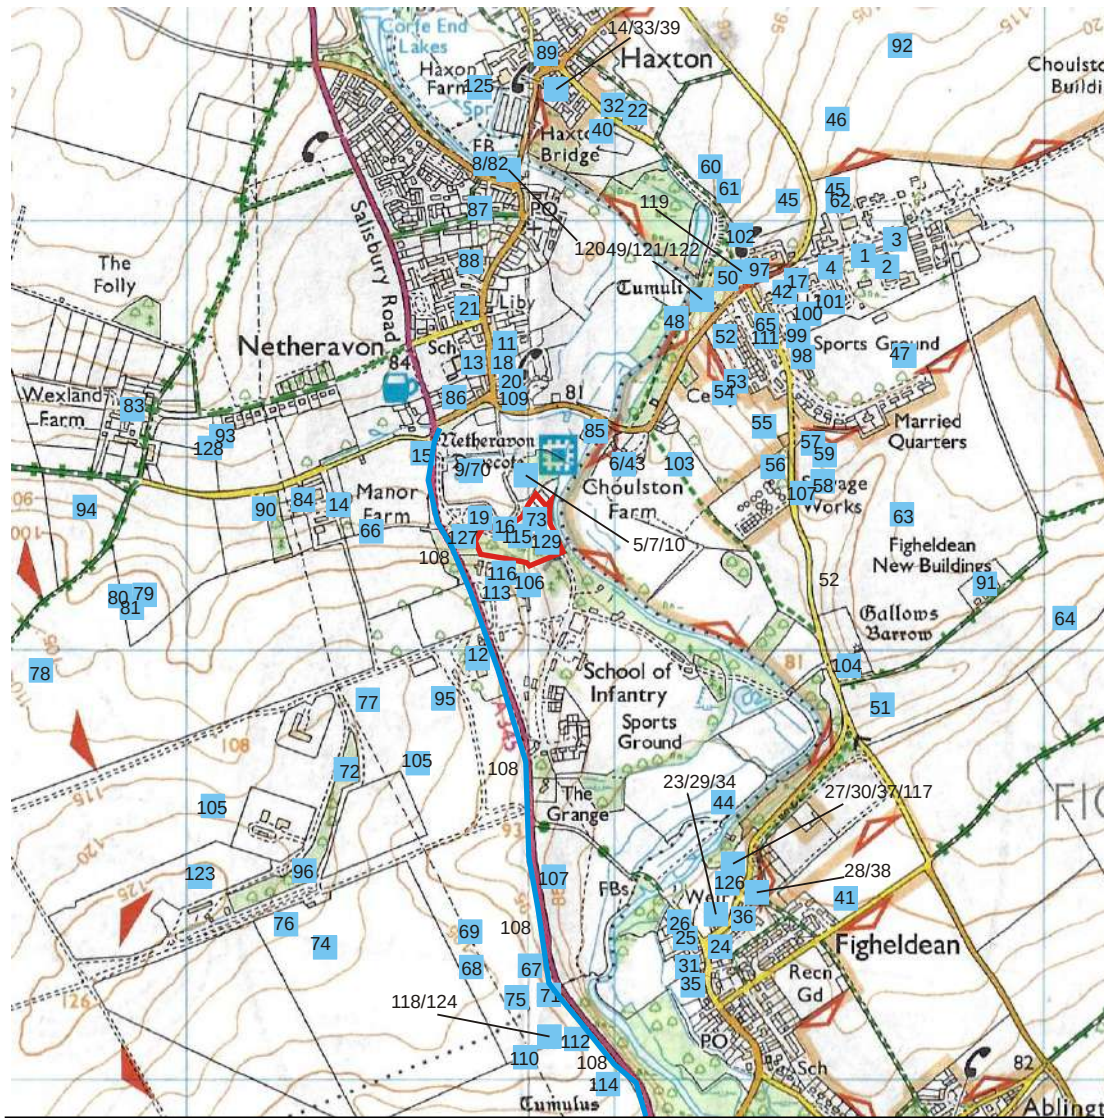
**Figure 14:** Cultural heritage sites within a 1.0km radius of the assessment site at an original scale of 1:25,000. The boundaries of the assessment site are shown outlined in red.
