# WATERS EDGE DERRYFIELDS ASHTON KEYNES

## PRELIMINARY ROOST ASSESSMENT (PRA)

| <b>Document File Ref:</b> | PRI24938 PRA |

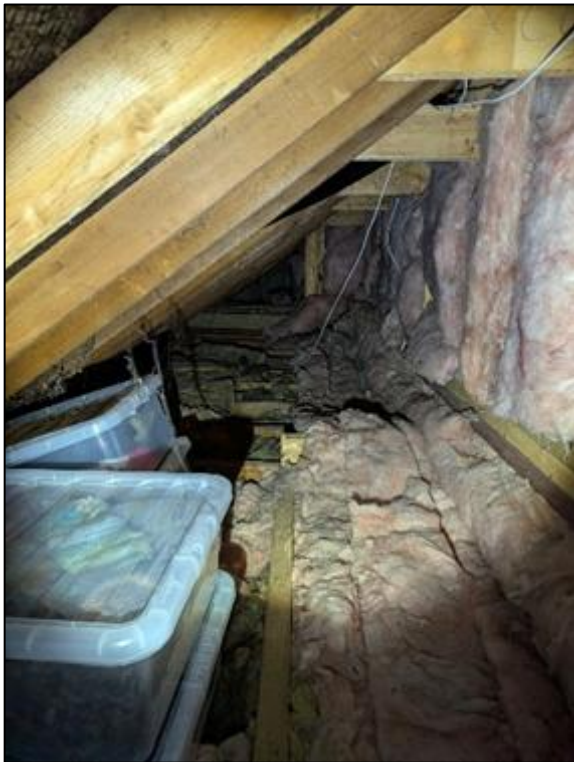
- 3.1. The residential building was a single storey brick-built structure with a pitched clay-tiled roof. The building features a front and rear roof void, the internal roof and felting were in good condition in both voids, with no obvious access points noted from within the voids.
- 3.2. Droppings were found scattered in both the rear and front roof voids, with a small aggregation of droppings observed in the rear roof void. Samples of the droppings were collected and sent for DNA analysis with Ecotype Genetics Ltd on 12<sup>th</sup> August 2025.
- 3.3. Results from the DNA analysis was received on 20<sup>th</sup> August 2025, concluding that the droppings pertained to pygmy shrew *Sorex minutus*.

**Image 1:** Front void of residential building

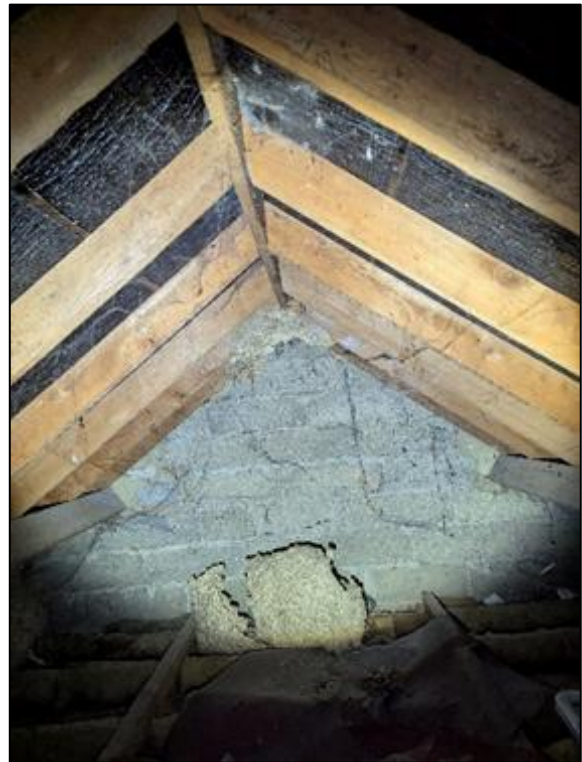
**Image 2:** Front void of residential building

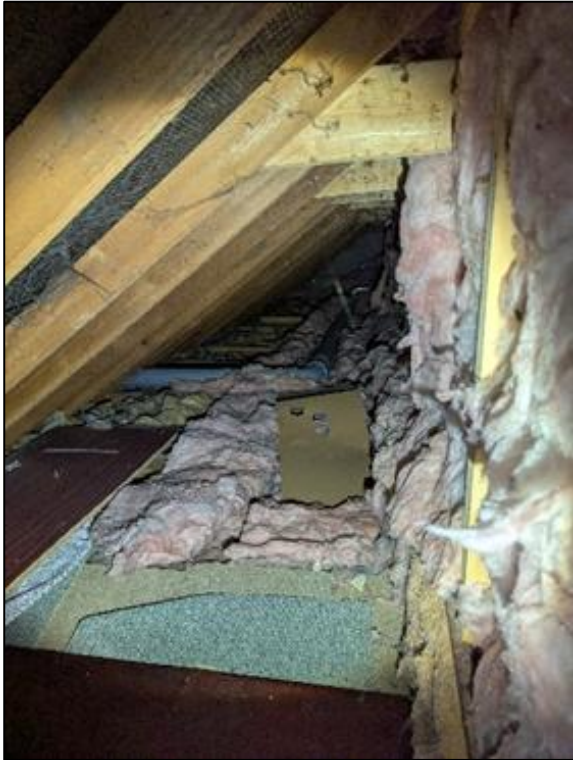
**Image 3:** Rear void of residential building

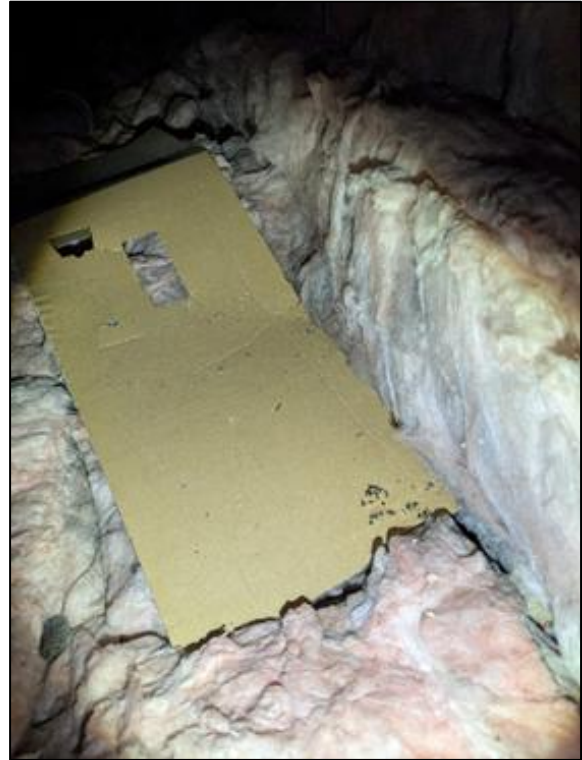
**Image 4:** Aggregation of droppings in rear void, later confirmed to be from pygmy shrew

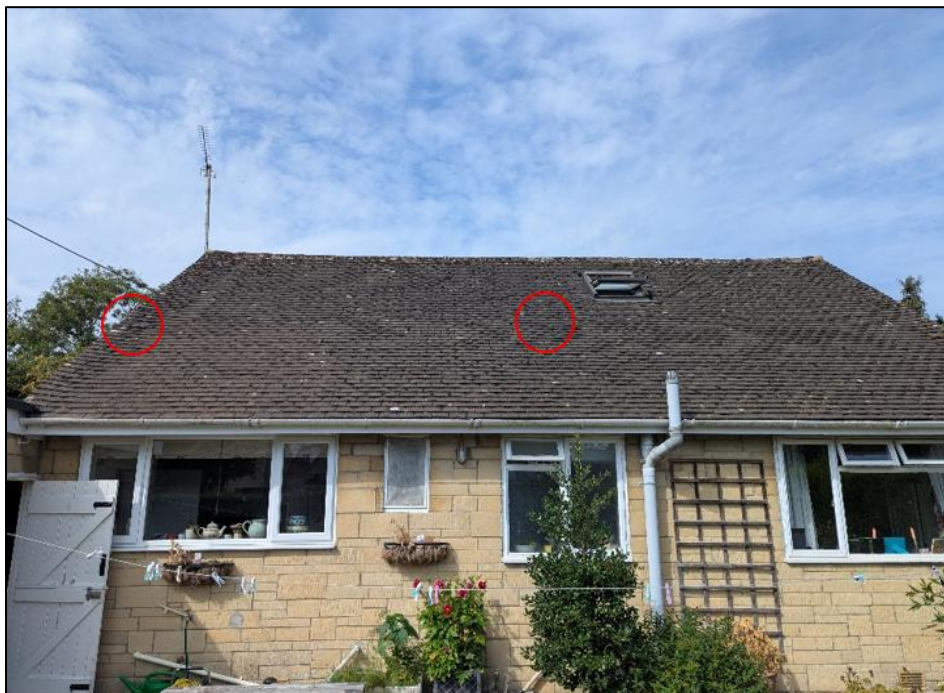
- 3.4. Externally, two potential access points to the rear roof void were located on the eastern aspect of the building where roof tiles had slipped. An additional Potential Roosting Feature (PRF) was observed on the southern aspect of the building where there was slight damage to the eaves.

**Image 5:** Eastern aspect of residential building with PRFs circled

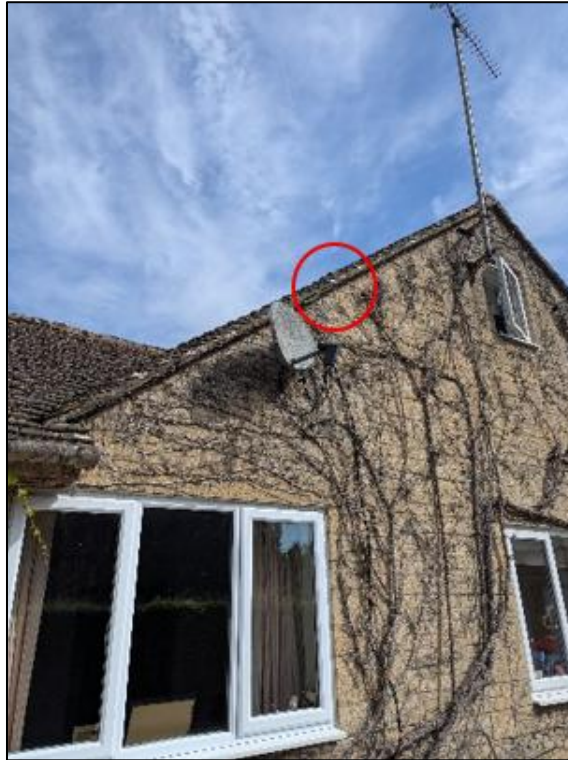
**Image 6:** Southern aspect of residential building with PRF circled

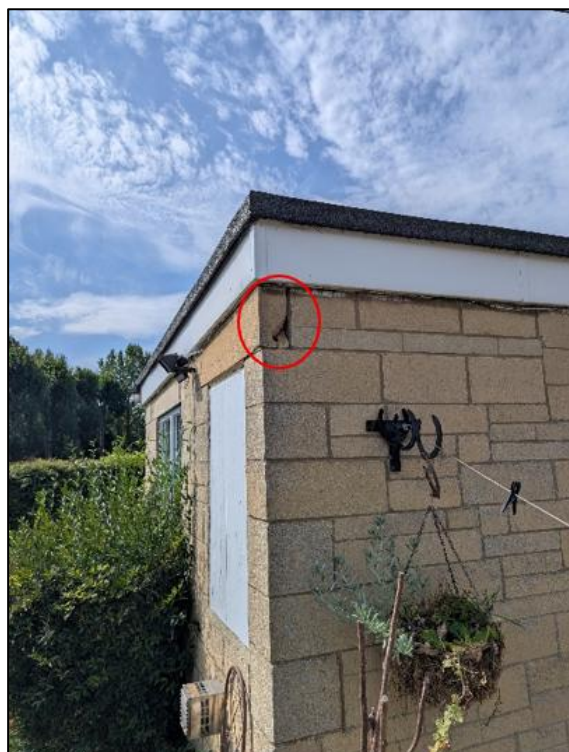
- 3.5. The garage was a brick-built structure with a flat bitumen felted roof with no roof void. No internal evidence of bats were found within the garage. Externally, a potential roosting feature was noted on the rear wall where a brick has been damaged, creating a small crevice.

**Image 7:** Rear garage with PRF circled
