## BAT ACTIVITY SURVEYS

BUILDINGS AT  
MANOR FARM  
LOWER ROAD  
ERLESTOKE  
SN10 5UE

| <b>Survey dates:</b> | 1 June 2023<br>6 July 2023<br>3 August 2023<br>24 August 2023 |

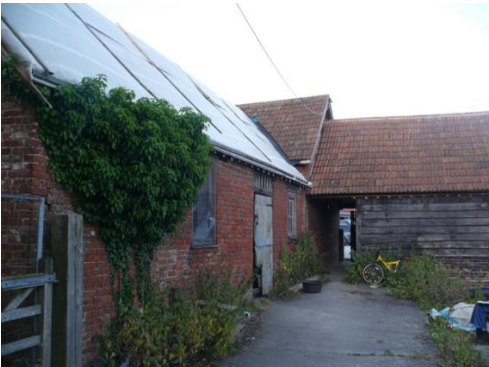
| Building 3 | |
|---|---|
| Southern elevation of building 3 showing growth of colonising ivy, intersection of the roof with building 9 and passageway between buildings 8 and 9 | Western gable end of building 3 |

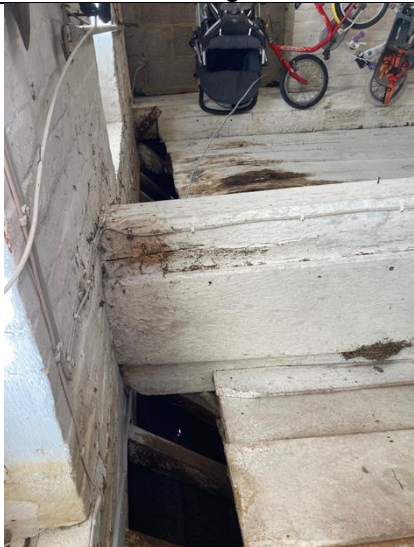
| Building 3 | |
|---|---|
| Undersurface of roof void of building 3 showing surrounding pitching gap | Gap between rafters of roof frame where the roof of building 3 intersects with the roof of building 9 (location of known Lesser Horseshoe bat roost) |

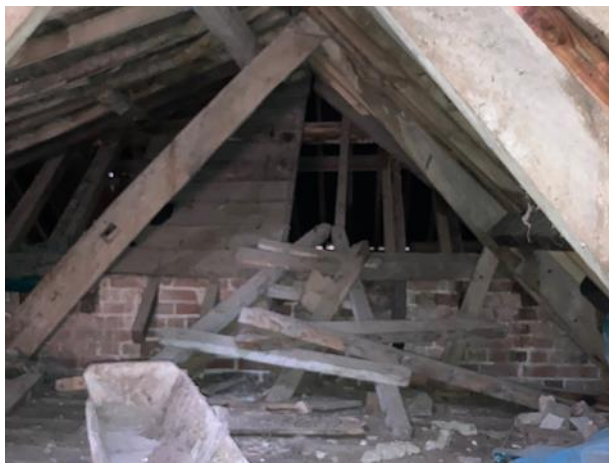
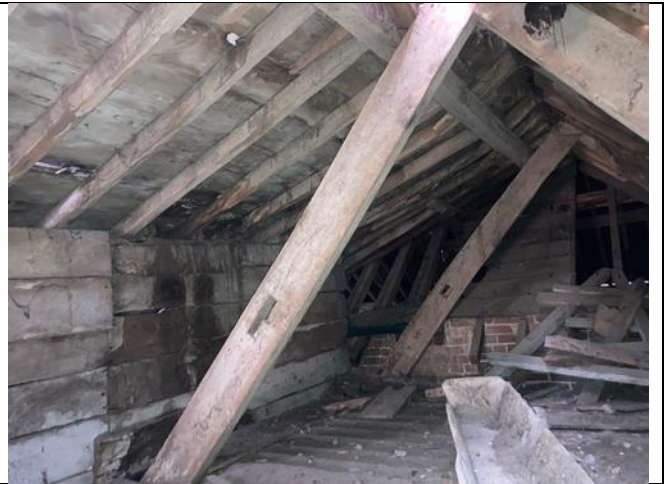
Roof void of building 3 taken by inserting camera through pitching gap  
Building 2

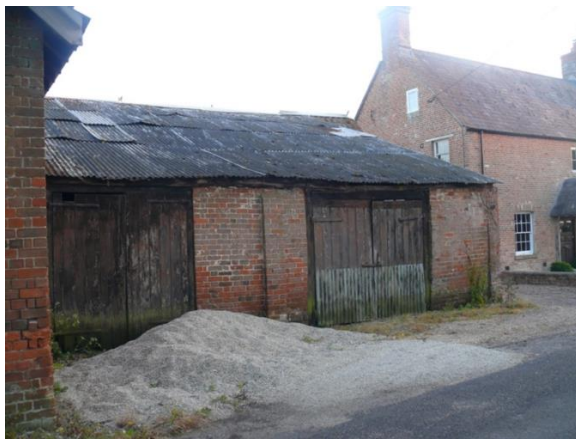
Northern elevation of building 2

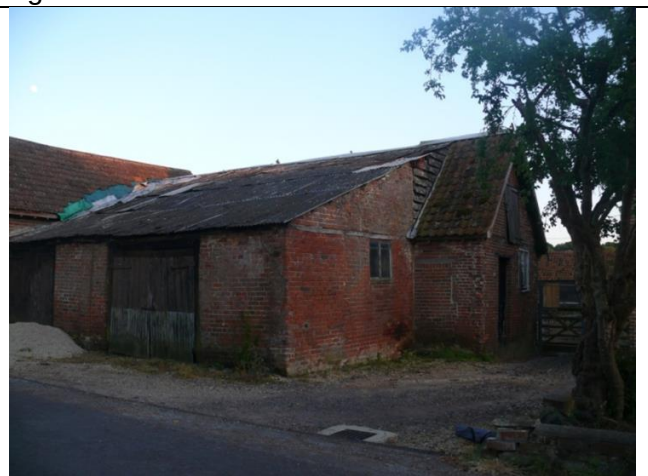
Western elevation of building 2 showing  
intersection with building 3

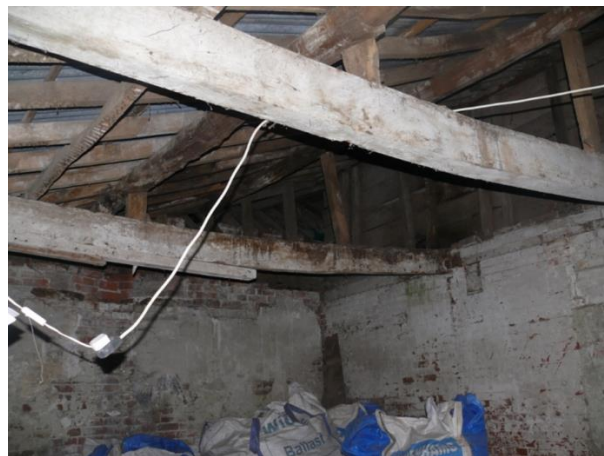
Eastern interior of building 2

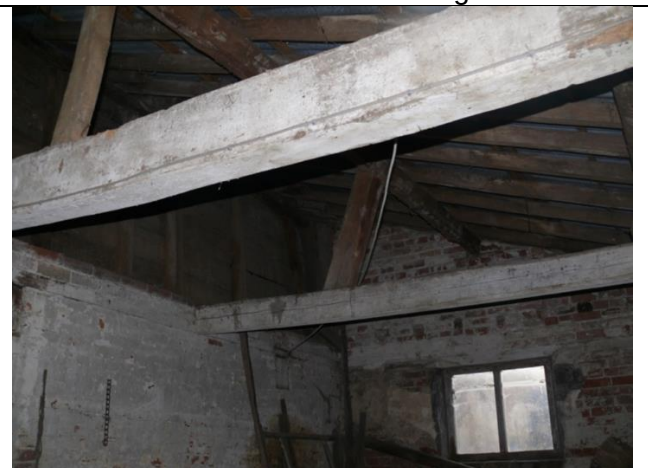
Western interior of building 2

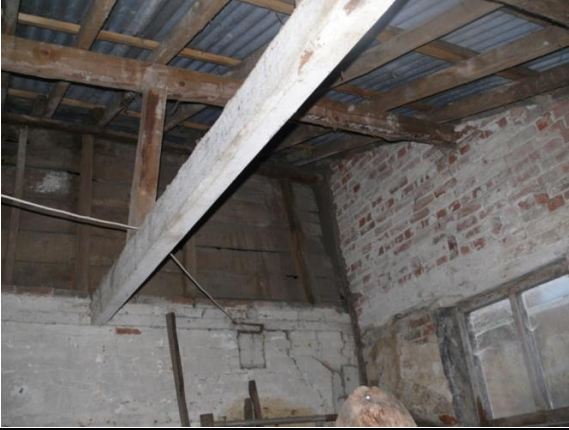
| <p>Unlined under surface of corrugated sheet metal roof covering and timber roof frame</p> | <p>Single skinned weatherboarding which tops the northern rear wall of building 2,</p> |

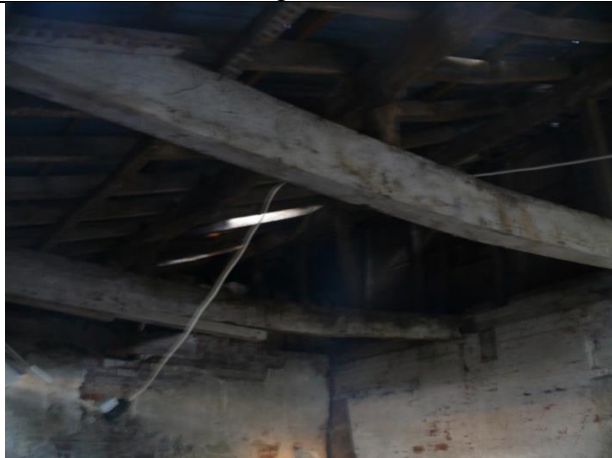
| <p>Light entering the dark interior of building 2 where corrugated metal roof sheet overlap</p> | <p>Intersection of roof frames of building 2, 3 and 9</p> |

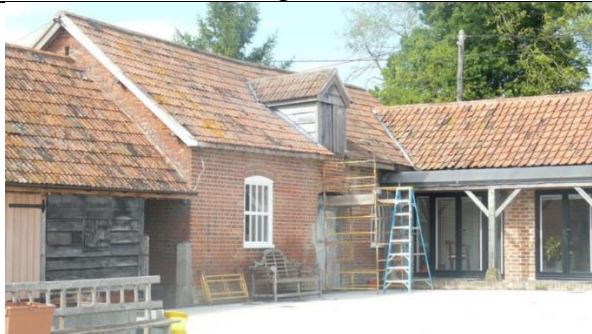
Eastern elevation of building showing dormer structure with timber doors which is the only means of physical access to the interior of roof void

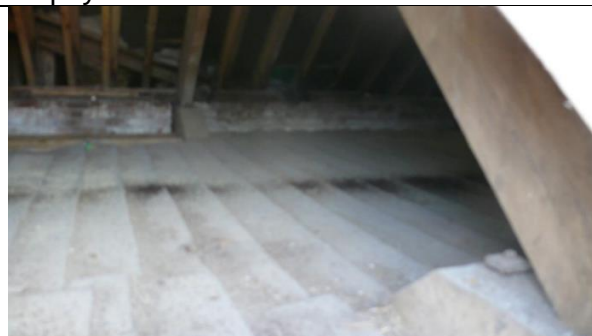
Interior of roof void showing deposit of bat droppings on floor below the line of the central ridge beam

A thin line of bat droppings was present on the roof void floor below the line of the entral ridge beam suggesting that the roof void was being used regularly by low numbers of Lesser Horseshoe bats. This would be in keeping with the estimated number of bats observed emerging.

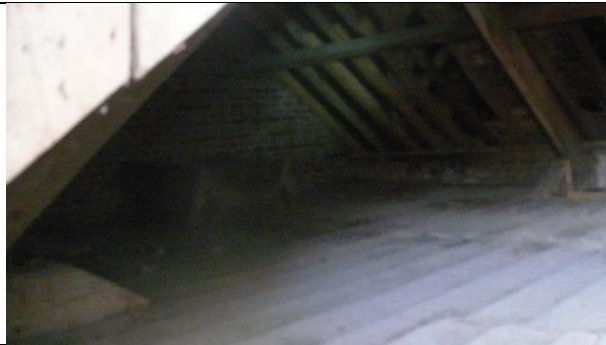
Intersection of roof frame with building 3 showing gaps between beams

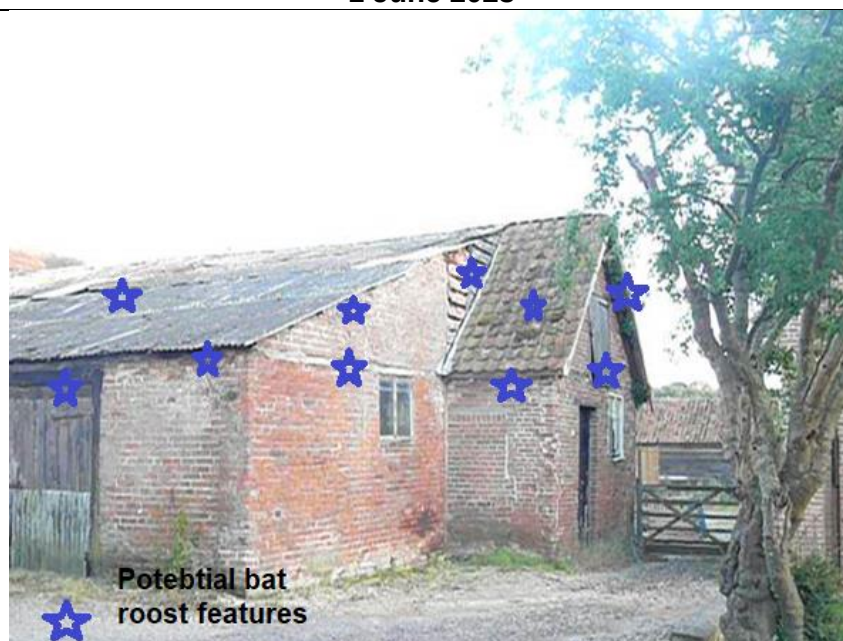
**Building 2 and western gable end of bulding 3  
Evening emergence survey  
1 June 2023**

Potential bat roost features and field of view

**Observations:** Bat activity levels were low and dominated by Common pipistrelles with a single Serotine bat detected during survey. Because of the direct connectivity of building 2 with the roof voids of buildings 2 and 9 a check was made prior to commencement of survey of the dark interior of building 2 for the physical presence of Lesser Horseshoes bats. None were found. However, during survey a brief check was made of the interior of building 2 and the echolocation calls of Lesser Horseshoe bats were immediately heard. A precise count was not possible but it was estimated that approximately 6 Lesser Horseshoe bats were flying with the dark interior and could be seen crossing the beam of a hand held torch. No Lesser Horseshoe bats were observed emerging and no other bat specie were observed emerging from any other part of the building structure.

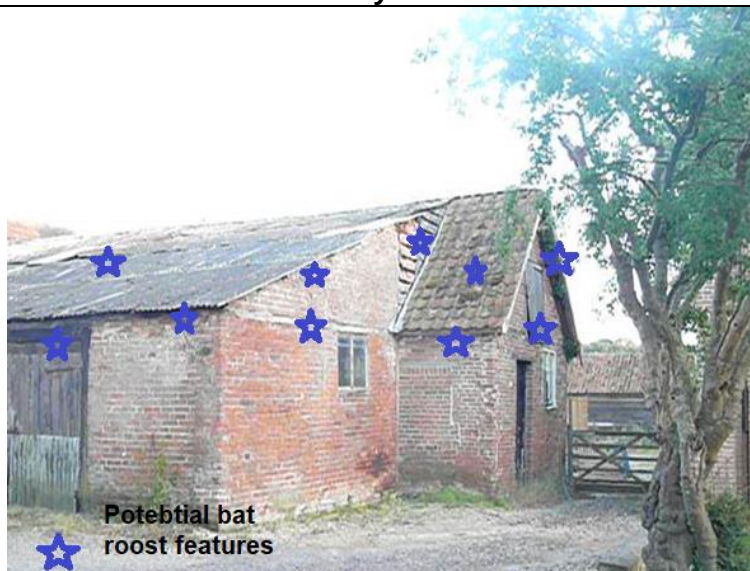
**Building 2 and western gable end of building 3  
Evening emergence survey  
6 July 2023**

**Field of view and potential bat roost features**

**Observations:** Survey was dominated by Common pipistrelle with high levels of activity. These bats appeared to fly into the site from the south west. No bats were observed emerging from any part of the building structure.

Again Lesser Horseshoe bats were observed and detected with the dark building interior but none were observed emerging.

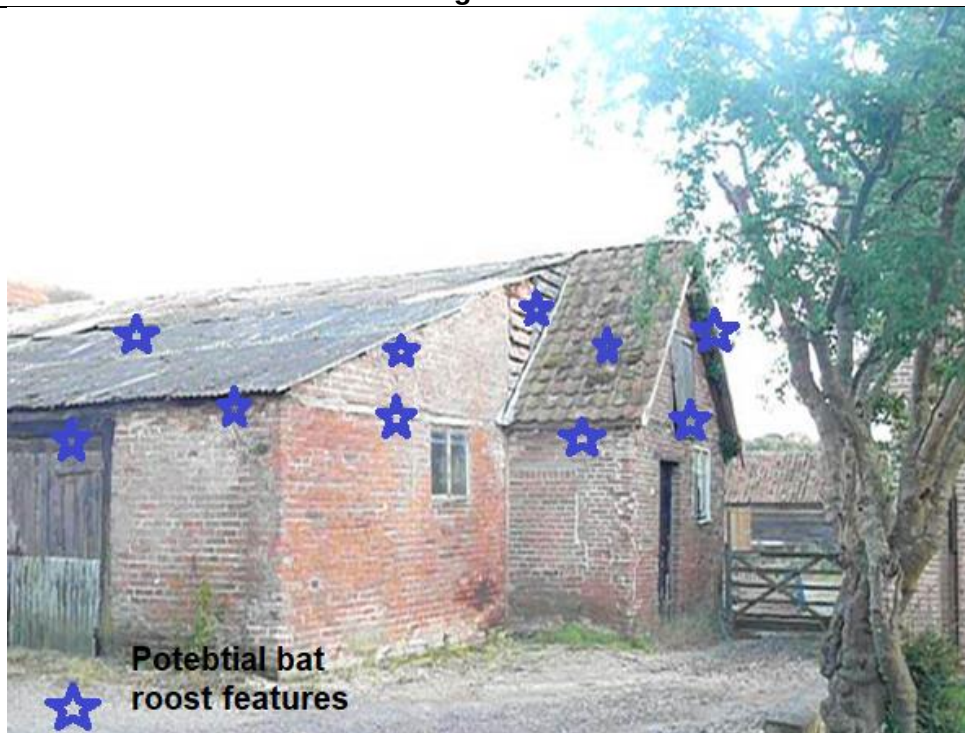
**Building 2 and western gable end of building 3  
Evening emergence survey  
3 August 2023**

**Potential bat roost features and field of view**

| <b>Observations:</b> No bats were observed emerging from the single storey lean but again Lesser Horseshoe bats were observed flying and detected within the dark interior. None of these bats emerged from the building. These bats appear to be entering the single storey lean-to to fly through intersections of the roof frame of building 2 with the roof frame of the building where the known Lesser Horseshoe bat roost is present. | | | | | |
