# Listed Building Consent Supporting Documents

Reinstatement & Remedial Works (Impact Damage)

## Rebuilding of Porch Structure

White Hart Inn, Ford, Chippenham.

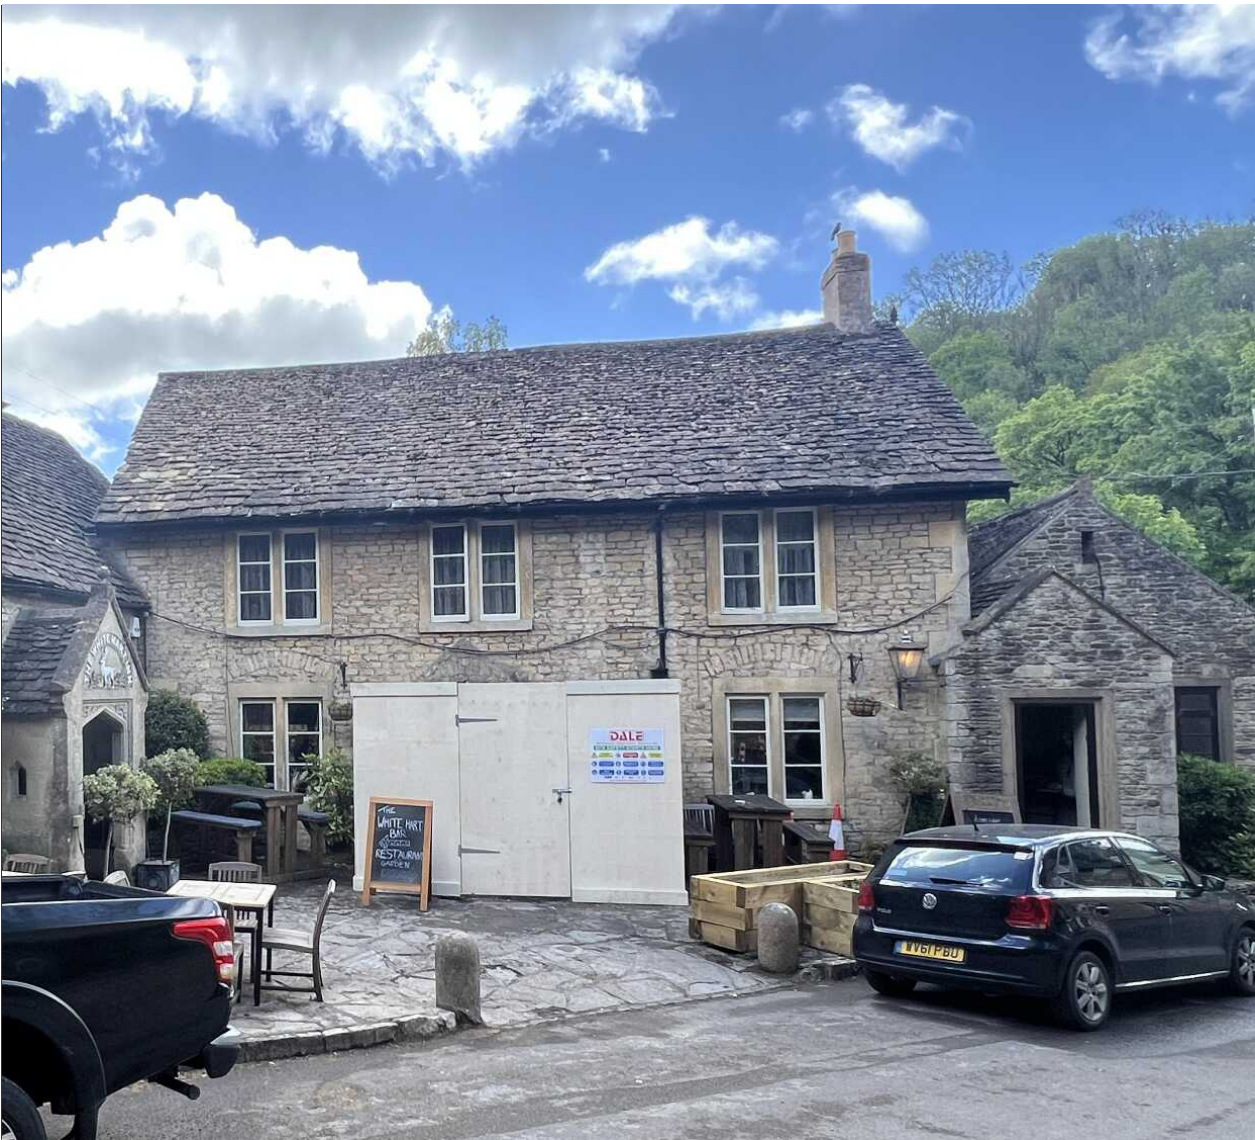
**Pic:1** Highway facing elevation of The White Hart. The photograph was taken at the time on inspection on 13th May 2026. The plywood hoarding is enclosing the area of impact damage caused by vehicle collision.

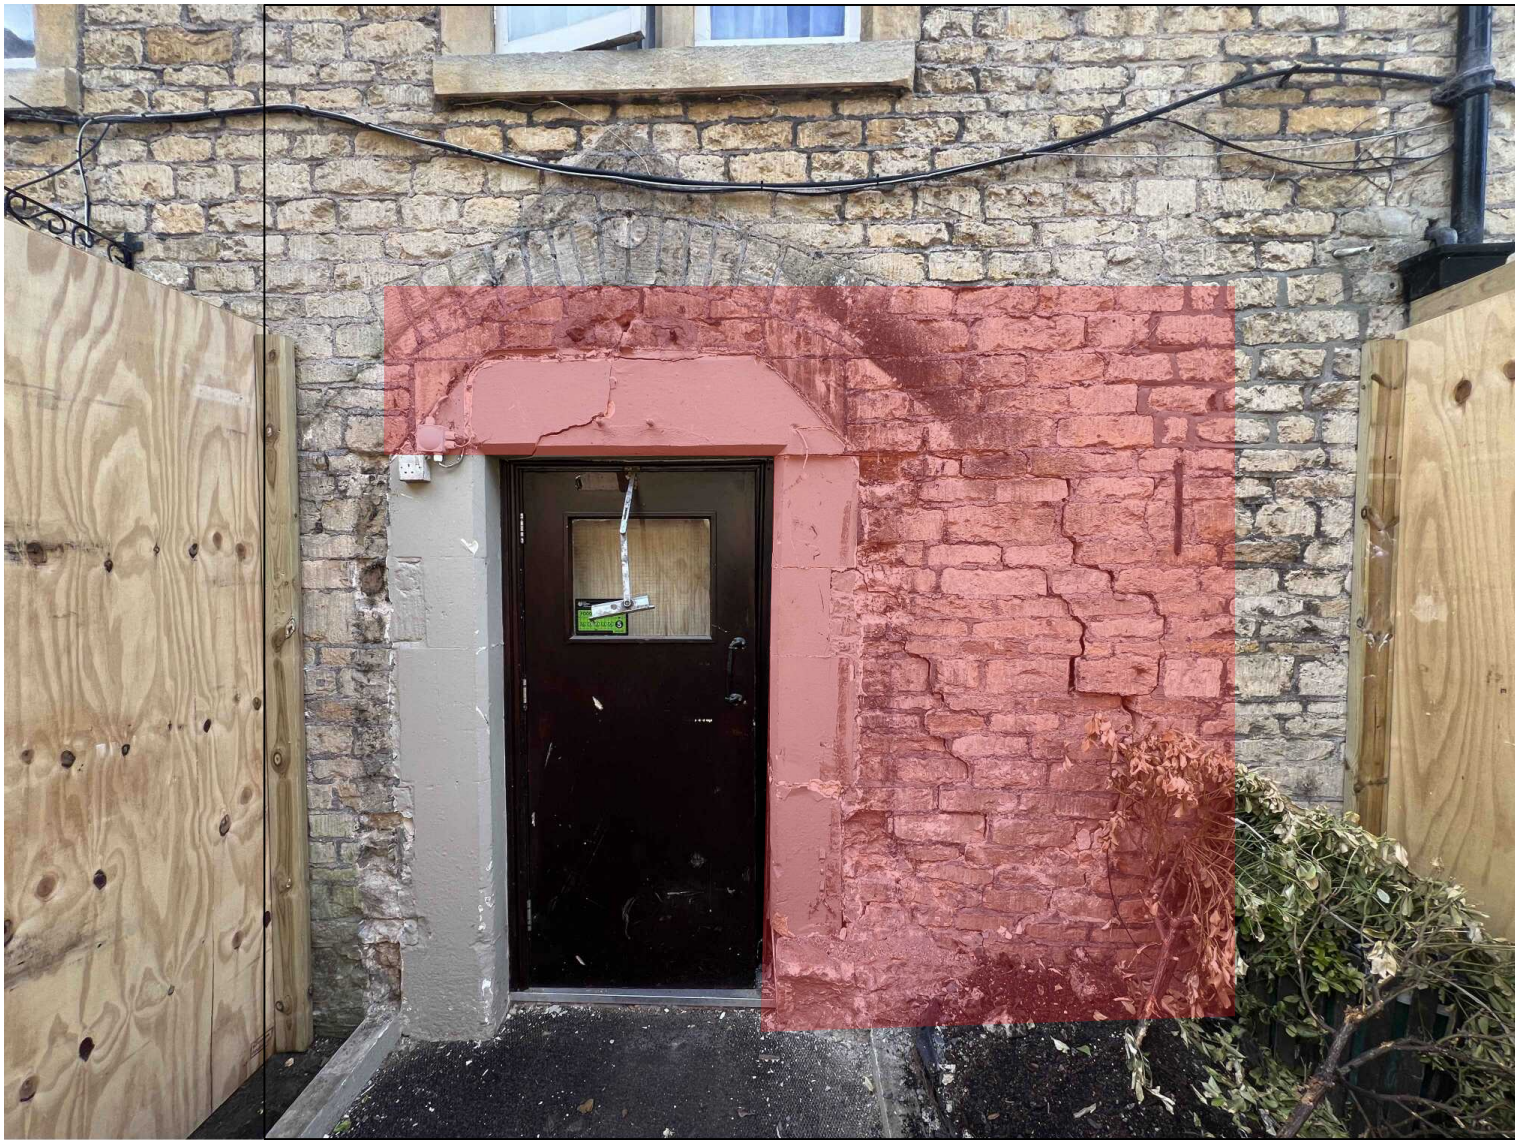
**Pic:2** Internal view of the affected area inside the protective hoarding enclosure. The outline of the porch structure that was severely damaged by the impact is visible on the face of the main wall. The debris of the structure following collapse has been removed. The 'footprint' of the structure remains, as the walls below ground were left in place. The dimensions used as the basis for reconstruction have been taken from the remaining elements and the marks left on the building face. Highlighted area for rebuilding (details shown in separate document). Refer in conjunction Pic.5 - Pic.10.

The step into the building from the porch (30-35mm) could be lost by incorporating a slight fall in the floor screed / finish, which would enhance accessibility. The door opening width of 960 mm (less the frame width, will remain as is.

It is thought that the original structure had a door in the outer porch opening that opened inwards, whereas the internal opening door opens outwards (fire escape door) . This would be problematical from an accessibility aspect. We would propose to omit the internal door altogether. Alternatively the door could open in and be fixed open by a stay during opening hours, or have the door swung so that it opens outward (increases accessibility limitations).

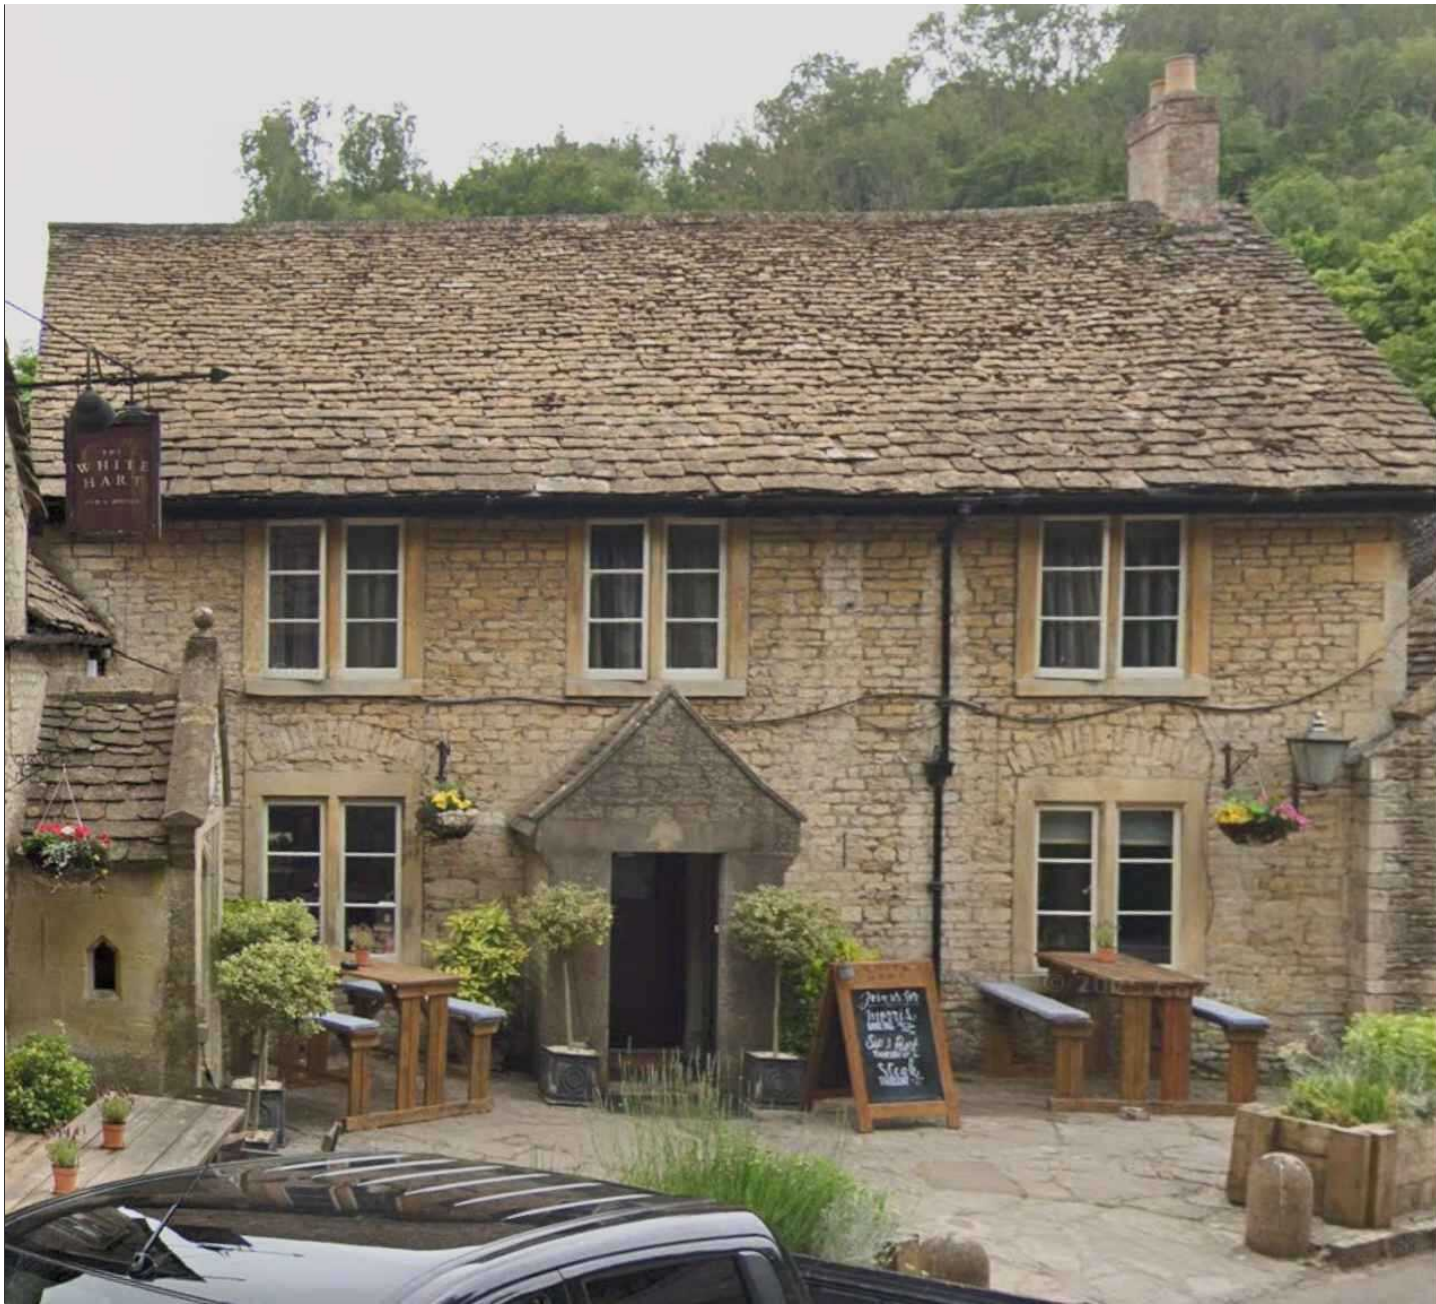
**Pic.3** An image of the elevation shown in Pic.1 prior to the damage event (Google Images 2025). The porch structure outlined.

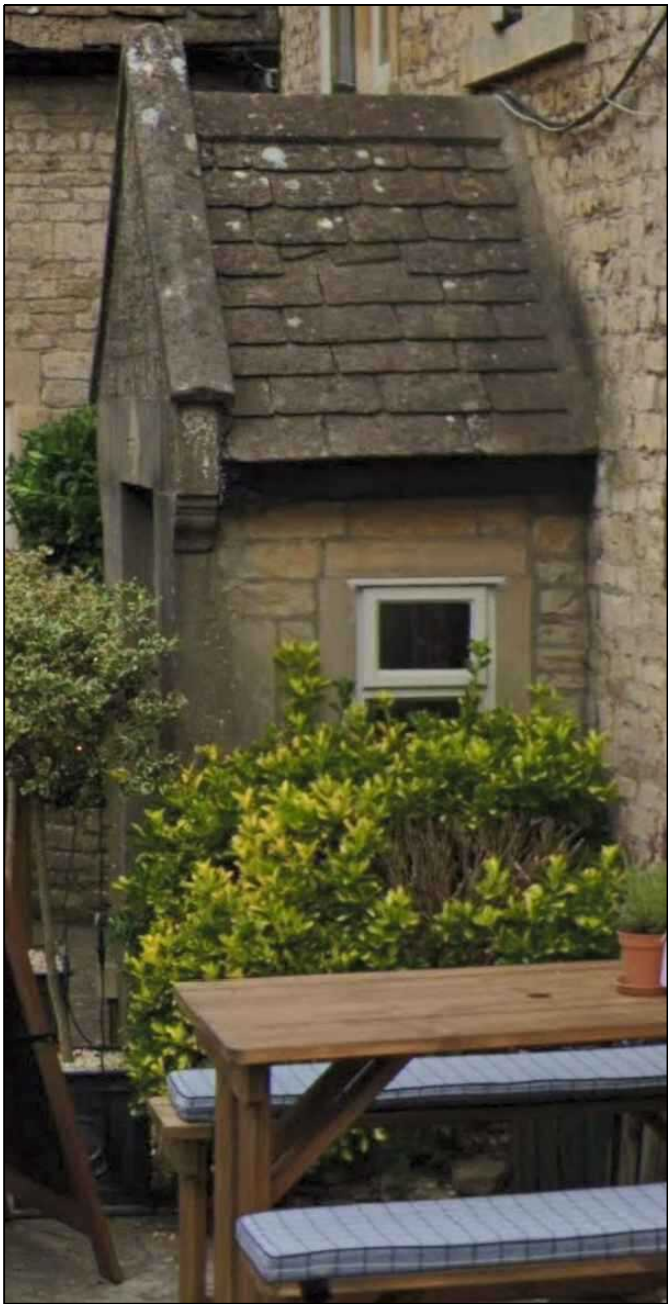
**Pic.4** Further to the preceding image, - The Side elevation is shown here (Google Images 2025). Visible element in this image include:

- Stone tiled roof covering in a diminishing gauge.
- Fascia board at eaves
- Side of profiled stone corbelled head
- Random rubble effect side wall
- Stone window opening surround
- Casement window with top opening sash

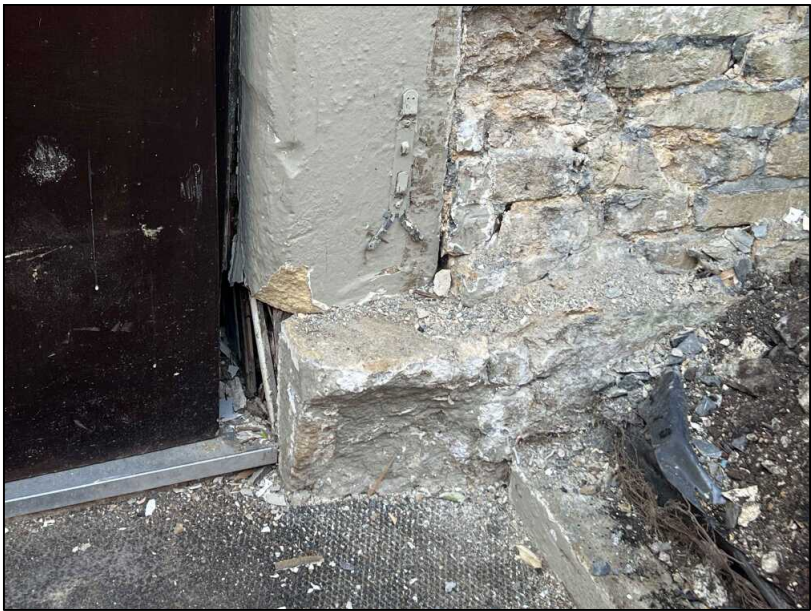
**Pic.5** The walls above ground are displaced in an area of approximately 1.3 metre wide. The impact has caused the walls to shear in a horizontal plane, moving the stone opening surround and the stone wall of the face of the main building by 100 mm or so. This area of wall will need to be dismantled and rebuilt, with temporary support required.

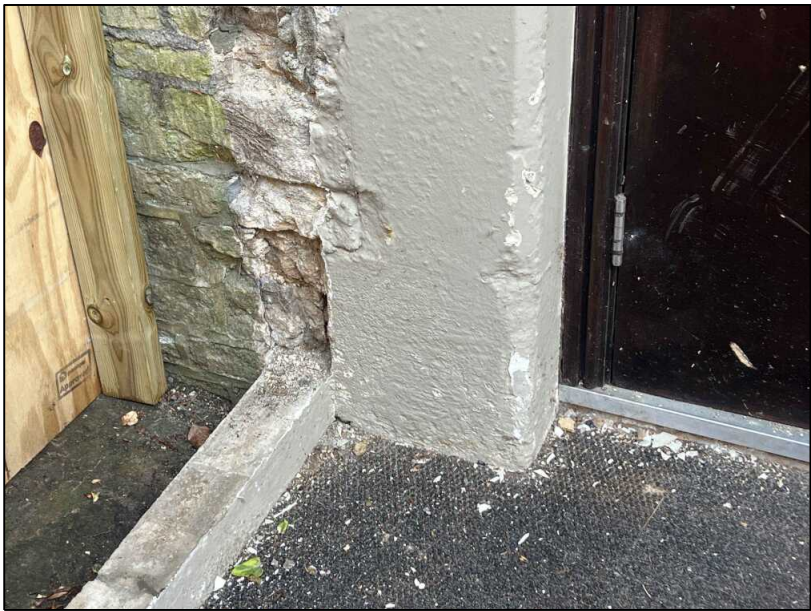
**Pic.6** The wall to the left side of the opening is not exhibiting any significant damage. The position of the porch structure wall is clearly visible. There does not appear to be have been any mechanical tie between the porch structure wall and the main walls.

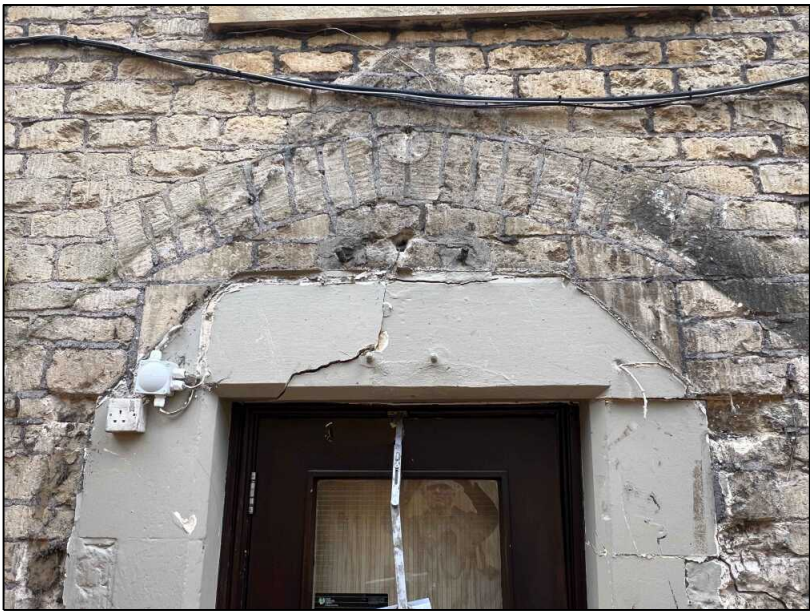
**Pic.7** At the head of the opening there is a cut stone lintel beneath a stress relieving arch (or formerly there was a wider opening). The lintel has cracked and its structural capacity is no longer sufficient as a result.

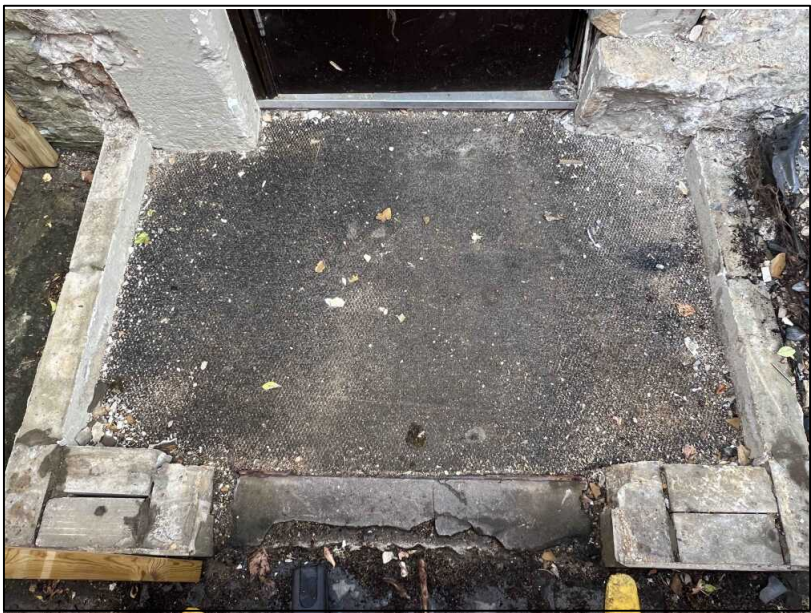
**Pic.8** The substructure remains in-situ. The flank walls are 100 mm thick (plus the thickness of the cladding of approx 25mm). The front walls are 200 mm thick. The area has a covering of carpet over a screed and tile floor surface, sitting presumably above a concrete slab.

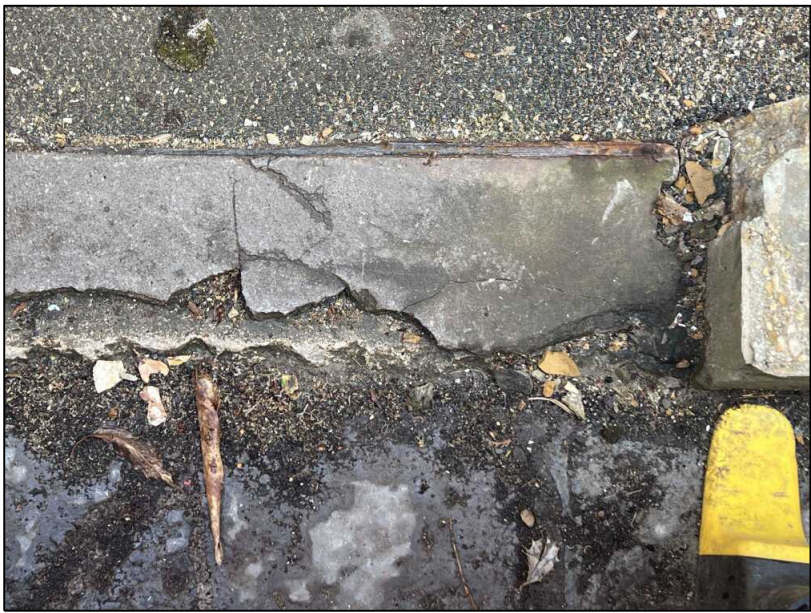
**Pic.9** The area has a covering of carpet over a screed and tile floor surface, sitting presumably above a concrete slab. The walling blocks can be seen to be a concrete mix using natural stone aggregate.

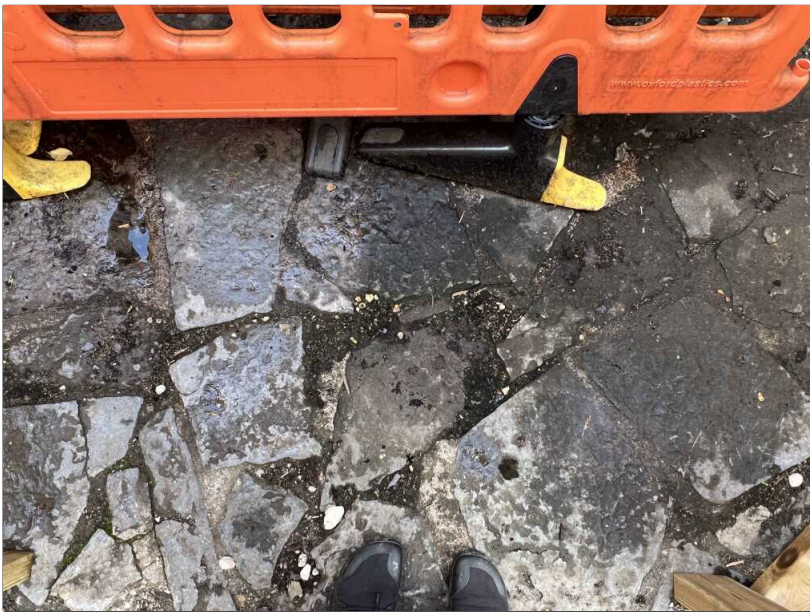
**Pic.10** The ground area surrounding the porch structure is of random shaped natural stone laid upon and jointed in a cement mortar - 'crazy paving'. Excavation of the existing substructure will require some removal and reinstatement of this surfacing.

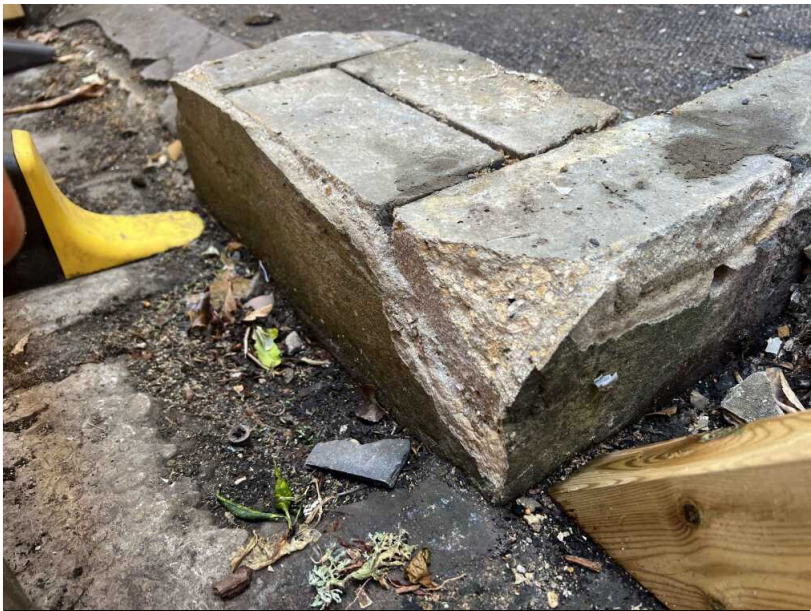
**Pic.11** A section through the wall is exposed following removal of the damaged walling. A block at the right side quoin is broken, exposing its core, which is a concrete mix using a coarse natural stone aggregate. The external wall face to the front and around 150mm of the side has been rendered. (These are not stone faced blocks)

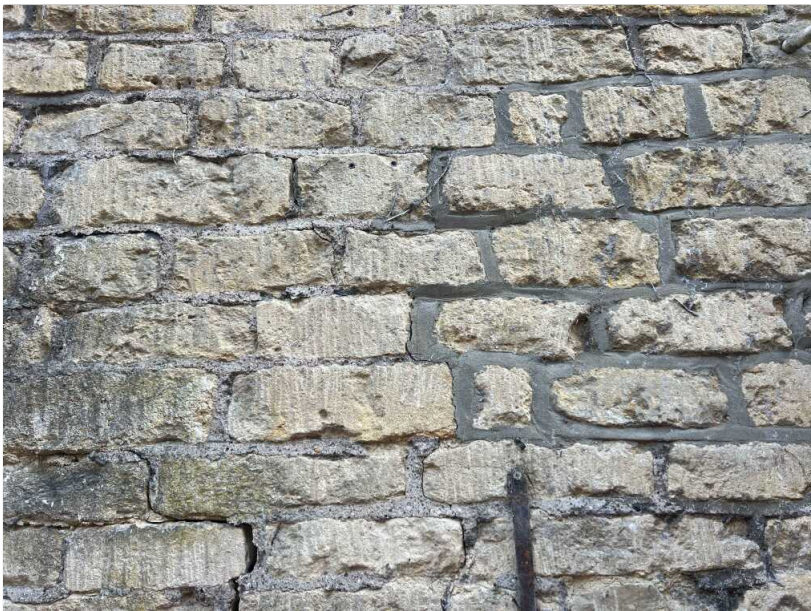
**Pic.14** An area of the face of the main building walls to which the porch structure abuts is shown here. The wall is composed of cropped natural Cotswold stone (which would have been quarried fairly locally). There is a mixture of lime mortar and cement mortar in the joints, the latter being some re-pointing work that is no longer considered appropriate.

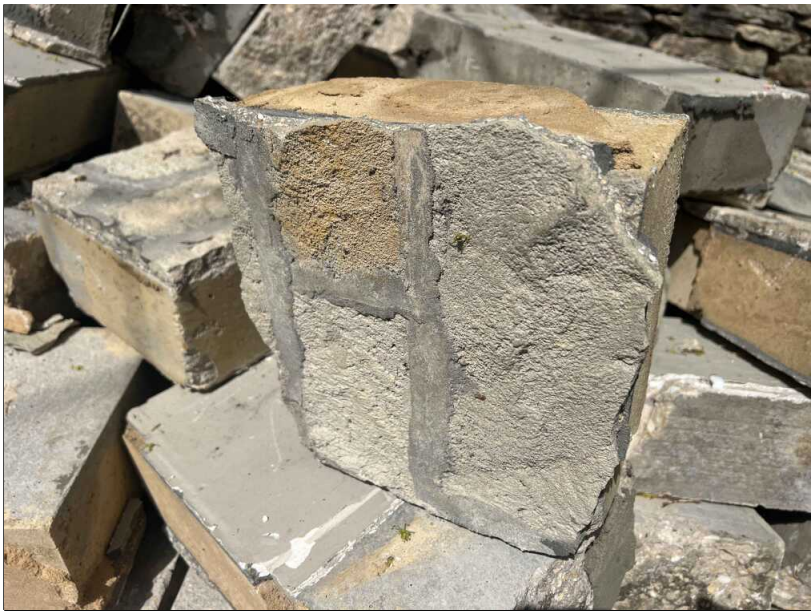
**Pic.12** Some of the masonry from the demolition arisings was set aside. The external face of the 'random rubble effect stone' can be seen to be a two coat render that has been applied to the block walls, which has has some colouring added. The joints have been scribed and 'pointed' in a cement mortar. This finish is an attempt to replicate the appearance of the main building walls to which this structure abuts.

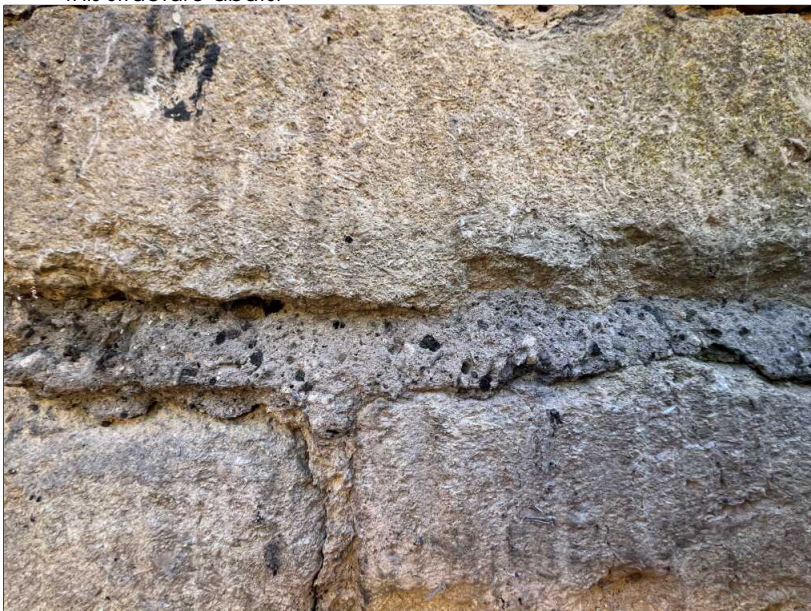
**Pic.15** A close view of the mortar typical of the external elevation (there are other variants, but this is thought to be the most common). This is a lime based mortar with inclusions. This mortar is the one selected for the rebuilding works. Matching this mortar is thought to be straightforward.

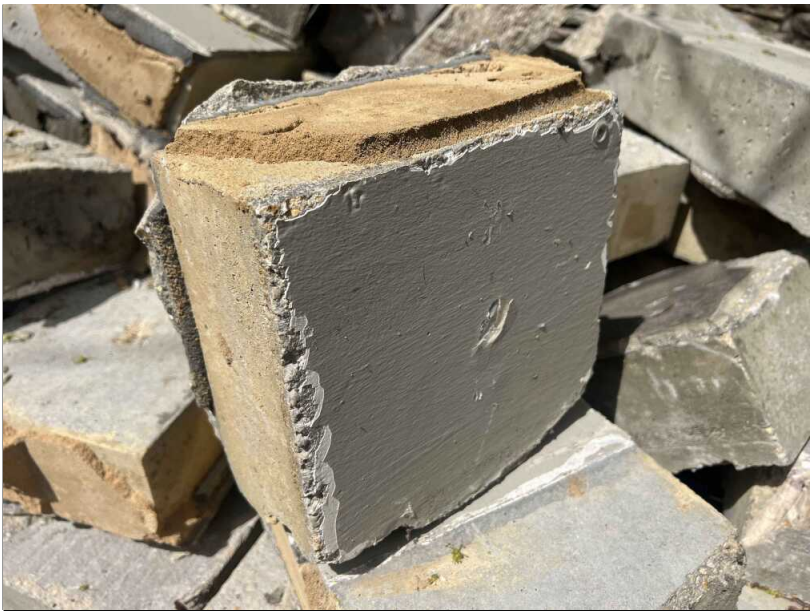
**Pic.13** The internal face of the porch structure is a smooth plaster finish that has been coated with an oil based paint. The bed joint of the block appears to be a coloured cement mortar.

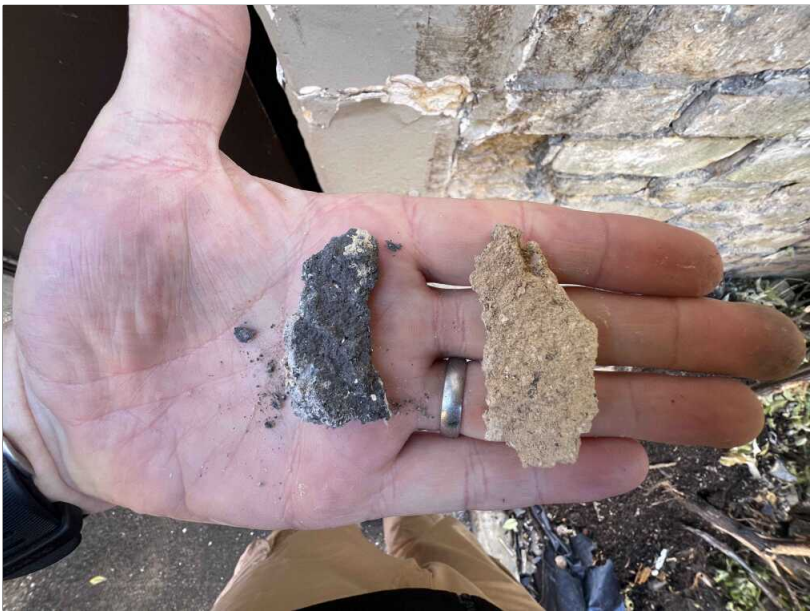
**Pic.16** Mortar variants.

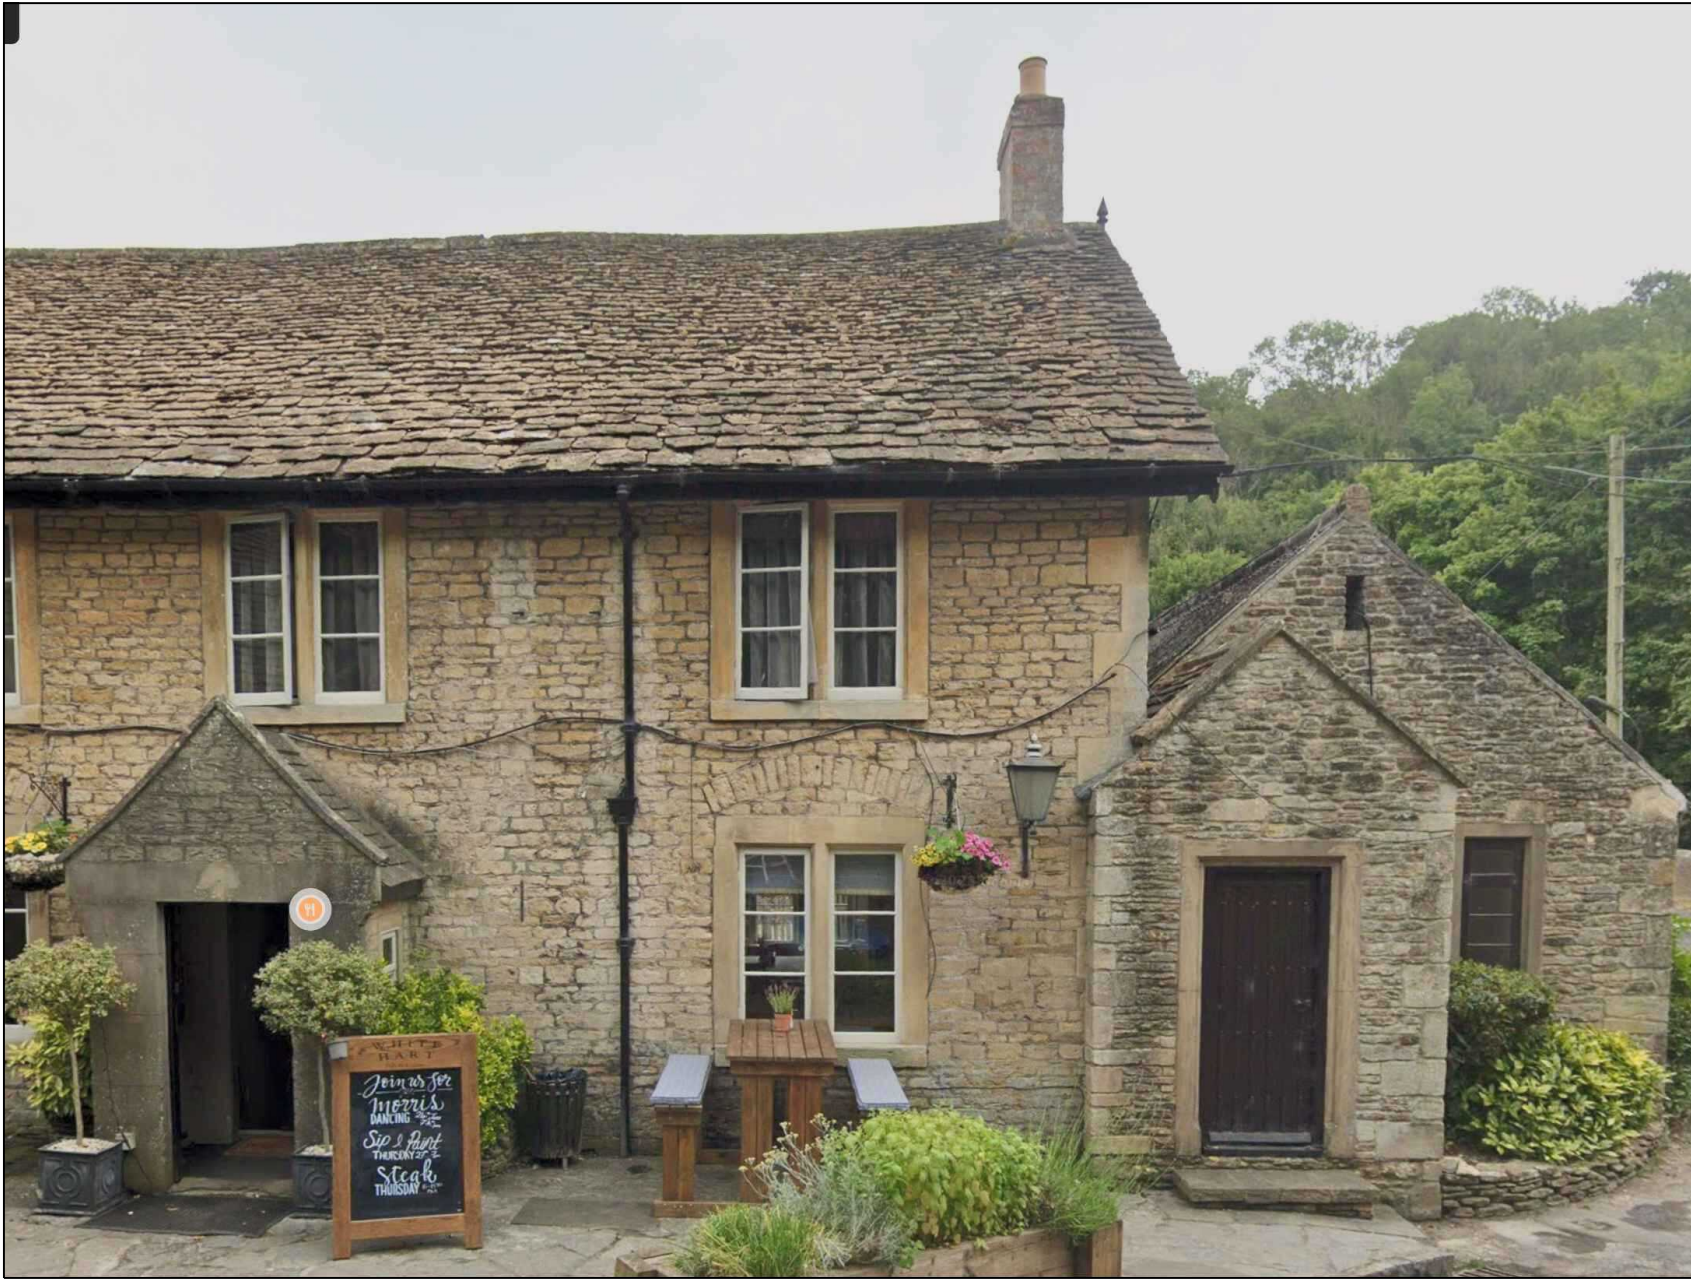
**Pic.17** This elevation of the building had two projections, the one to the left side now removed following extensive damage. It has been suggested that the composition of the damaged porch was inferior to the surrounding elements, in that the stone effect was a render, the blocks were concrete and suchlike. The preference for rebuilding was that natural 'real' stone be considered in the design.

External stone wall construction of period buildings such as this one would not have a 100mm thickness. As it would be impracticable to have a natural stone smooth block interior and a cropped stone wall exterior - within a wall thickness of 125mm overall (including the render affect stone), it is proposed that the walls be thickened to accommodate two materials - with an overall thickness of 275mm. The 150 mm difference to be accommodated by increasing the overall width by 75mm per side, and reducing the internal width by 75mm each side.

Taking some design / appearance elements from the existing projection to the right side, shown in Pic.18.2 - the direction of the rebuilding to be considered by the Conservation Officer on their individual merits, and subsequent alterations to the initial proposals to be incorporated if desired.

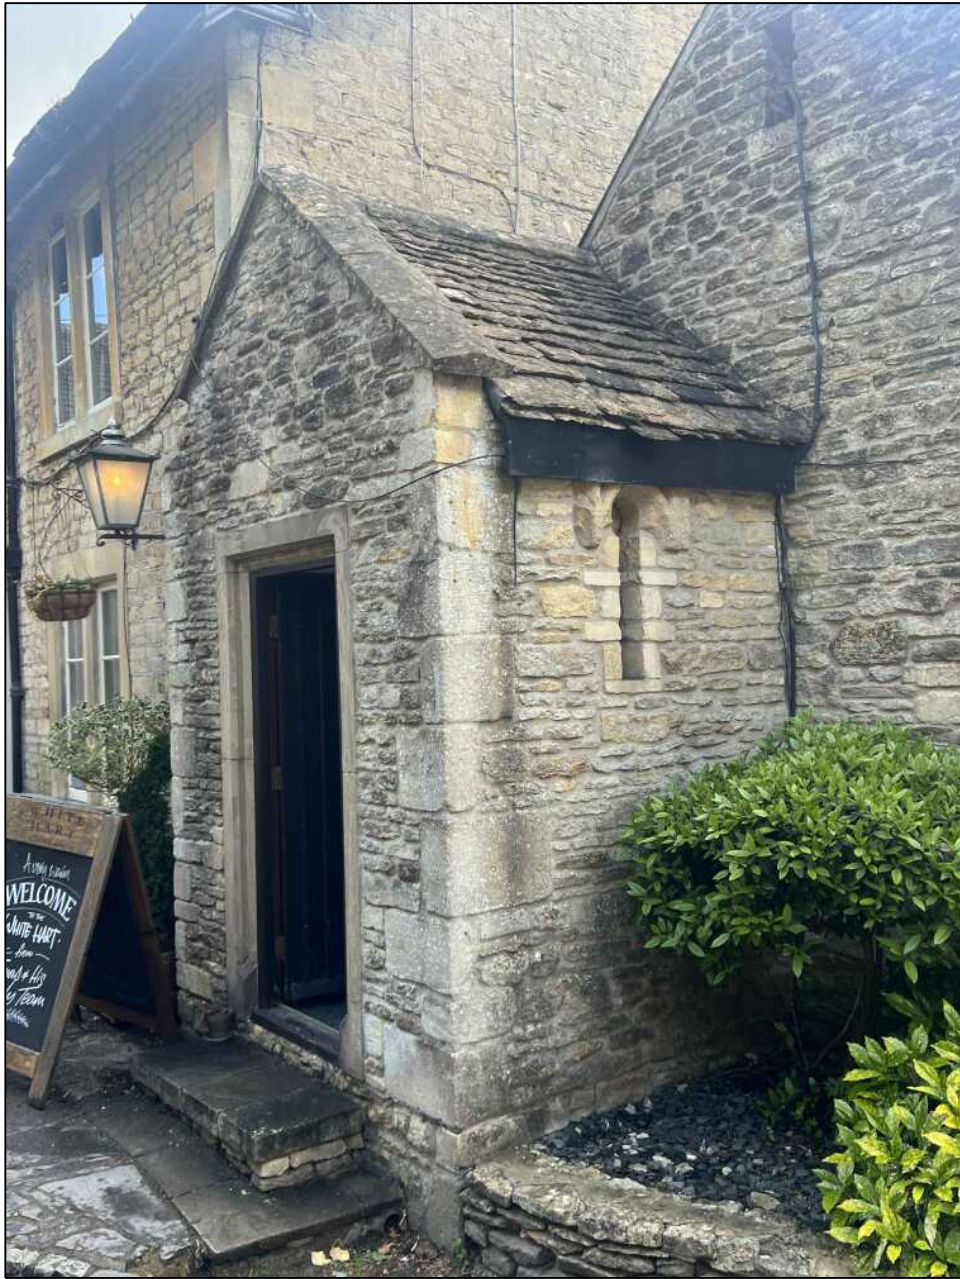
**Pic.18** The proposal detailing has borrowed elements of construction from the adjacent projection shown here.

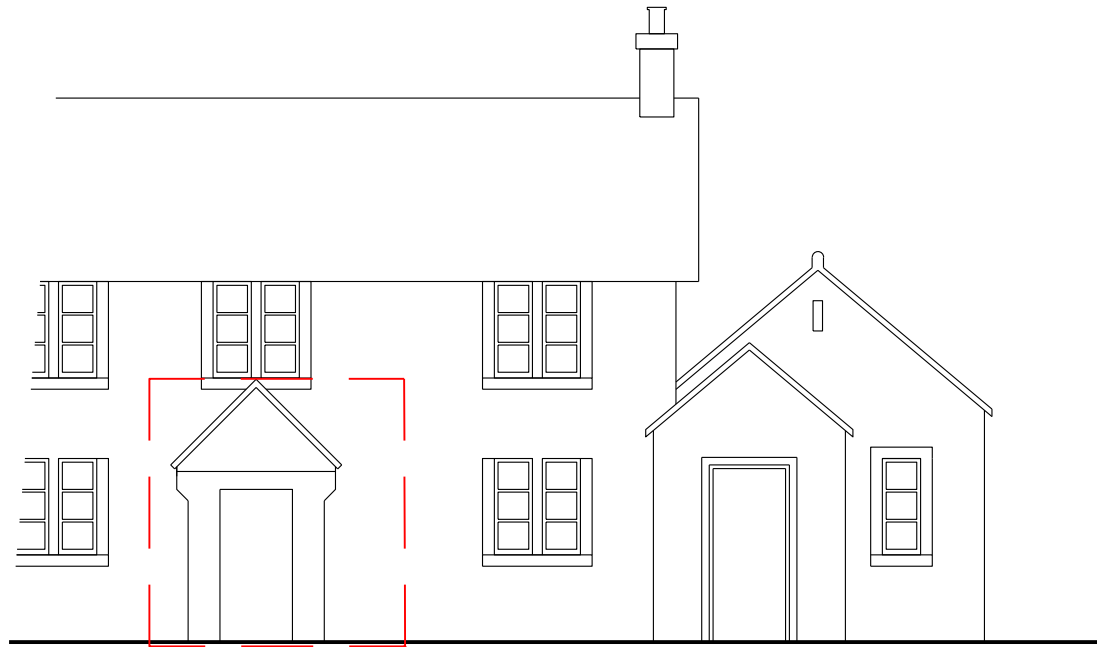
**E.01**  
Front Elevation As Existing  
Scale - 1:100 @ A3

Extent of Rebuilding Works

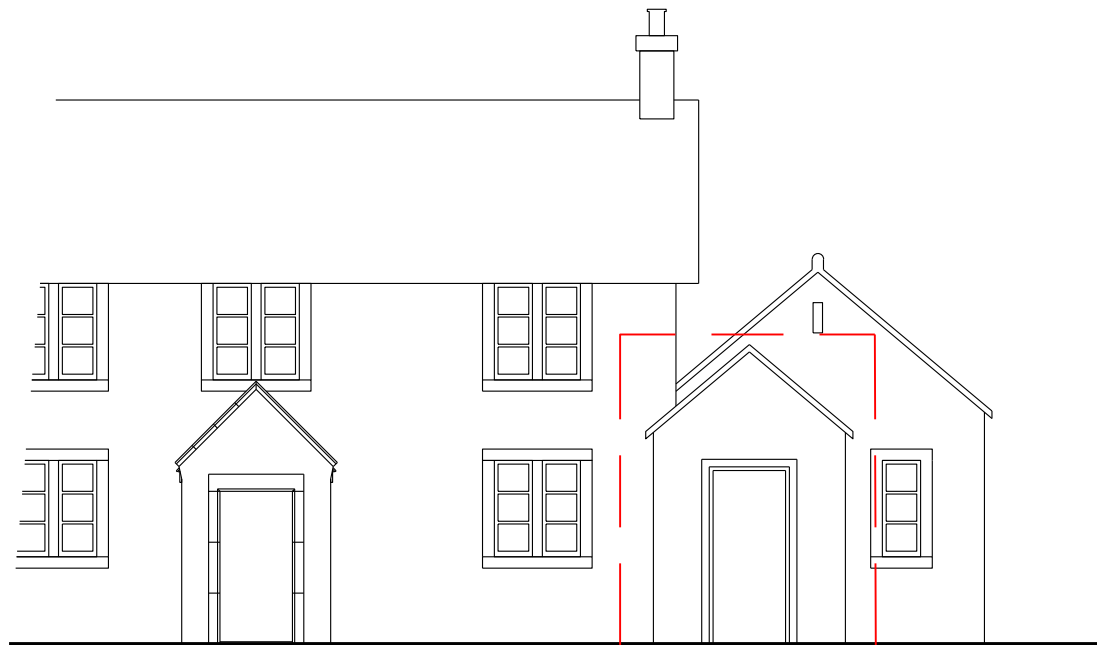
**E.02**  
Front Elevation As Proposed  
Scale - 1:100 @ A3

Existing elements of adjacent remaining projection  
detailing incorporated into reinstatement
