| Site | Purton Sewage Treatment Works |
| <p>Maydencroft Limited was commissioned by Thames Water to undertake an Ecological Walkover Survey of the proposed working area within Purton STW, Wiltshire. The purpose of the survey was to identify any ecological constraints associated with the installation of a new welfare unit.</p> <p>The proposed works involve the installation of a new permanent welfare unit at Purton STW. The unit will be positioned on an area of modified grassland, which will be replaced with suitable hardstanding to provide structural support. It is anticipated that the welfare unit will be delivered and positioned on site using a lorry-mounted crane which can access the area via the pre-existing infrastructure.</p> <p>This report has been prepared based on preliminary plans and should be revisited if any revisions are made. This ecological assessment will help inform future considerations to mitigate potential ecological impacts during the proposed works.</p> | |

| Project | Purton STW Ecological Walkover | | |

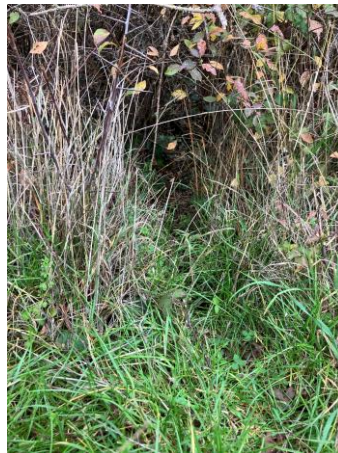
Plate 2: Mammal path leading into scrub

The habitats on-site provide suitable opportunities for badgers for foraging, commuting, and potential sett excavation, while maintaining good connectivity with the surrounding natural environment and waterbodies. The dense scrub offers suitable cover for commuting and sett-building, whereas the grassland provides potential foraging resources. The sloped topography of the mixed scrub is particularly well-suited for sett construction. Although no setts were identified during the survey, the dense scrub could easily conceal such features. Several signs of badger activity were recorded, including distinct mammal paths, potential snuffle holes, and push-unders within the chain-link fence. A more definitive sign of badger activity was recorded in the form of badger scat (*w3w: decoding.tram.stardom*). The scat

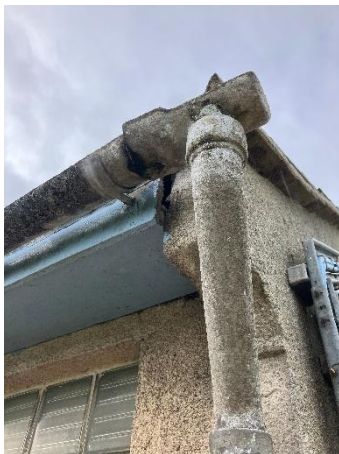
Plate 4: Potential roost feature 1 (PRF 1) within Building 1

The scattered trees on-site were assessed as generally having limited potential to support roosting bats. The trees are predominantly composed of young to semi-mature trees and did not exhibit any potential roost features (PRFs). However, it should be noted that many trees were covered by ivy cladding. Building 1 adjacent to the works area (Reference 3) contained several PRFs. These have been detailed in Table 1 (*at the end of the note*). At the time of survey, the loft space was inaccessible. Given the number of features that may provide potential roosting opportunities for bats the building is assessed as having low suitability for roosting bats. The building is not considered to have hibernation potential due to its solid concrete construction and likely limited insulation, therefore it does not offer the thermally stable environment necessary to support hibernation roosts.

| Feature Number | Location | Type | Height (metres) | Size (inches) | Description |
|---|---|---|---|---|---|
| 1 | East elevation | Gap between soffit box and wall | 2 | 2 x 4 | Tall gap present between fascia board and north wall leading into soffit space. |

- Prohibit heavy vehicle and plant access within 10m of Building 1 (Reference 3) to minimise disturbance to roosting bats from ground vibrations; where access is unavoidable, use track matting to reduce and absorb vibrations.
- All works should be undertaken during normal working daylight hours. Any artificial lighting (if absolutely required) should not illuminate the boundary habitats;
- Where security lighting is required, it is recommended that these are motion activated with hooded luminaires and directed away from the boundaries;
- No lighting should fall or be directed on to the boundary vegetation;

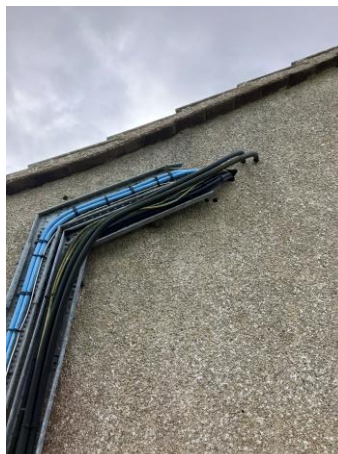
Plate 5: Building 1 PRF 2

| Feature Number | Location | Type | Height (metres) | Size (inches) | Description |
|---|---|---|---|---|---|
| 2 | North elevation | Holes in the wall | 2.5 | 2 | Several holes in north elevation wall likely leading into loft void. |

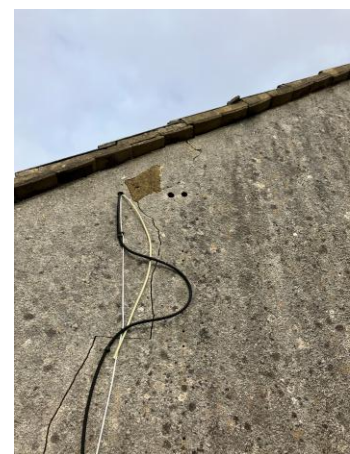
Plate 6: Building 1 PRF 3

| Feature Number | Location | Type | Height (metres) | Size (inches) | Description |
|---|---|---|---|---|---|
| 3 | South elevation | Holes in the wall | 2.5 | 2 | Several holes in south elevation wall likely leading into loft void. |

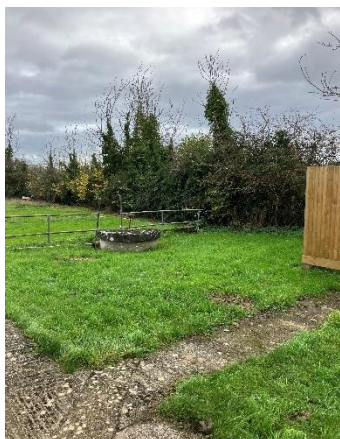
Plate 7: Reference 1 modified grassland

The area proposed to accommodate the welfare unit comprises modified grassland with a low species density. The sward is mixed in height, ranging between 5-15cm, with cock's-foot (*Dactylis glomerata*) dominating. Though not recently mown, the grassland has been previously managed, with little to no damage or bare ground present. Some areas appear damper, with hairy bittercress (*Cardamine hirsuta*) and sphagnum moss (*Sphagnum* spp.) present, particularly towards the adjacent sludge tank. Other species noted include perennial ryegrass (*Lolium perenne*), sphagnum moss, ribwort plantain (*Plantago lanceolata*), dove's-foot cranesbill (*Geranium molle*), common ragwort (*Jacobaea vulgaris*), spiny sow-thistle (*Sonchus asper*), dandelion (*Taraxacum officinale*), creeping cinquefoil (*Potentilla reptans*), and creeping buttercup (*Ranunculus repens*). A dry well approximately 1m in diameter is located within the grassland.

A portion of the modified grassland habitat (Reference 1) will be lost to facilitate the 6m x 3.5m hardstanding area. Other areas of modified grassland may also be temporarily disturbed by storage of materials and vehicle access. The proposed works may also require the removal of approximately 6m<sup>2</sup> of the bramble scrub in order to facilitate the welfare unit.

- Restrict vehicle and machinery access to pre-defined tracks or hardstanding areas.
- Use temporary matting or trackway systems for heavy machinery if crossing grassland is unavoidable.
- Clearly mark boundaries of retained grassland with temporary fencing or barriers.
- Avoid works when soil is wet, as this increases compaction risk.
- Scarify and re-seed compacted patches with a suitable grassland mix.

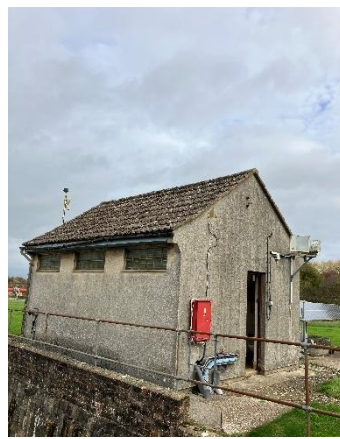
Plate 9: Reference 3 Building 1

Several buildings are present on site. The building closest to the works area (Building 1, Reference 3) is a small control room containing a single toilet. The building is constructed from concrete and features a box-gable roof with clay tiles and asbestos guttering. Paned windows set in mortar are present on the east and west elevations, situated beneath overhanging eaves and soffit boxes. A single wooden door is present on both the north and south elevations.

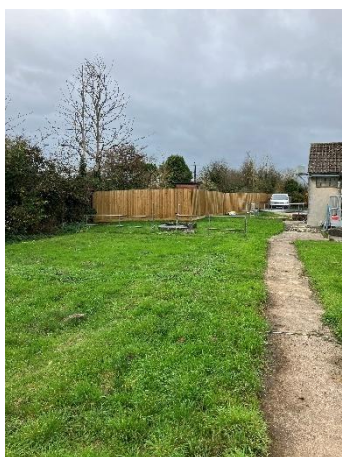
Plate 10: Reference 4 modified grassland

Adjacent to Reference 1 is another area of modified grassland growing over previously filled sludge tanks, with their boundaries still visible through the grassland. The sward is uniformly low, with an average height of approximately 7cm and a low species density. Small amounts of scattered bramble (*Rubus fruticosus*) are present, and evidence of rabbit (*Oryctolagus cuniculus*) activity is visible through droppings and scratch marks. One area of the grassland is heavily disturbed along the fence boundary, where stone chippings have been laid, and ruderal species are growing through, such as bristly ox-tongue (*Helminthotheca echioides*), cleavers (*Galium aparine*), thistle (*Cirsium* spp.), and dove's-foot cranesbill. The majority of the grassland's composition is similar to that described above, with the addition of tufted hair-grass (*Deschampsia cespitosa*), red fescue (*Festuca rubra*), and curly dock (*Rumex crispus*).

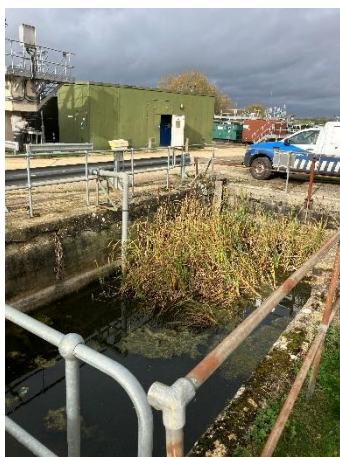
Plate 11: Reference 5 sludge tank

Immediately northwest of the works area is a sludge tank (Reference 5) constructed of concrete and sunken into the ground, surrounded by metal railings. The water within the tank appears to have low turbidity and supports aquatic vegetation. The water level is approximately 1.5m below ground level, with the total depth unknown. A wooden ramp, comprising a foot-wide plank, has been positioned from the tank's edge into the water, presumably to allow wildlife to escape. Vegetation identified within the tank includes broad-leaved cattail (*Typha latifolia*) and duckweed (*Lemna* spp.), though additional submerged species were present but not identified.

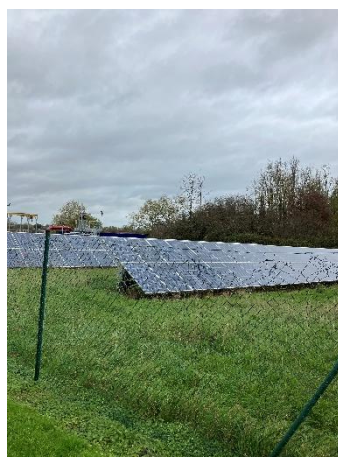
Plate 12: Reference 7 tall modified grassland surrounding solar panels

Just east of the works area is a small solar farm surrounded by unmanaged tall grass with a similar composition to Reference 6.

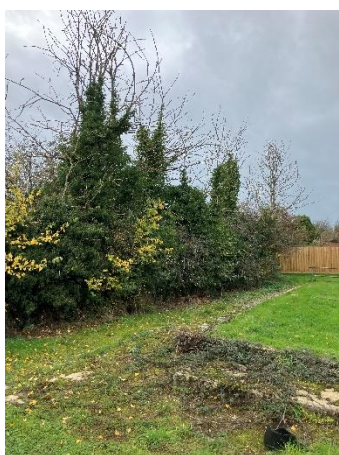
Plate 13: Reference 8 dense mixed scrub with scattered trees

Running along the southern boundary of the STW is a narrow strip of dense mixed scrub with scattered trees. Situated just inside this strip is a chain-link fence that encloses the entire site. The scrub is approximately 3m in width and comprises a mixture of mature and young growth, established on a slope descending to a dry ditch. The majority of the scattered trees within the scrub area are dead and are heavily clad in common ivy (*Hedera helix*). Common ivy also forms dense ground cover at the periphery, alongside common nettle (*Urtica dioica*). The scrub species identified include blackthorn (*Prunus spinosa*), hawthorn (*Crataegus monogyna*), field elm (*Ulmus minor*), and elder (*Sambucus nigra*).

Scrub removal should be avoided wherever possible. However, if the clearance of scrub or dense vegetation is necessary, a two-phase vegetation clearance method should be employed to minimise risks to GCN and other protected species. This should be carried out under the supervision of an ECoW during peak GCN activity periods. The initial cut should reduce vegetation to approximately 30cm (1 foot) in height, allowing the areas to be inspected for signs of great crested newt, other protected species and hibernacula, and allowing species to disperse naturally. Following the confirmed absence of protected species and great crested newt the final cut can be undertaken. Rubble piles, logs, and deadwood should be dismantled under ECoW supervision at all times if removal is required.

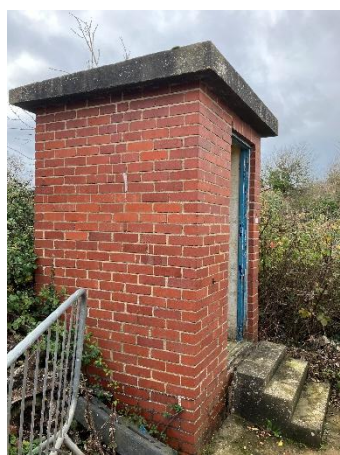
Plate 14: Reference 11 small building within bramble scrub

Within the bramble scrub, a small building (Reference 11), with a floor area of no more than 1.5m<sup>2</sup>, is present. The structure is constructed from red brick with a shed-style concrete roof. There is no door present, though an opening with a deteriorating door frame remains. Wooden planks have been laid across the floor, presumably covering access to an area beneath the ground surface.

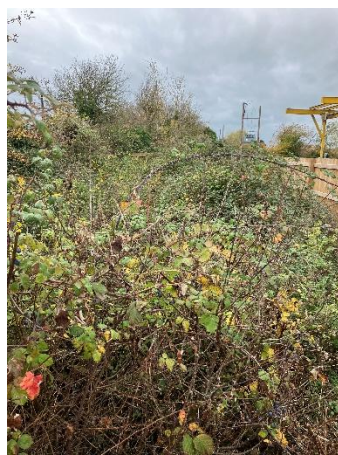
Plate 15: Reference 12 bramble scrub

Bordering the area of grassland proposed for the welfare unit is a section of dense bramble scrub, cordoned off by wooden fence panels. Within this area are two sunken tanks constructed of red brick and mortar, each approximately 1.5m<sup>2</sup> in area. The tanks appear to have previously held water but are currently dry, with vegetation growing in and around them. Various materials have been stored within the area, including wooden planks, Heras fencing, old machinery, and general litter and waste. Vegetation within the area is dominated by bramble, with dog-rose (*Rosa canina*), blackthorn, common nettle, common ivy, and occasional tree saplings, including goat willow (*Salix caprea*), also present.

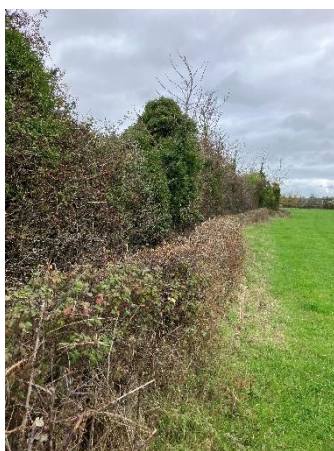
Plate 19: Native blackthorn hedgerow

Running immediately south of the mixed scrub is a short, heavily managed blackthorn hedgerow, separated from the scrub by a dry ditch. Further east, opposite the solar farm, a section of the ditch is wet, holding a shallow level of water (several millimetres) and supporting rush species (*Juncus* spp.).

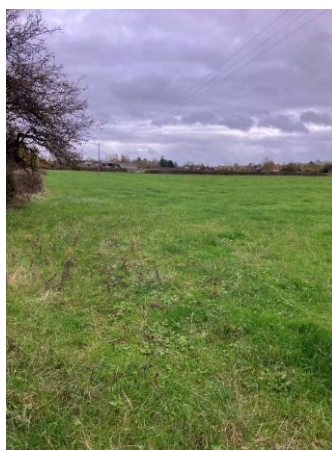
Plate 20: Reference 13 other neutral grassland pasture field

Beyond the blackthorn hedgerow lies a large pasture field (Reference 13) comprising neutral grassland of low botanical diversity and quality. The water treatment works infrastructure surrounds the remainder of the works area.

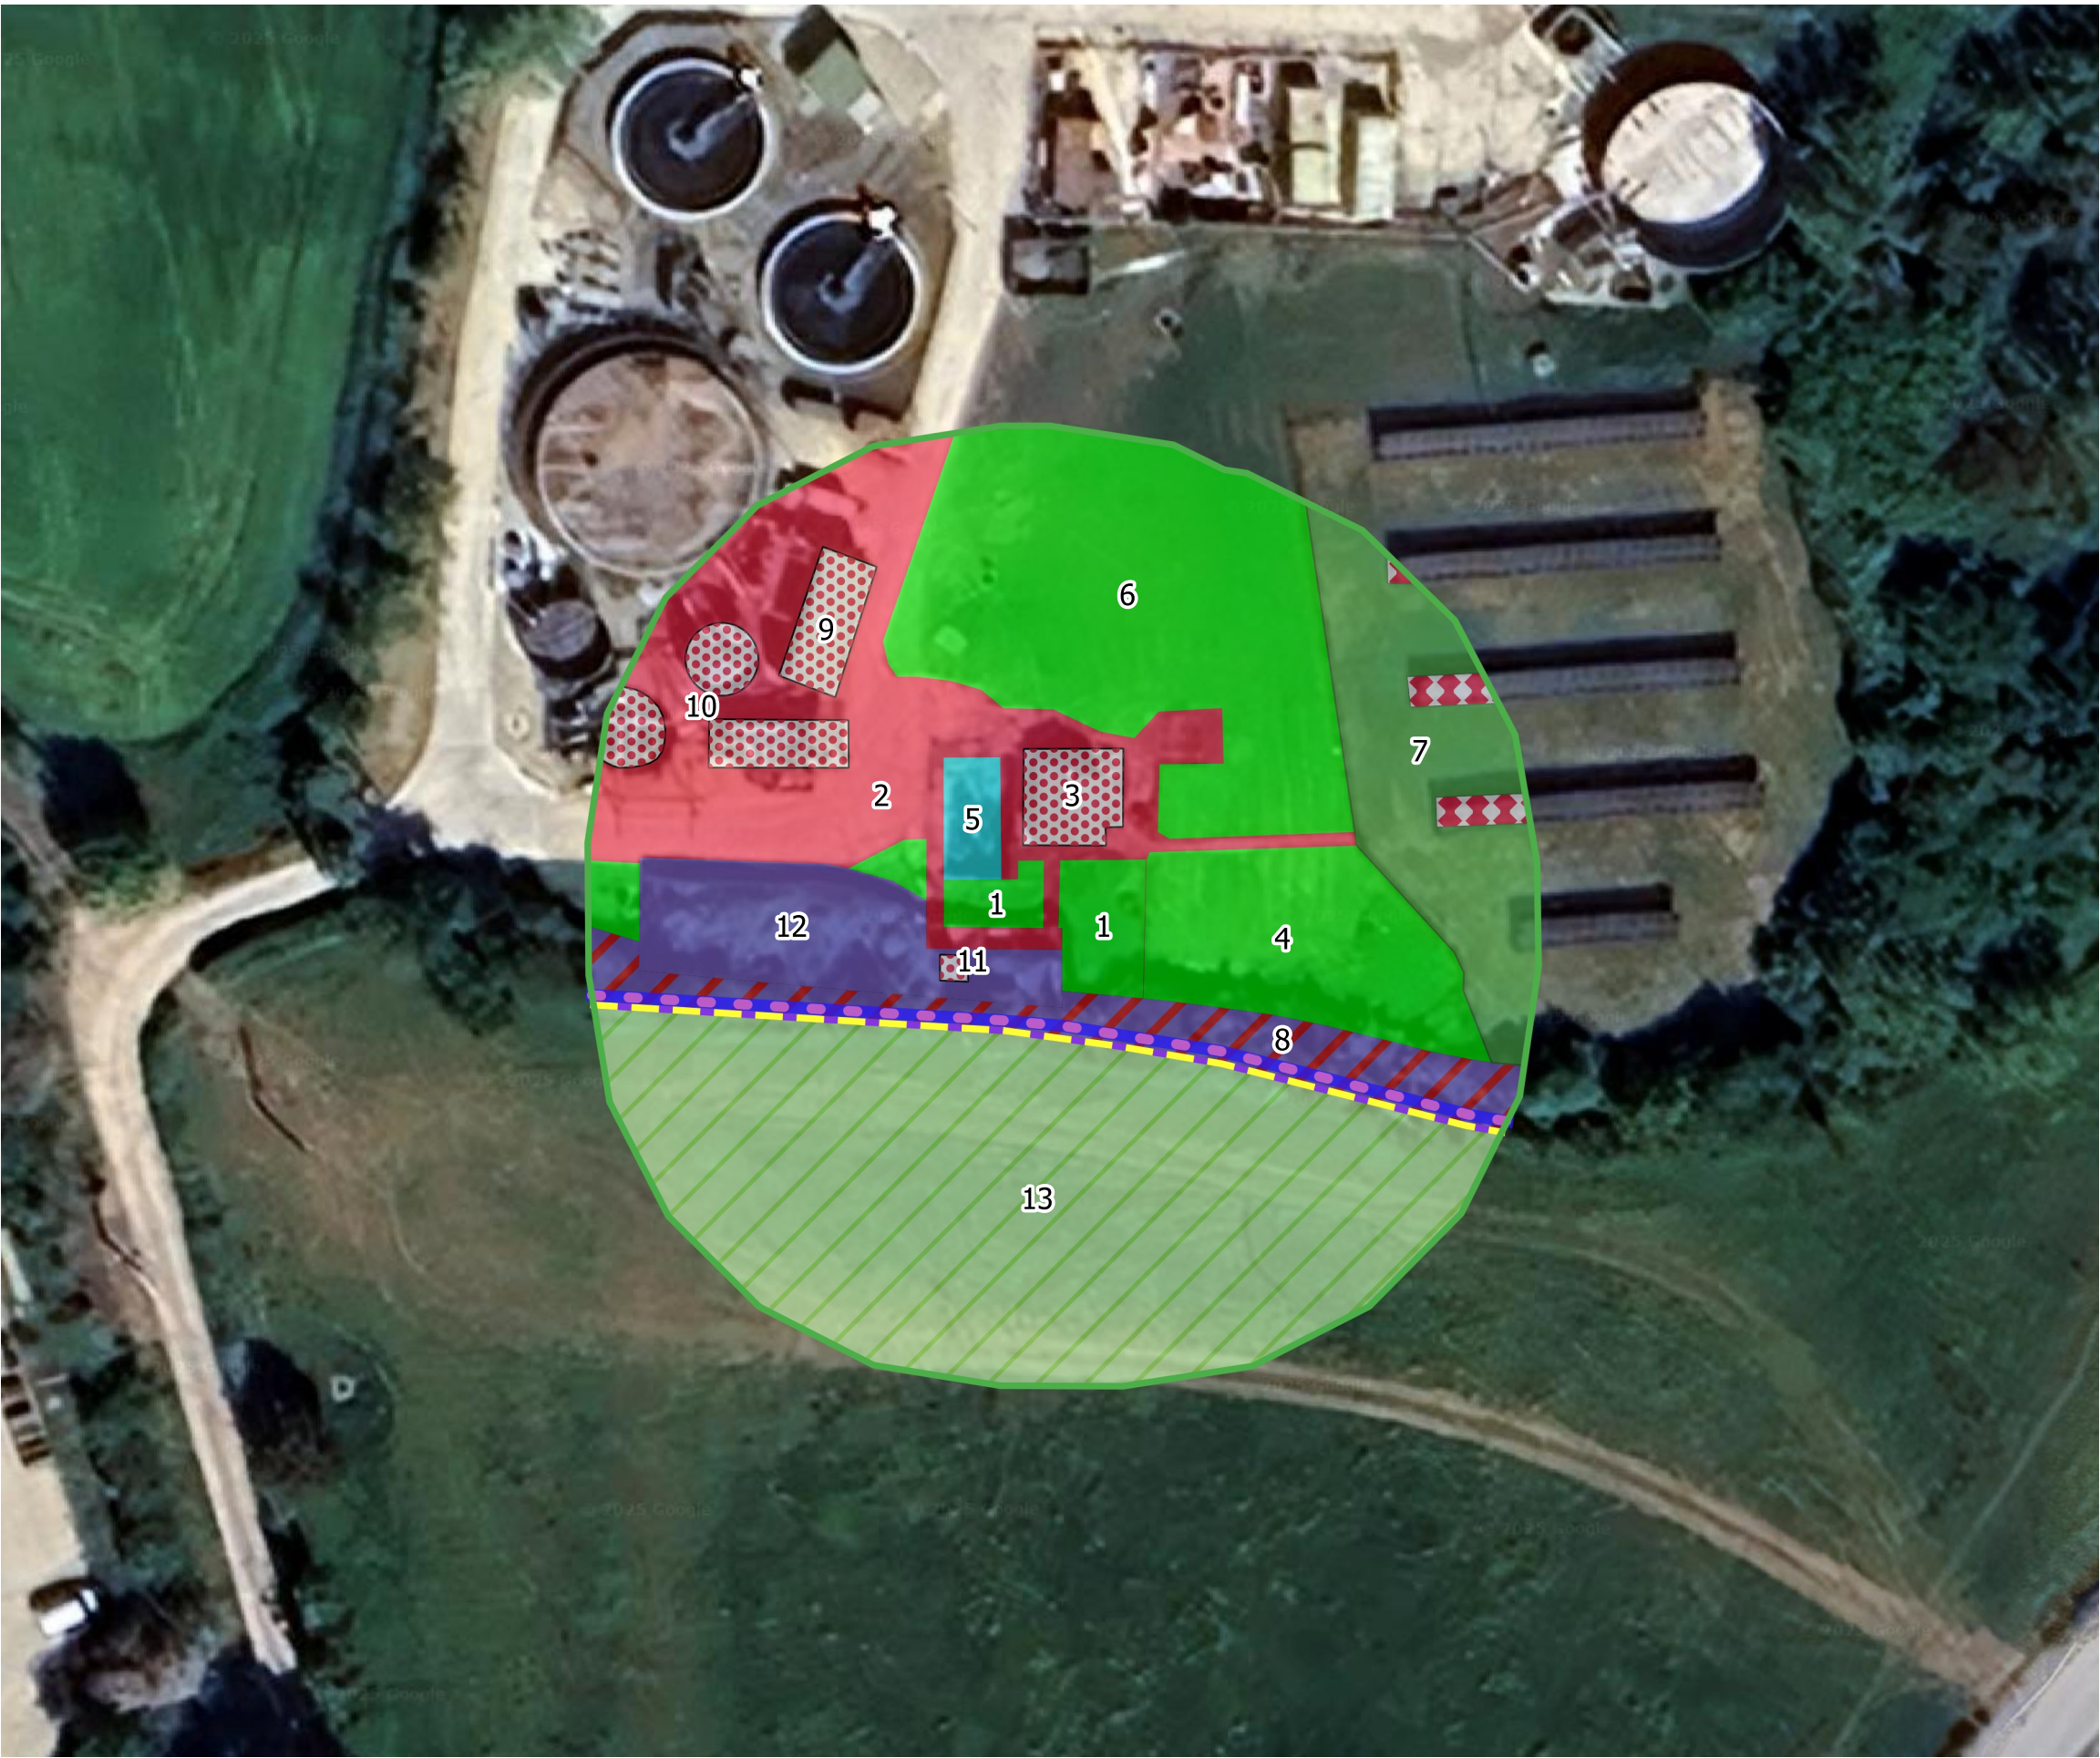
| Title | Habitat Map | | |

- Key**
- 30m Buffer
  - h3h, 50 - Dry ditch
  - h2a - Native hedgerow
  - g4, 128 - Tall modified grassland
  - g3 - Neutral grassland
  - g4 - Modified grassland
  - h3d - Bramble scrub
  - h3h - Mixed scrub
  - u1b5 - Buildings
  - u1b6 - Other developed land
  - u1e - Built linear features
  - r1g - Other standing water
