**BS5837:2012 Trees in Relation to Demolition,  
Design and Construction.**

**Tree Survey and Arboricultural Impact Assessment**

**West Dean Farm, West Dean, Salisbury, Wiltshire. SP5 1HP**

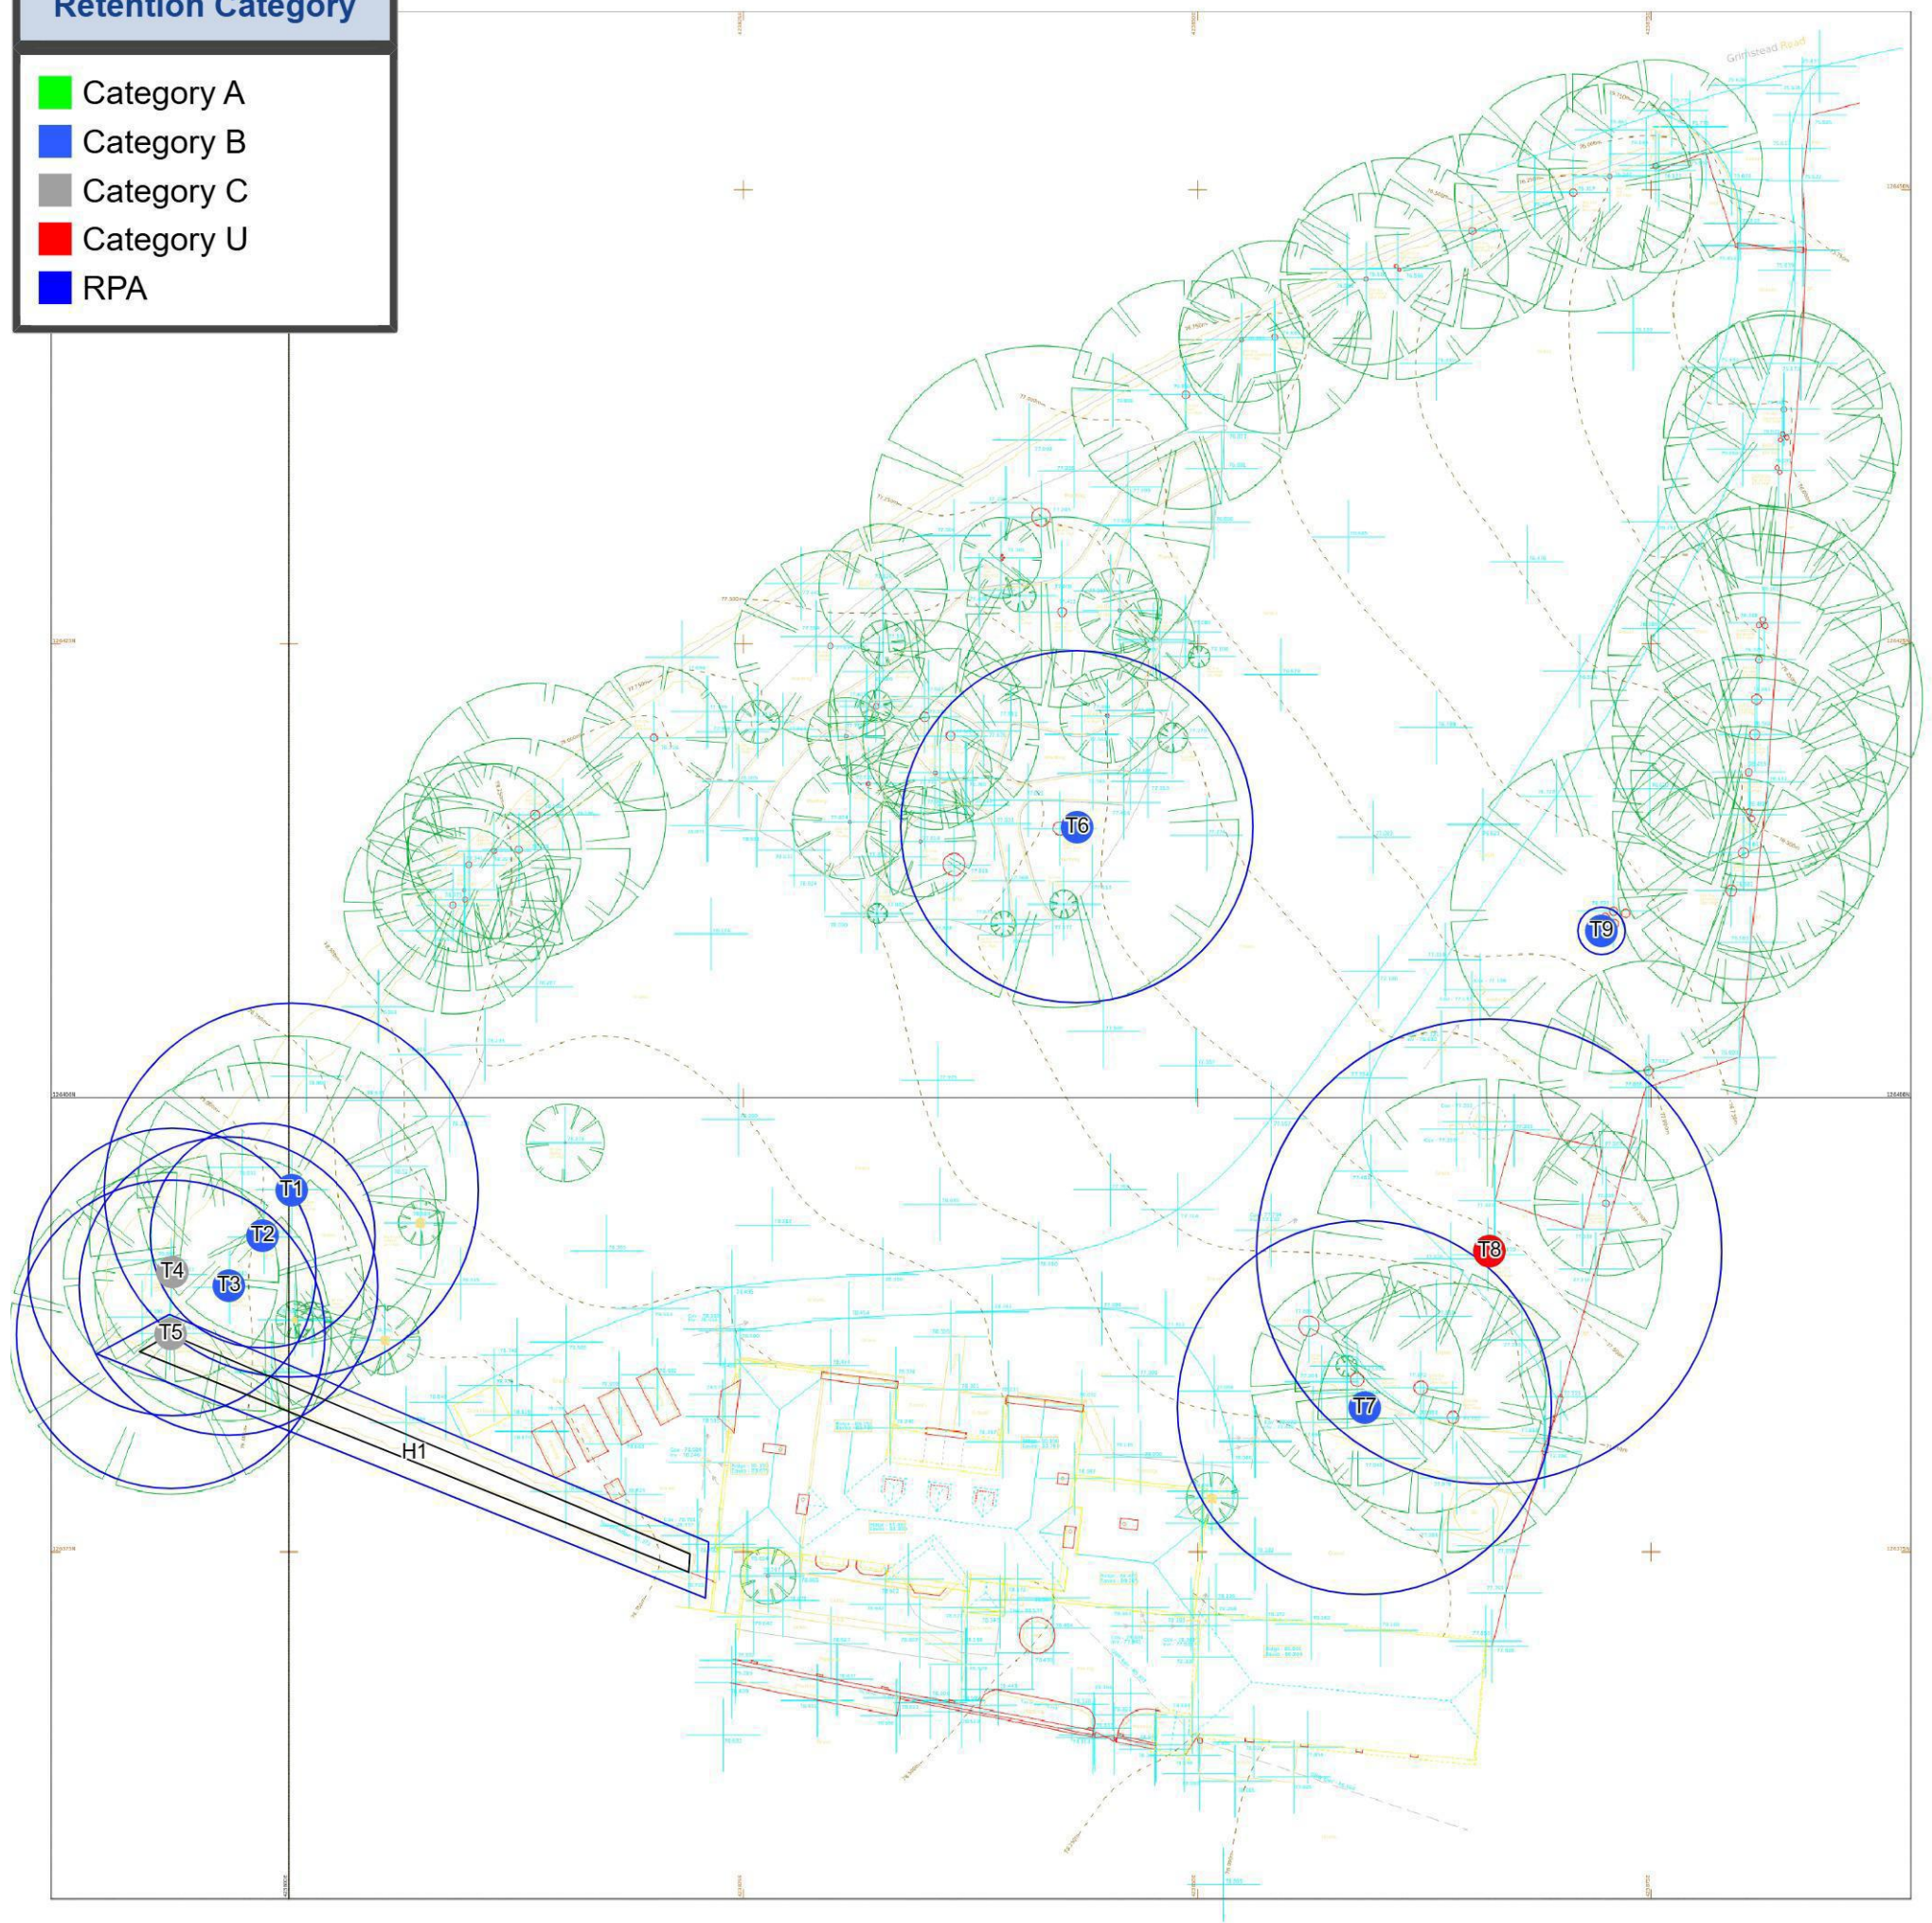
- 5.1. The Tree Constraints Plan (Appendix 4) is overlaid on the topographical survey 23059-1,2,3 supplied by Richmond Bell Architects, and indicates tree positions and notional Root Protection Areas (RPAs). The proposed position of the various structures is not illustrated on the drawing to allow for repositioning if required.

- 8.1. Tree protection methods (fencing and ground) must be used to reduce the impact of the proposed development upon retained trees and positioned at the extent of the Root Protection Areas marked by a blue line on the Tree Constraints Plan.

The plan located to the rear of this report shows the approximate extent of Root Protection Areas (RPAs) marked in grey hatching. The RPAs have been calculated in accordance with the methodology set out within Appendices C and D of BS5837: 2012, using the stem diameter dimensions obtained during the site visit.
