**OUTBUILDINGS,  
at MANOR FARMHOUSE, WORTON**

**Heritage Assessment**

**February 2023**

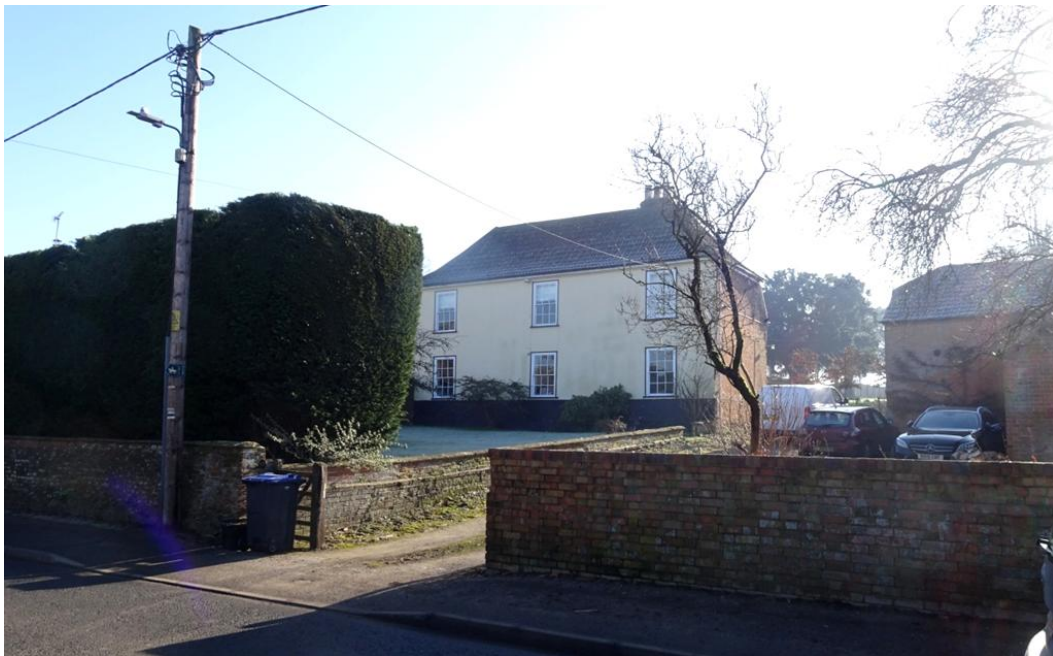
**Photo 2. Manor Farm House from High Street, with the outbuildings on the extreme right**

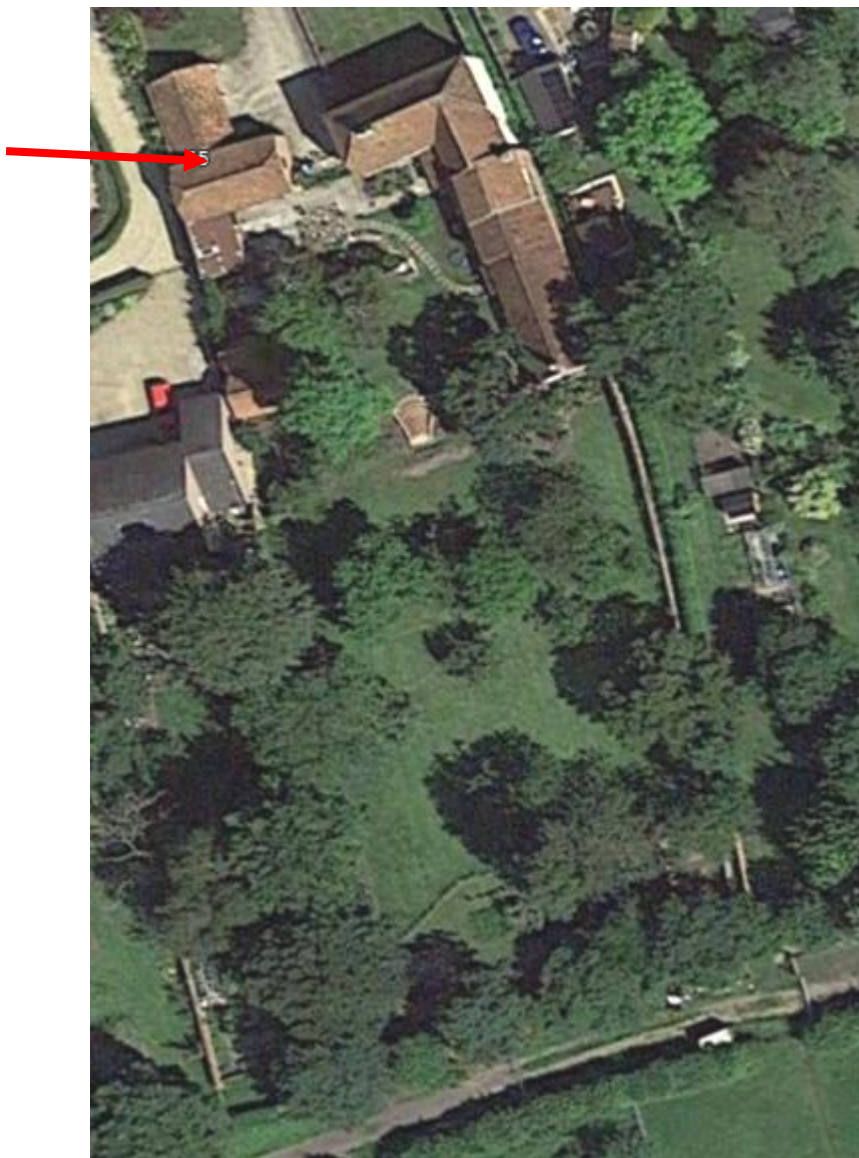
**Figure 1. Aerial image of Manor Farm House and its grounds, with the outbuildings arrowed**

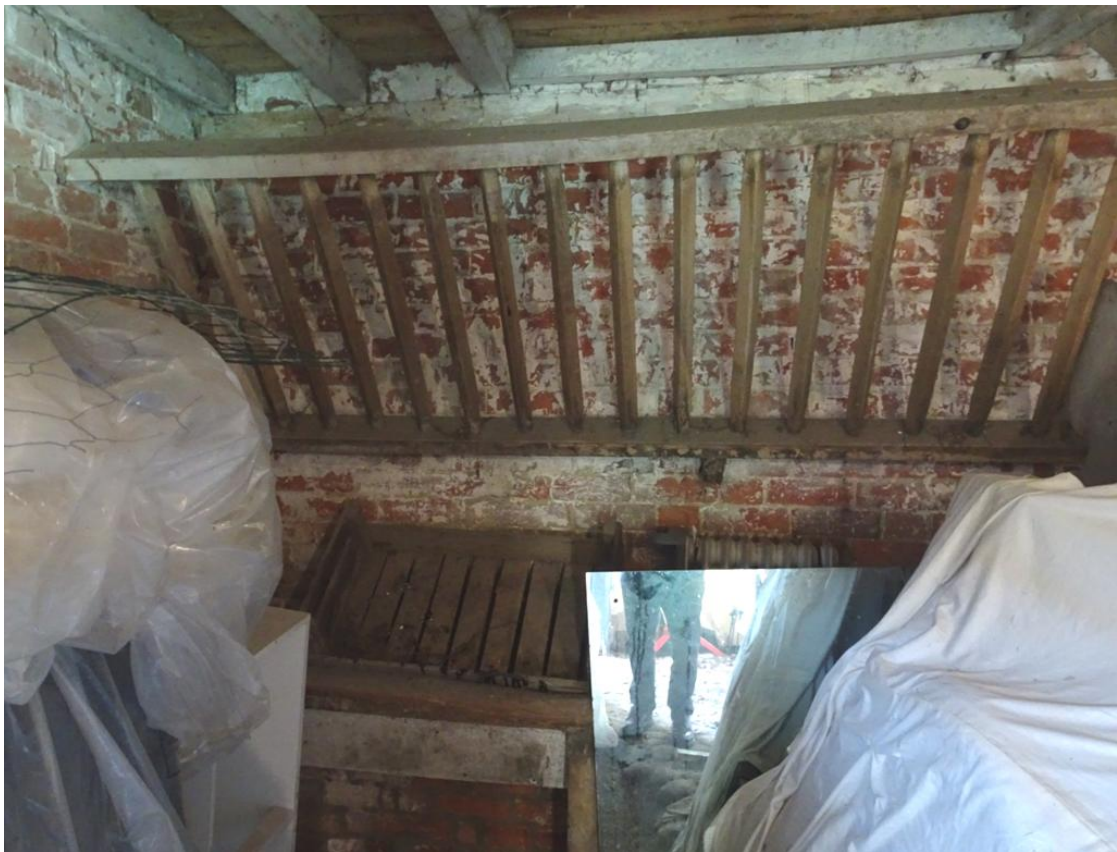
- 3.8 The main range of the outbuildings is of one and half stories with brick walls beneath a clay tiled roof. This contains the hallmarks of a stable. A timber ground floor partition sub-divides the floor plan. The western half has a roughly cobbled floor with a crude drainage channel, and a timber hayrack and trough against the west gable end. There is a low stall divider and a narrow hatch leading up to a loft where hay would have been supplied through a pitching hole in the eastern gable. The hay would have been swept into the hayrack through a gap in the floor or a trap door. The structure seems too small to have housed shire or cart horses and it was probably used by domestic ponies or nags. A trap is likely to have been housed within the adjacent open-fronted structure. The eastern half of the main range has a dirt floor and may have been used as an occasional loose box.

**Photo 3. The hayrack and manger (partly obscured by a mirror)**

- 6.3 The final scheme should avoid the introduction of overtly domestic features such as porches and conservatories. An equally important objective, however, should be the retention of as much significant historic fabric as possible, together with the use of compatible materials and methods of repair. The tiled roof and the brickwork walls should be retained, and the ground floor hayrack and manger should be kept as a feature.

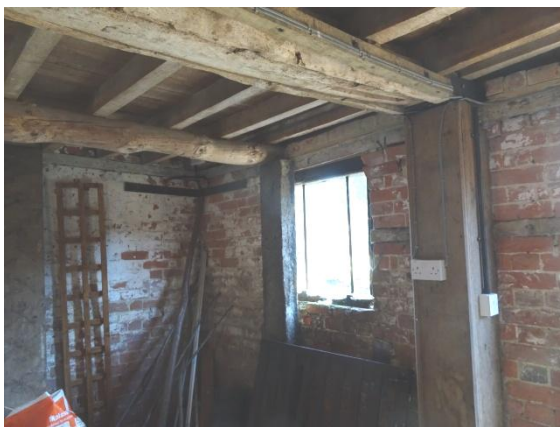
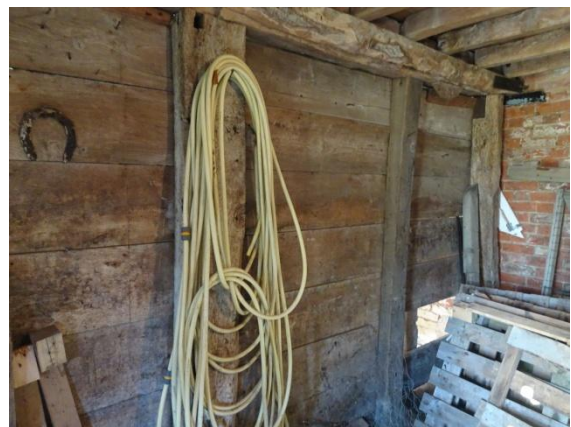
- 4.5 Alterations to the original structure have further weakened its character. A pole beam and a number of posts formed by railway sleepers have been inserted to support the first floor structure. Furthermore, the structure of the partition within the ground floor of the main range is formed with timber posts that are not correctly jointed into the oversailing beam. The timber stall divider in the western half was also cobbled together by an unskilled craftsman.

**Photo 4 (left) an original floor beam with inserted pole beam both supported by posts that have been added, and Photo 5 the ground floor partition with posts seemingly wedged into position.**

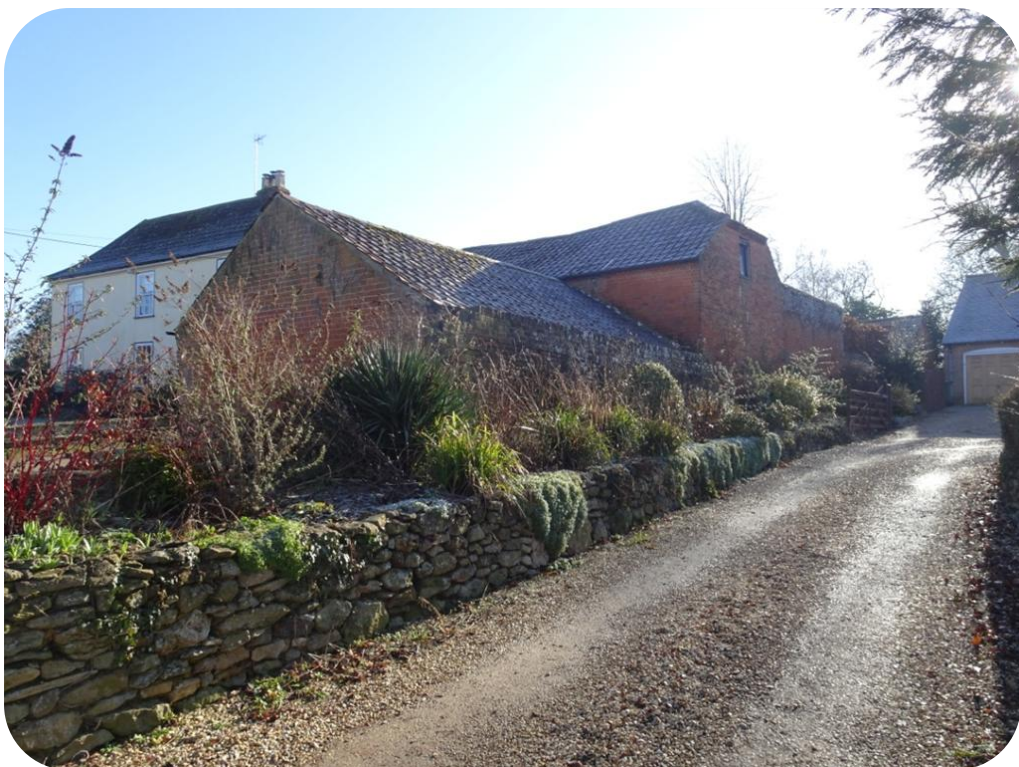
**Photo 10. The west flank of the outbuildings with the access drive to 65 High Street in the foreground.**
