## **TECHNICAL NOTE**

### **Drainage Calculations**

#### **237 London Road, Chippenham**

Lanmor Consulting has been appointed to provide the below ground Drainage Design and Calculations for the proposed development at 237 London Road, Chippenham, SN15 3AP. The proposed development is for the construction of a single, detached 3-bed house in the rear garden of the existing property. Planning permission was granted by Wiltshire Council in 2025 and this report is to address condition 3 of that approval [ref PL/2024/05413].

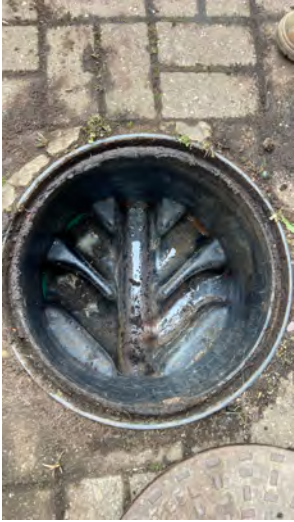
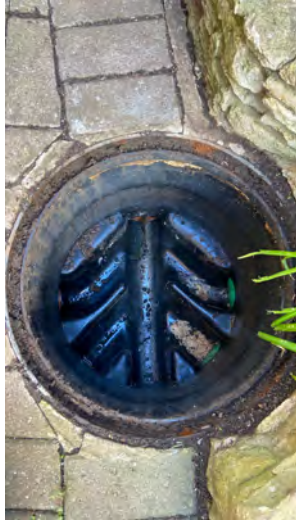
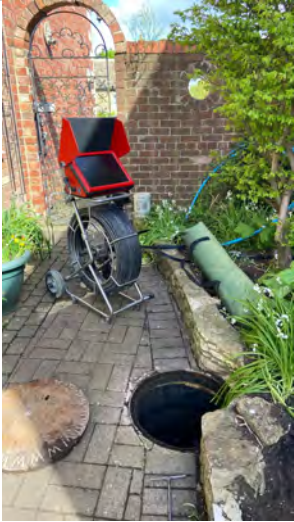
| Job Number<br><b>1521488</b> | Surveyed by (Operator)<br><b>A Anderson</b> | Base Unit<br><b>HITAR4XYJT</b> | Date<br><b>15/04/2026</b> |
|---|---|---|---|
| <p><b>Manhole / Access Point: IC1 Internal</b></p> | | <p><b>Manhole / Access Point: IC2 Internal</b></p> | |
| <p><b>Manhole / Access Point: IC2 Location</b></p> | | <p><b>Property: Front Elevation</b></p> | |

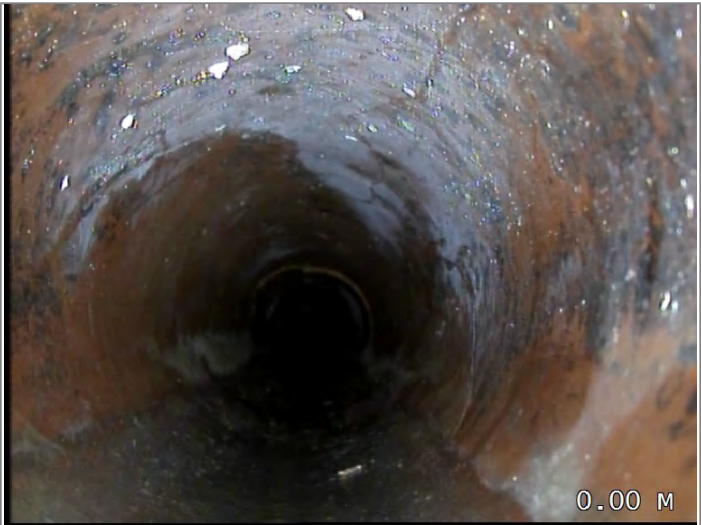
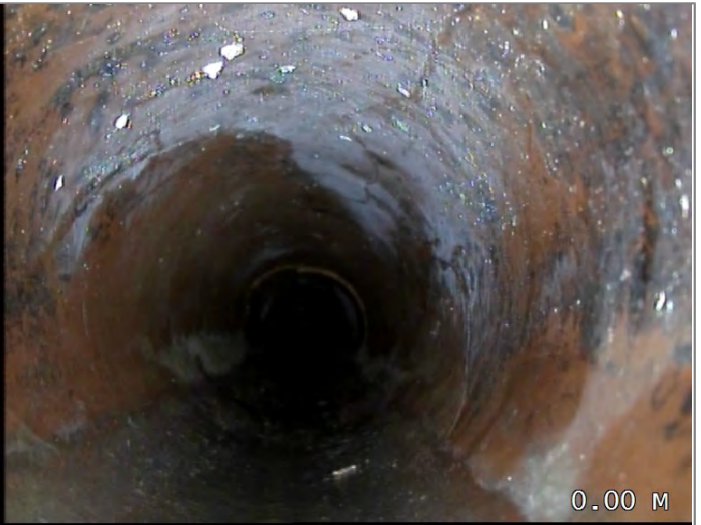
| Job Number<br>1521488 | Surveyed by (Operator)<br>A Anderson | Base Unit<br>HITAR4XYJT | Date<br>15/04/2026 |
|---|---|---|---|
| <p>0.00 M</p> <p>Start node type, inspection chamber, reference IC1</p> | | <p>0.00 M</p> <p>Water level 0% height/diameter</p> | |

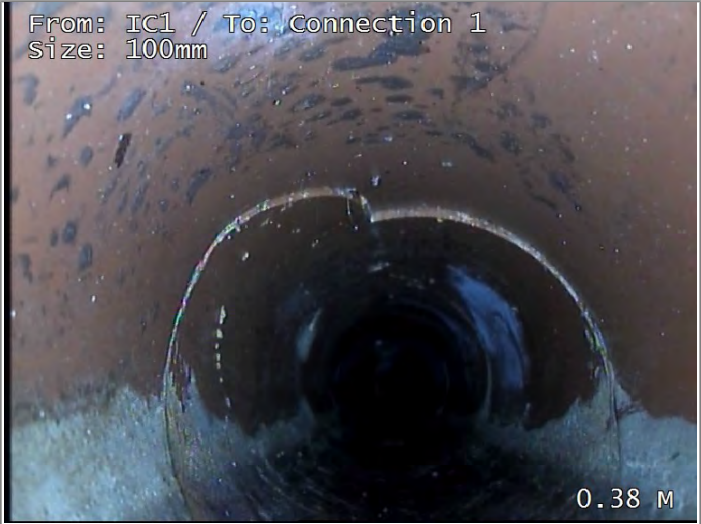
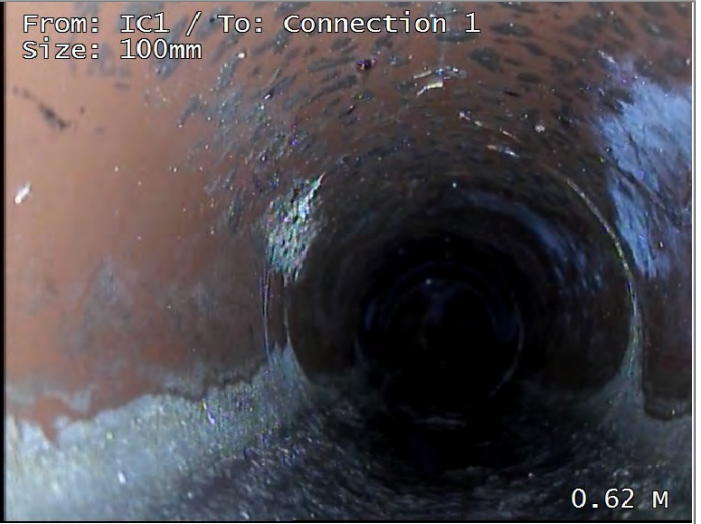
| Position | Code | Description | Photo | Type/Grade |
|---|---|---|---|---|
| 0.38 | FC | Fracture circumferential from 12 to 12 o'clock | 14653322 | Structural / 3 |
| 0.62 | FC | Fracture circumferential from 12 to 12 o'clock | 14653328 | Structural / 3 |

| Job Number<br>1521488 | Surveyed by (Operator)<br>A Anderson | Base Unit<br>HITAR4XYJT | Date<br>15/04/2026 |
|---|---|---|---|
| <p>From: IC1 / To: Connection 1<br/>Size: 100mm</p> <p>0.38 M</p> <p>Fracture circumferential from 12 to 12 o'clock</p> | | <p>From: IC1 / To: Connection 1<br/>Size: 100mm</p> <p>0.62 M</p> <p>Fracture circumferential from 12 to 12 o'clock</p> | |

In this section the survey identified Fractures in the pipe work at 0.38 + 0.62mtrs.

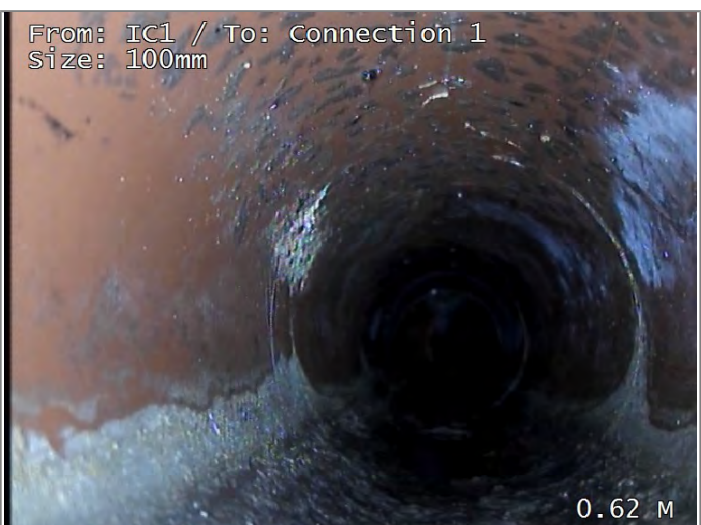
| Position | Code | Description | Photo | Type/Grade |
|---|---|---|---|---|
| 0.62 | CL | Crack longitudinal at 12 o'clock | 14653333 | Structural / 2 |

| Job Number<br>1521488 | Surveyed by (Operator)<br>A Anderson | Base Unit<br>HITAR4XYJT | Date<br>15/04/2026 |
|---|---|---|---|
| <p>From: IC1 / To: Connection 1<br/>Size: 100mm</p> <p>0.62 M</p> <p>Crack longitudinal at 12 o'clock</p> | | <p>From: IC1 / To: Connection 1<br/>Size: 100mm</p> <p>1.31 M</p> <p>Line of drain/sewer deviates right</p> | |

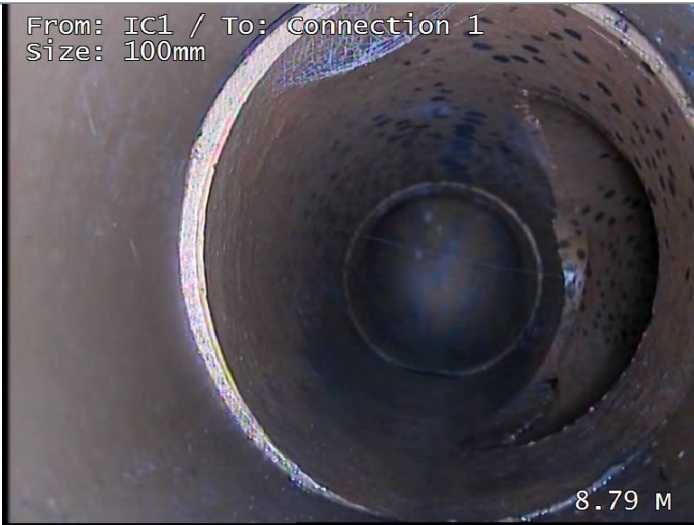
| Job Number<br><b>1521488</b> | Surveyed by (Operator)<br><b>A Anderson</b> | Base Unit<br><b>HITAR4XYJT</b> | Date<br><b>15/04/2026</b> |
|---|---|---|---|
| <div> <div> From: IC1 / To: Connection 1<br/>Size: 100mm </div> <div>8.79 M</div> <div>Connection other than junction at 3 o'clock, diameter 100mm</div> </div> | | | |

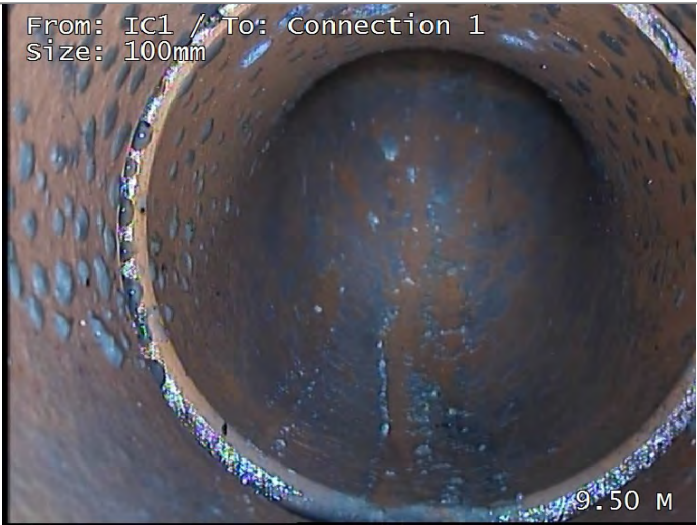
| Job Number<br><b>1521488</b> | Surveyed by (Operator)<br><b>A Anderson</b> | Base Unit<br><b>HITAR4XYJT</b> | Date<br><b>15/04/2026</b> |
|---|---|---|---|
| <div> <div> From: IC1 / To: Connection 1<br/>Size: 100mm </div> <div>9.50 M</div> <div>Line of drain/sewer deviates up</div> </div> | | | |

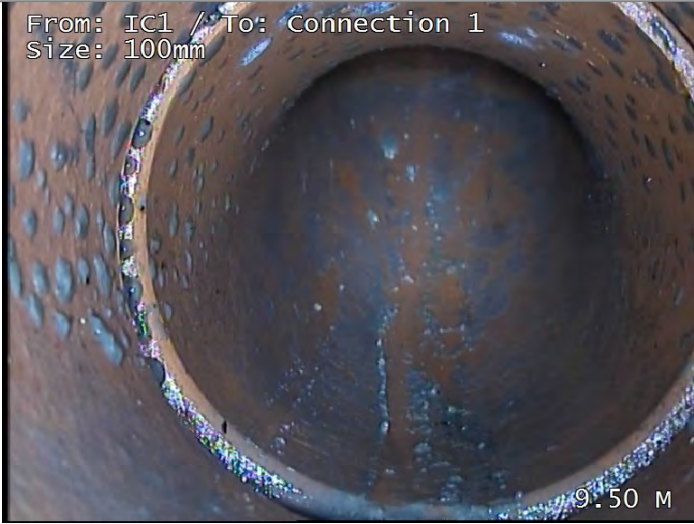
| Job Number<br><b>1521488</b> | Surveyed by (Operator)<br><b>A Anderson</b> | Base Unit<br><b>HITAR4XYJT</b> | Date<br><b>15/04/2026</b> |
|---|---|---|---|
| <div> <div> From: IC1 / To: Connection 1<br/>Size: 100mm </div> <div>9.50 M</div> <div>Water level 0% height/diameter</div> </div> | | | |

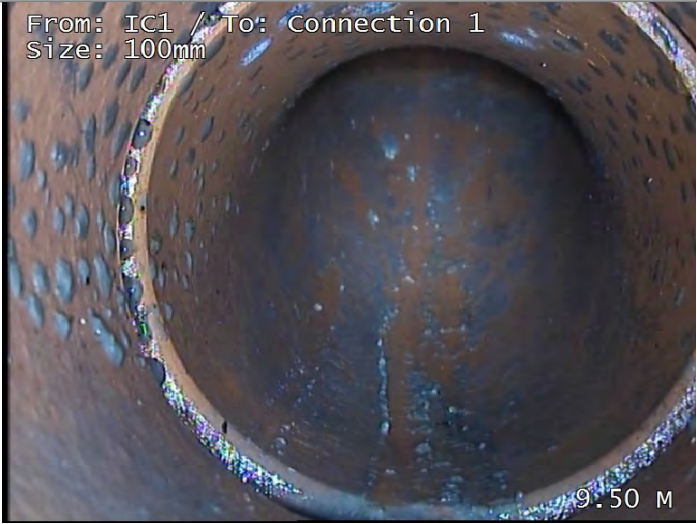
| Job Number<br><b>1521488</b> | Surveyed by (Operator)<br><b>A Anderson</b> | Base Unit<br><b>HITAR4XYJT</b> | Date<br><b>15/04/2026</b> |
|---|---|---|---|
| <div> <div> From: IC1 / To: Connection 1<br/>Size: 100mm </div> <div>9.50 M</div> <div>End of survey: At Rest-bend to the sink waste outlet (outside Toilet).</div> </div> | | | |

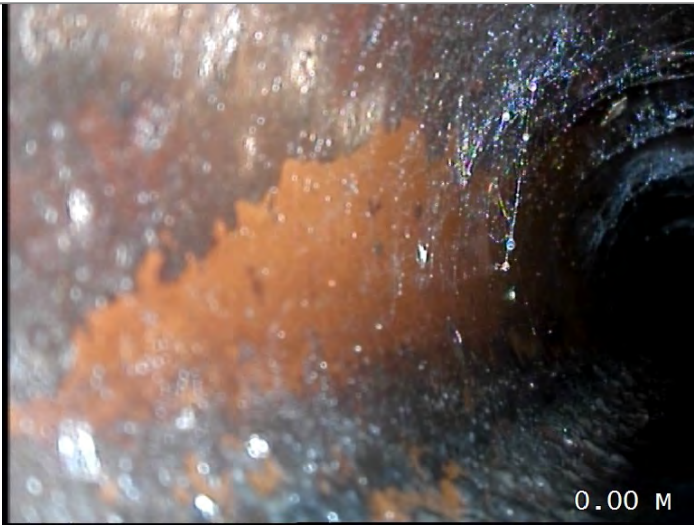
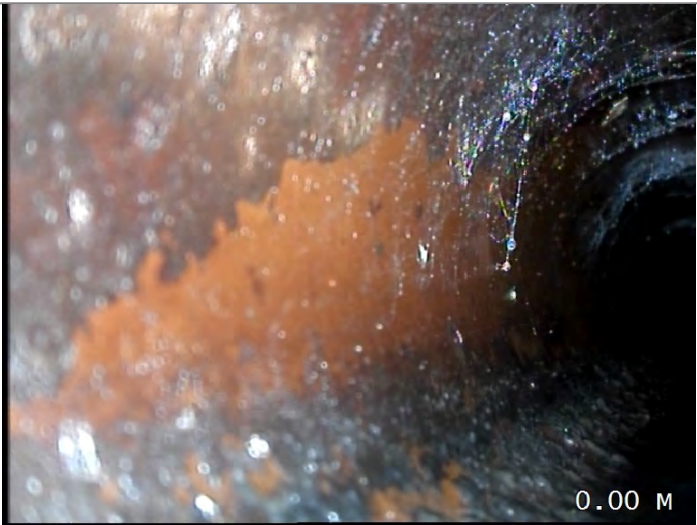
| Job Number<br>1521488 | Surveyed by (Operator)<br>A Anderson | Base Unit<br>HITAR4XYJT | Date<br>15/04/2026 |
|---|---|---|---|
| <p>0.00 M</p> <p>Start node type, inspection chamber, reference IC1</p> | | <p>0.00 M</p> <p>Water level 0% height/diameter</p> | |

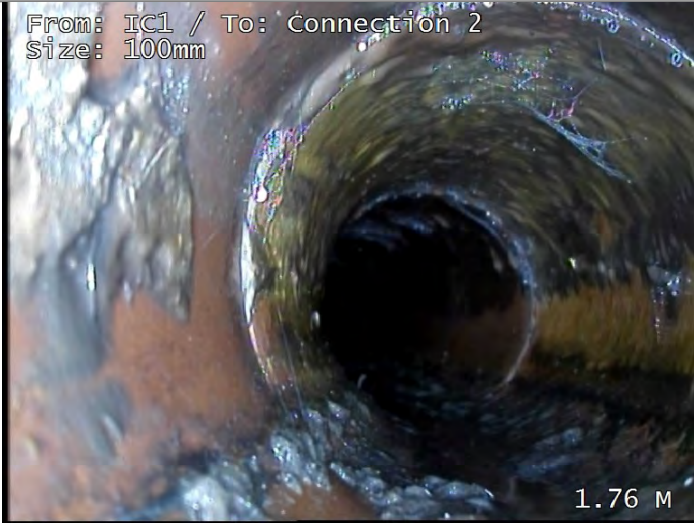
| Job Number<br>1521488 | Surveyed by (Operator)<br>A Anderson | Base Unit<br>HITAR4XYJT | Date<br>15/04/2026 |
|---|---|---|---|
| <p>From: IC1 / To: Connection 2<br/>Size: 100mm</p> <p>1.76 M</p> <p>Line of drain/sewer deviates left</p> | | <p>From: IC1 / To: Connection 2<br/>Size: 100mm</p> <p>4.33 M</p> <p>Attached deposits, grease from 4 to 10 o'clock 50% cross-sectional area loss - Remark: Build up on outlet to Gully 1.</p> | |

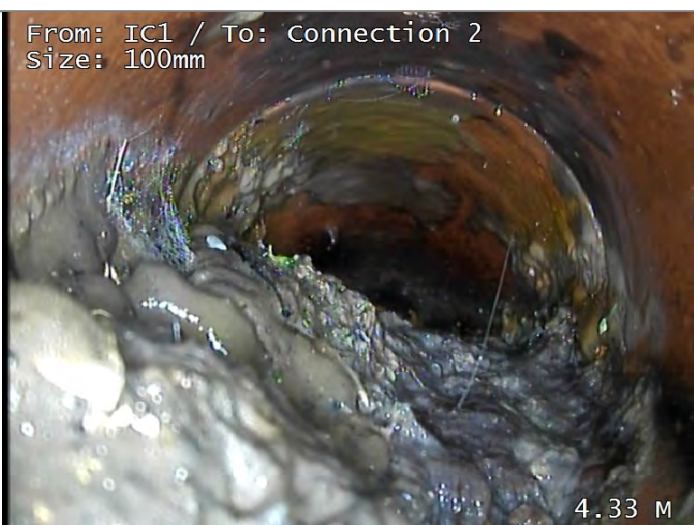
| Job Number<br>1521488 | Surveyed by (Operator)<br>A Anderson | Base Unit<br>HITAR4XYJT | Date<br>15/04/2026 |
|---|---|---|---|
| <p>From: IC1 / To: Connection 2<br/>Size: 100mm</p> <p>4.33 M</p> <p>End of survey: At outlet to Gully 1.</p> | | | |

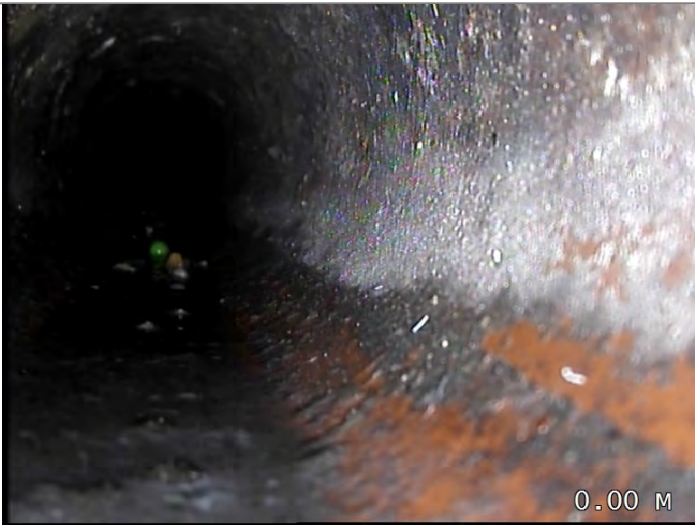
| Job Number<br><b>1521488</b> | Surveyed by (Operator)<br><b>A Anderson</b> | Base Unit<br><b>HITAR4XYJT</b> | Date<br><b>15/04/2026</b> |
|---|---|---|---|
| <p>0.00 M</p> <p>Start node type, inspection chamber, reference IC1</p> | | | |

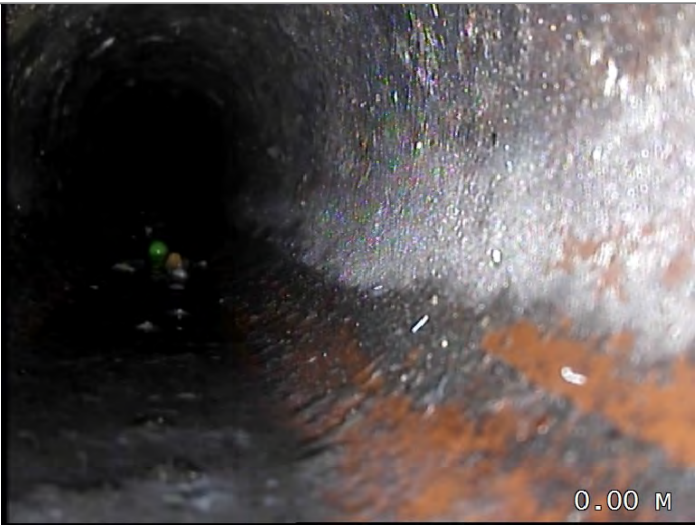
| Job Number<br><b>1521488</b> | Surveyed by (Operator)<br><b>A Anderson</b> | Base Unit<br><b>HITAR4XYJT</b> | Date<br><b>15/04/2026</b> |
|---|---|---|---|
| <p>0.00 M</p> <p>Water level 0% height/diameter</p> | | | |

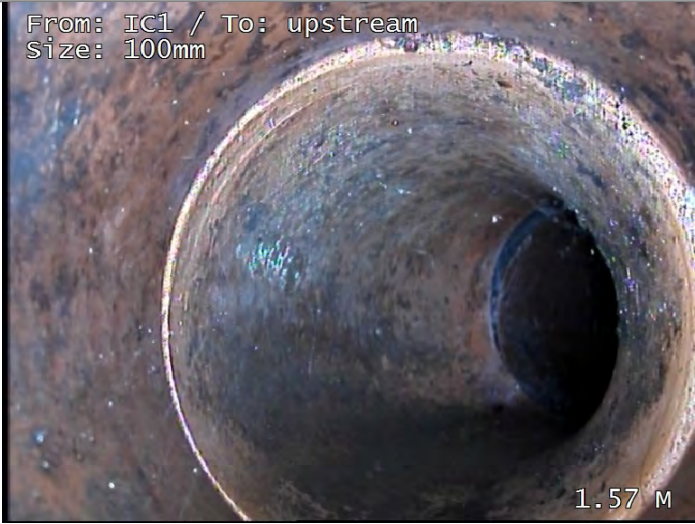
| Job Number<br><b>1521488</b> | Surveyed by (Operator)<br><b>A Anderson</b> | Base Unit<br><b>HITAR4XYJT</b> | Date<br><b>15/04/2026</b> |
|---|---|---|---|
| <p>From: IC1 / To: upstream<br/>Size: 100mm</p> <p>1.57 M</p> <p>Line of drain/sewer deviates right</p> | | | |

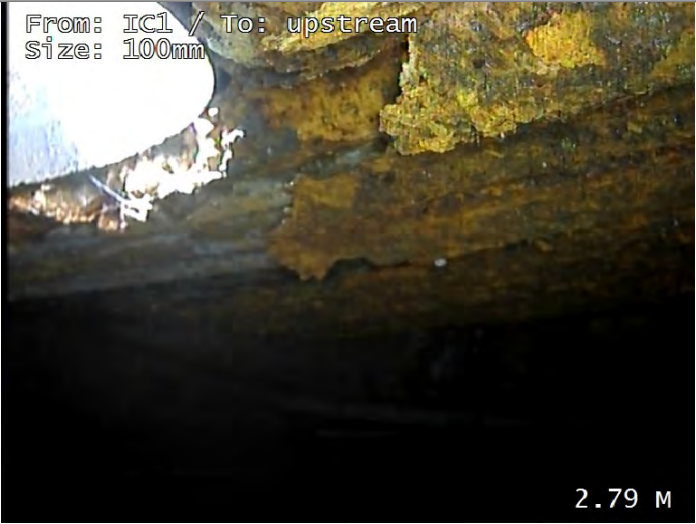
| Job Number<br><b>1521488</b> | Surveyed by (Operator)<br><b>A Anderson</b> | Base Unit<br><b>HITAR4XYJT</b> | Date<br><b>15/04/2026</b> |
|---|---|---|---|
| <p>From: IC1 / To: upstream<br/>Size: 100mm</p> <p>2.79 M</p> <p>Water level 0% height/diameter</p> | | | |

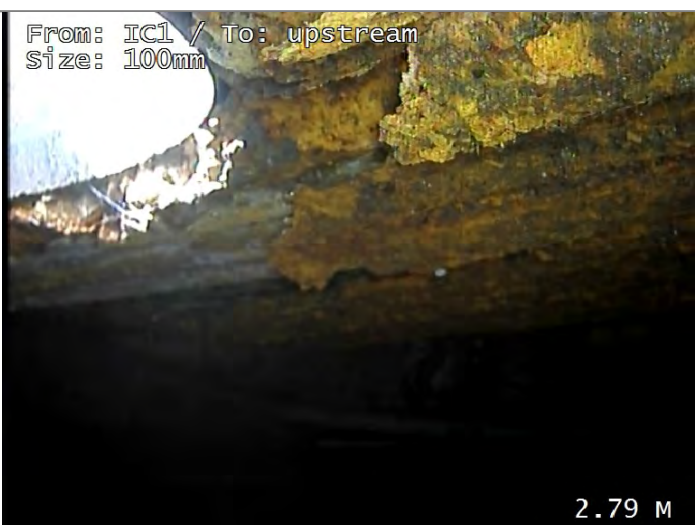
| Job Number<br><b>1521488</b> | Surveyed by (Operator)<br><b>A Anderson</b> | Base Unit<br><b>HITAR4XYJT</b> | Date<br><b>15/04/2026</b> |
|---|---|---|---|
| <p>From: IC1 / To: upstream<br/>Size: 100mm</p> <p>2.79 M</p> <p>Finish node type, inspection chamber, reference ICS1 (Catch-pit ?).</p> | | | |

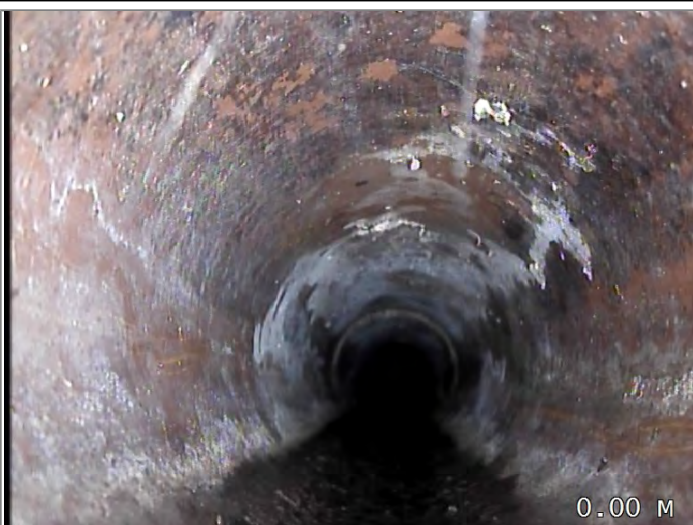
Start node type, inspection chamber, reference IC1

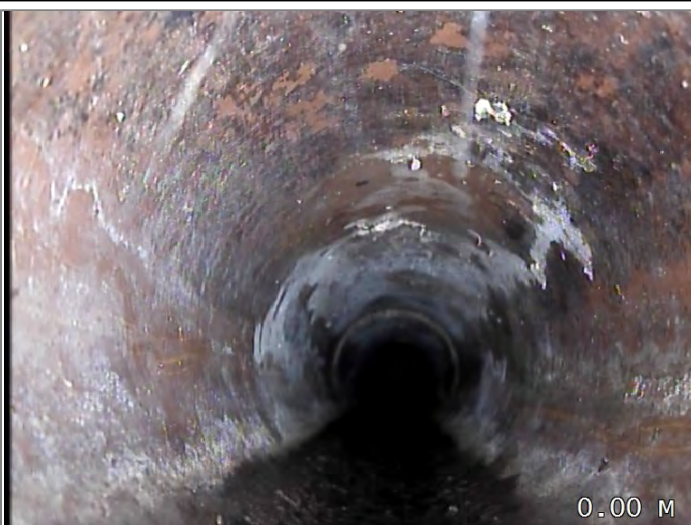
Water level 0% height/diameter

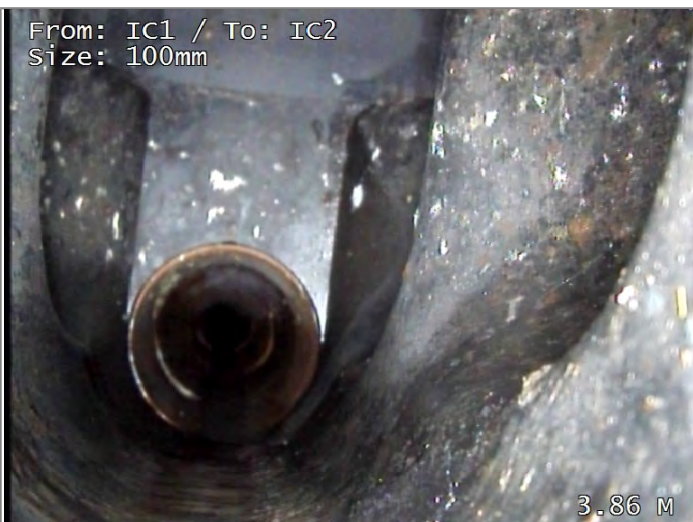
Water level 0% height/diameter

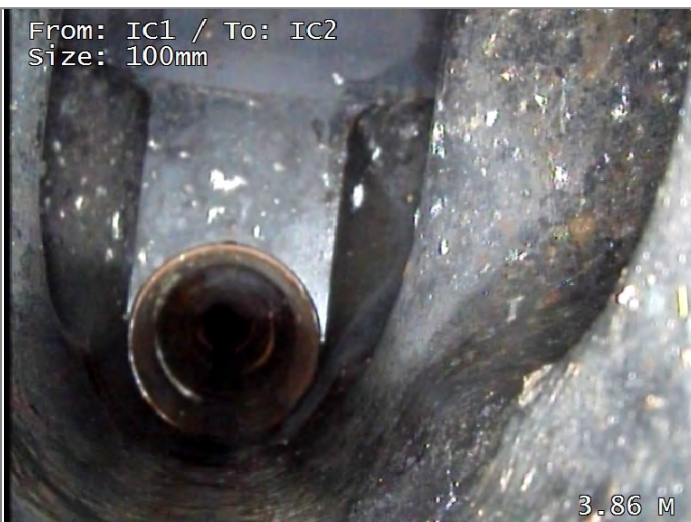
Finish node type, inspection chamber, reference IC2

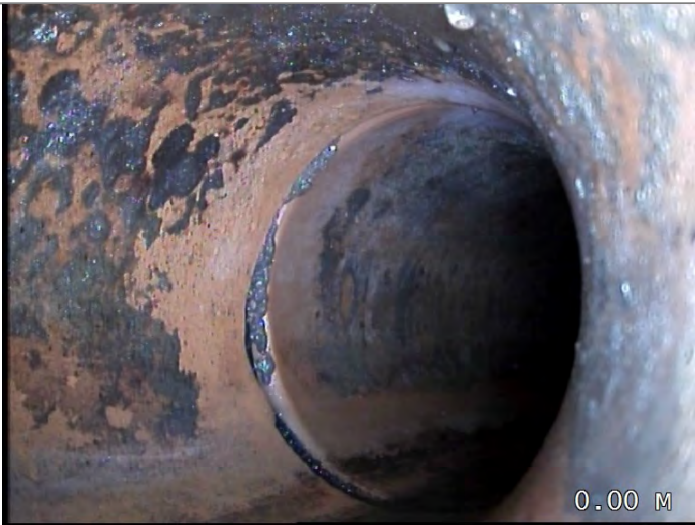
| Job Number<br><b>1521488</b> | Surveyed by (Operator)<br><b>A Anderson</b> | Base Unit<br><b>HITAR4XYJT</b> | Date<br><b>15/04/2026</b> |
|---|---|---|---|
| <p>0.00 M</p> <p>Start node type, inspection chamber, reference IC2</p> | | | |

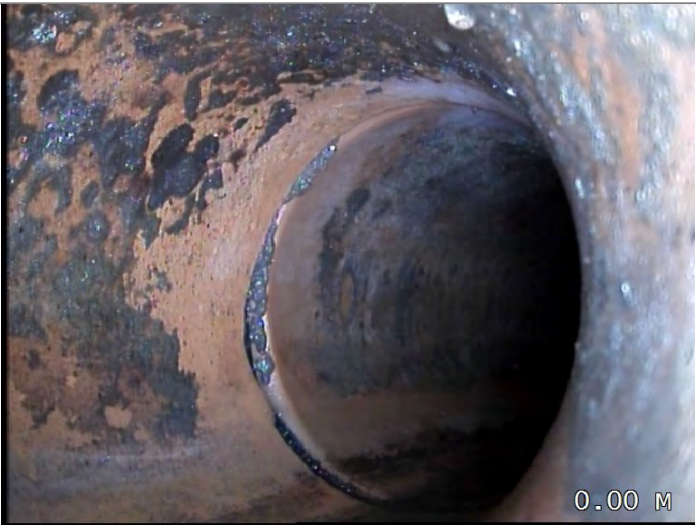
| Job Number<br><b>1521488</b> | Surveyed by (Operator)<br><b>A Anderson</b> | Base Unit<br><b>HITAR4XYJT</b> | Date<br><b>15/04/2026</b> |
|---|---|---|---|
| <p>0.00 M</p> <p>Water level 0% height/diameter</p> | | | |

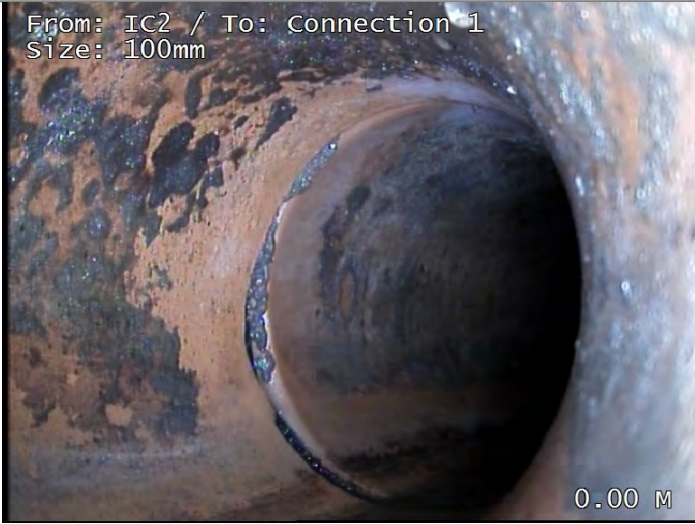
| Job Number<br><b>1521488</b> | Surveyed by (Operator)<br><b>A Anderson</b> | Base Unit<br><b>HITAR4XYJT</b> | Date<br><b>15/04/2026</b> |
|---|---|---|---|
| <p>From: IC2 / To: Connection 1<br/>Size: 100mm</p> <p>0.00 M</p> <p>Line of drain/sewer deviates right</p> | | | |

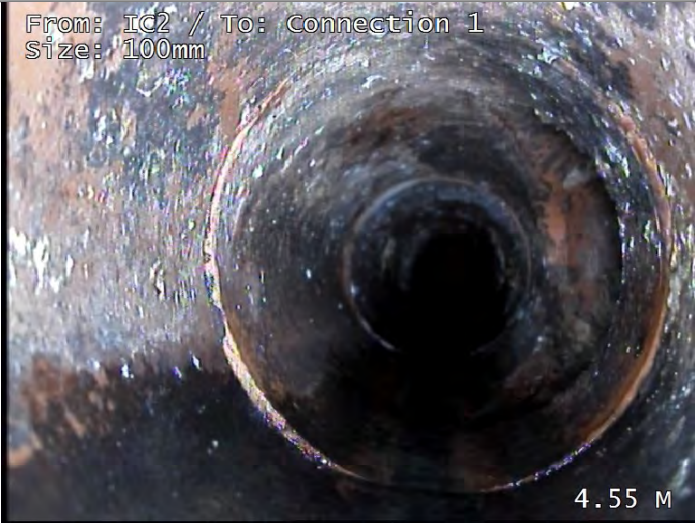
| Job Number<br><b>1521488</b> | Surveyed by (Operator)<br><b>A Anderson</b> | Base Unit<br><b>HITAR4XYJT</b> | Date<br><b>15/04/2026</b> |
|---|---|---|---|
| <p>From: IC2 / To: Connection 1<br/>Size: 100mm</p> <p>4.55 M</p> <p>Connection other than junction at 3 o'clock, diameter 100mm</p> | | | |

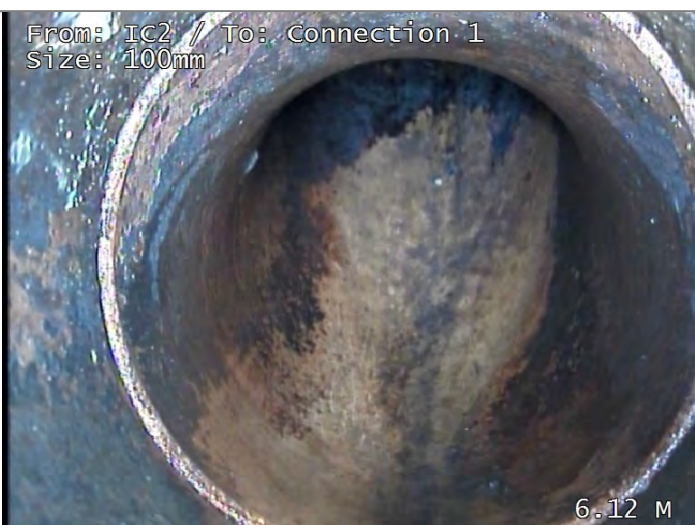
| Job Number<br><b>1521488</b> | Surveyed by (Operator)<br><b>A Anderson</b> | Base Unit<br><b>HITAR4XYJT</b> | Date<br><b>15/04/2026</b> |
|---|---|---|---|
| <p>From: IC2 / To: Connection 1<br/>Size: 100mm</p> <p>6.12 M</p> <p>Line of drain/sewer deviates up</p> | | | |

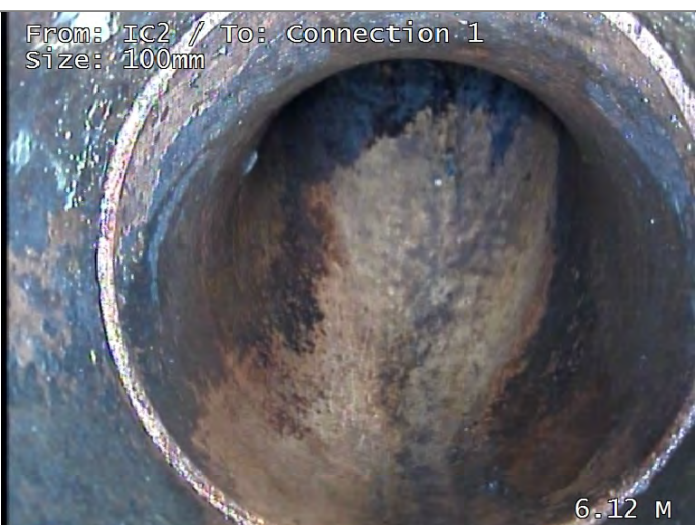
| Job Number<br><b>1521488</b> | Surveyed by (Operator)<br><b>A Anderson</b> | Base Unit<br><b>HITAR4XYJT</b> | Date<br><b>15/04/2026</b> |
|---|---|---|---|
| <p>From: IC2 / To: Connection 1<br/>Size: 100mm</p> <p>6.12 M</p> <p>Water level 0% height/diameter</p> | | | |

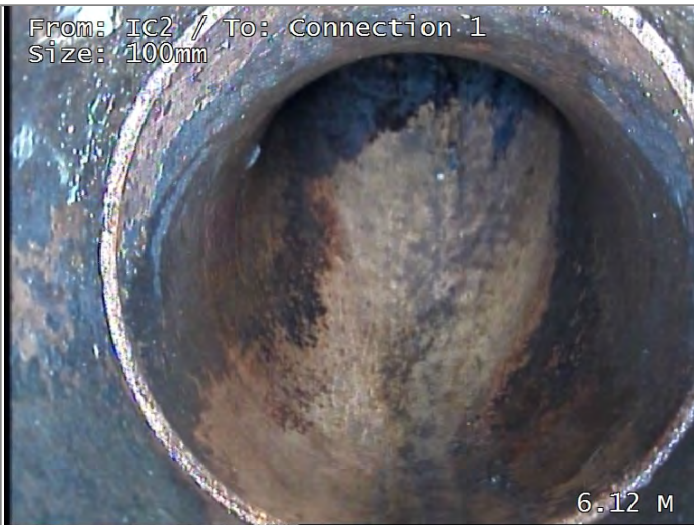
End of survey: At Rest-bend to Soil pipe (SP).

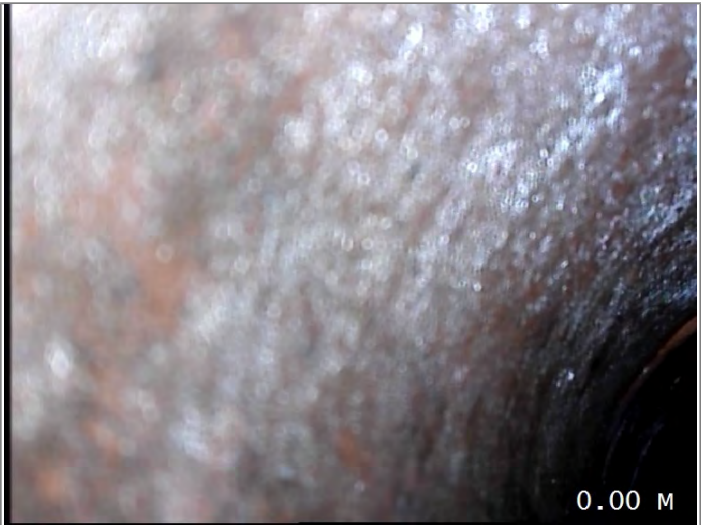
| Job Number<br><b>1521488</b> | Surveyed by (Operator)<br><b>A Anderson</b> | Base Unit<br><b>HITAR4XYJT</b> | Date<br><b>15/04/2026</b> |
|---|---|---|---|
| <p>0.00 M</p> <p>Start node type, inspection chamber, reference IC2</p> | | <p>0.00 M</p> <p>Water level 0% height/diameter</p> | |

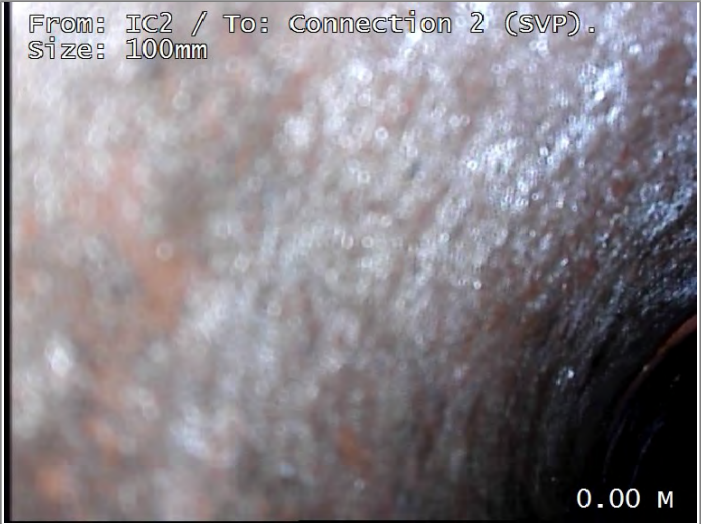
| Job Number<br><b>1521488</b> | Surveyed by (Operator)<br><b>A Anderson</b> | Base Unit<br><b>HITAR4XYJT</b> | Date<br><b>15/04/2026</b> |
|---|---|---|---|
| <p>From: IC2 / To: Connection 2 (SVP).<br/>Size: 100mm</p> <p>0.00 M</p> <p>Line of drain/sewer deviates right</p> | | <p>From: IC2 / To: Connection 2 (SVP).<br/>Size: 100mm</p> <p>0.21 M</p> <p>Connection other than junction at 3 o'clock, diameter 100mm - Remark:<br/>SVP Connection</p> | |

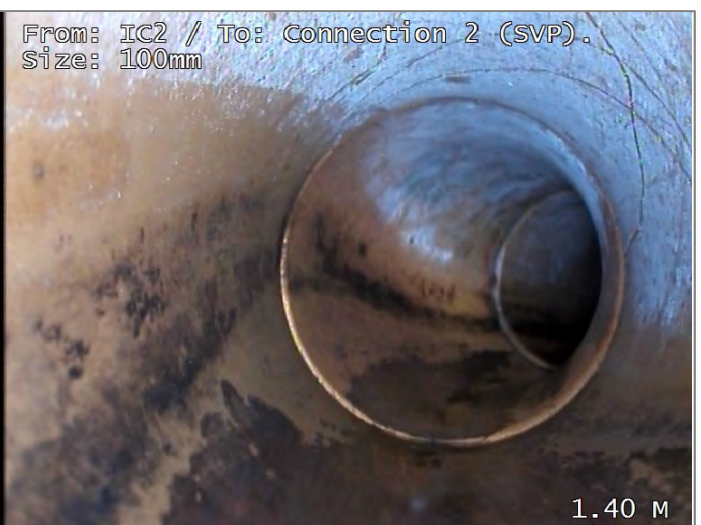
| Job Number<br><b>1521488</b> | Surveyed by (Operator)<br><b>A Anderson</b> | Base Unit<br><b>HITAR4XYJT</b> | Date<br><b>15/04/2026</b> |
|---|---|---|---|
| <p>SVP Connection</p> | | <p>From: IC2 / To: Connection 2 (SVP).<br/>Size: 100mm</p> <p>1.40 M</p> <p>Line of drain/sewer deviates right</p> | |

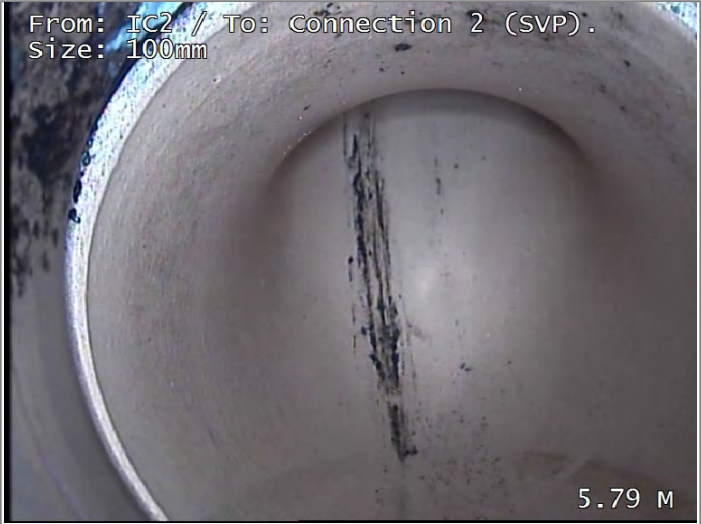
| Job Number<br><b>1521488</b> | Surveyed by (Operator)<br><b>A Anderson</b> | Base Unit<br><b>HITAR4XYJT</b> | Date<br><b>15/04/2026</b> |
|---|---|---|---|
| <div> <div> <p>From: IC2 / To: Connection 2 (SVP).<br/>Size: 100mm</p> <p>5.79 M</p> <p>Water level 0% height/diameter</p> </div> <div> <p>From: IC2 / To: Connection 2 (SVP).<br/>Size: 100mm</p> <p>5.79 M</p> <p>End of survey: At Rest-bend to the Toilet.</p> </div> </div> | | | |

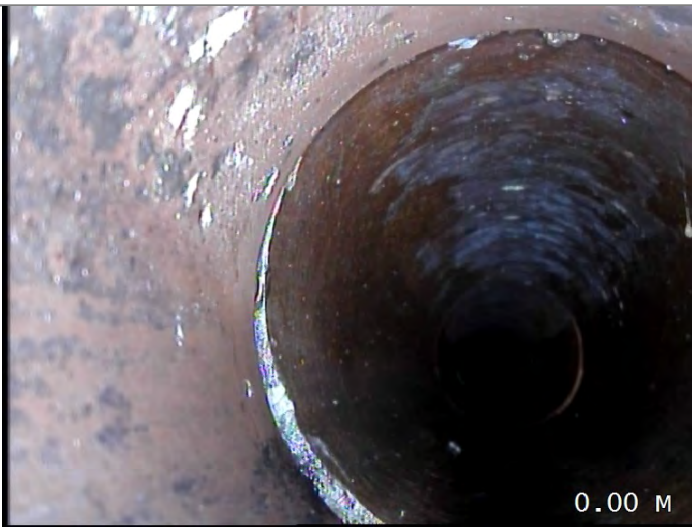
| Job Number<br><b>1521488</b> | Surveyed by (Operator)<br><b>A Anderson</b> | Base Unit<br><b>HITAR4XYJT</b> | Date<br><b>15/04/2026</b> |
|---|---|---|---|
| <p>0.00 M</p> <p>Start node type, inspection chamber, reference IC2</p> | | | |

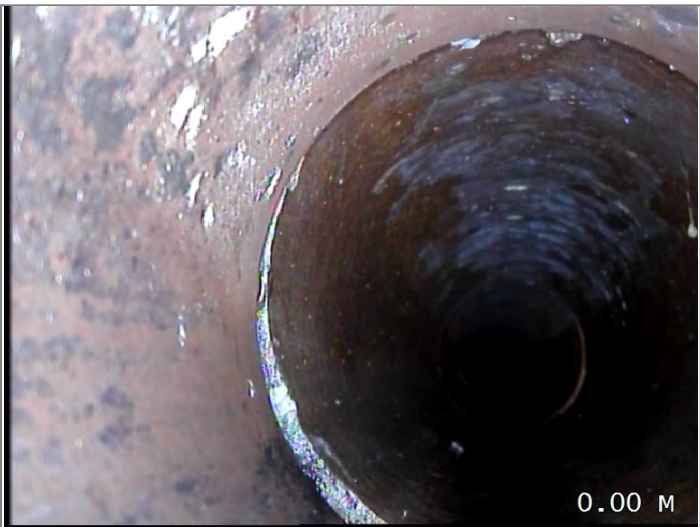
| Job Number<br><b>1521488</b> | Surveyed by (Operator)<br><b>A Anderson</b> | Base Unit<br><b>HITAR4XYJT</b> | Date<br><b>15/04/2026</b> |
|---|---|---|---|
| <p>0.00 M</p> <p>Water level 0% height/diameter</p> | | | |

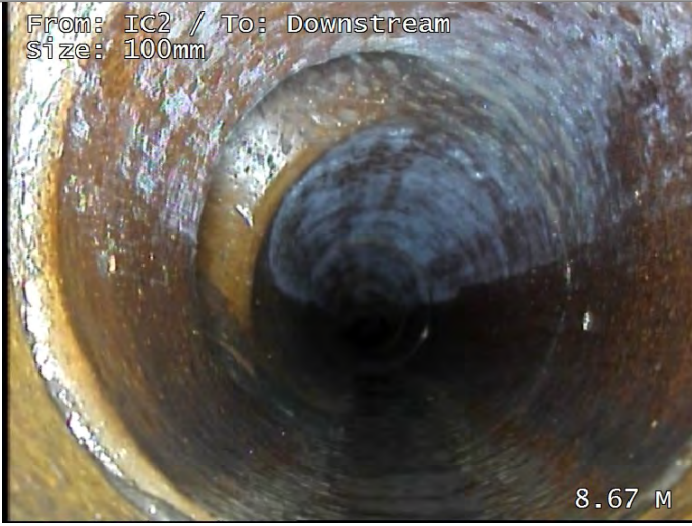
| Job Number<br><b>1521488</b> | Surveyed by (Operator)<br><b>A Anderson</b> | Base Unit<br><b>HITAR4XYJT</b> | Date<br><b>15/04/2026</b> |
|---|---|---|---|
| <p>From: IC2 / To: Downstream<br/>Size: 100mm</p> <p>8.67 M</p> <p>Connection other than junction at 10 o'clock, diameter 100mm</p> | | | |

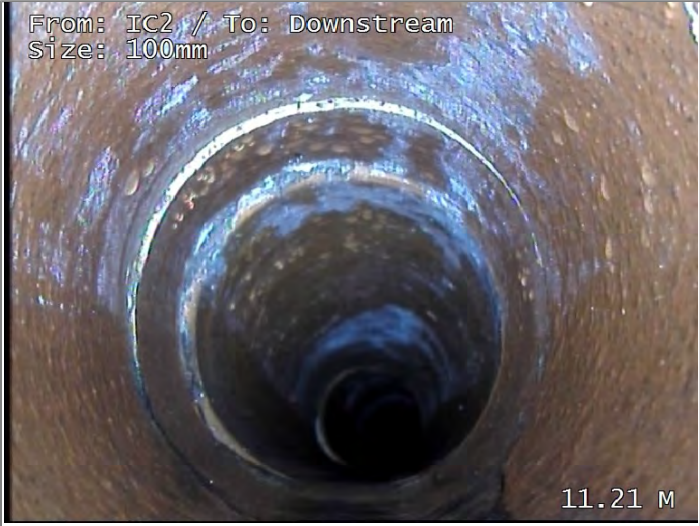
| Job Number<br><b>1521488</b> | Surveyed by (Operator)<br><b>A Anderson</b> | Base Unit<br><b>HITAR4XYJT</b> | Date<br><b>15/04/2026</b> |
|---|---|---|---|
| <p>From: IC2 / To: Downstream<br/>Size: 100mm</p> <p>11.21 M</p> <p>Line of drain/sewer deviates down</p> | | | |

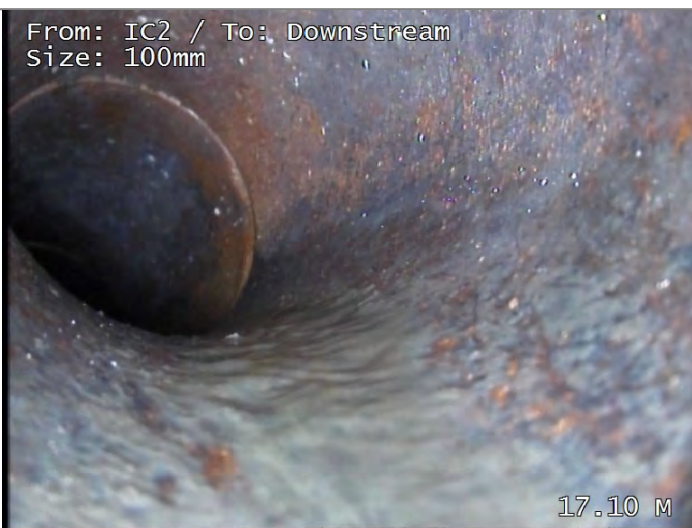
| Job Number<br><b>1521488</b> | Surveyed by (Operator)<br><b>A Anderson</b> | Base Unit<br><b>HITAR4XYJT</b> | Date<br><b>15/04/2026</b> |
|---|---|---|---|
| <p>From: IC2 / To: Downstream<br/>Size: 100mm</p> <p>17.10 M</p> <p>Dimension change to 150mm</p> | | | |

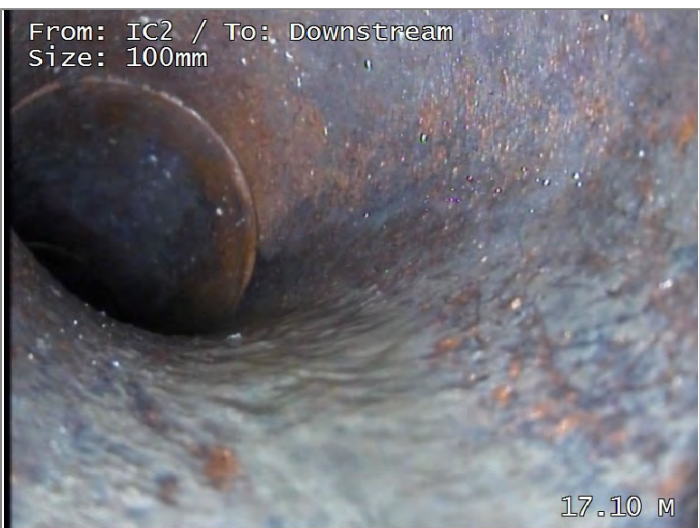
| Job Number<br><b>1521488</b> | Surveyed by (Operator)<br><b>A Anderson</b> | Base Unit<br><b>HITAR4XYJT</b> | Date<br><b>15/04/2026</b> |
|---|---|---|---|
| <p>From: IC2 / To: Downstream<br/>Size: 100mm</p> <p>17.10 M</p> <p>Line of drain/sewer deviates left</p> | | | |

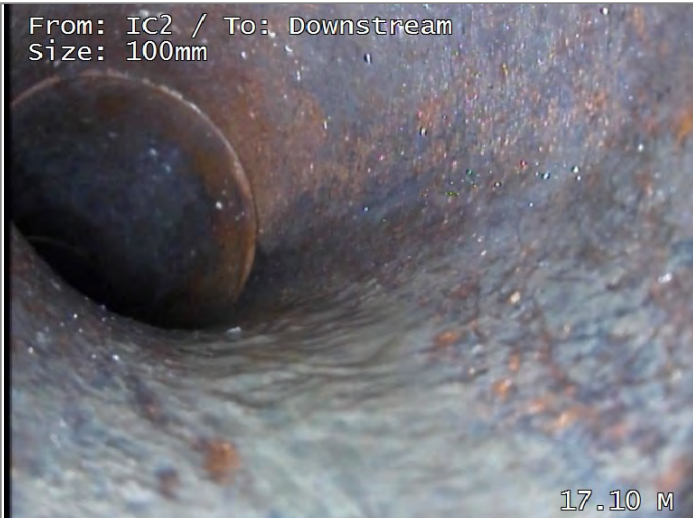
Line of drain/sewer deviates down

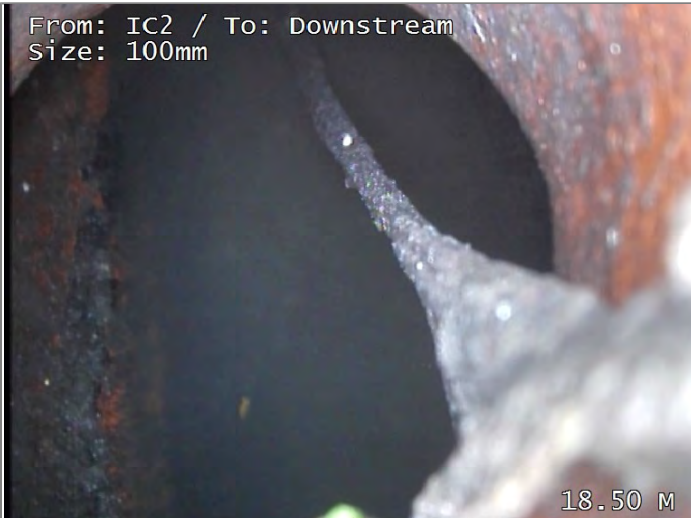
Water level 0% height/diameter
