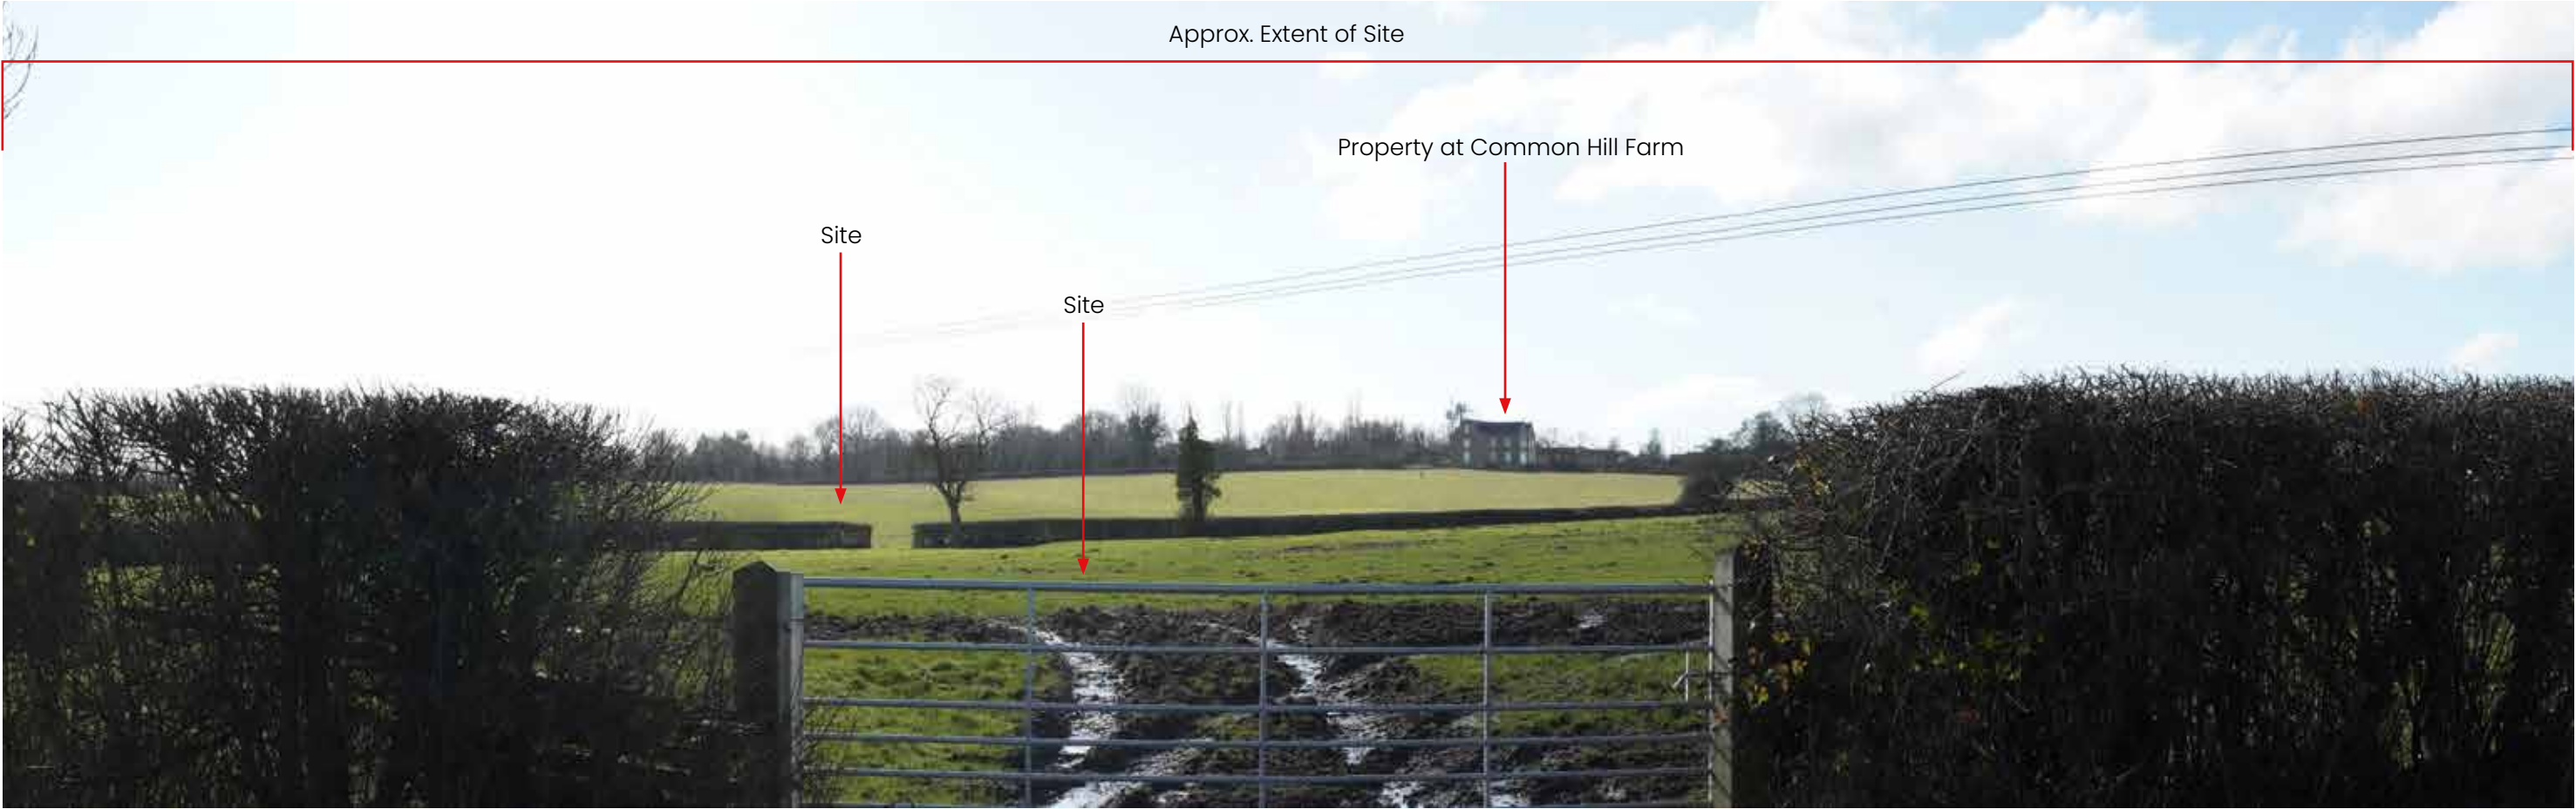
Viewpoint 1 – from Stones Lane looking south into the site

| Time and Date: | 13:58<br>04.02.26 | Receptors | Road users and pedestrians along Stones Lane | Proposed View | View would look over the proposed open space comprising of SUDS basin, grassland, tree and native scrub planting, with the new properties visible beyond. |
| Visualisation Type: | Type 1 | Receptor Sensitivity | Medium | Magnitude of Change | High – major addition of features and change to composition of view, with the proposed development prominent in the foreground of the view |
| Projection | Cylindrical | Existing View | <p>View through existing field gate looking into the site. Gate framed by hedgerows which, in combination with other vegetation beyond, partly restrict the view.</p> <p>View looks over a pastoral field located to the north east of the larger parcel of the site, towards the hedgerows and hedgerow trees which sit within the site.</p> <p>Beyond this sits the property adjacent to the site at Common Hill Farm. In the middle distance, low voltage overhead lines cross the view.</p> | Visual Impact at Year 1 | Major adverse |

| Camera: | Sony A7III<br>Full Frame | Receptor Susceptibility | Medium – users travelling through the landscape on minor roads | Mitigation & Enhancement | Setting back of the development from Stones Lane, with area of open space in the foreground. Planting of trees and retention of existing hedgerow. |
| | | | | Residual Impact at Year 15 | Moderate adverse – with the visual impact reduced as the proposed planting matures |

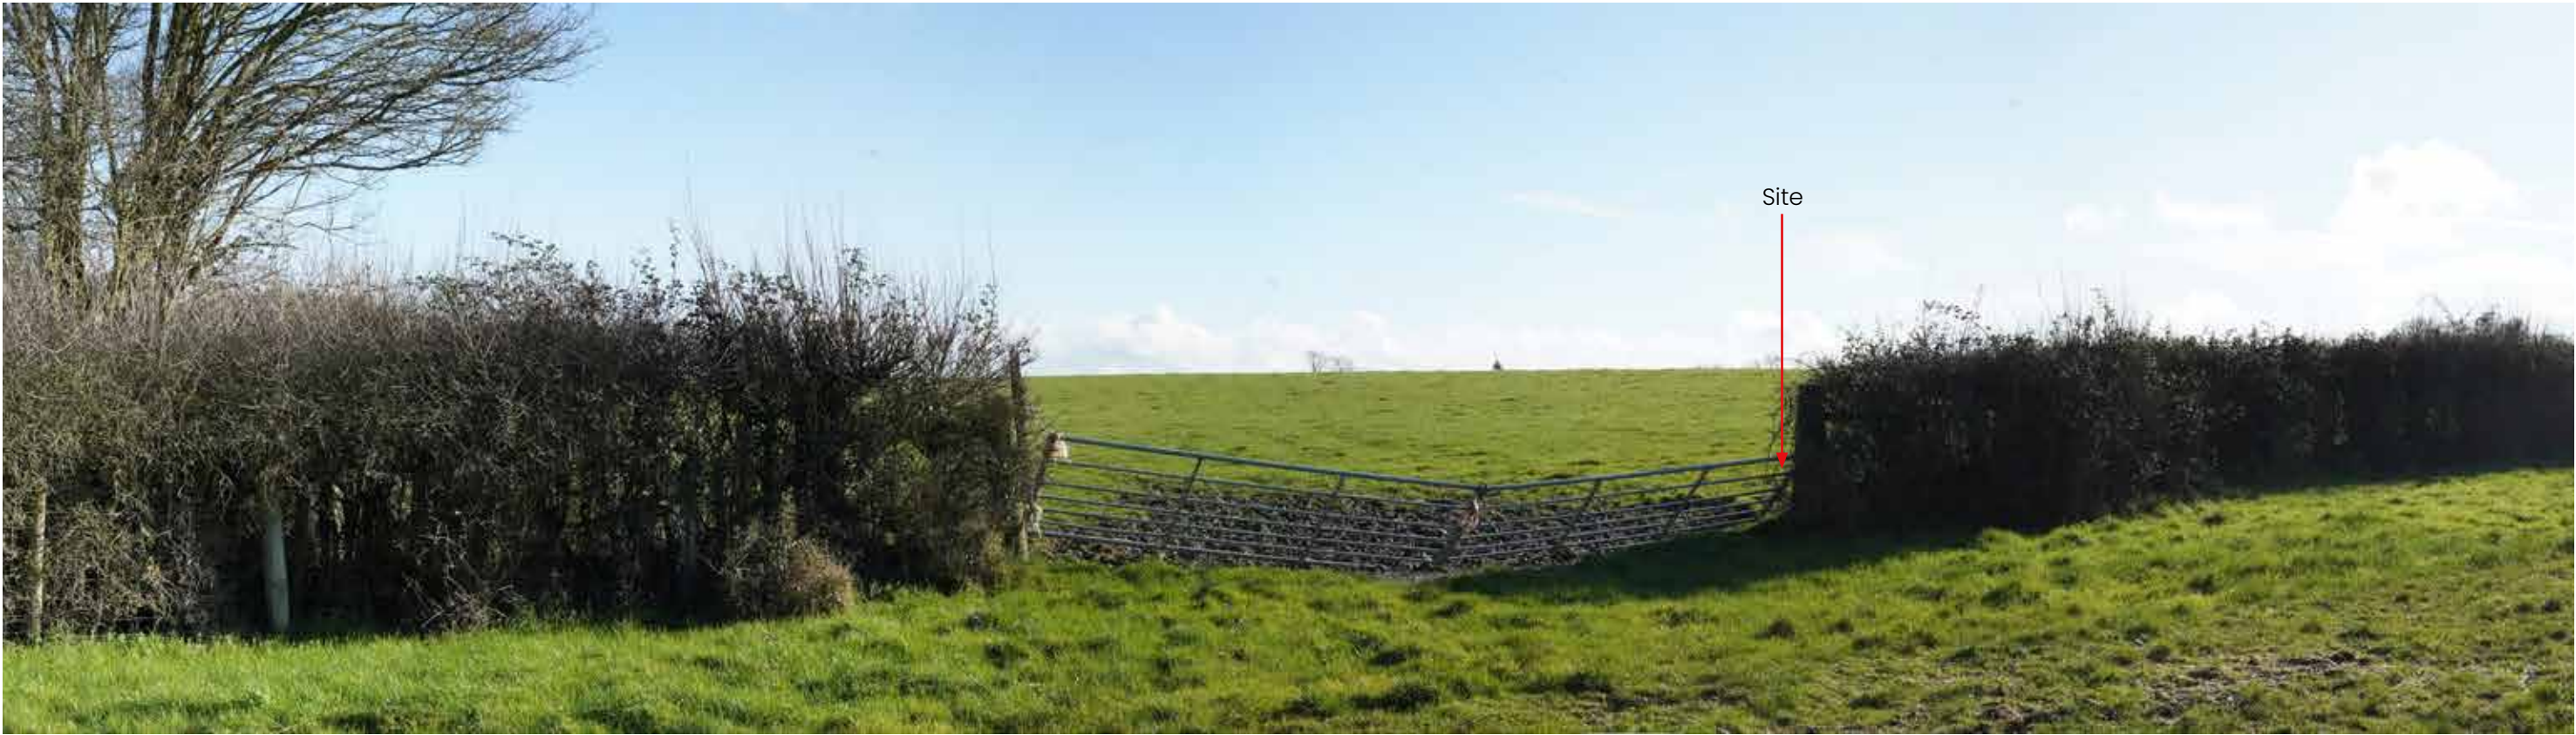
Viewpoint 2 – from public footpath CRIC30, just west of Stones Lane looking south

| Distance to Site: | (Within site) | Value of View | Medium – unremarkable scenic quality within undesignated landscape | Magnitude of Change | High – major addition of features and change to composition of view, with the proposed development prominent in the foreground of the view |
| Focal Length: | 50mm | Existing View | View over pastoral field towards a field gate set between hedgerows which frame the view, in conjunction with mature trees to the left, limiting the view beyond into another pastoral field. | | |
| Visualisation Type: | Type 1 | Proposed View | Viewpoint would be located within the proposed SANG area, close to the proposed SUDs basin, set within wildflower meadows with native scrub and tree planting and surfaced recreational paths. The proposed community allotments would be in the immediate right of the view along with the retained existing hedgerow.<br><br>Beyond the hedgerow the frontages of new dwellings would be visible. Views of the dwellings would be filtered by the retained hedgerow and proposed new planting. | | |

| Time and Date: | 14:26<br>04.02.26 | Receptors | Footpath users along CRIC30 | Mitigation & Enhancement | Retention of existing hedgerow and proposed scattered tree and native scrub planting. |
| Camera: | Sony A7III Full Frame | Receptor Sensitivity | High | Residual Impact at Year 15 | Major adverse – although the visual impact will reduce as the proposed planting matures, but not significantly |

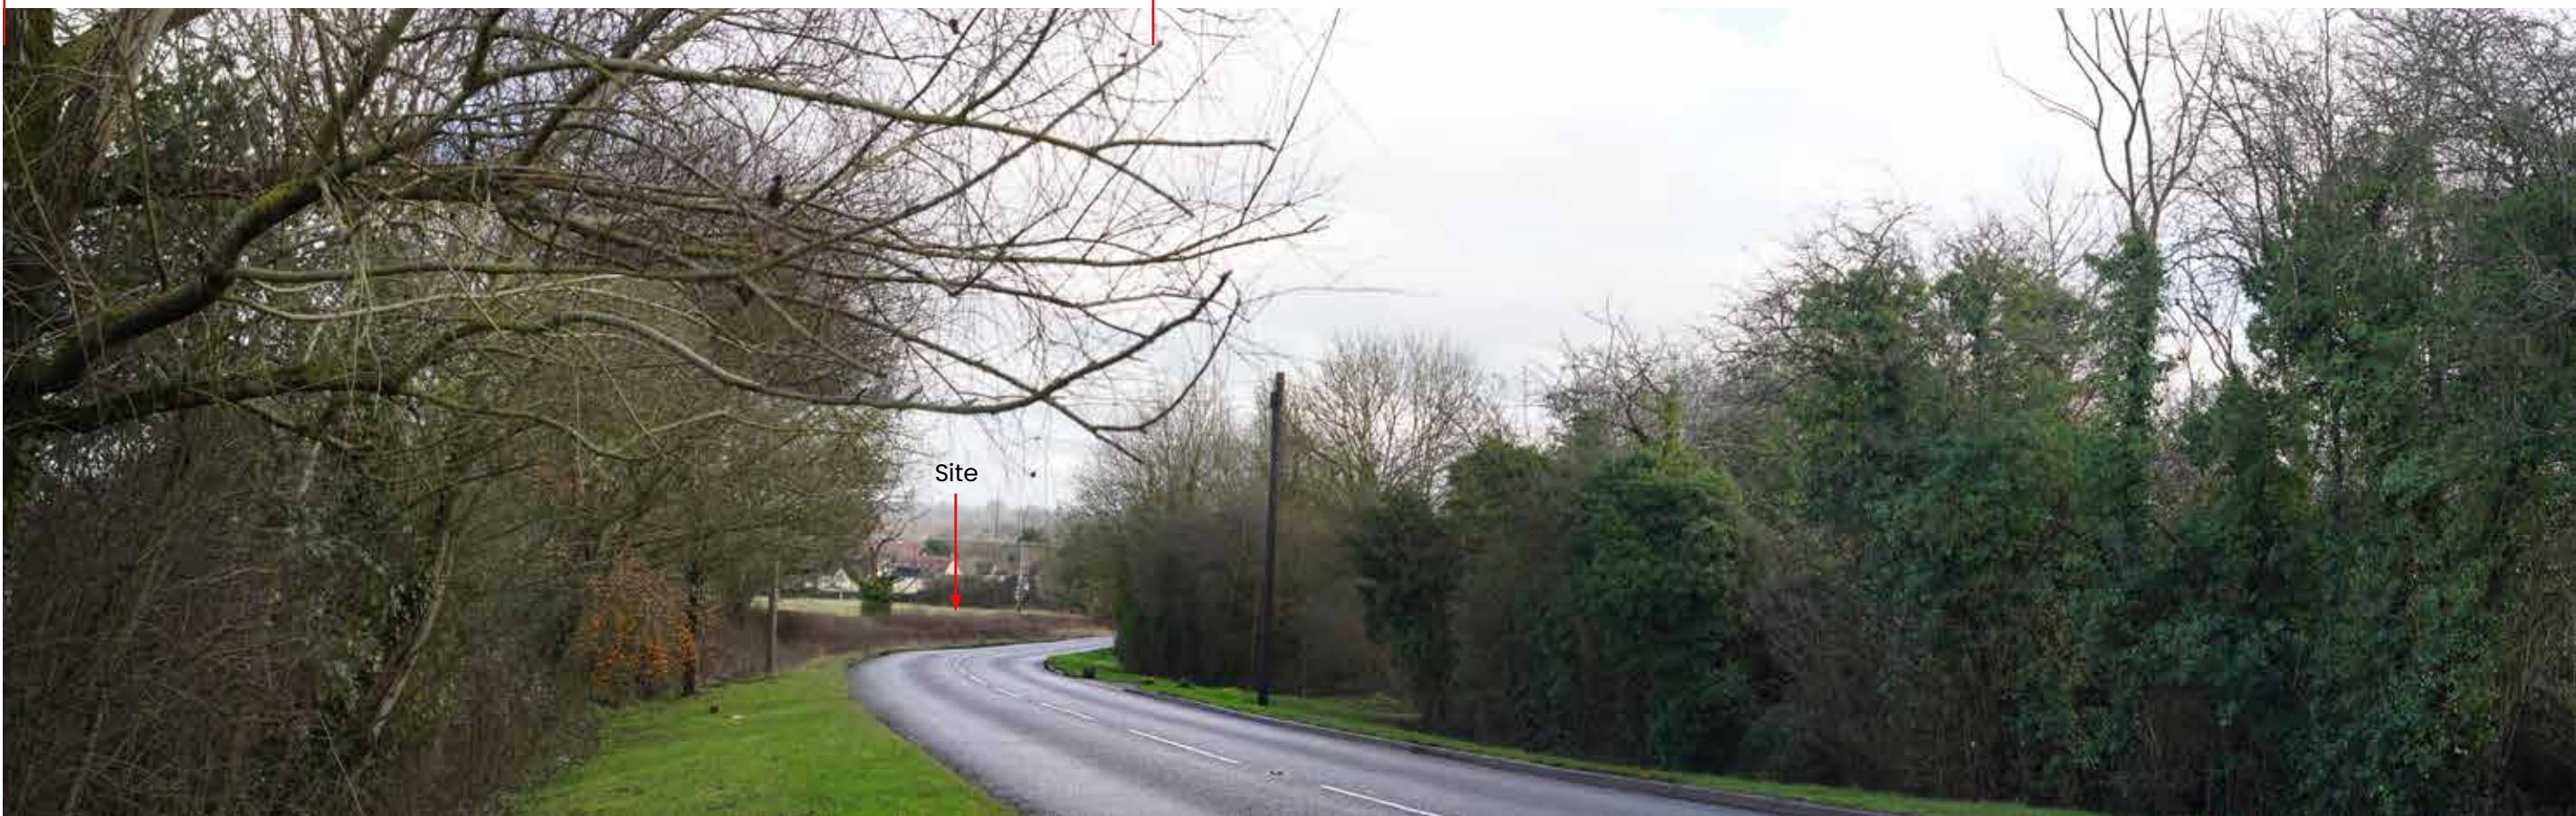
Viewpoint 4 – View from the B4040 by Common Hill Farm looking east

| Time and Date: | 12:29<br>04.02.26 | Receptors | Road users | Proposed View | The proposed development would be visible in the middle distance beyond the hedgerow boundary which sits between the site and Malmesbury Road/B4040. The first floors and roofs of new dwellings anticipated be visible beyond the proposed native buffer and tree planting at the south-eastern corner of the site. |
| Visualisation Type: | Type 1 | Existing View | View along Malmesbury Road/B4040 towards Cricklade, with properties at the western edge of the town discernible in the distance and vegetation beyond.<br><br>Overhead wires and pole are visible in the mid-distance, across the road, which is bordered by dense hedgerow and mature trees which obscure much of the view. | Magnitude of Change | Low – moderate addition of features within the view, seen in conjunction with existing built form and filtered by existing and proposed planting. |

| Focal Length: | 50mm | Receptor Sensitivity | Low | Mitigation & Enhancement | Retention of existing hedgerows. Setting back of the development from the western boundary. New scattered tree and native woodland buffer planting along the western boundary and tree planting to the southern boundary. |
| Projection | Cylindrical | | | Visual Impact at Year 1 | Slight adverse |
| | | | | Residual Impact at Year 15 | Negligible adverse – with the visual impact reduced as the proposed planting matures |

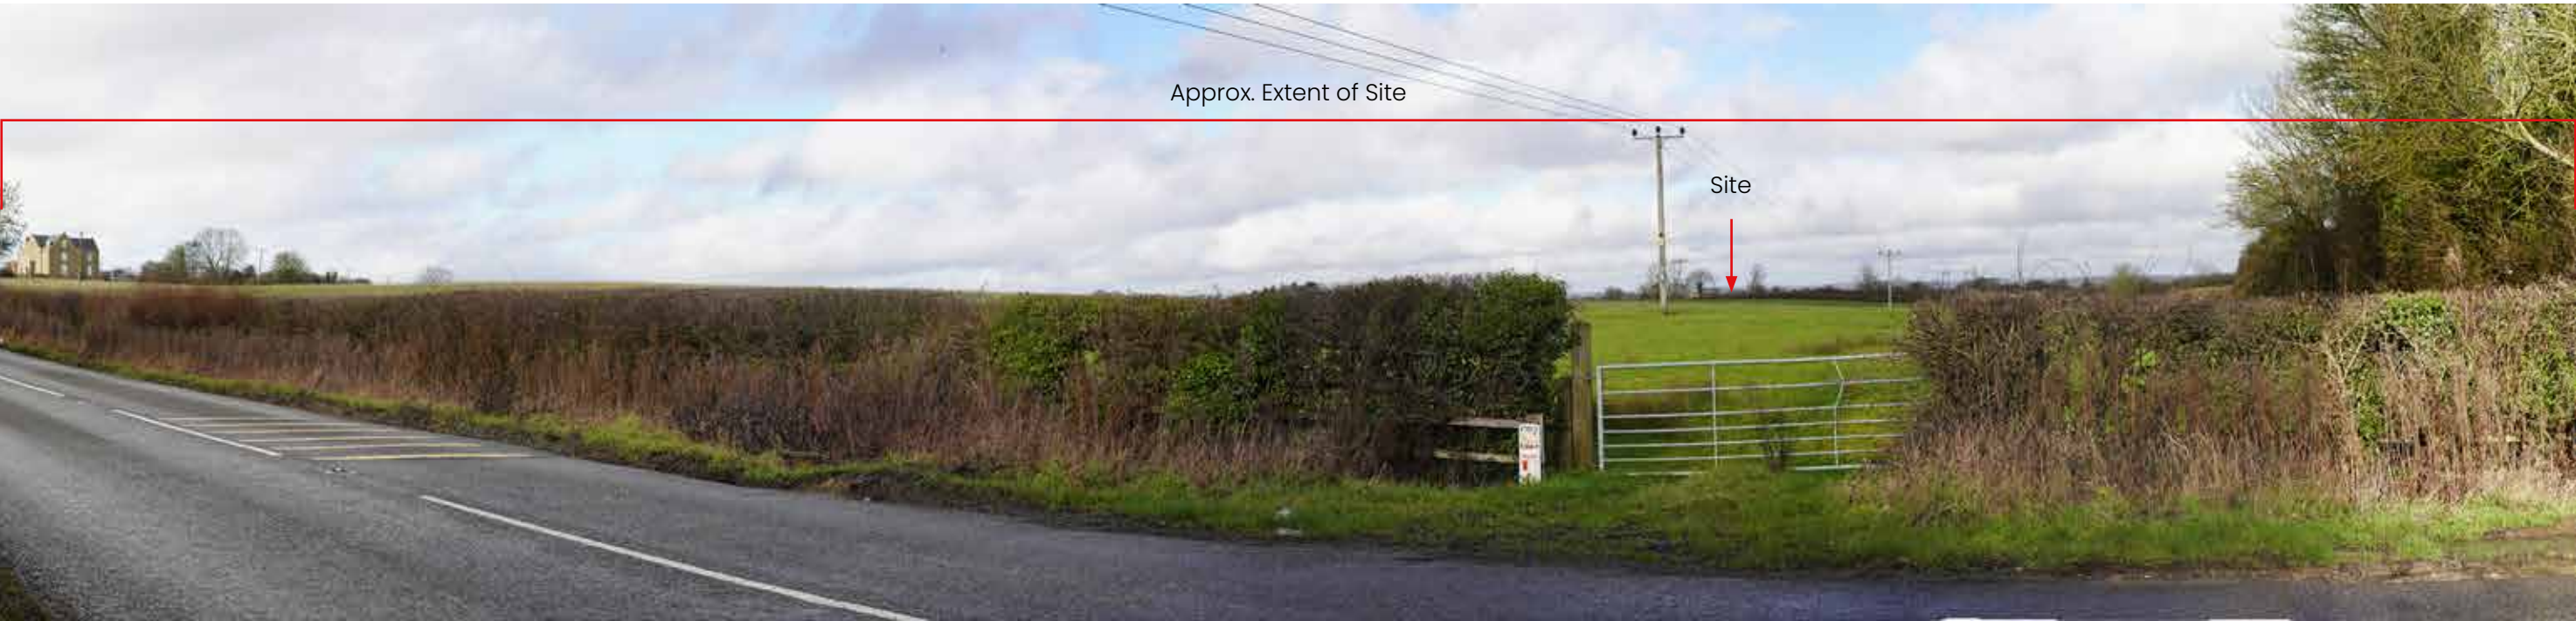
Viewpoint 5 – View from the B4040 looking north into the site

| Time and Date: | 12:38<br>04.02.26 | Receptors | Road users | Proposed View | The proposed development will be visible in the foreground of the view, set back from the south eastern corner by the provision of open space, which comprises play space, informal open space, wildflower meadows and proposed tree planting, with the frontages of new dwellings visible beyond. The view will look along the new tree lined primarily access road through the development. New dwellings will also be visible along the site boundary which borders Malmesbury Road/B4040, partially limited by the retained existing hedgerow. |
| Projection | Cylindrical | Existing View | View across Malmesbury Road/B4040 towards hedgerow forming the site boundary in the foreground, including a field gate access point. Beyond this lies a pastoral field located within the south east of the site, crossed by overhead wires. Vegetation is discernible across the field in the distance, and the property at Common Hill Farm is visible to the left. | Magnitude of Change | High – major change in the composition of the view, affecting a major proportion of the view. |

| | | | | Visual Impact at Year 1 | Moderate adverse |
| | | | | Residual Impact at Year 15 | Moderate adverse – although the visual impact will reduce as the proposed planting matures, but not significantly |

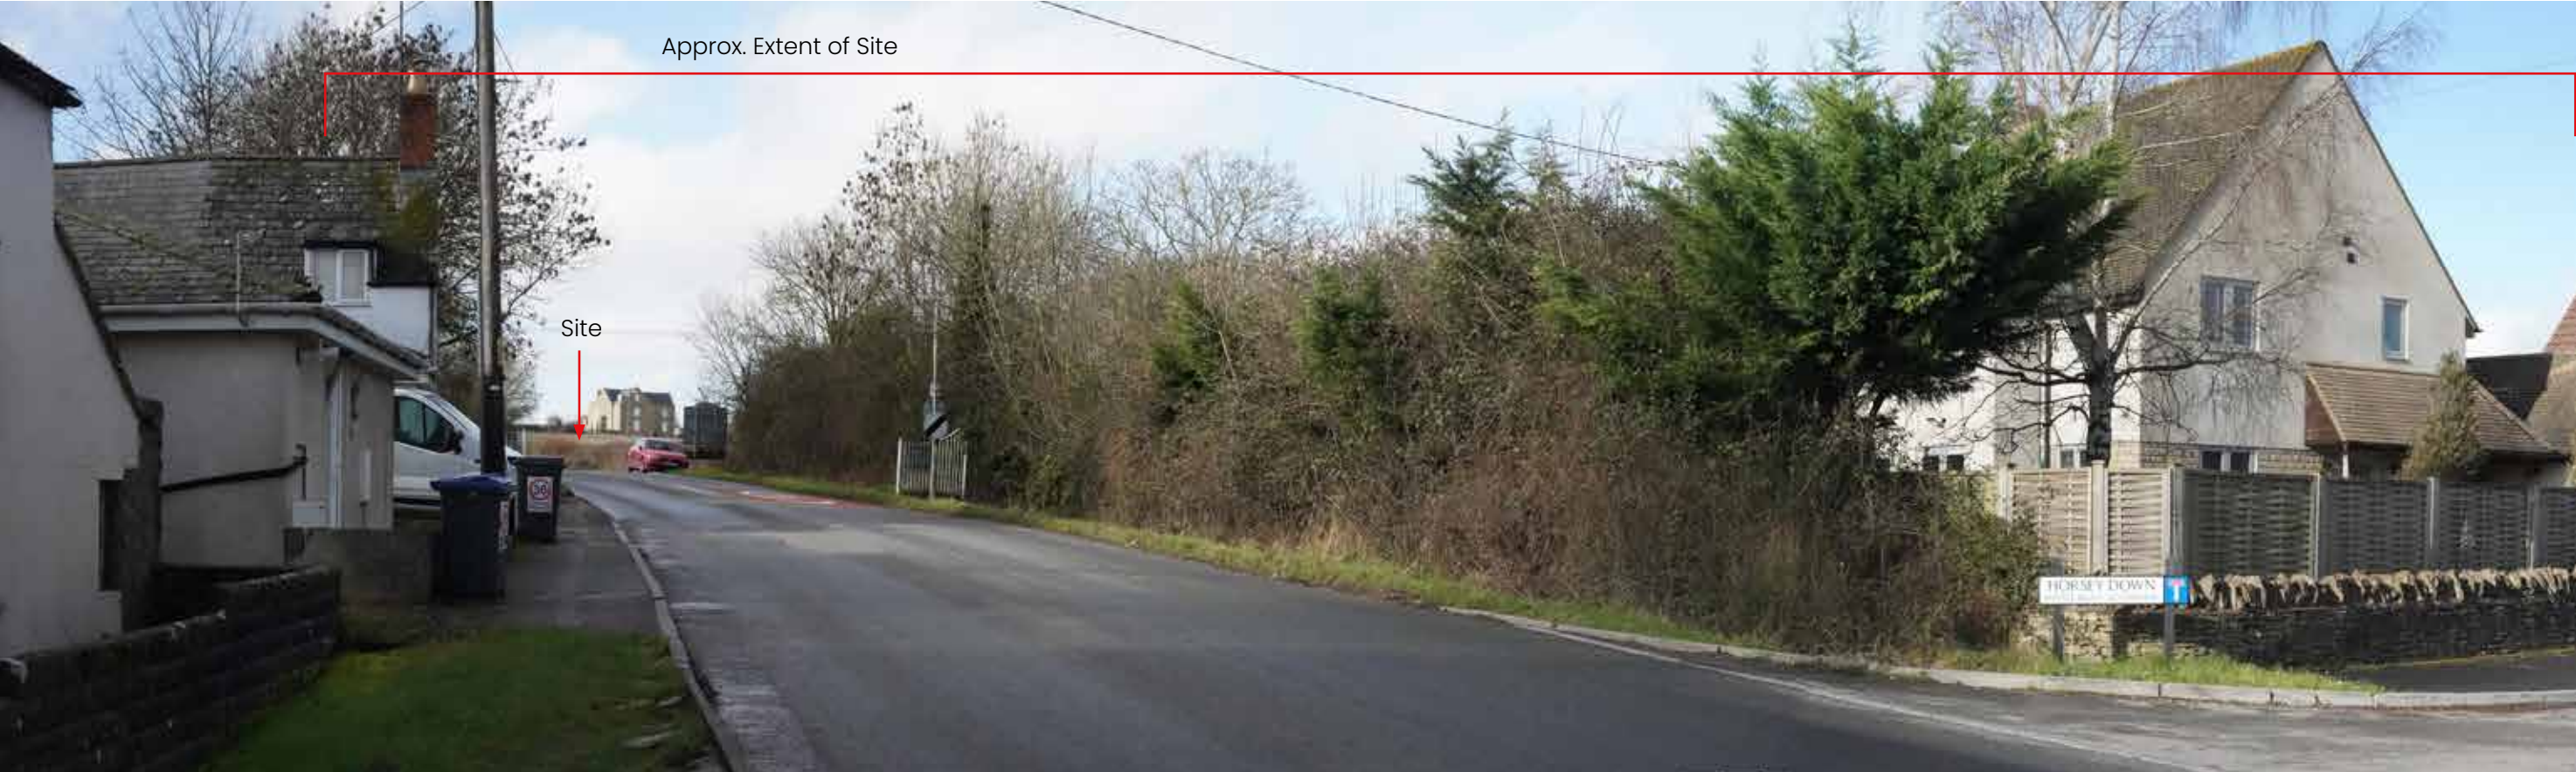
Viewpoint 6 – View along B4040 at junction with Horsey Down, looking west

| Time and Date: | 13:01<br>04.02.26 | Receptors | Road users and pedestrians | Proposed View | New dwellings will be visible beyond proposed tree planting and allotments behind the existing retained hedgerow at the site boundary. |
| Visualisation Type: | Type 1 | Receptor Sensitivity | Medium | Magnitude of Change | Negligible – minor change in composition of view and minor proportion of view affected |
| Projection | Cylindrical | Existing View | Properties at the western edge of Cricklade, along Malmesbury Road/B4040 and on Horsey Down, are visible in the foreground. Looking along the road towards the property at Common Hill Farm, the pastoral field forming the southern area of the site is visible beyond its hedgerow boundary in the mid-distance. Hedgerow and hedgerow tree planting comprise a large proportion of the foreground, sitting between the road and the properties on Horsey Down. | Visual Impact at Year 1 | Negligible adverse |

| Camera: | Sony A7III<br>Full Frame | Receptor Susceptibility | Medium – pedestrians and people travelling on B road within residential area | Mitigation & Enhancement | Setting back of the proposed development from the south eastern corner of the site, retention of existing hedgerow and planting of new trees to south eastern corner and southern site boundary. |
| | | | | Residual Impact at Year 15 | Negligible adverse |

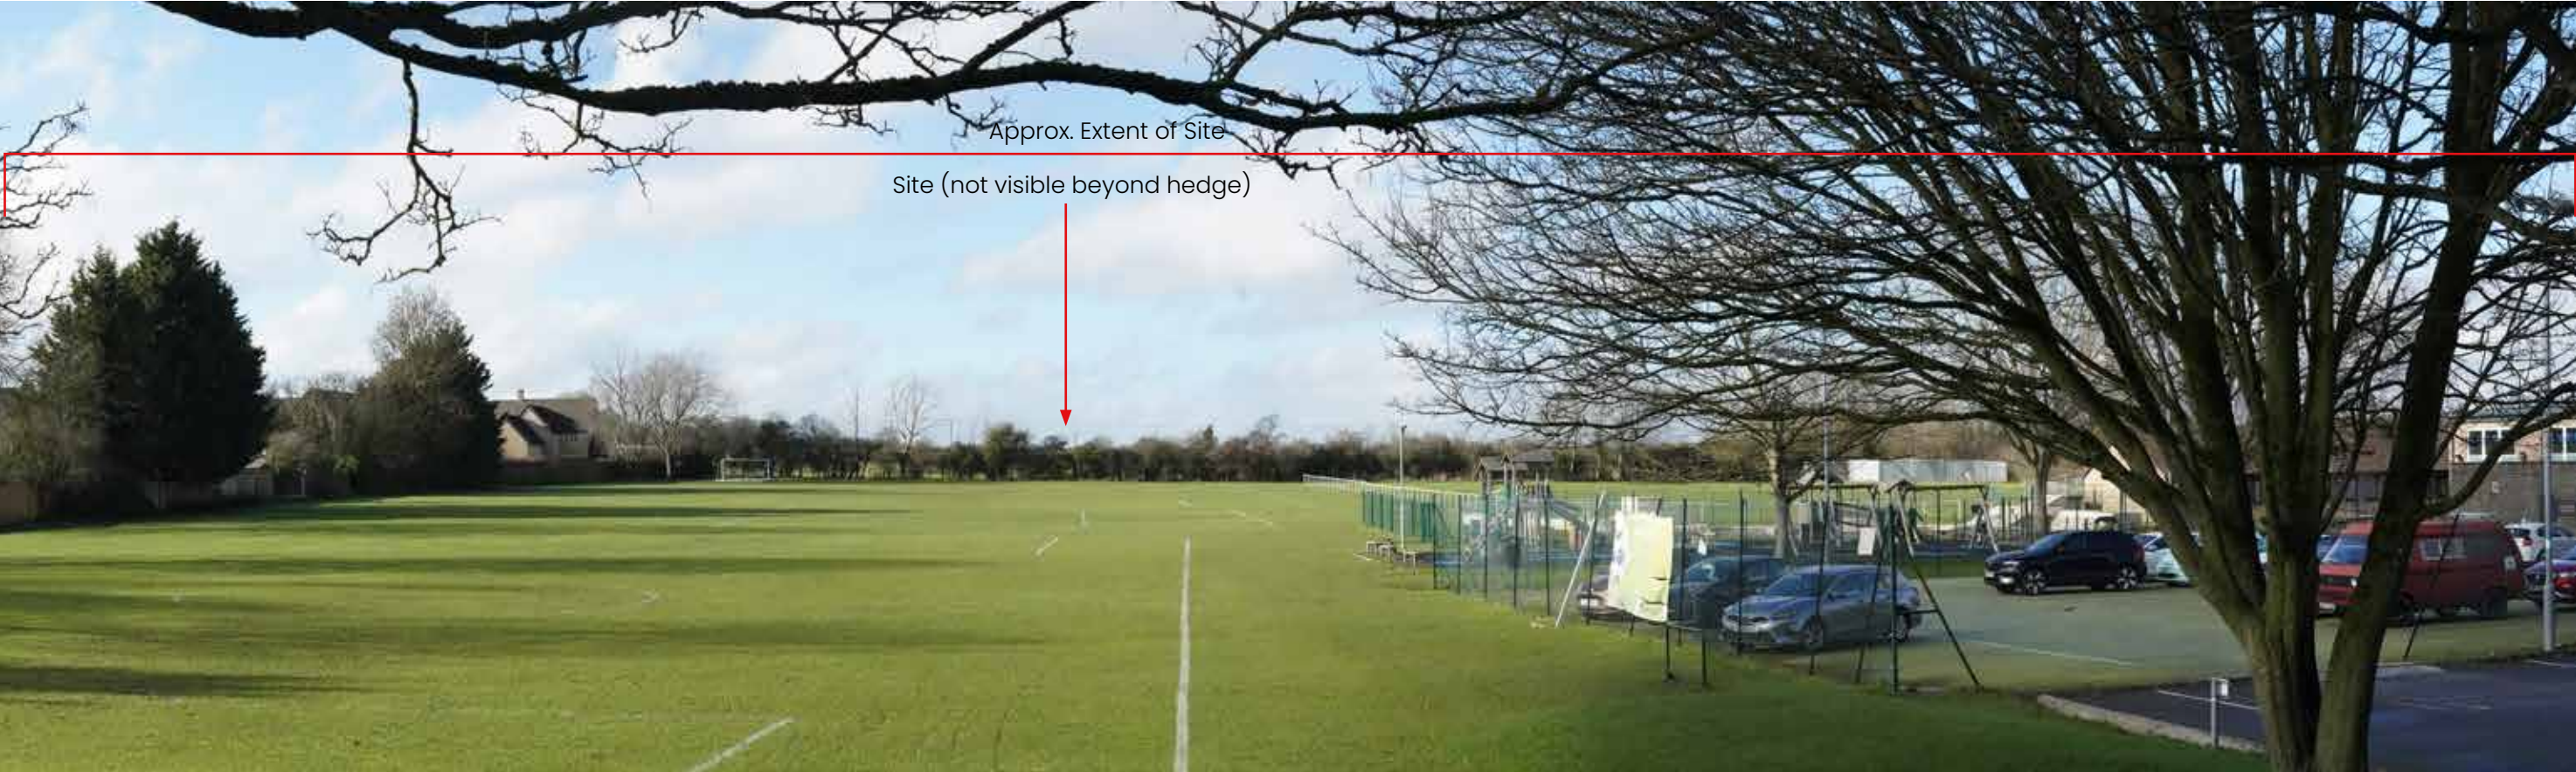
Viewpoint 7 – View from Cricklade Leisure Centre looking west

| Time and Date: | 13:13<br>04.02.26 | Receptors | Footpath users and users of sports grounds at Cricklade Leisure Centre | Proposed View | View is anticipated to remain largely unchanged. The tops of rooftops of new dwellings may be visible beyond the hedgerow at the edge of the sports ground. |
| Visualisation Type: | Type 1 | | | Magnitude of Change | Negligible – proposed development is anticipated to be either slightly or not at all visible |
| Projection | Cylindrical | Existing View | View across Cricklade Leisure Centre sports grounds towards hedgerow and mature hedgerow trees in the distance. Properties on Common Hill/B4040 discernible to the left beyond mature trees, hedgerows and fencing to rear gardens. The Leisure Centre building is just visible beyond the trees and car park in the foreground. The playground of the leisure centre is discernible behind the car park. | Visual Impact at Year 1 | Negligible / neutral |

| Direction of View: | West | | | | Proposed development would be screened by the Bloor development should it be consented. |
| Focal Length: | 50mm | Receptor Sensitivity | Medium | Mitigation & Enhancement | Setting back of the residential development from the eastern boundary and proposed tree planting. |

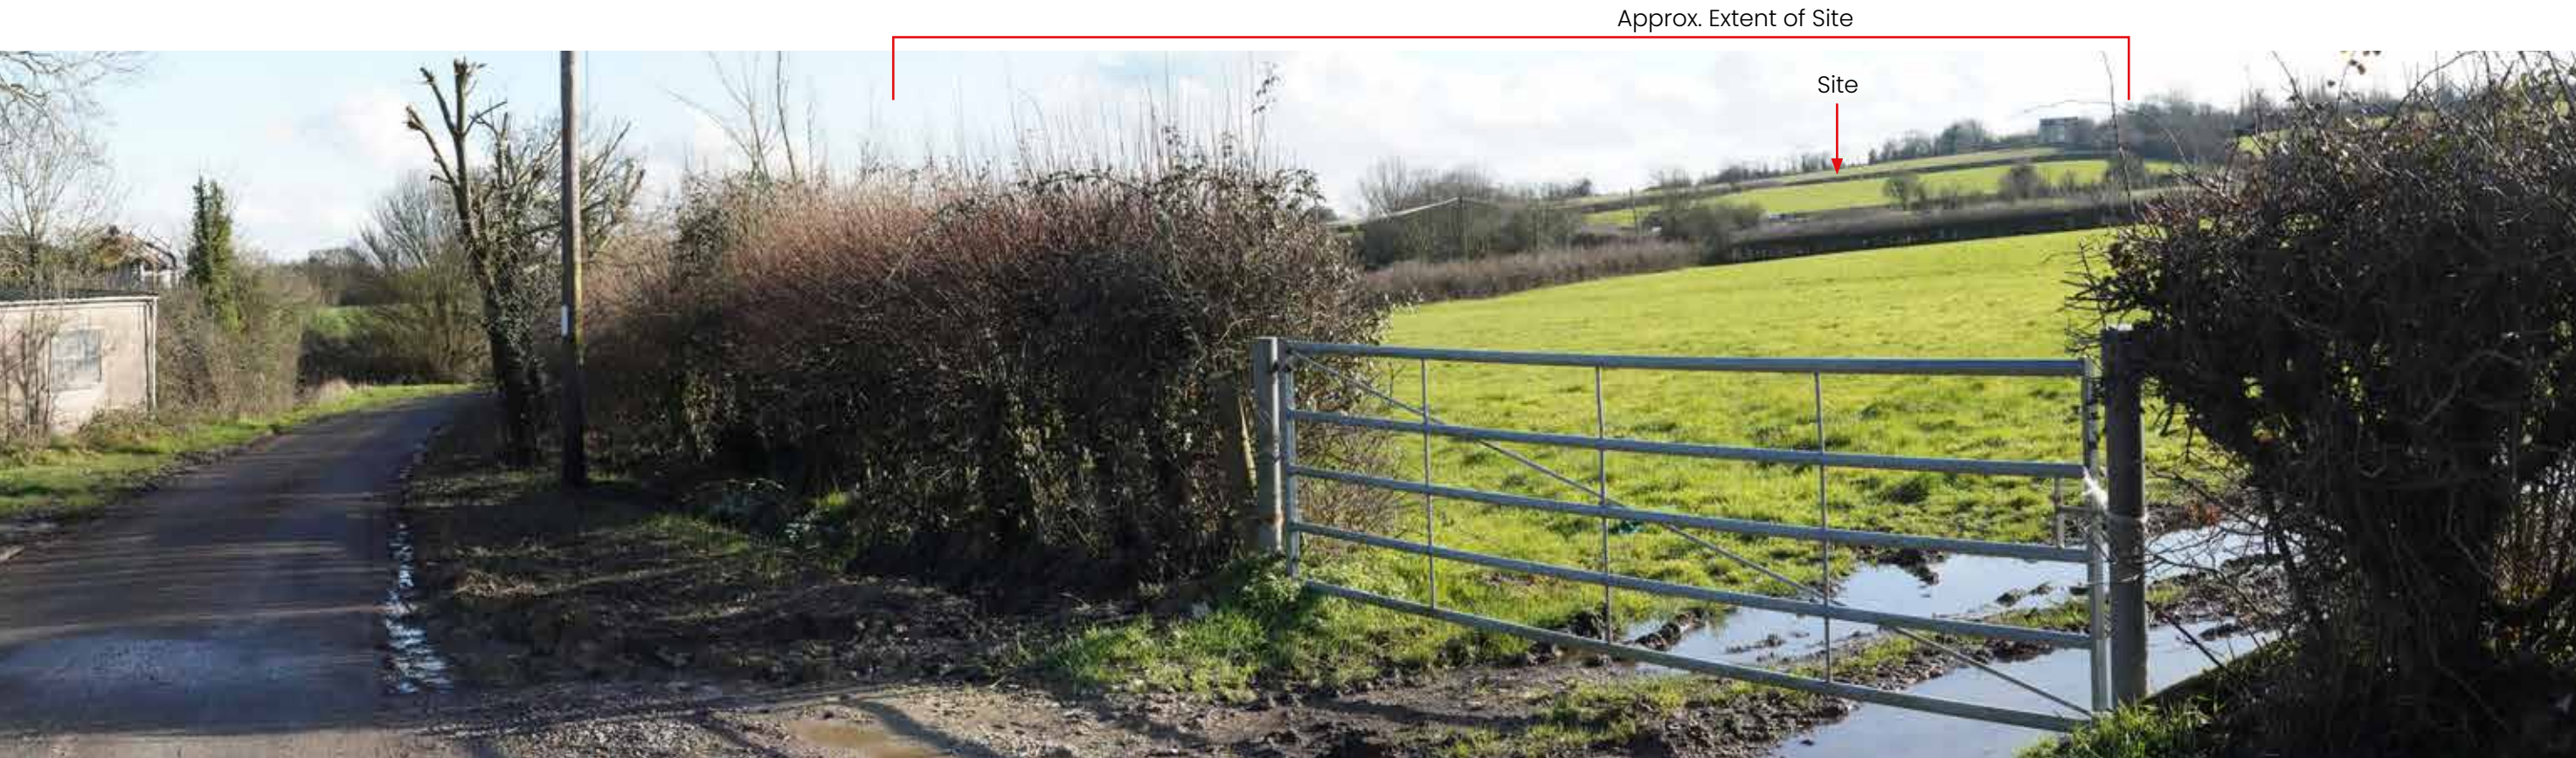
Viewpoint 8 – View from Hailstone Farm along Stones Lane looking south

| Time and Date: | 14:58<br>04.02.16 | Receptors | Road users and pedestrians | Proposed View | The proposed development will be visible in the middle distance, with views of new dwellings filtered by proposed scattered tree planting within an area of proposed open space (SANG) to the north of the site, including the retained existing hedgerow and proposed scrub planting. |
| Visualisation Type: | Type 1 | | | Magnitude of Change | Low – moderate addition of features in the view at mid-distance |
| Projection | Cylindrical | Existing View | View along Stones Lane with farm buildings to the left, and pastoral fields bound by hedgerows to the right. A field gate opening sits in the foreground of the view, between hedgerows that bound a pastoral field in the foreground. Beyond this field are numerous other pastoral fields, one of which is the site, visible in the distance in front of the property at Common Hill Farm. | Visual Impact at Year 1 | Slight adverse |

| Focal Length: | 50mm | Receptor Sensitivity | Medium | Mitigation & Enhancement | Setting back of the residential development to the south, behind an area of open space and part of the proposed SANG, including scattered tree planting and retention of existing hedgerows. |
| | | | | Residual Impact at Year 15 | Negligible adverse – as proposed planting matures |

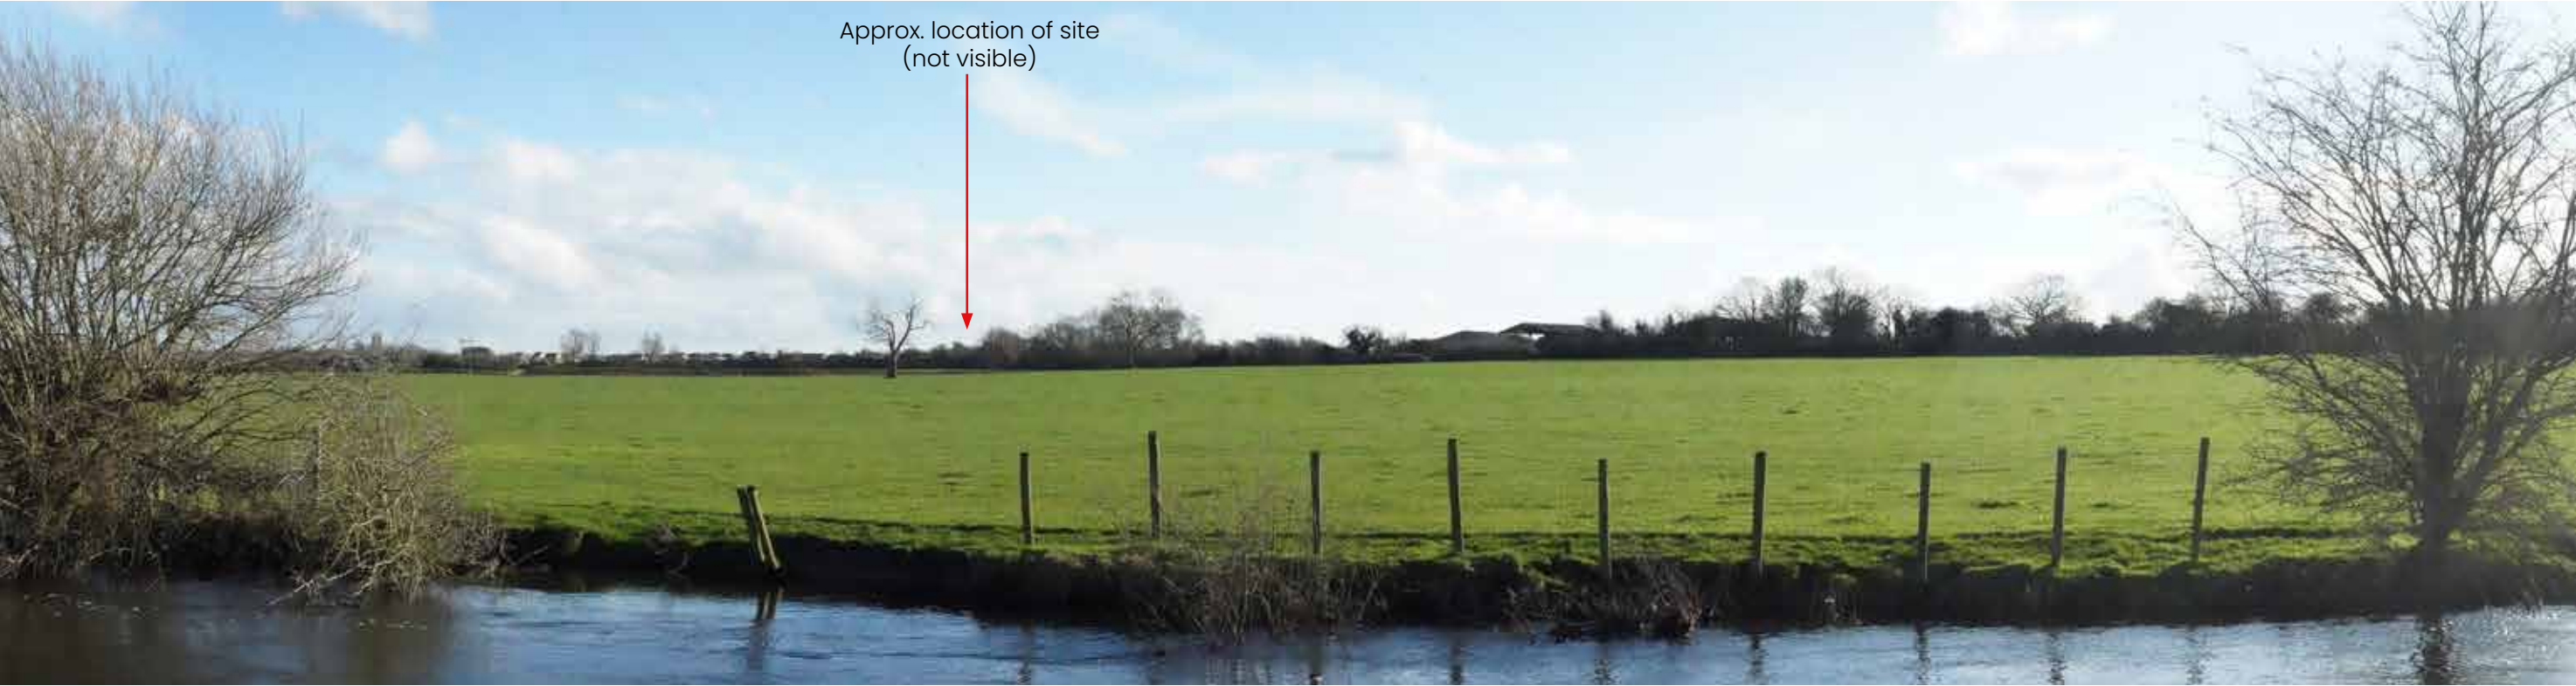
Viewpoint 10 – View from where the Thames Path joins public footpath CRIC35/the Thames and Severn Way, looking south

| Time and Date: | 15:55<br>04.02.26 | Receptors | Footpath users | Proposed View | The proposed development is not anticipated to be visible from this location due to the intervening landform and vegetation. |
| Direction of View: | South | Receptor Susceptibility | High – PROW users | Magnitude of Change | No change |
| Focal Length: | 50mm | Existing View | View over low lying pastoral field across River Thames in the foreground with riverside trees and post and wire field boundary. Vegetation line in the mid-distance with buildings at Hailstone Farm beyond and properties on the edge of Cricklade discernible in the distance to the left. | Residual Impact at Year 15 | None |

| Distance to Site: | 450m | Value of View | Medium – moderate scenic quality within undesignated landscape | Mitigation & Enhancement | None required |
| Camera: | Sony A7III<br>Full Frame | Receptor Sensitivity | High | Visual Impact at Year 1 | None |
