## **Land West of Bliss Farm, Trowbridge, BA14 6DS**

### **Ground Investigation**

**Hills Homes Developments Ltd**

**November 2024**

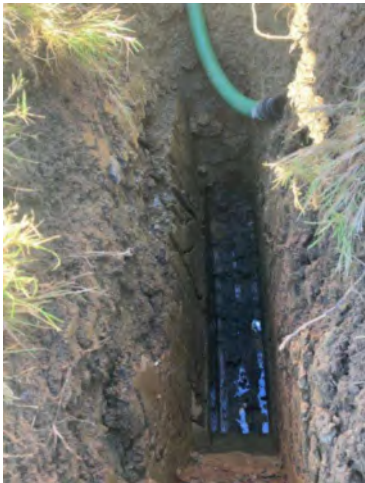
| Depth (m) | Sample / Tests | Water Depth (m) | Field Records | Level (mOD) | Depth (m) (Thickness) | Description | Legend | Water |
|---|---|---|---|---|---|---|---|---|
| | | | | | | Stiff light blue grey slightly sandy CLAY. Abundant pockets of selenite crystals present. (WEATHERED OXFORD CLAY FORMATION) | | |

| <b>Remarks</b><br><br>Infiltration testing performed.<br>Trial pit sides remained stable upon completion.<br>No obvious roots observed.<br>No groundwater encountered during excavation.<br>Trial pit backfilled with arisings.<br>No obvious signs of contamination noted.<br><br>Logged in accordance BS5930:2015 | | |

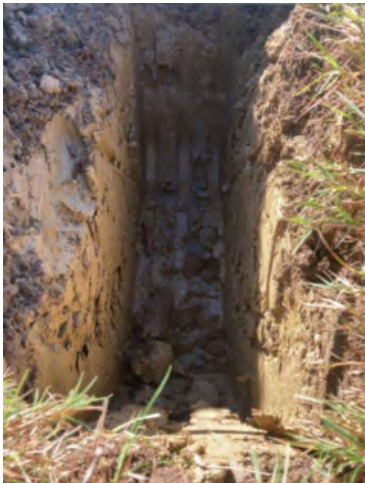
| 0.10<br>0.30<br>0.30<br>0.40<br>0.50<br>0.60<br>0.80<br>0.90 | C<br>C<br>D<br>80kPa<br>D<br>C<br>D<br>130kPa | | | | <div><div></div><div>(0.20)</div><div></div><div>(0.20)</div><div></div><div>(0.25)</div><div></div><div>(0.45)</div><div></div><div>(0.55)</div><div></div><div>1.00</div></div> | <div>Grass onto, dark brown slightly sandy slightly gravelly CLAY. Gravel is fine to medium flint. (TOPSOIL LIKE MADE GROUND)</div> <div>Firm dark brown slightly sandy slightly gravelly CLAY. Gravel is composed of fine to medium subangular to subrounded flint. (ALLUVIUM)</div> <div>Stiff light blue mottled orange and brown slightly sandy CLAY. Abundant pockets of selenite crystals present. (WEATHERED OXFORD CLAY FORMATION)</div> <div>Complete at 1.00m</div> | <div><div></div><div></div><div></div><div></div></div> | | |
| | | | | | | Remarks<br>Infiltration testing performed.<br>Trial pit sides remained stable upon completion.<br>No obvious roots observed.<br>No groundwater encountered during excavation.<br>Trial pit backfilled with arisings.<br>No obvious signs of contamination noted. | | | |

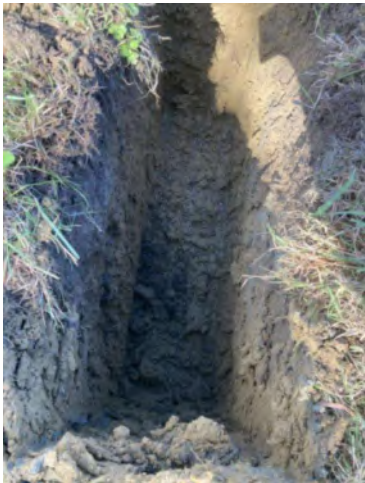
| 1.00<br>1.06<br><br>1.50<br>1.50 | D<br>10kPa<br><br>5kPa<br>D | | | | (1.50) | Stiff light blue mottled orange and brown slightly sandy CLAY. Abundant pockets of selenite crystals present. (WEATHERED OXFORD CLAY FORMATION) | | | |
| | | | | | | Remarks<br><br>No obvious signs of contamination noted.<br>Trial pit backfilled with arisings.<br>No groundwater encountered during excavation.<br>No obvious roots observed.<br>Trial pit sides remained stable upon completion.<br>Infiltration testing performed. | | | |

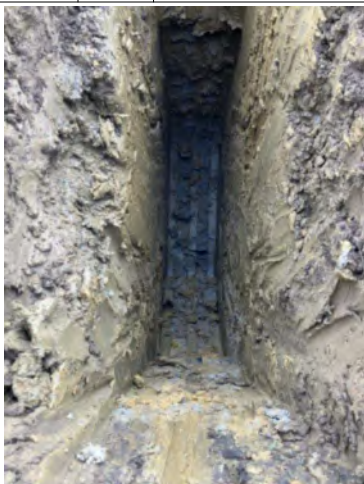
| | | | | | (1.00) | Stiff light blue mottled orange and brown slightly sandy CLAY. Abundant pockets of selenite crystals present. (WEATHERED OXFORD CLAY FORMATION) | | | | |
| | | | | | LWD testing performed at c.0.50m depth.<br>Trial pit sides remained stable upon completion.<br>No obvious roots observed.<br>No groundwater encountered during excavation.<br>Trial pit backfilled with arisings.<br>No obvious signs of contamination noted. | | | | | |

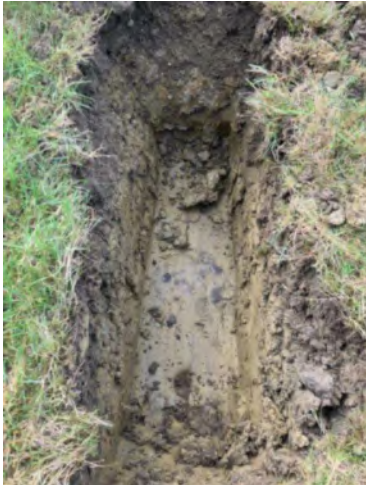
| <div>0.30</div> | <div>D</div> | | | | <div> <div>(0.20)</div> <div>0.20</div> <div>(0.30)</div> <div>0.50</div> <div>(0.40)</div> <div>0.90</div> </div> | <div> <div>Grass onto, firm dark brown slightly sandy gravelly organic CLAY. Gravel is composed of fine to medium flint. (TOPSOIL LIKE MADE GROUND)</div> <div>Firm dark brown mottled orange slightly sandy slightly gravelly CLAY. Gravel is composed of fine to medium subangular to subrounded flint. (ALLUVIUM)</div> <div>Soft yellow brown very sandy slightly gravelly CLAY. Gravel composed of fine to coarse subangular to subrounded flint. (ALLUVIUM)</div> <div>Complete at 0.90m</div> </div> | | <div> </div> | |
| <div> </div> | | | | | | <div> <div>Remarks</div> <div> LWD testing performed at c.0.50m depth.<br/> Trial pit sides remained stable upon completion.<br/> No obvious roots observed.<br/> No groundwater encountered during excavation.<br/> Trial pit backfilled with arisings.<br/> No obvious signs of contamination noted. </div> <div> <div>Logged in accordance BS5930:2015</div> <div> <div>Scale (approx)</div> <div>1:50</div> </div> <div> <div>Logged By</div> <div>AA</div> </div> <div> <div>Figure No.</div> <div>P24-286.TP02</div> </div> </div> </div> | | | |

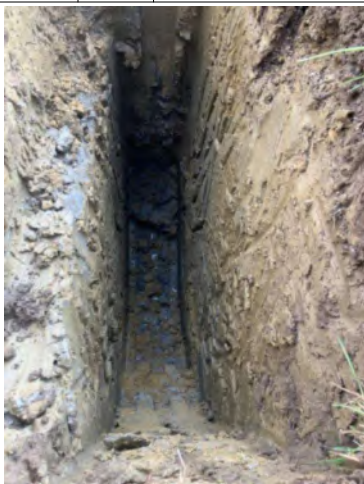
| 1.90 | D | | | | (2.10) | Stiff light blue mottled orange and brown slightly sandy CLAY. Abundant pockets of selenite crystals present. (WEATHERED OXFORD CLAY FORMATION) | | | | | |
| | | | | | | <div>Remarks</div> <div>LWD testing performed at c.0.50m depth.<br/>Trial pit sides remained stable upon completion.<br/>No obvious roots observed.<br/>No groundwater encountered during excavation.<br/>Trial pit backfilled with arisings.<br/>No obvious signs of contamination noted.</div> | | | | | |

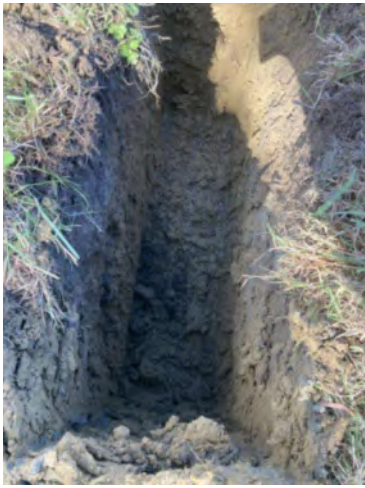
| | <b>Remarks</b><br><br>LWD testing performed at c.0.50m depth.<br>Trial pit sides remained stable upon completion.<br>No obvious roots observed.<br>No groundwater encountered during excavation.<br>Trial pit backfilled with arisings.<br>No obvious signs of contamination noted. | | |

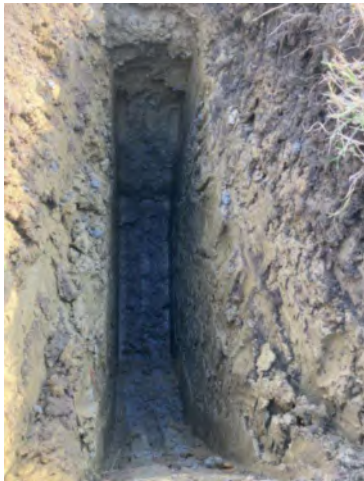
| | | | | | 1.00 | | Stiff light blue mottled orange and brown slightly sandy CLAY. Abundant pockets of selenite crystals present. (WEATHERED OXFORD CLAY FORMATION) | | |
| <div><div></div><div>Remarks<br/><br/>LWD testing performed at c.0.50m depth.<br/>Trial pit sides remained stable upon completion.<br/>No obvious roots observed.<br/>No groundwater encountered during excavation.<br/>Trial pit backfilled with arisings.<br/>No obvious signs of contamination noted.<br/><br/>Logged in accordance BS5930:2015</div></div> | | | | | | | | | |

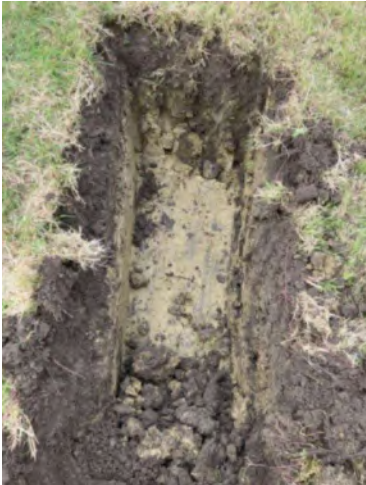
| 0.10<br>0.25<br>0.50 | C<br>D<br>D | | | | <div><div>(0.20)</div><div>(0.20)</div><div>(0.30)</div><div>(0.50)</div><div>(0.30)</div><div>(0.80)</div></div> | <div><div>Grass onto, firm dark brown slightly sandy gravelly organic CLAY. Gravel is composed of fine to medium flint. (TOPSOIL LIKE MADE GROUND)</div><div>Firm dark brown mottled orange slightly sandy slightly gravelly CLAY. Gravel is composed of fine to medium subangular to subrounded flint. (ALLUVIUM)</div><div>Stiff light blue mottled orange and brown slightly sandy CLAY. Abundant pockets of selenite crystals present. (WEATHERED OXFORD CLAY FORMATION)</div><div>Complete at 0.80m</div></div> | <div><div></div><div></div><div></div></div> | | |
| <div></div> | | | | | | Remarks<br><br>LWD testing performed at c.0.50m depth.<br>Trial pit sides remained stable upon completion.<br>No obvious roots observed.<br>No groundwater encountered during excavation.<br>Trial pit backfilled with arisings.<br>No obvious signs of contamination noted. | | | |

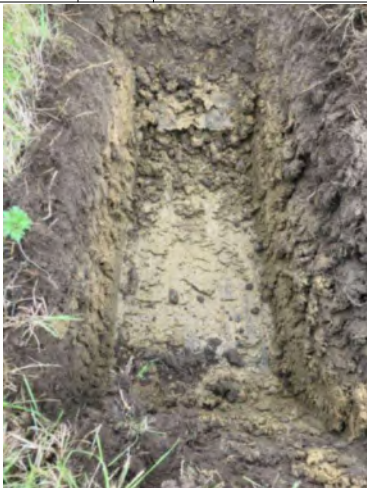
| Depth (m) | Sample / Tests | Water Depth (m) | Field Records | Level (mOD) | Depth (m) (Thickness) | Description | Legend | Water |
|---|---|---|---|---|---|---|---|---|
| | | | | | 0.80 | Complete at 0.80m | | |

| <b>Remarks</b><br><br>LWD testing performed at c.0.50m depth.<br>Trial pit sides remained stable upon completion.<br>No obvious roots observed.<br>No groundwater encountered during excavation.<br>Trial pit backfilled with arisings.<br>No obvious signs of contamination noted. | | |

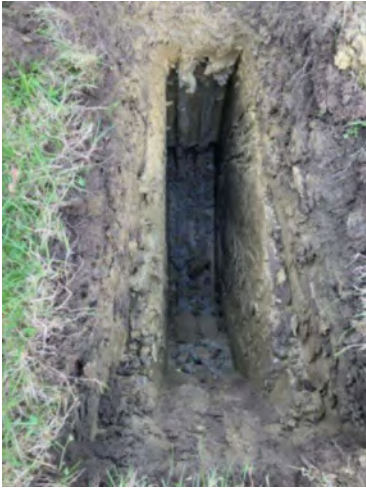
| | <b>Remarks</b><br><br>LWD testing performed at c.0.50m depth.<br>Trial pit sides remained stable upon completion.<br>No obvious roots observed.<br>No groundwater encountered during excavation.<br>Trial pit backfilled with arisings.<br>No obvious signs of contamination noted. | | |

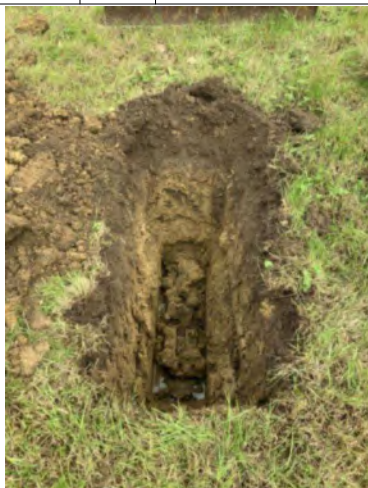
| Depth (m) | Sample / Tests | Water Depth (m) | Field Records | Level (mOD) | Depth (m) (Thickness) | Description | Legend | Water |
|---|---|---|---|---|---|---|---|---|
| 0.50 | C | | | | (0.80) | Firm dark brown mottled orange slightly sandy slightly gravelly CLAY. Gravel is composed of fine to medium subangular to subrounded flint. (ALLUVIUM) | | |

LWD testing performed at c.0.50m depth.  
Trial pit sides remained stable upon completion.  
No obvious roots observed.  
No groundwater encountered during excavation.  
Trial pit backfilled with arisings.  
No obvious signs of contamination noted.
