# INTERNAL PHOTOGRAPHS

## PURTON HOUSE CHURCH END PURTON

25-168

### Refurbishment & Repairs

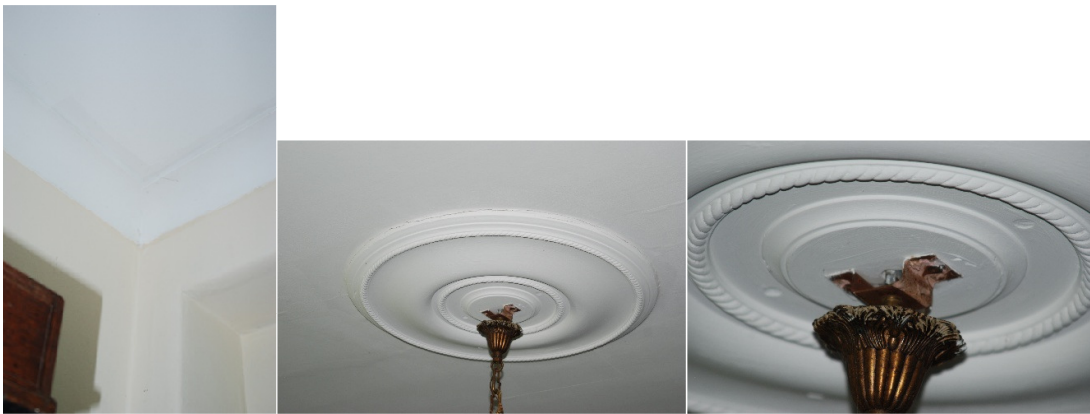
## Ceiling

The coving is not original, and neither is the ceiling rose. The ceiling rose is not central of the room. Both the coving and the ceiling rose are the result of an interior design makeover of the 1980's, with the items purchasable from a local DIY store of its day. The ceiling rose is poorly fitted to the ceiling with visible screws present. The fixing of the light fitting is reliant on the electrical wiring to hold it to the ceiling.

As well as providing support to the light fitting the remainder of the electrics has been added as and when required resulting in exposed wiring and boxed fittings, all of which currently detract from the appearance of the room but more importantly offer a great risk to the safe operation of the room as the wiring is not even covered in trunking but left exposed with insufficient clips to adequately retain the cables securely against the walls.

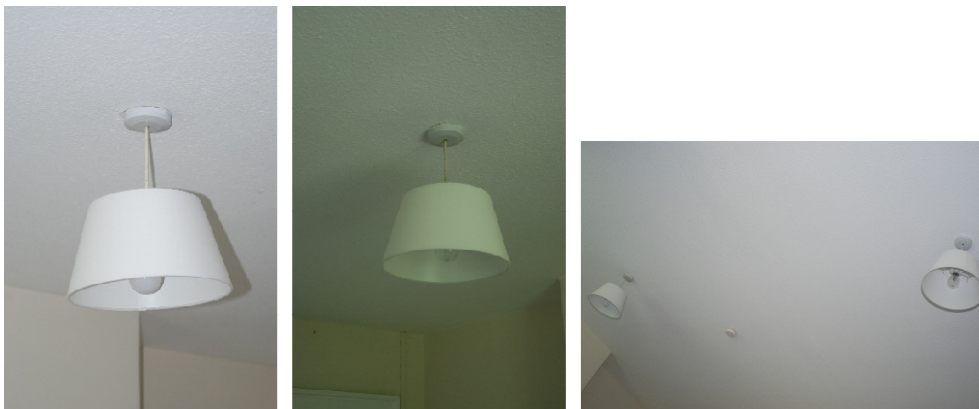
Ceiling

Two light fittings to this room neither of which are centrally located & and considering the current location of sanitary fittings, is a disaster waiting to happen with regard to the proximity of live electrical wiring and water.

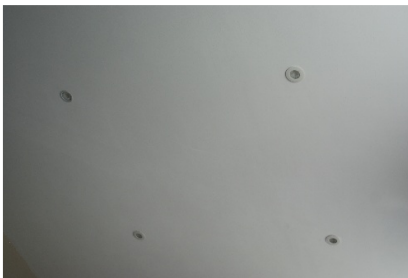
Ceiling

Four recessed halogen style light fittings to this room.

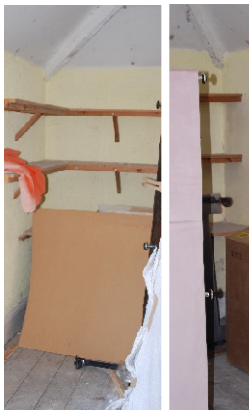
Wall D

There is clear 'scarring' to this room of previous changes to it's layout.
